Lessons Learned

Parkview Avenue Bridge over US 131

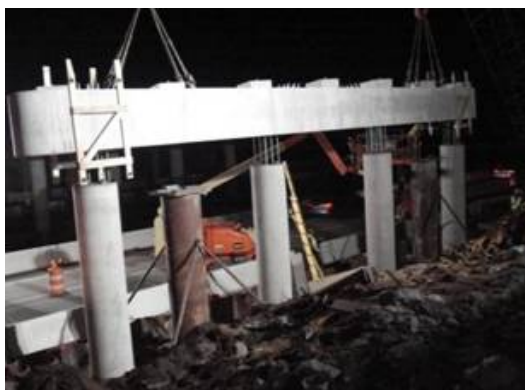
1(a) Pier cap placement

During placement of pier caps, to align reinforcement with the corrugated ducts in the pier cap to establish the connection, a construction worker had to stay in a bucket truck more than 20 ft in the air (Figure 1a).

Pier erection is an issue with grouted post-tensioned ducts or sleeves. Caps than span a maximum of three columns can reduce the likelihood of alignment issues. Wide bridges can be designed with two cap pieces and an expansion joint. If necessary, the caps can be connected with a cast-in-place closure pour. The caps can be designed to work without the closure pour for dead load, thereby allowing erection of the superstructure prior to placement and curing of the joint.

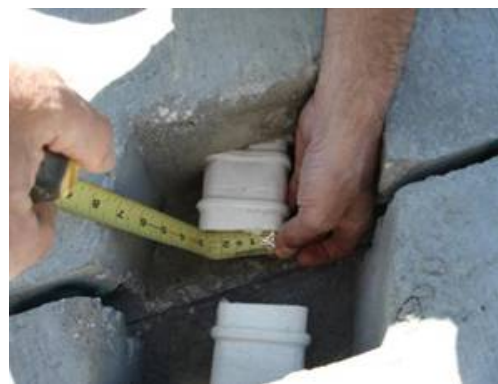
1(b) Post-tension duct misalignment

All 48 full-depth deck panels were placed over the beams in four days. Post-tensioning duct misalignments were observed after placing all the panels and aligning the shear pockets in the panels with the shear stud locations on the beams (Figure 1b). After evaluating several alternatives, the 48 panels were re-cast; the re-casting resulted in a two-month delay. When the new panels were placed on the girders, about 20 percent of the shear studs did not align because of girder geometric tolerances. This necessitated drilling new holes on the girder top flange. In addition, ad hoc changes to the original design details at the abutment that were made during construction may compromise durability of the structural system.

It is important to specify and enforce tolerances. Welding shear studs onto plates embedded in the girders after deck erection can eliminate shear stud misalignment issues. The post-tensioning alignment is a specification issue, requiring specification of a tight tolerance measured from a common working point. Also, 2-inch-diameter round ducts have more forgiveness since they can accommodate more than the typical four strands per duct.
