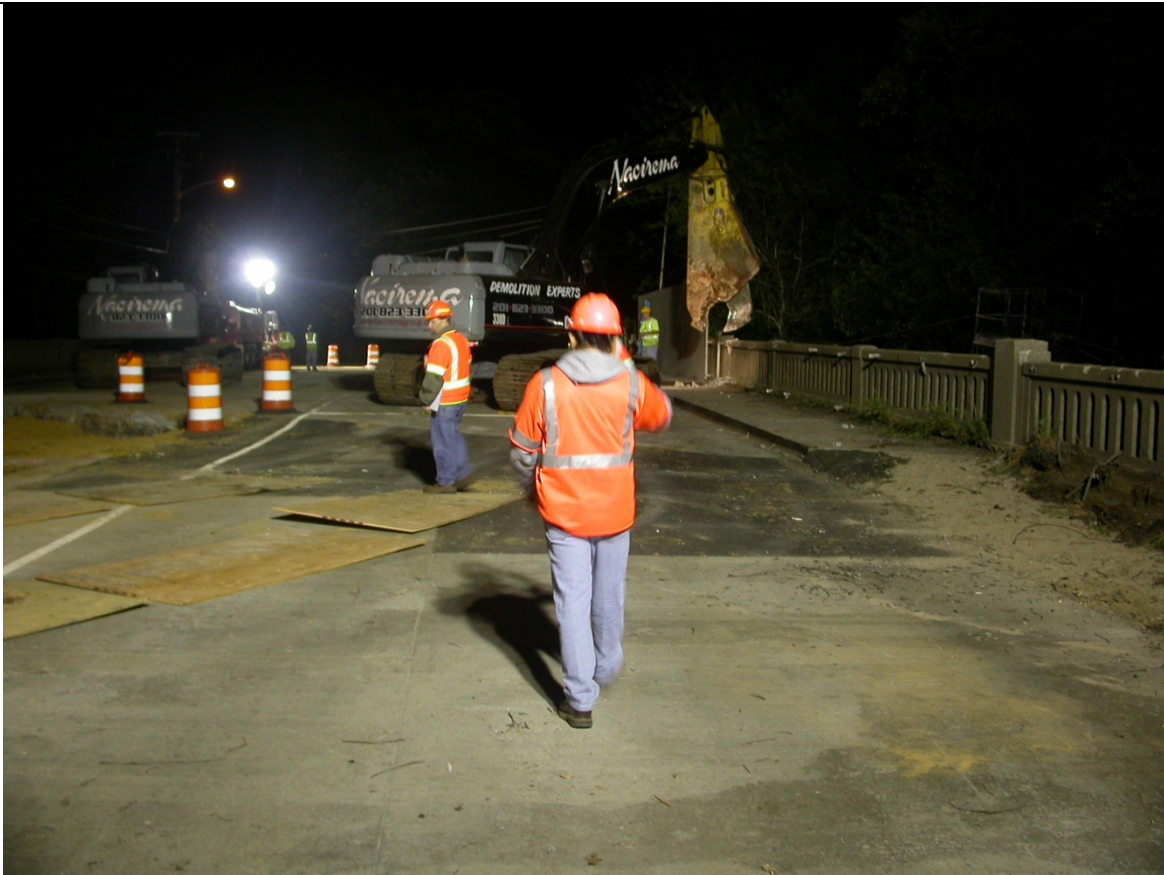
Photo 1: Balustrade removal during Stage 3 (Weekend) Construction, staging sequence suggested this to be done during Stage 2 Construction (per Sheet 31 of 56).

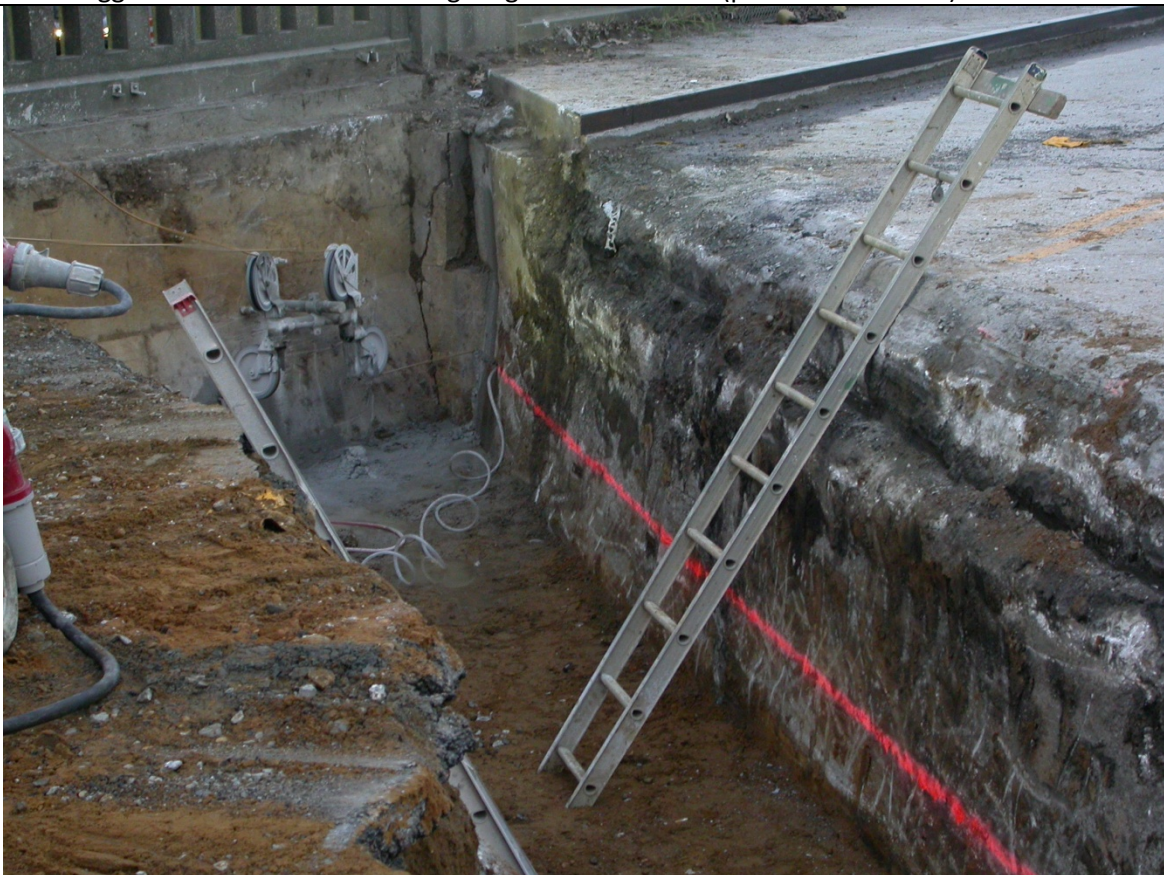
Photo 2: Backwall and South Wingwalls at Eastbound Lanes not cut during Stage 2, staging sequence suggested backwall removal and wingwall partial demo during Stage 2 (per sheet 31 of 50)

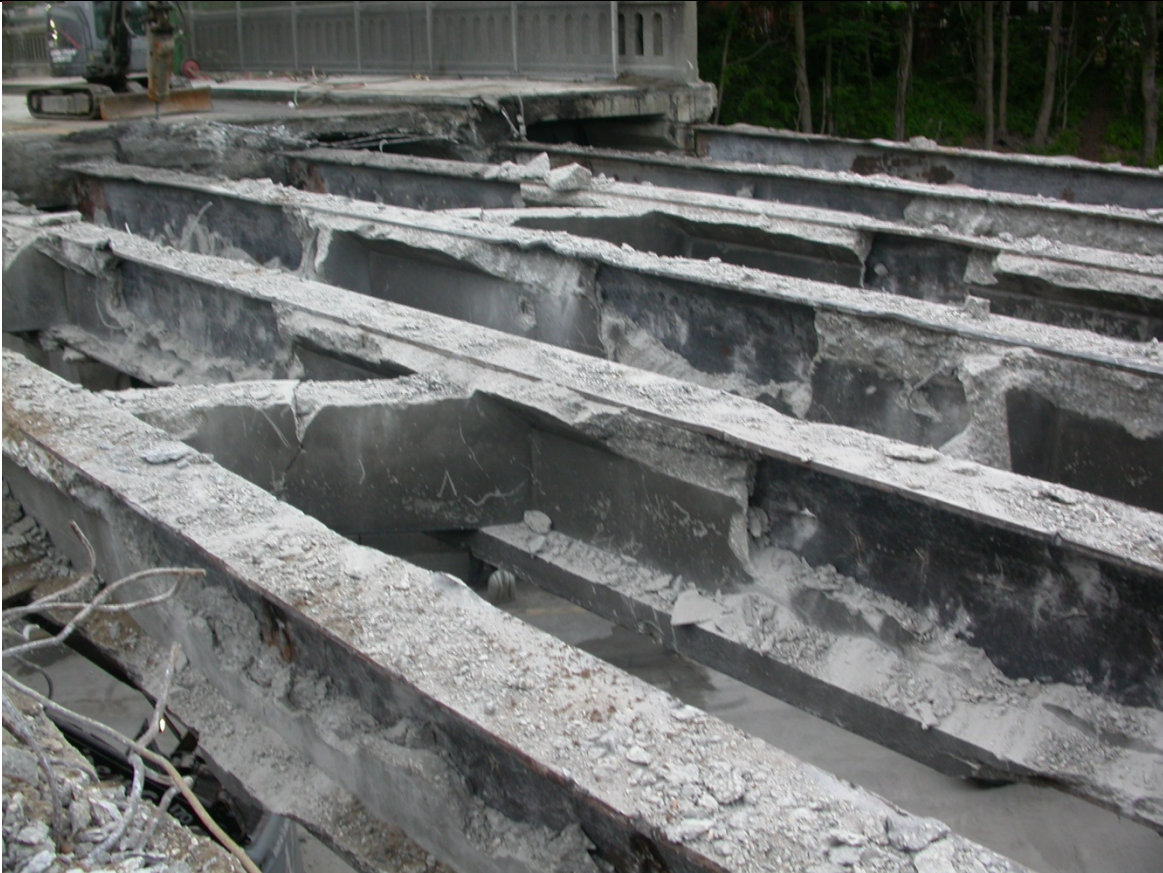
Photo 3: Extent of work to be demolished conventionally. Shown are the beams over Southbound Route 9 with deck removed – 12 hrs into Stage 3 (Weekend) Construction.

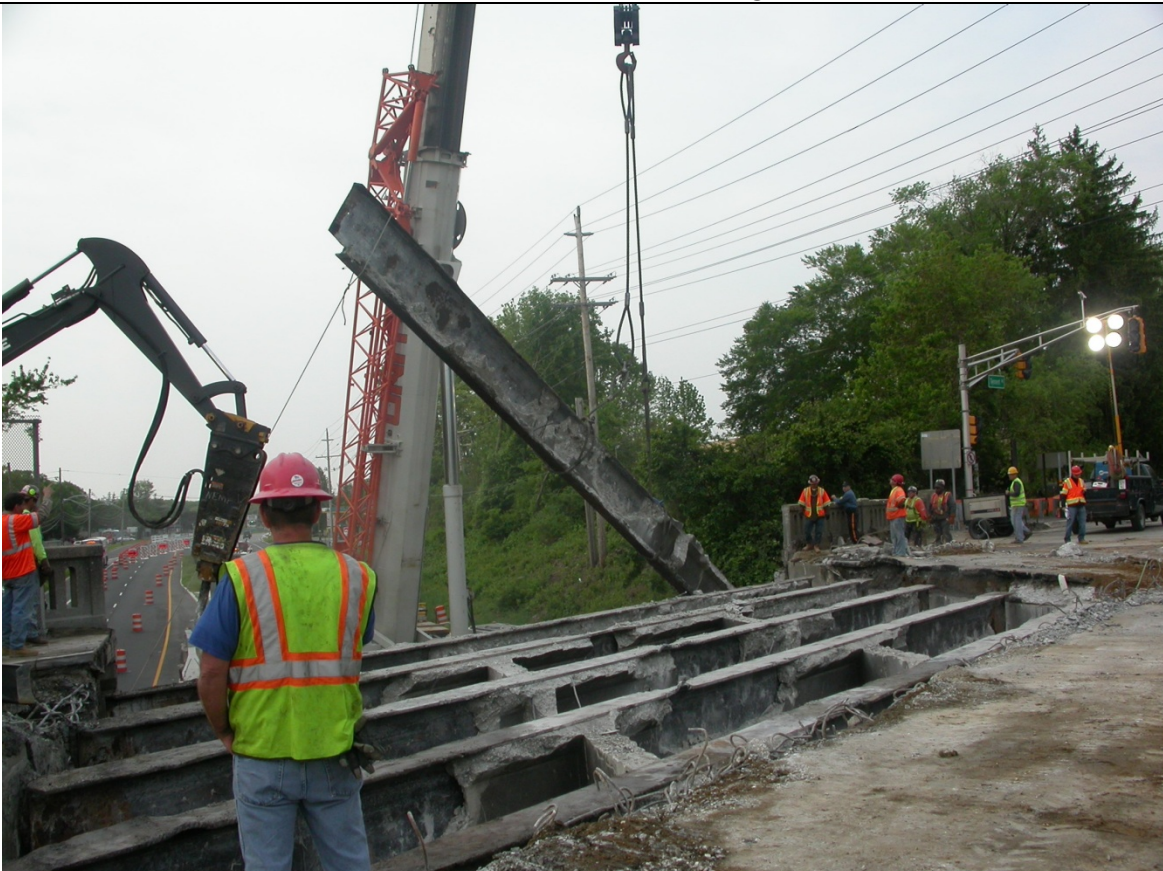
Photo 4: Difficulties removing South Fascia Beam, note that had utilities run along the South fascia instead of the north fascia the Verizon lines could have damaged.

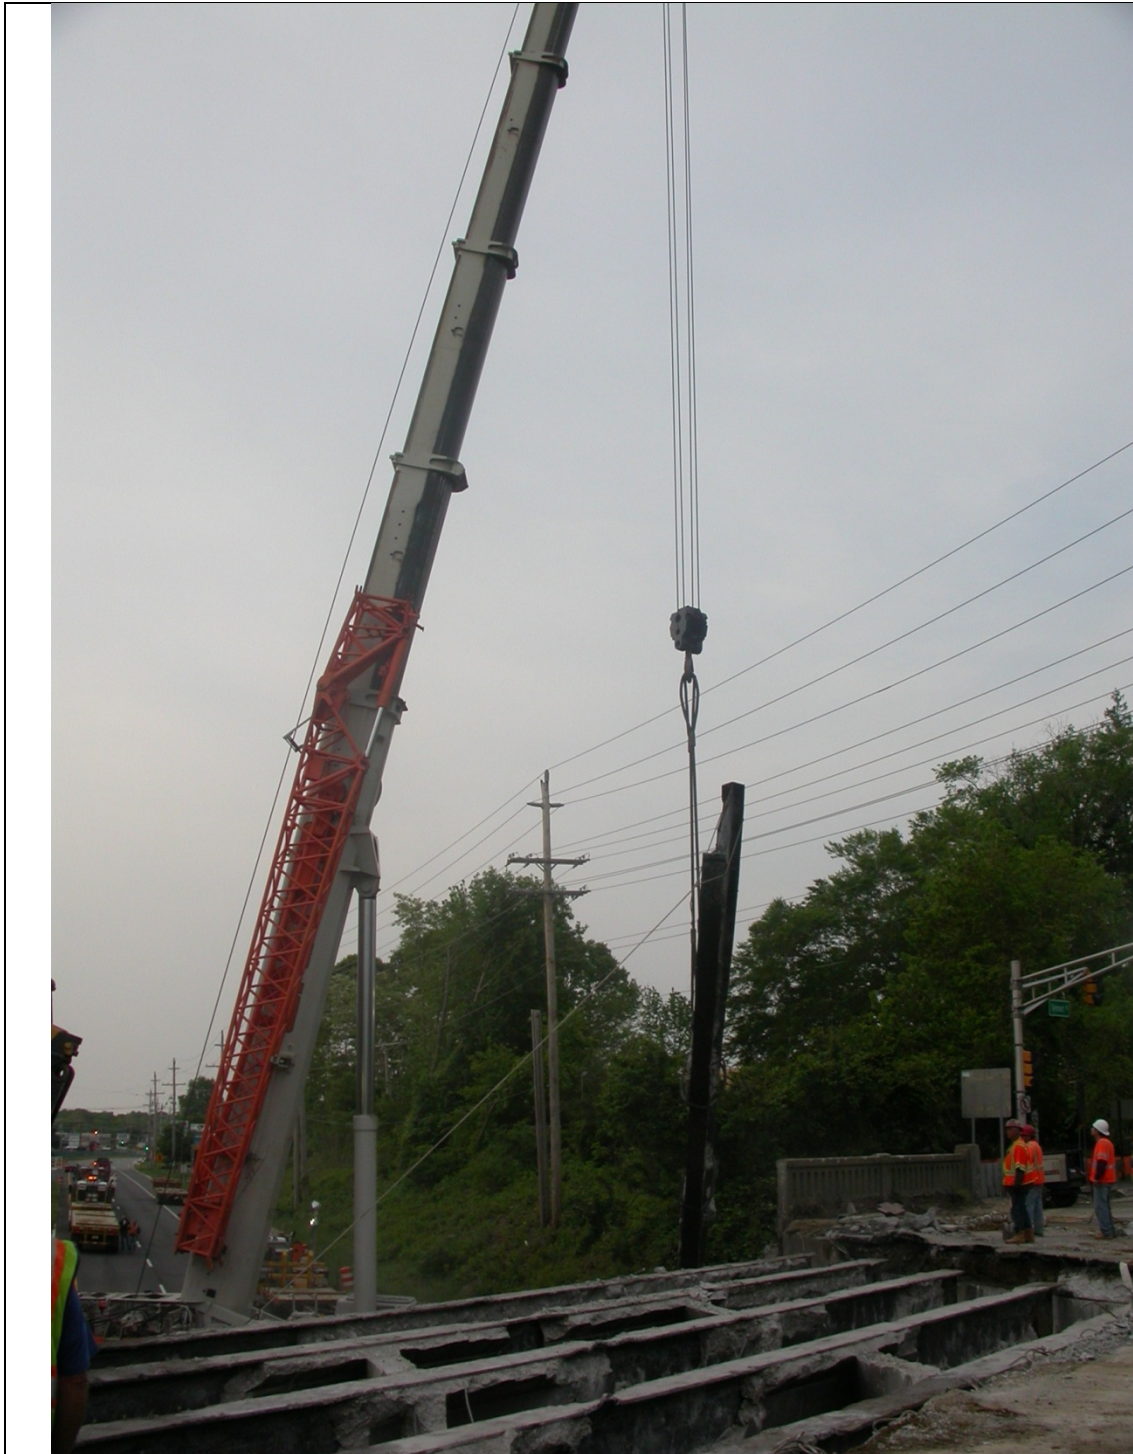
Photo 5: Continued difficulties removing Beams, note that had utilities run along the South fascia instead of the north fascia the Verizon lines could have damaged.

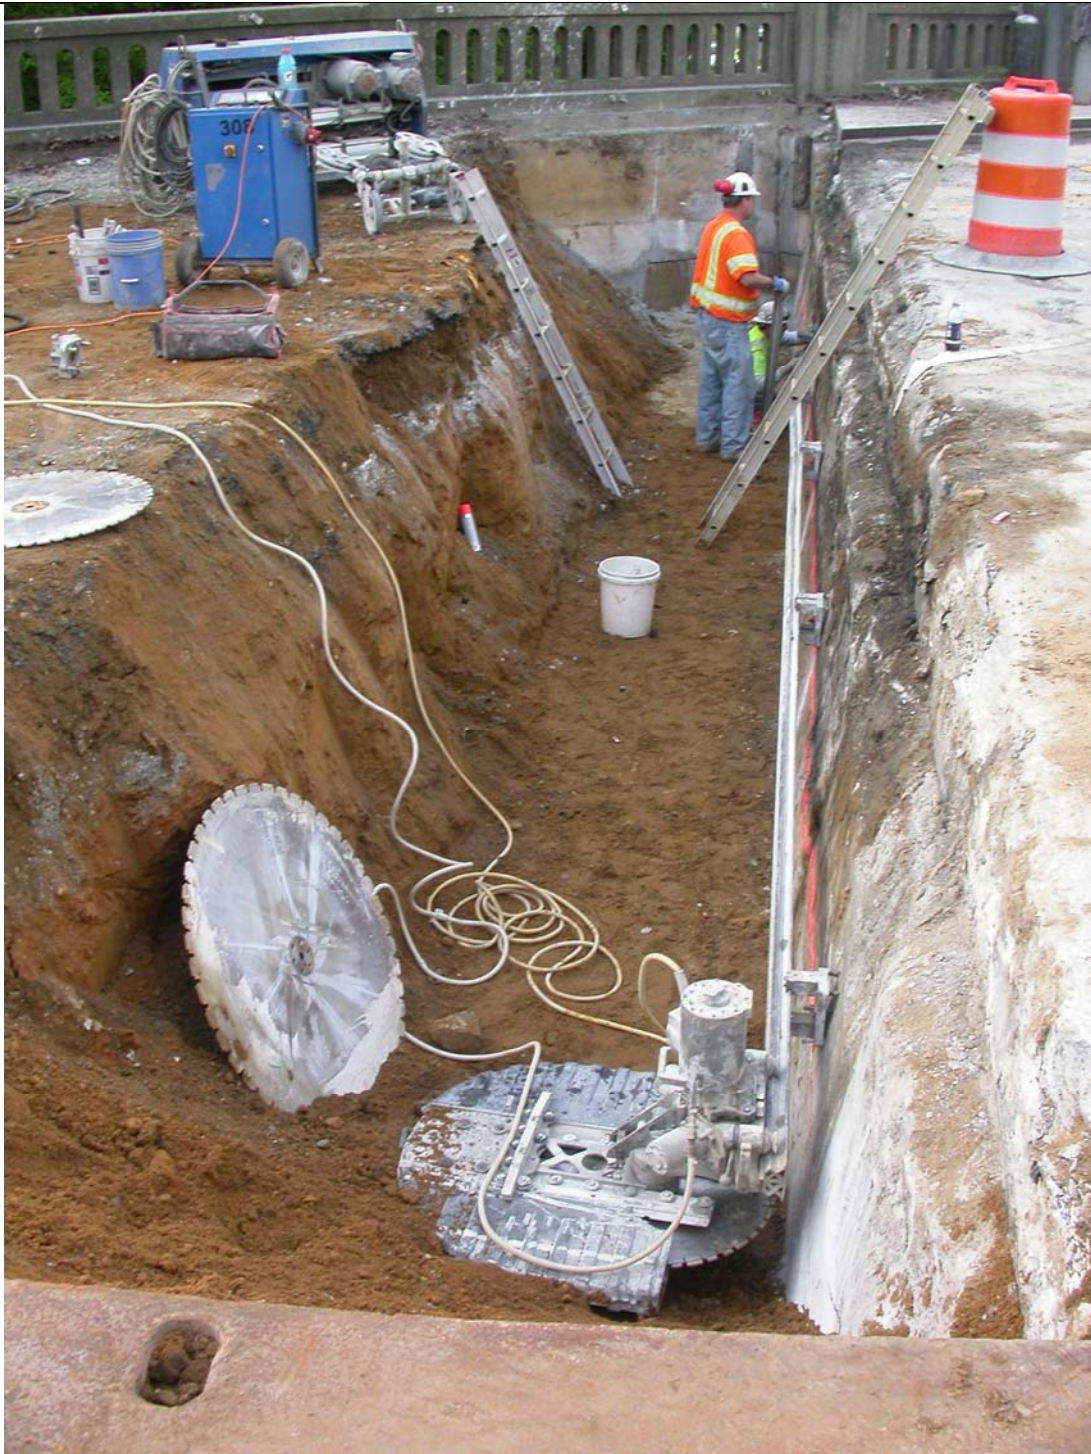
Photo 6: Extent of work cutting work remaining, backwall and wingwalls have not been removed - 12 hrs into Stage 3.

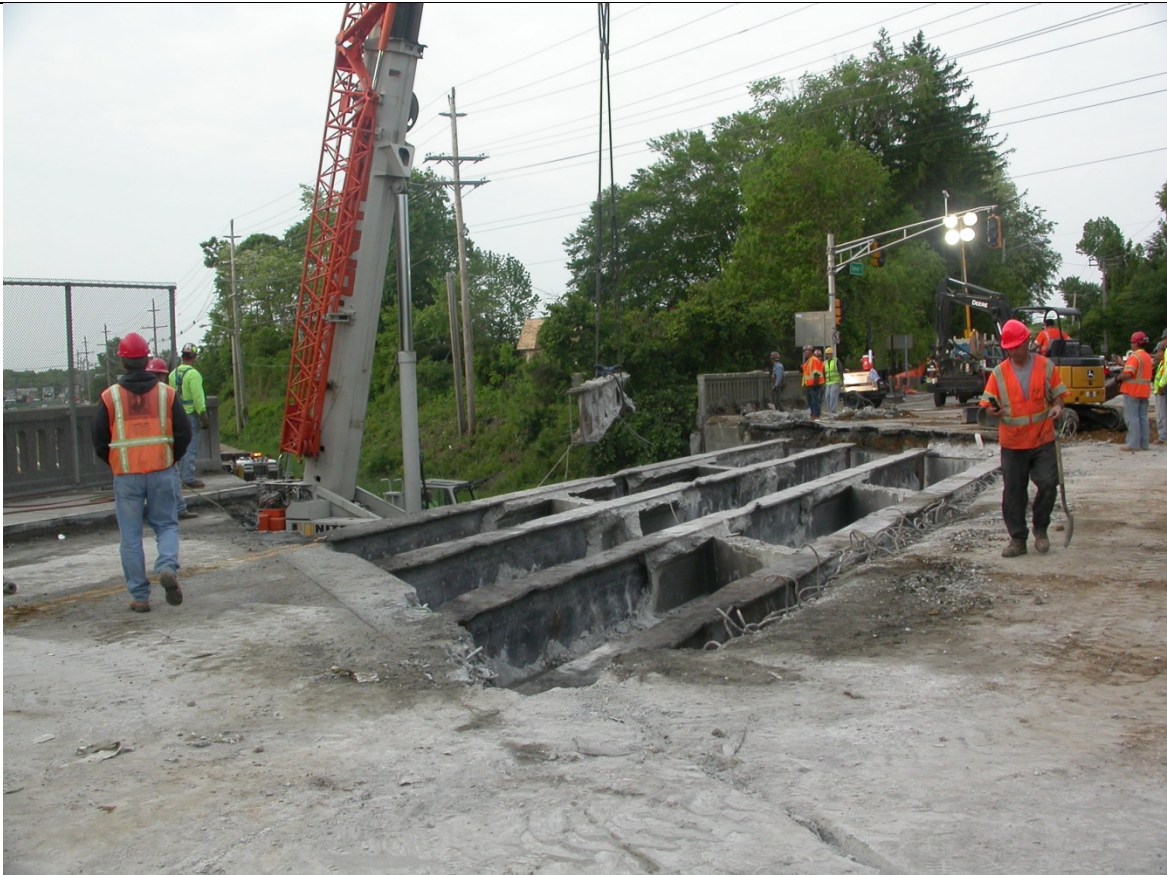
Photo 7: Completed Construction late Saturday Morning.

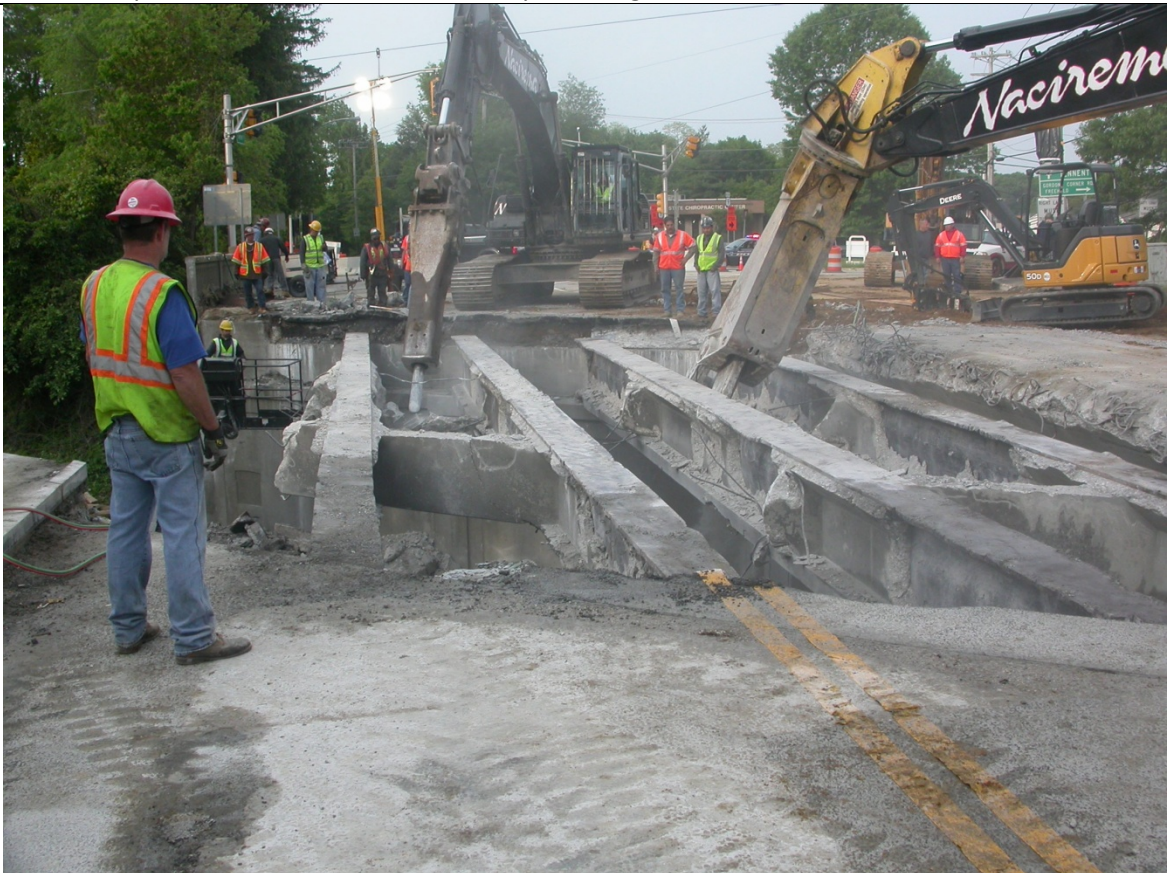
Photo 8: Contractor had to remove all diaphragms, because original demolition plan had shown that beams were to be removed in pairs, the Prime contractor had not informed the demolition contractor that they were removing beams one-by-one because the demolition technique proved inadequate.

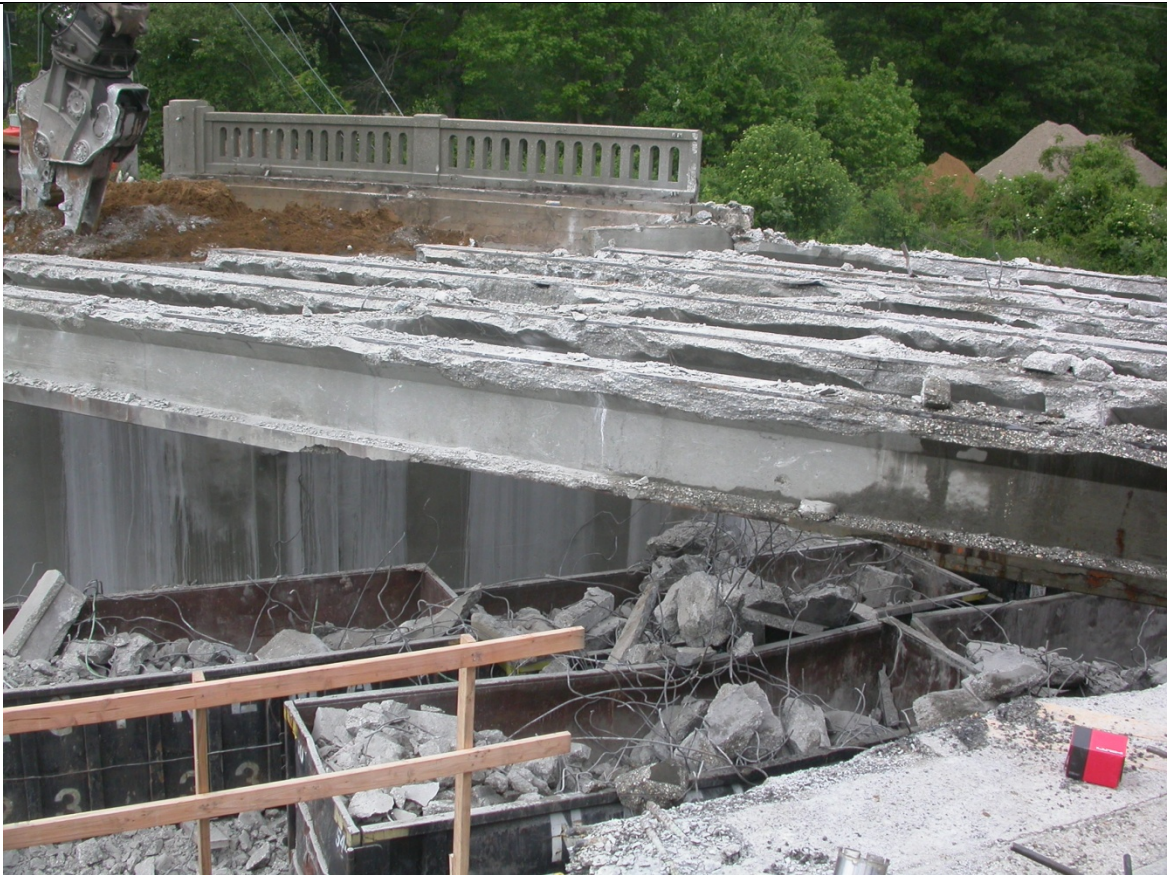
Photo 9: Dumpsters placed below the bridge to catch debris as excavators knocked deck and encasement from beams. Long periods of time were lost as dumpsters filled up and needed to be removed and new dumpsters installed. (18 hours into Stage 3)

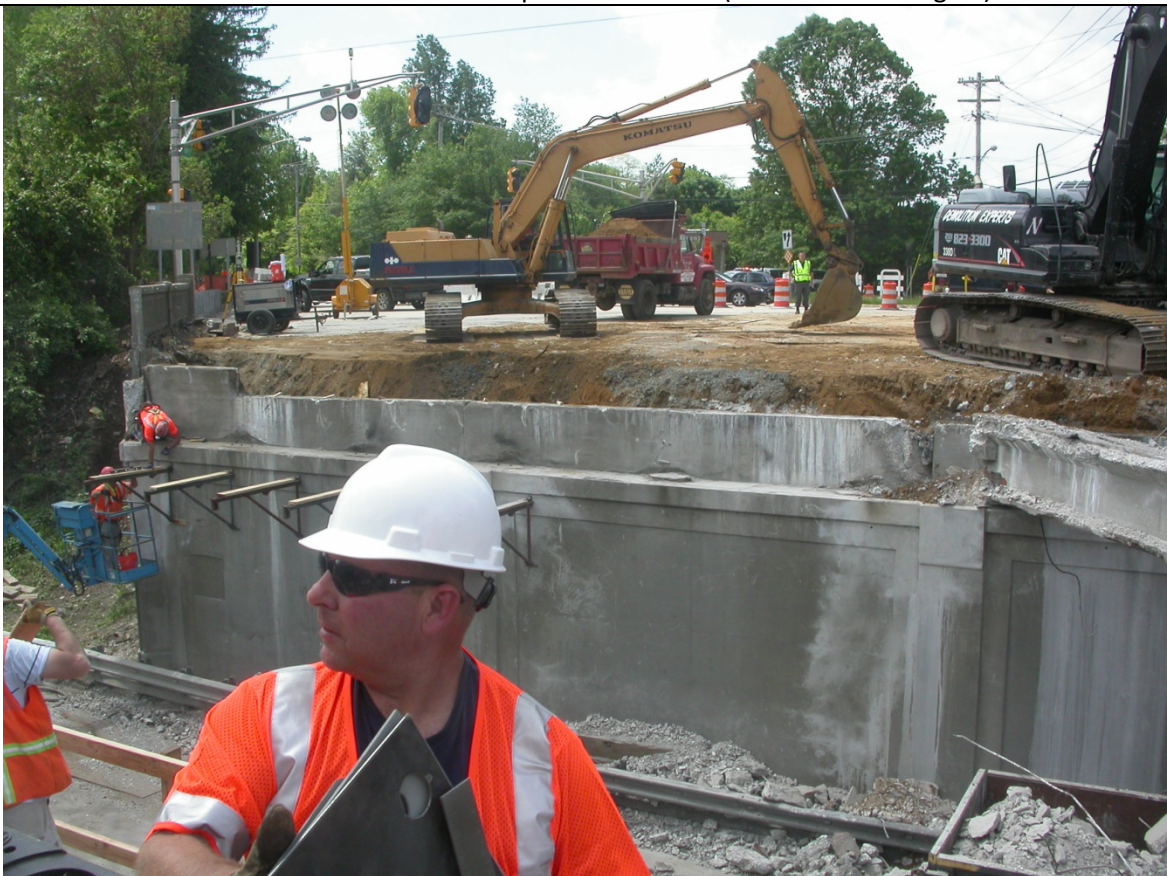
Photo 10: Backwall and Wingwalls have not been cut-down 18 hours into Demolition, the required cores for anchor bolts have not been begun.

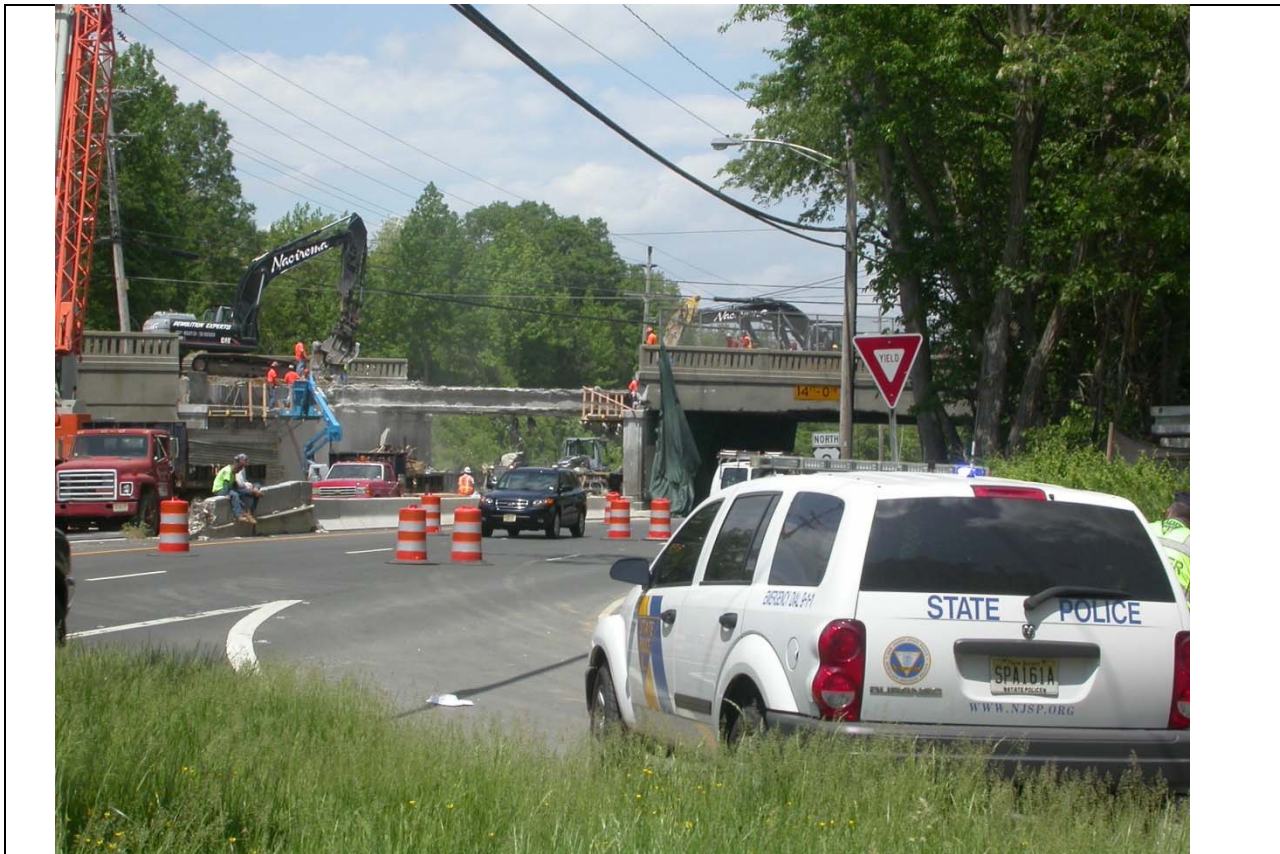
Photo 11: Saturday Morning approaching Noon.

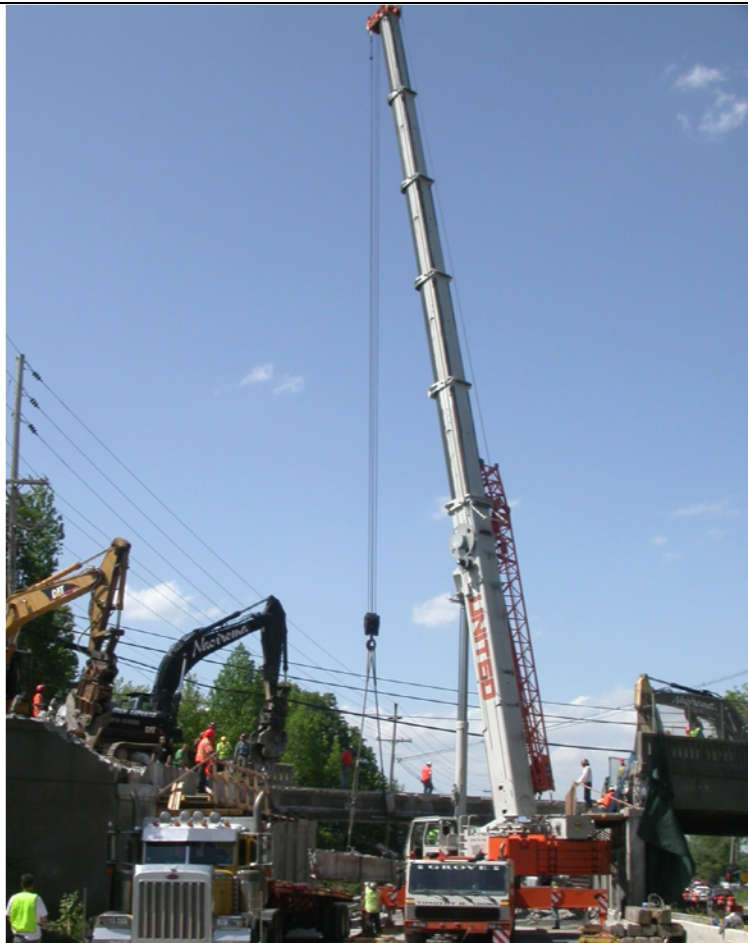
Photo 12: Crane Positioning for Beam removal, note that backwall and wingwalls are not cut (Sat 2pm).

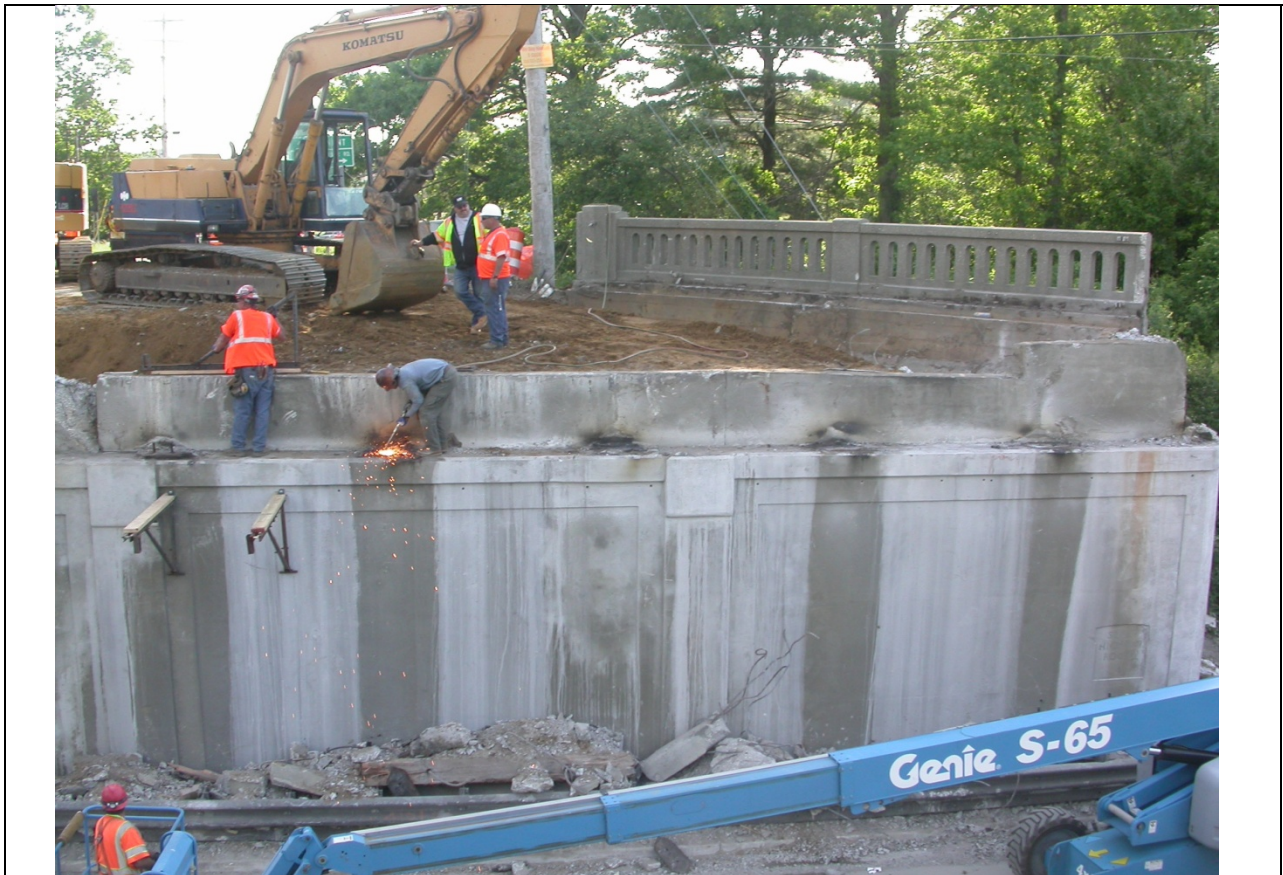
Photo 13: Limited demolition of the existing backwall has been performed. (Sat. 5pm)

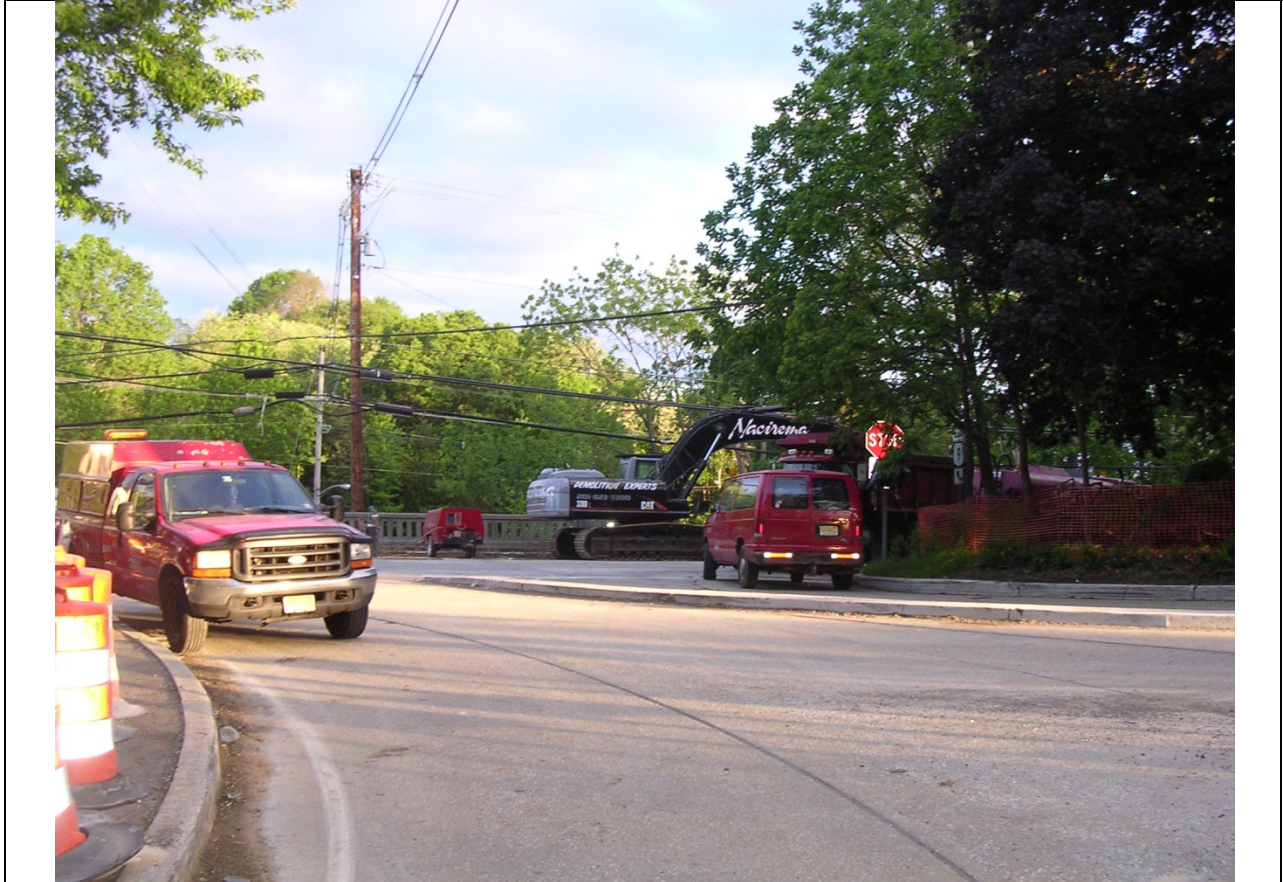
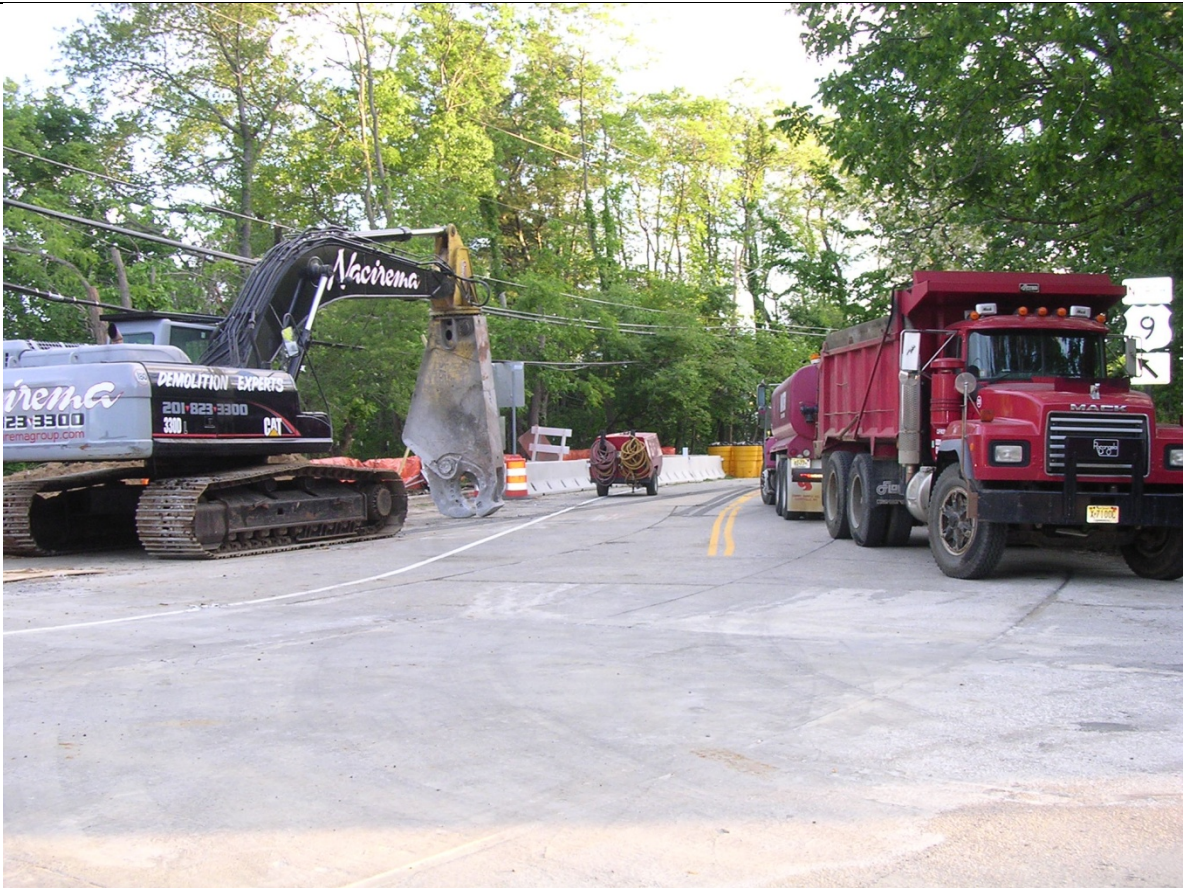
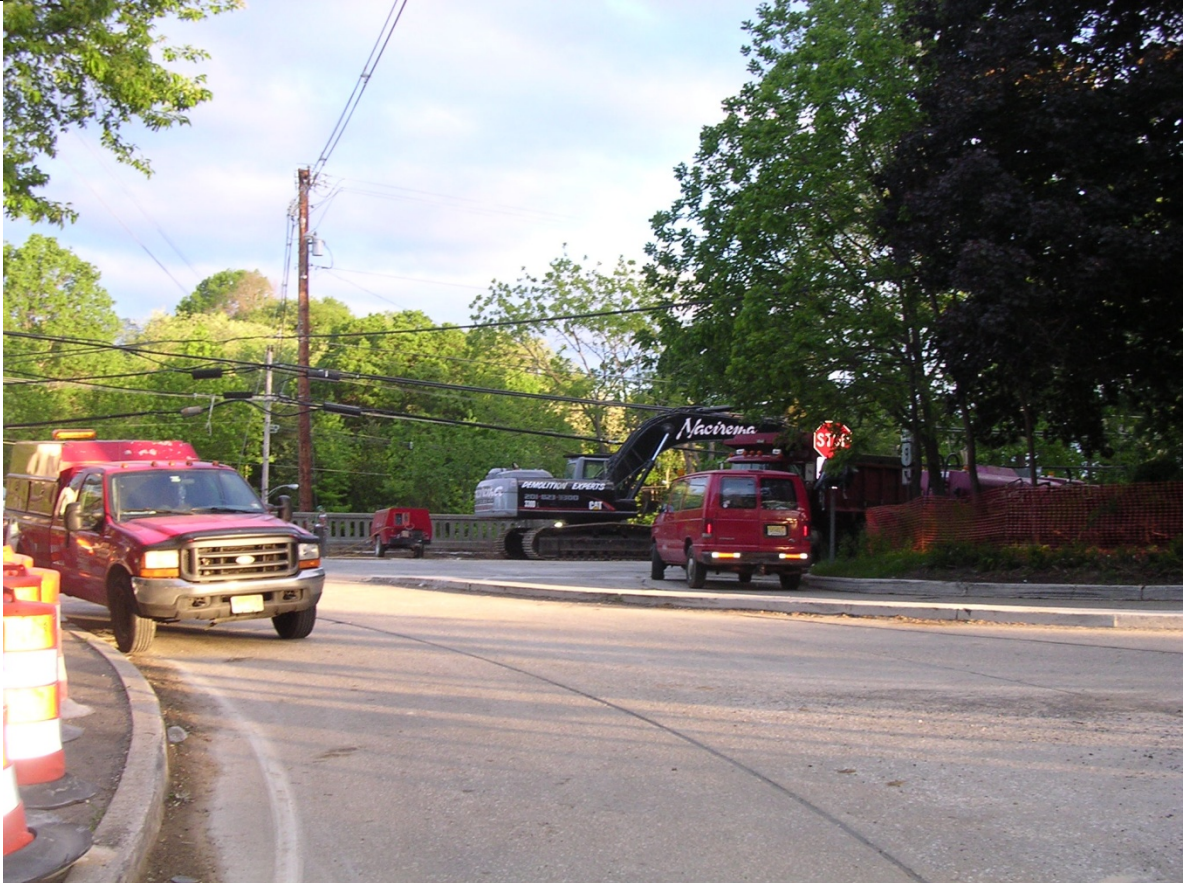
Photo 14: Staging Area at East Abutment (Contractor had proposed to use this ramp to detour Route 9 Traffic) being utilized for construction.

Photo 15: Staging Area at East Abutment (Contractor had proposed to use this ramp to detour Route 9 Traffic) being utilized for construction.

Photo 16: Staging Area at East Abutment (Contractor had proposed to use this ramp to detour Route 9 Traffic) being utilized for construction.

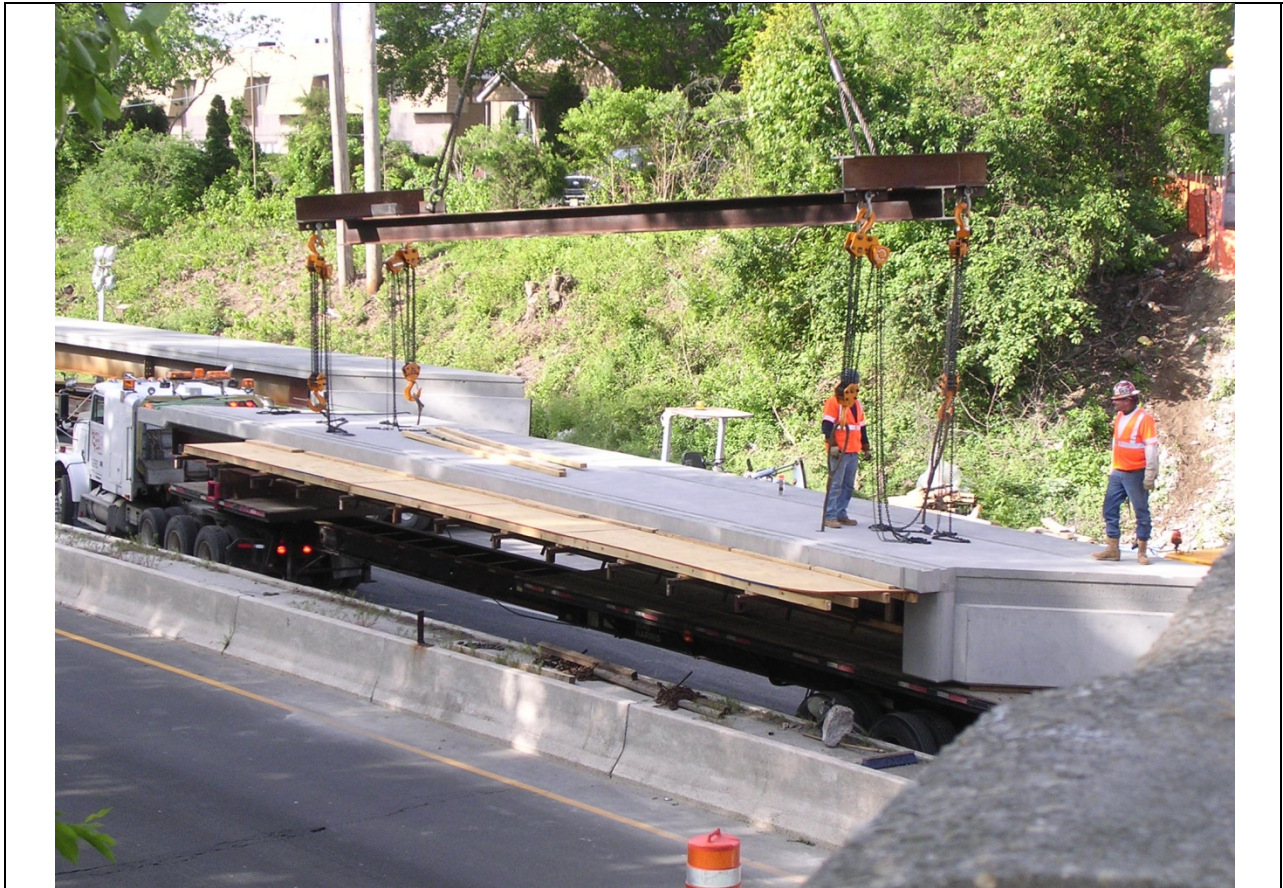
Photo 17: Attempted Use of the "Spreader Beam", which was not used due to excessive rotation of the main beam due to torsion. (Sun 8am)

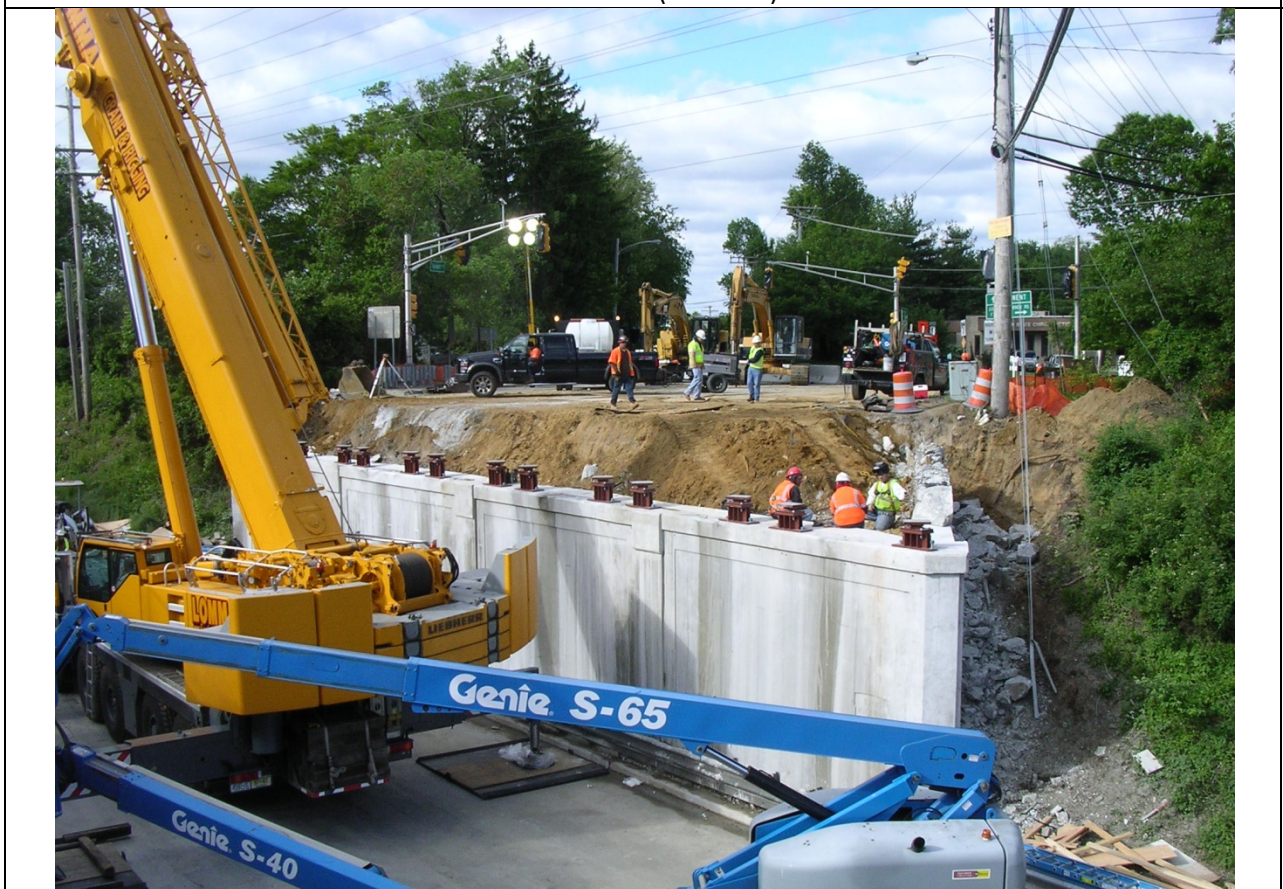
Photo 18: Bridge Seat, Bolsters, Bearings and wingwalls ready for precast sections to be placed. (Sun 8am) Note the crane shown is the 2<sup>nd</sup> crane on the job.

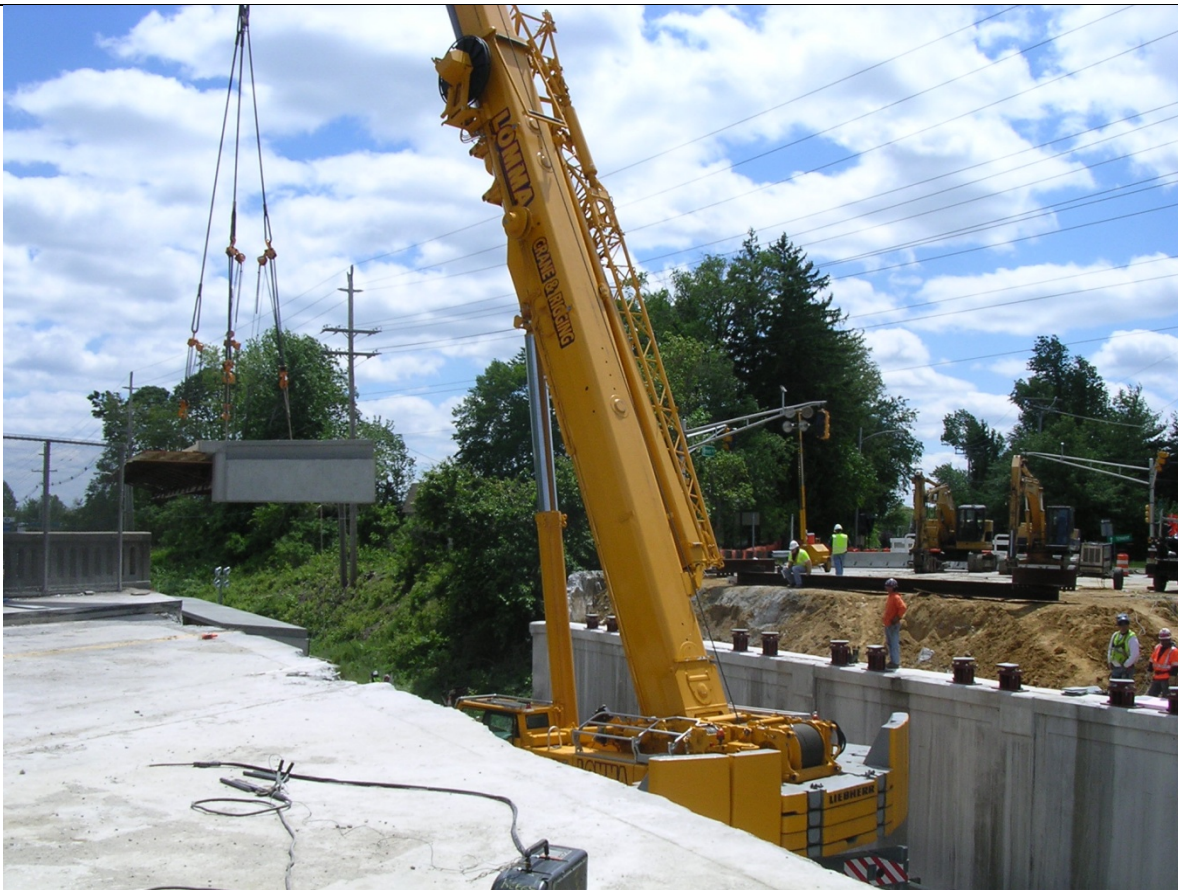
Photo 19: First Section being lifted into place. (Sun 1pm)

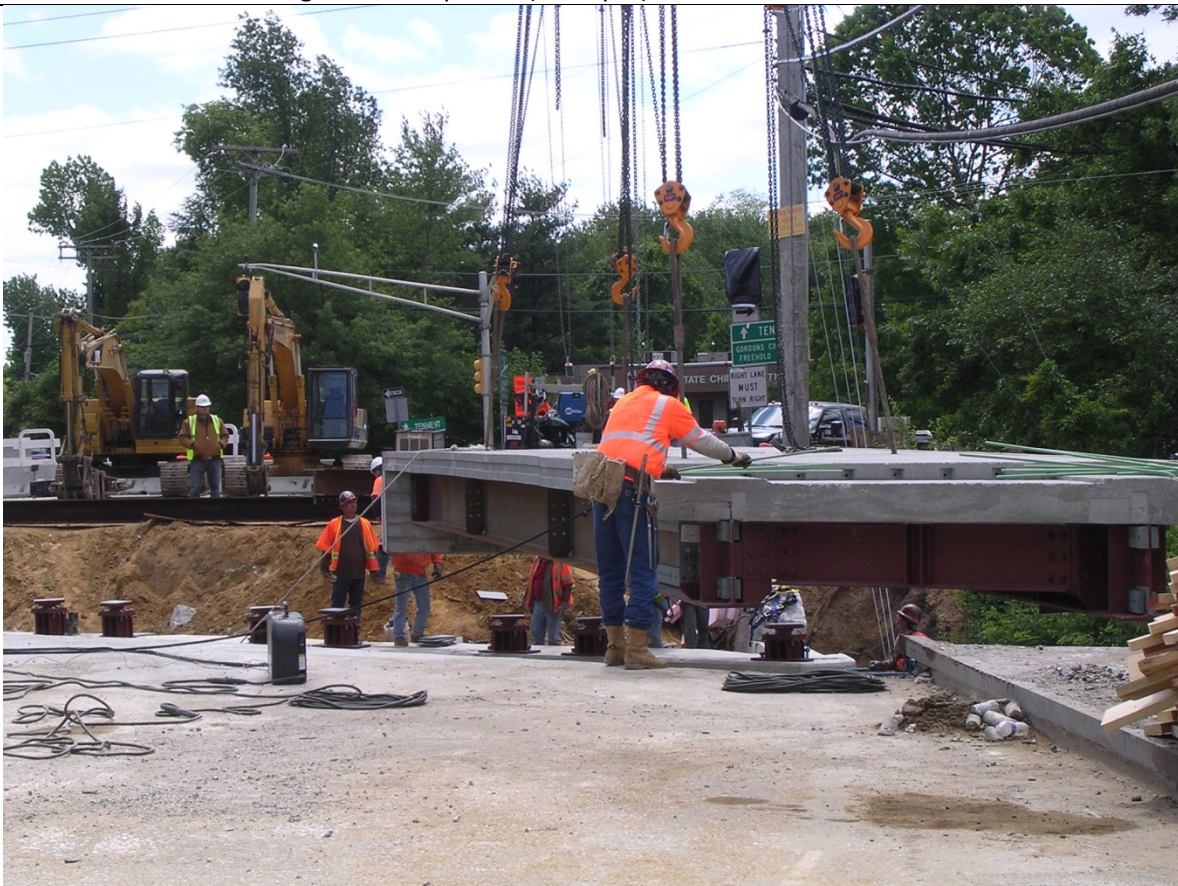
Photo 20: First Section being lifted into place. Note the number of Iron Workers/ Laborers required to land section. (Sun 1pm)
