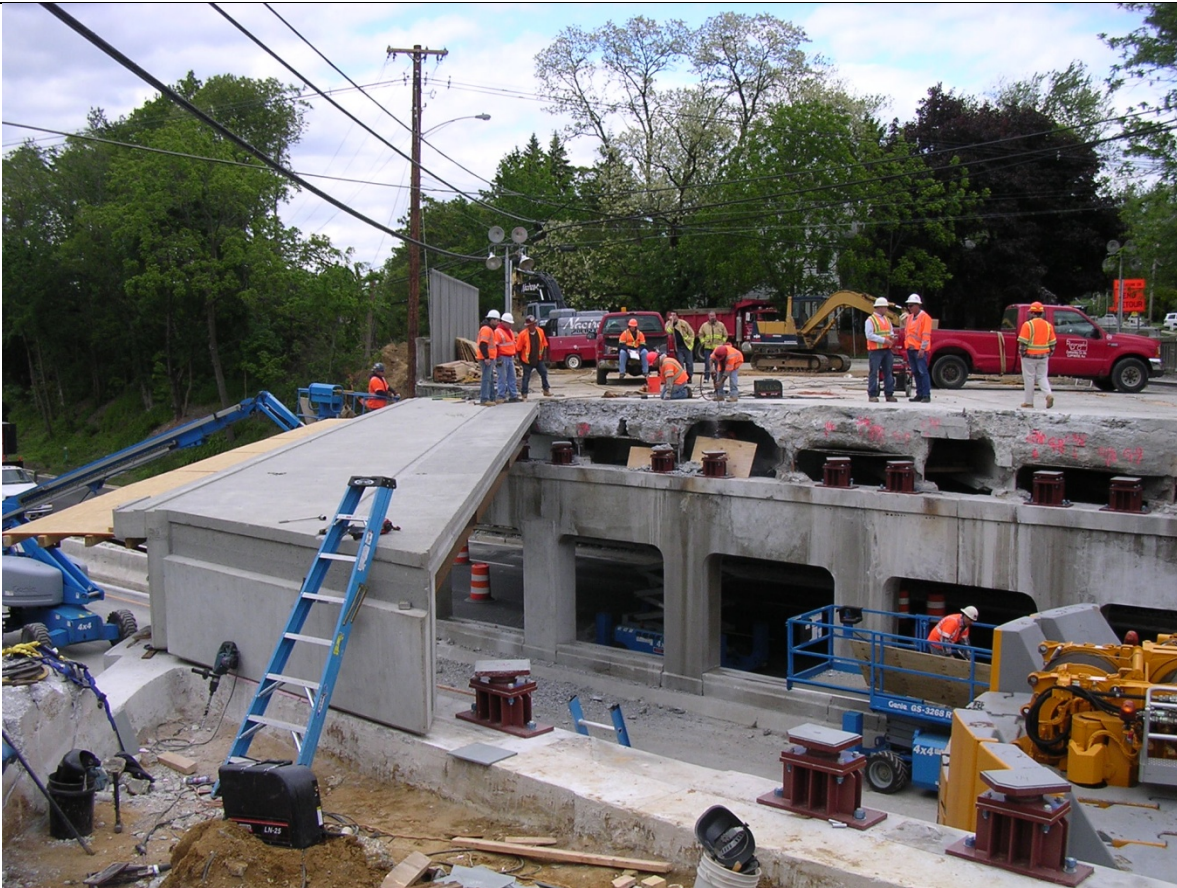
Photo 21: First Section in place. Note the orientation of the bearing with respect to the header and abutment. (Sun 4pm)

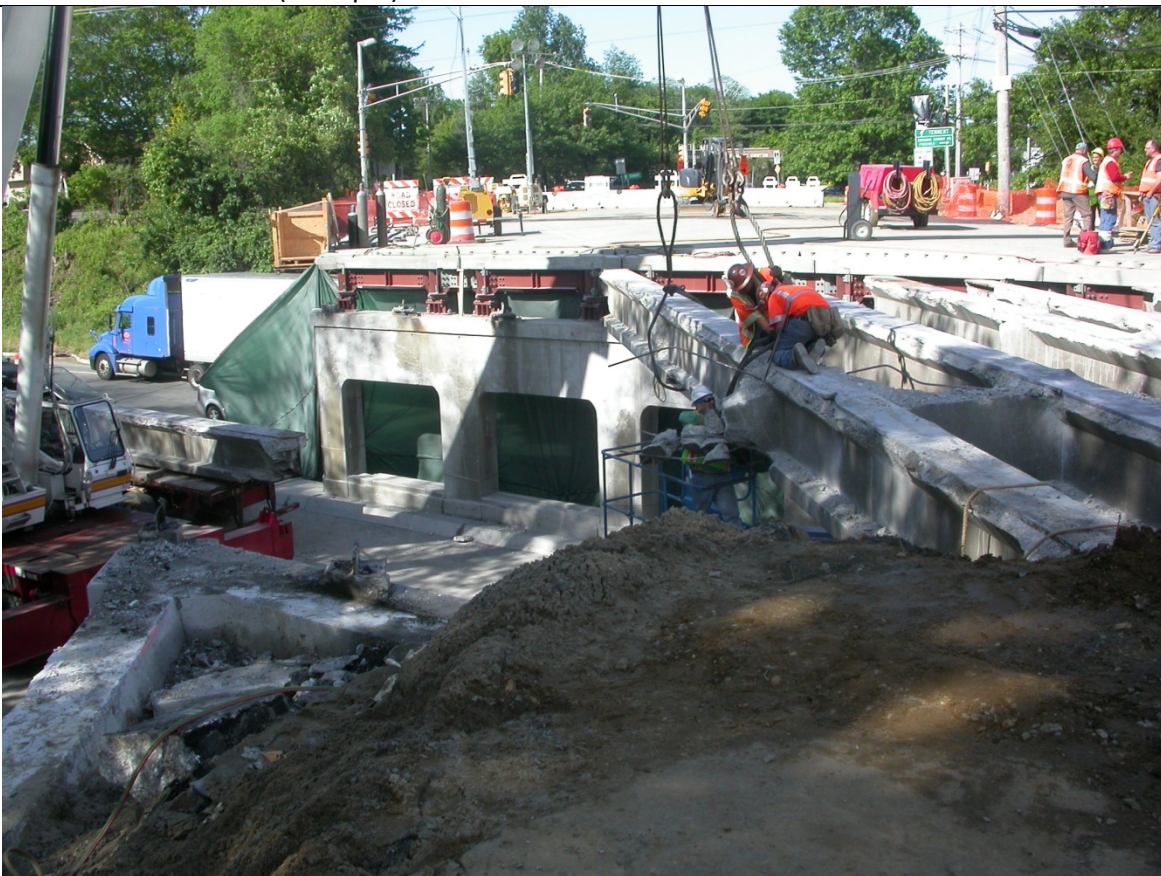
Photo 22: Weekend 2 – Three (3) Beams removed, encasement has been left on the beam during removal. (Sat 8am)

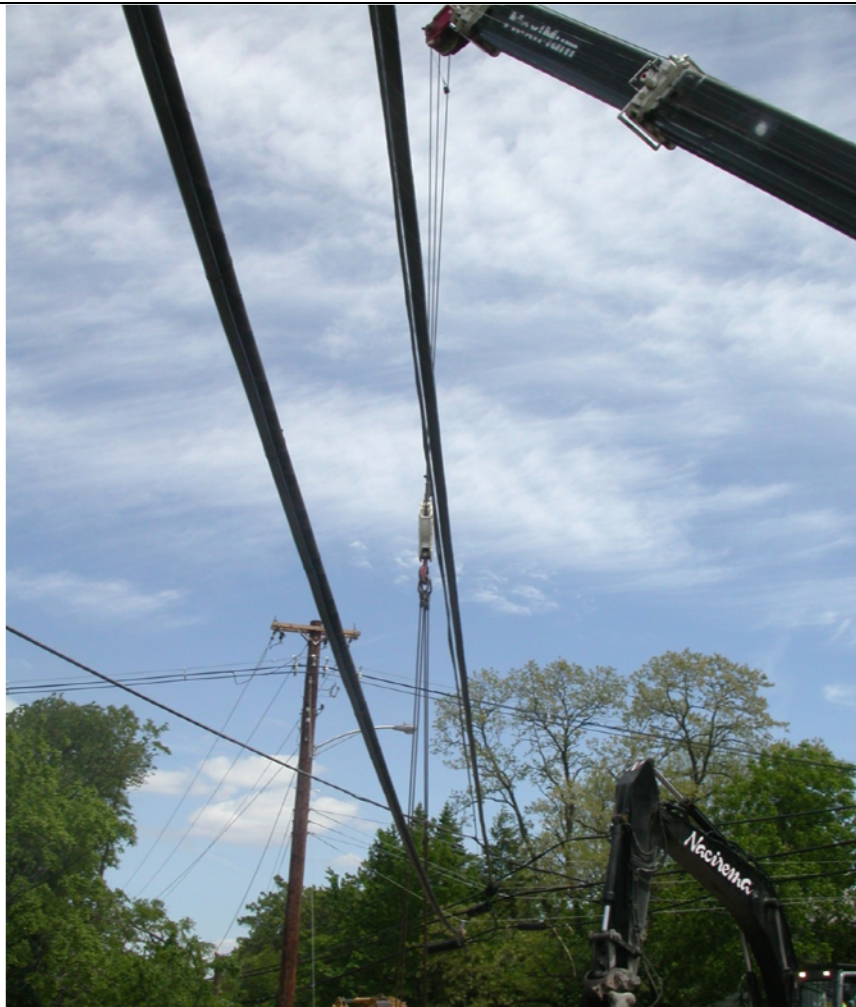
Photo 23: Weekend 2 – Note Proximity of Utilities to Crane.

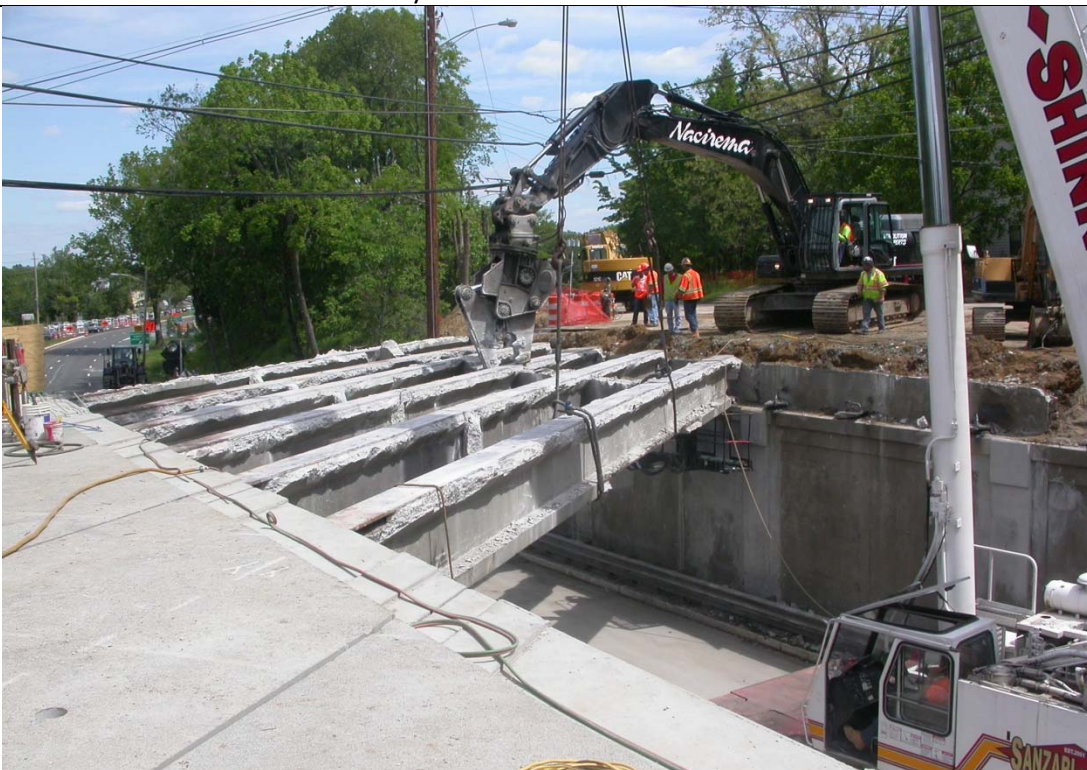
Photo 24: Weekend 2 – Diaphragm Demolition. (Sat 11am)

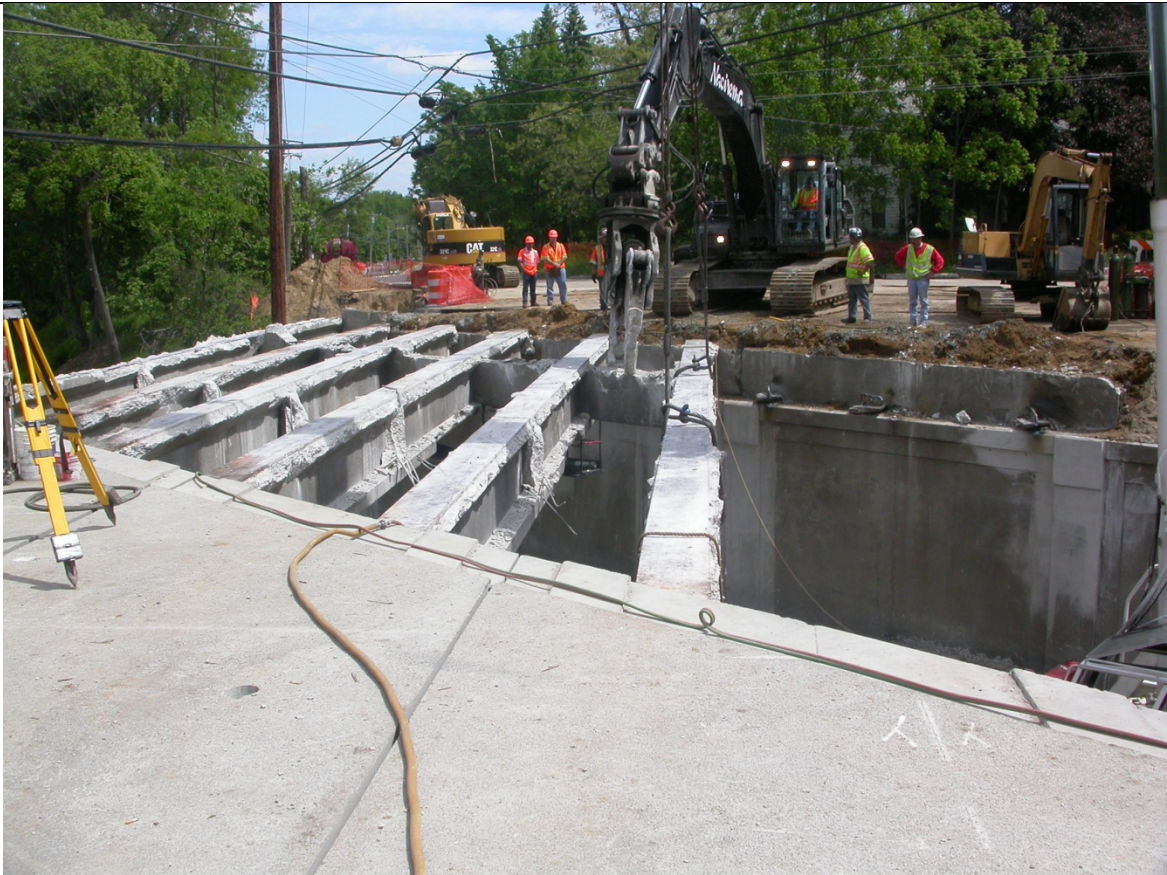
Photo 25: Weekend 2 - Diaphragm Demolition. (Sat 11am)

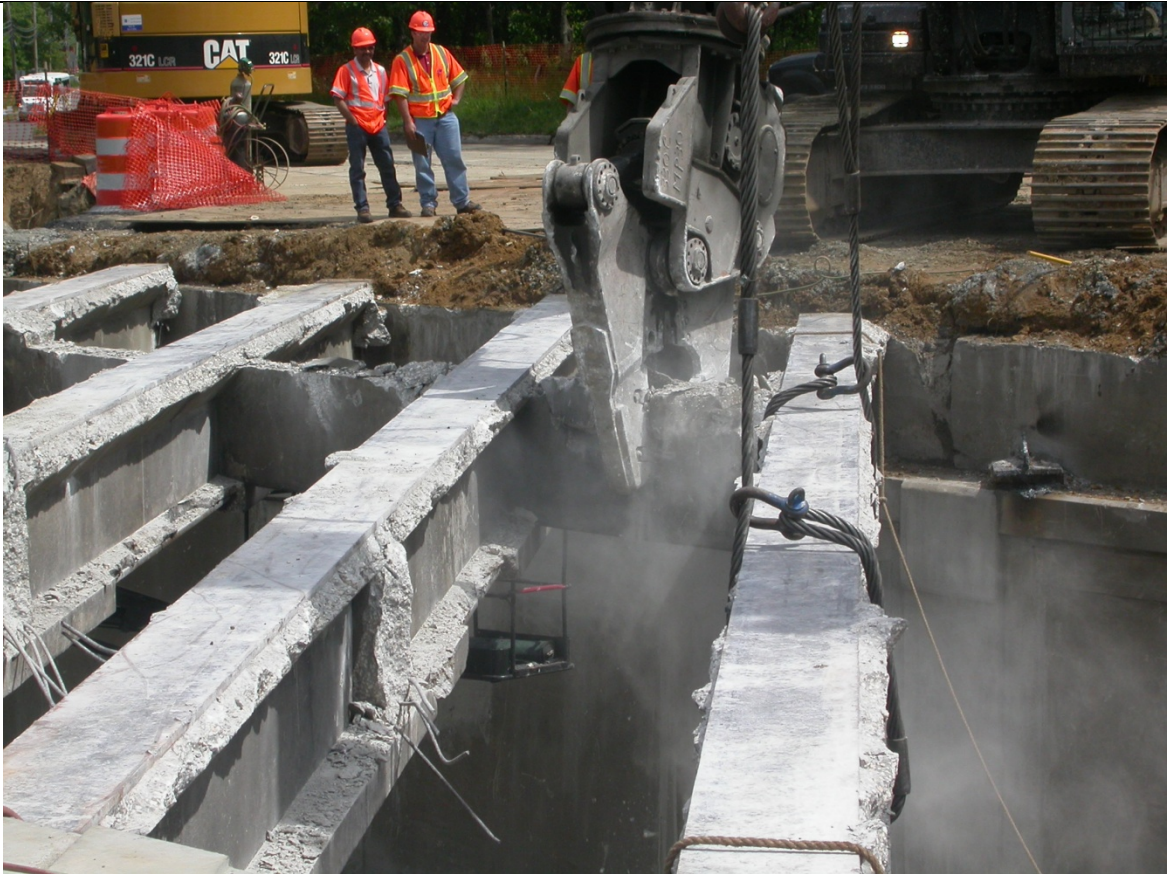
Photo 26: Weekend 2 – Close-up Diaphragm Demolition. (Sat 11am)

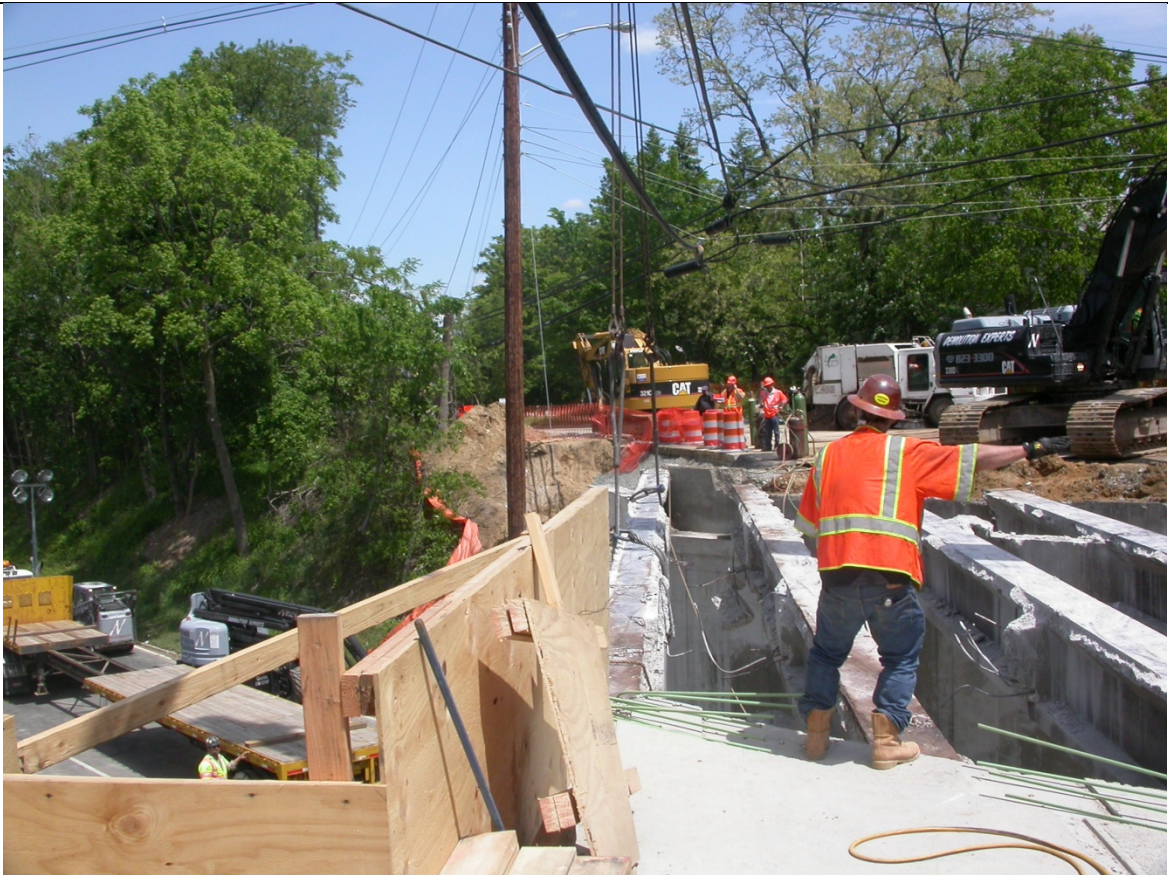
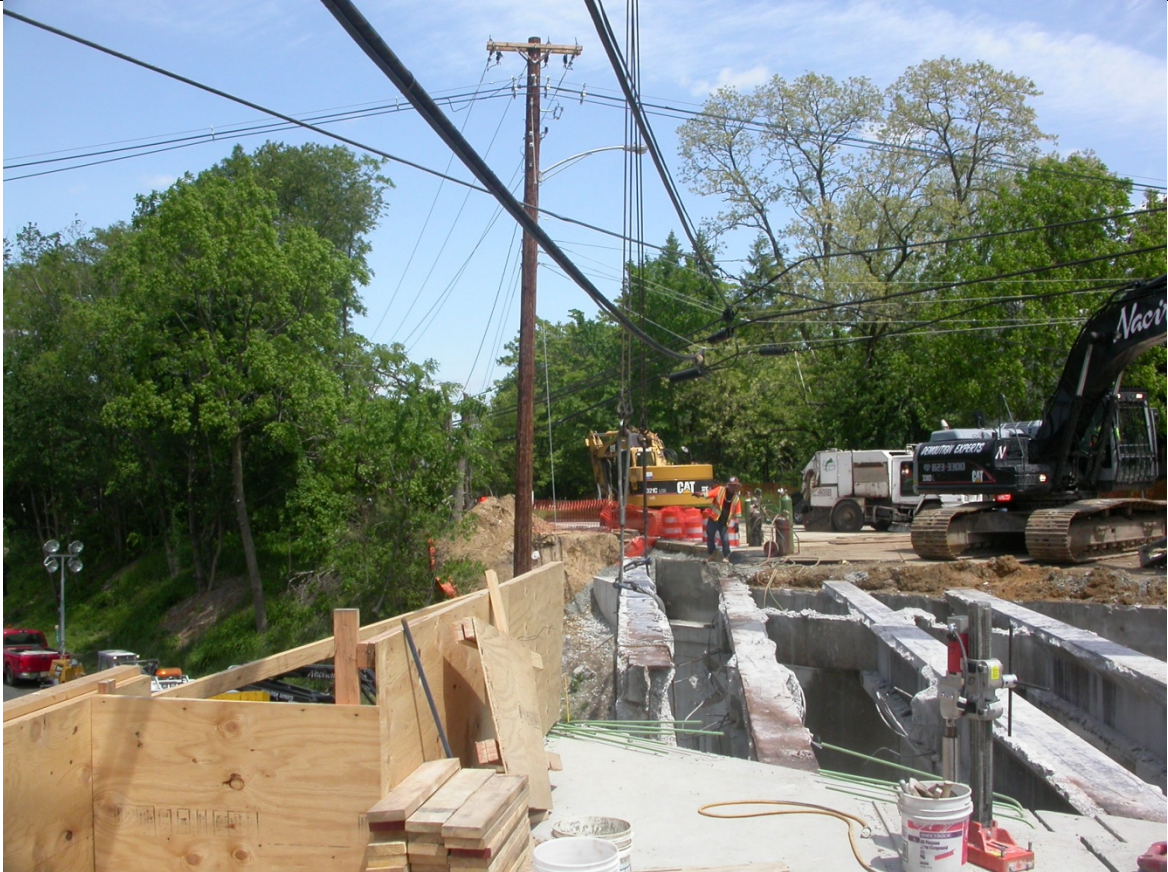
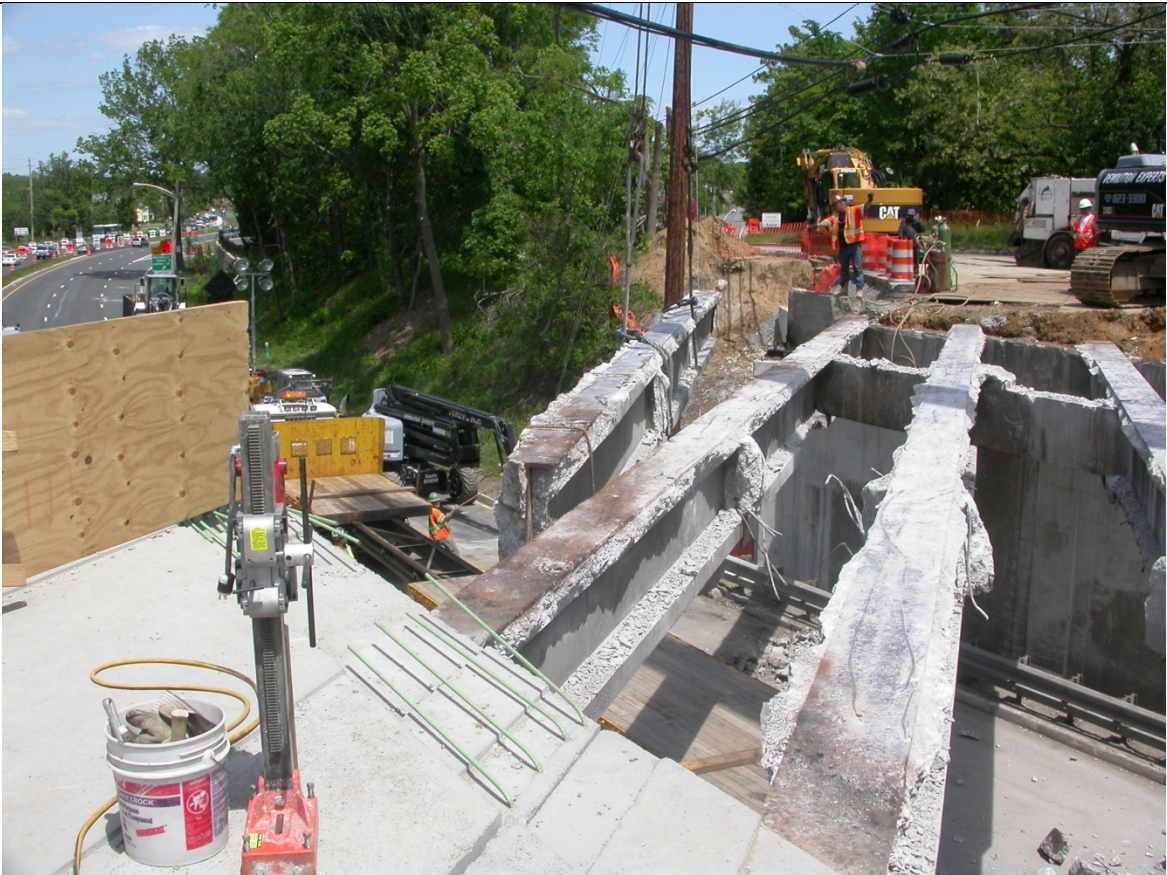
Photo 27: Weekend 2 – Beam Removal, note proximity to overhead telephone. (Sat 12:30 pm)

Photo 28: Weekend 2 – Beam Removal, note proximity to overhead telephone. (Sat 12:30 pm)

Photo 29: Weekend 2 – Beam Removal, note proximity to overhead telephone. (Sat 12:30 pm)

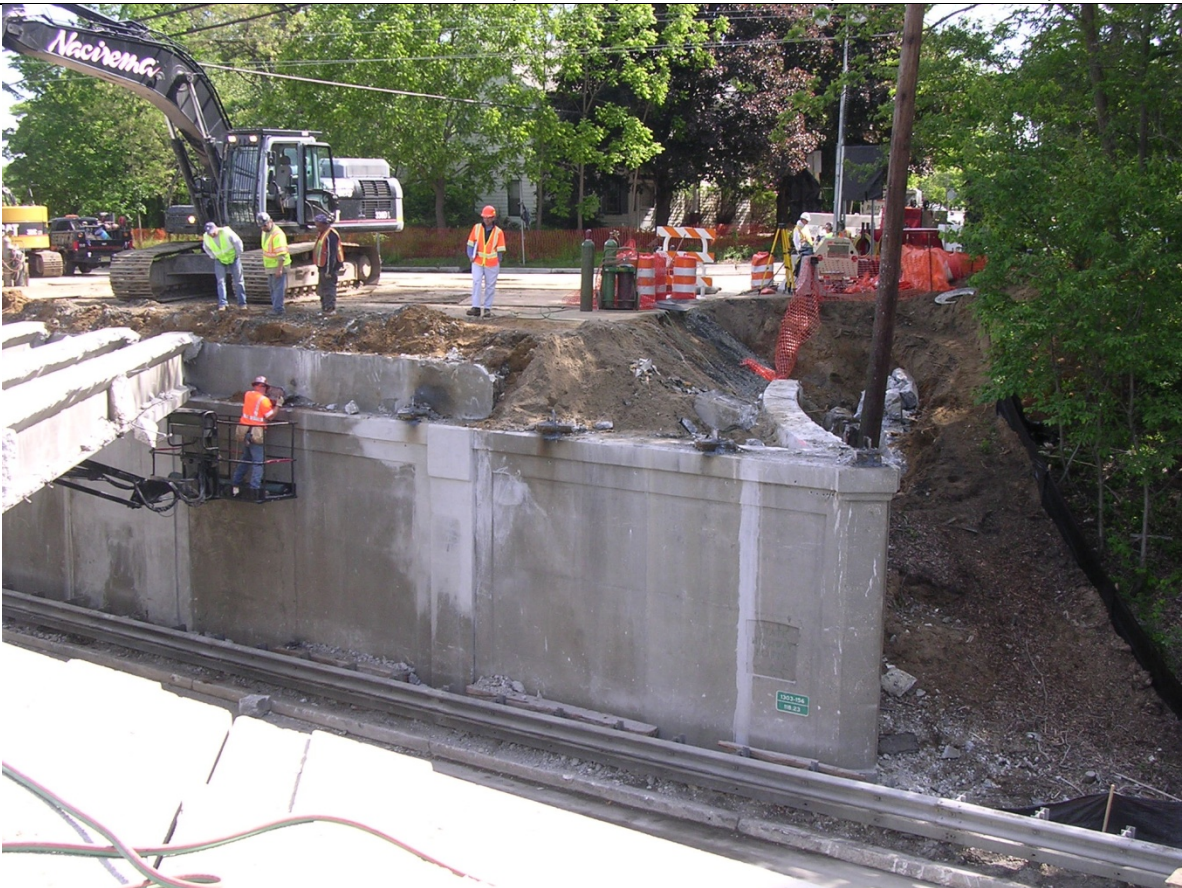
Photo 30: Weekend 2 – Headwall demolition. (Sat 9 am)

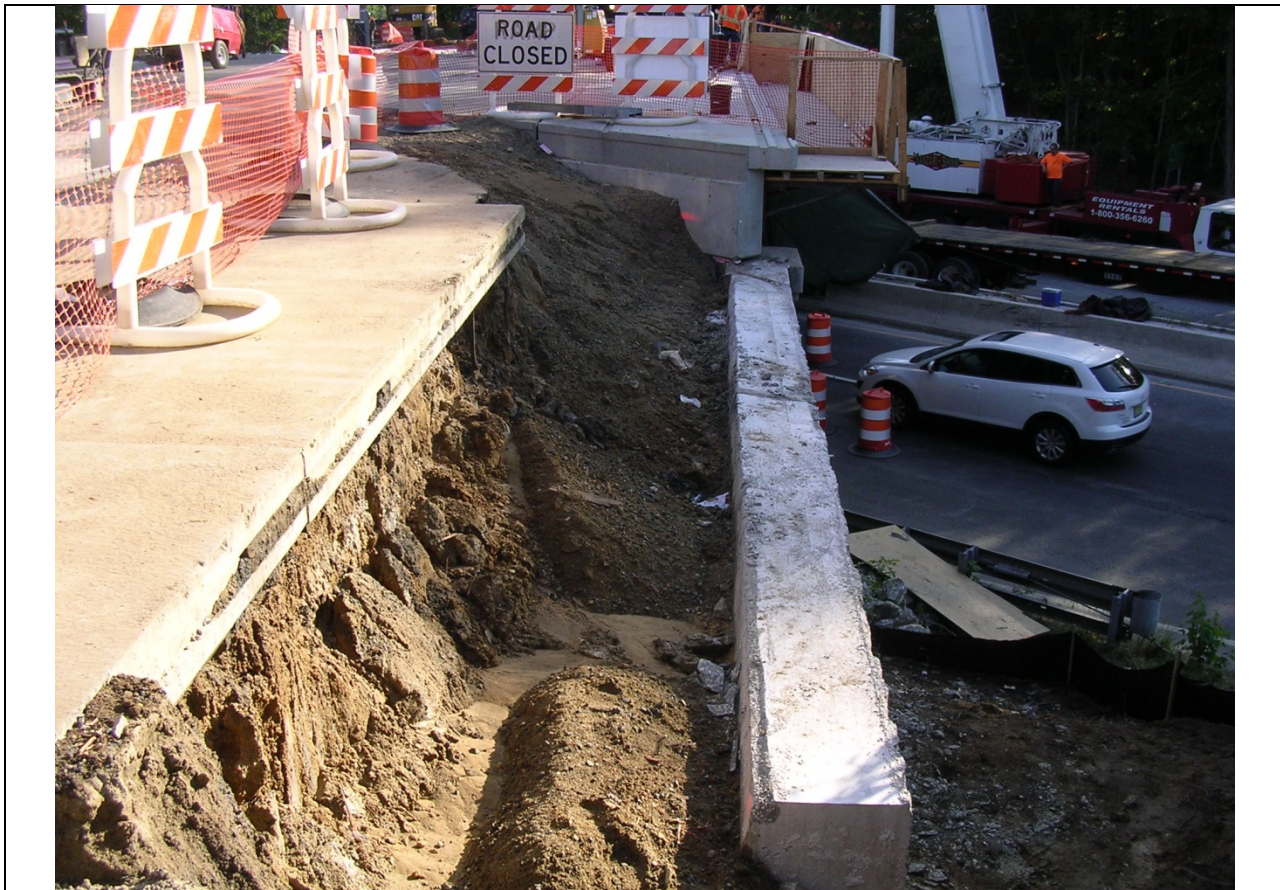
Photo 31: Weekend 2 – Wingwall removal provided space for superstructure.

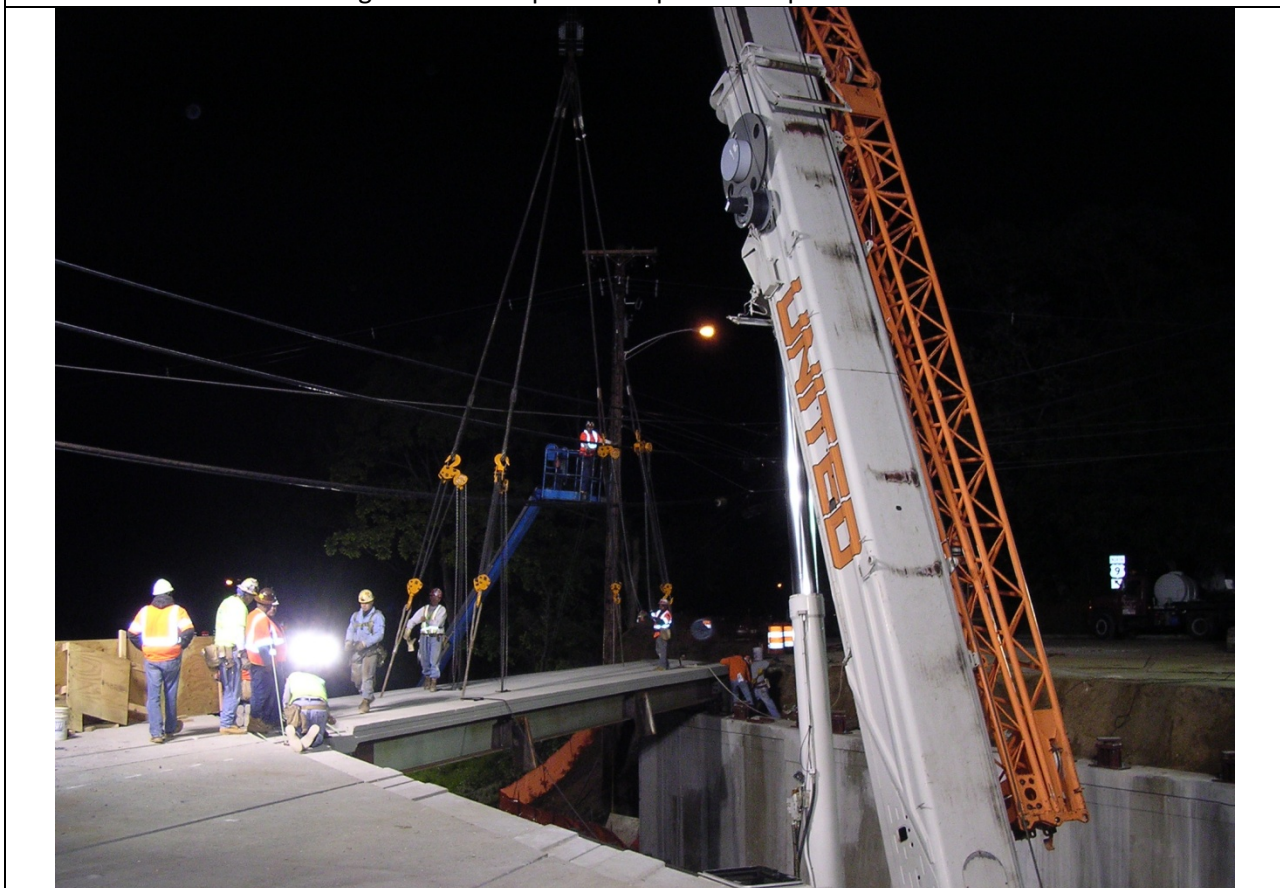
Photo 32: Weekend 2 – First precast section erected, note man in basket pulling utilities as crane sets section. (Sun 3 am)
