MPC 17-321 | C. Pantelides, D. Brown, J. Parks, and M.J. Ameli

Seismic Retrofit of Spliced Sleeve Connections for Precast Bridge Piers

March 2017

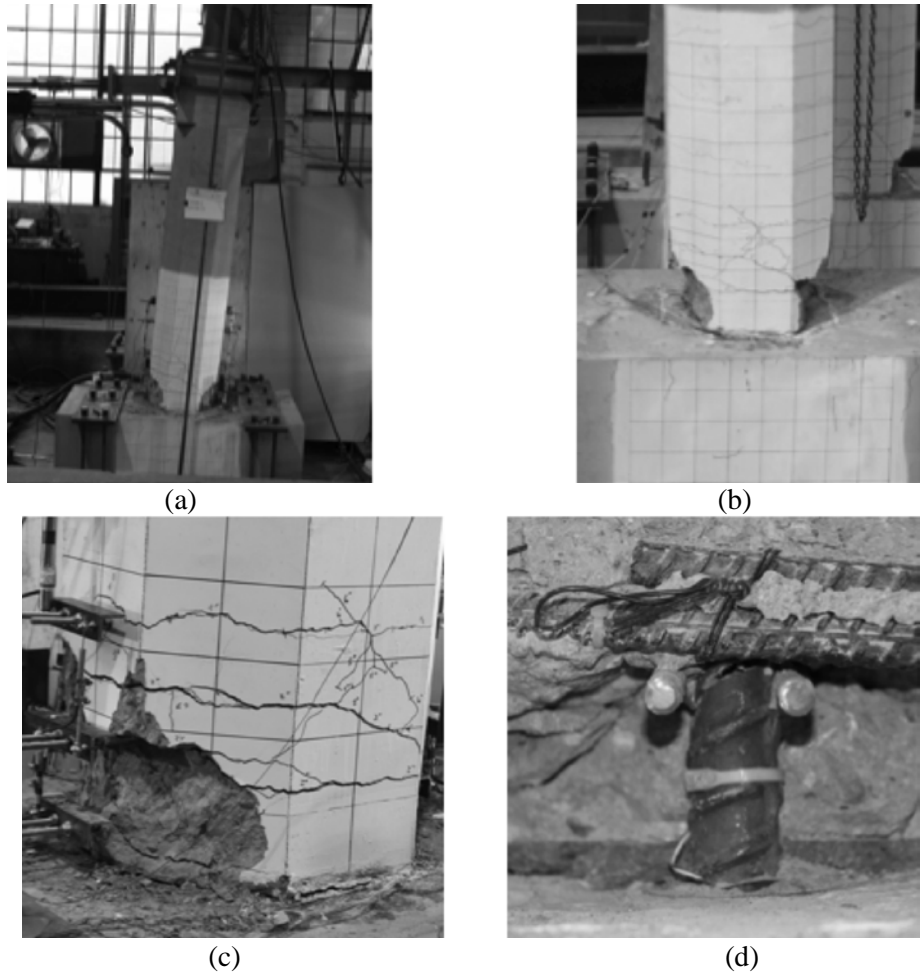
Specimen NM-O was a precast concrete column-to-footing assembly that had six GGSS connectors located in the footing. The hysteretic response of this specimen is shown in Figure 3.1, and the damage condition during the final displacement step of 7 inches and after testing is shown in Figure 3.2. It can be seen from the hysteresis curves that the ultimate load achieved during the test was 38.8 kip; the ultimate drift achieved was 6.42%, and the displacement ductility was equal to 6.1. The failure mode of the specimen was crushing of the column concrete followed by longitudinal rebar failure. The east extreme longitudinal bar fractured during the first cycle of the 7-in. displacement step, approximately 3 inches above the top of the footing. The lateral load capacity in the west direction was severely diminished once the east longitudinal rebar fractured. The lateral load capacity in the west direction, after the longitudinal rebar fractured, dropped to 65% of the ultimate lateral load capacity. A plastic hinge is evident at the column-footing interface of specimen NM-O; spalling extends up the column for a distance of 8 to 12 inches on the west and east extreme column faces. Structural cracking of the column occurred at three levels located approximately 6 inches, 10 inches, and 14 inches above the footing. The maximum crack width at the 6 in., 10 in., and 14 in. levels was 0.050 inches, 0.025 inches, and 0.030 inches, respectively. Cracking extended up the column higher than 14 inches but remained hairline in width throughout testing in this region.

**Figure 3.2** Final damage of specimen NM-O: (a) ultimate displacement of 7 inches, (b) column and footing cracking, (c) plastic hinge region, (d) fractured east longitudinal rebar

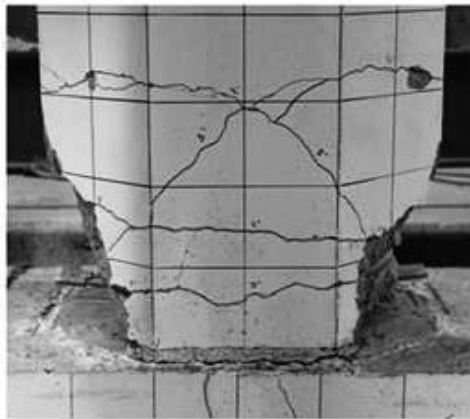
The failure mode of specimen LE-O was fracture of an extreme longitudinal bar. The extreme west longitudinal bar fractured in LE-O. Once the extreme longitudinal bar fractured, the lateral load capacity of the specimens dropped below 20% of the ultimate load capacity. From the hysteresis curves, shown in Figure 3.3, the ultimate load achieved during the test was 37.7 kip; the ultimate drift achieved was 6.50%, and the displacement ductility was equal to 5.8. A very well developed plastic hinge was formed at the column-to-pier cap interfaces where extensive spalling and cracking occurred, as shown in Figure 3.4. Major structural cracking was isolated to three distinct heights from the footing or pier cap interface, where the highest crack was located 12 inches up the column for LE-O; these crack widths ranged from 0.016 to 0.060 inches.

**Figure 3.4** Final damage of specimen LE-O showing plastic hinge region

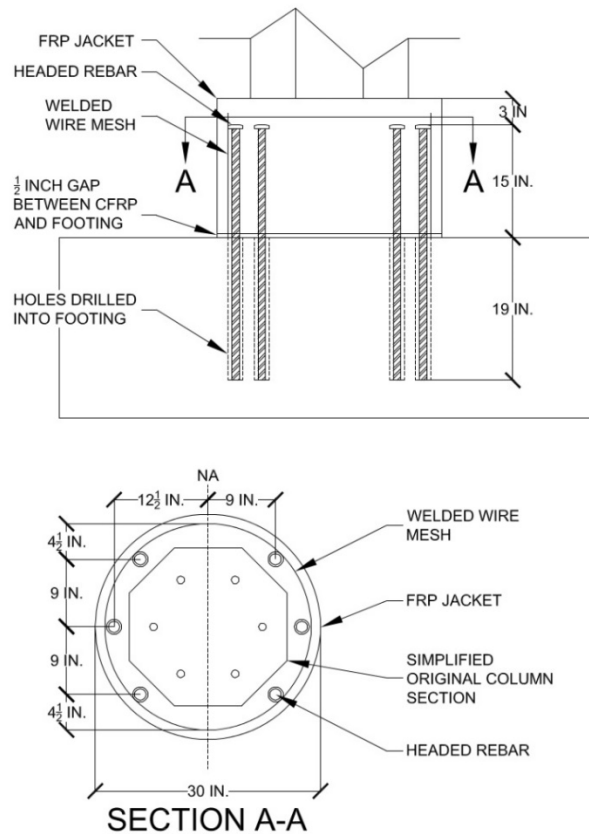
**Figure 4.2** Repair design details for specimen NM-O

The repair details for specimen NM-O are shown in Figure 4.2; the details for specimen LE-O were identical. There are three components for the repair that must be designed: headed rebar, CFRP wrap, and non-shrink concrete. As usual with design, the different repair components rely upon one another, making the design process iterative. The headed steel bars are designed to increase the moment capacity of the repaired cross-section to a value larger than  $M_{\text{joint}}$ . The contribution of the as-built longitudinal rebar can be conservatively ignored when determining the repaired cross-section moment capacity. This

assumption should be made when longitudinal bars have fractured or buckled in the as-built column prior to repair. The moment capacity provided by the headed rebar is controlled by the area of steel that is provided and the moment arm of the steel. Placement of the headed rebar fixes the moment arm of each rebar and should be determined from several design criteria. First, a minimum clear spacing between the as-built column and the center of the headed rebar should be maintained to allow space for drilling into the footing; in the present case this was 2 inches. Space should also be provided between the headed rebar and the CFRP wrap to allow proper bonding of the CFRP composite to the concrete and development of the headed rebar. The smallest diameter possible for the CFRP wrap should be selected to facilitate an economical design and to minimize interference with surrounding objects when the repair is installed in the field. From these design criteria, the placement of the headed rebar and the diameter of the CFRP jacket can be designed iteratively. In practice, the headed rebar should be distributed around the repair evenly since the direction of lateral load from a future earthquake is not known.

headed rebar to the neutral axis,  $f_c'$  is the nominal compressive strength of the repair concrete, and  $b_w$  is the effective width of the repair. An appropriate margin of safety should be maintained between the flexural capacity of the section and the demand. These design equations lead to six No.8 Grade 60 headed bars placed, as shown in Figure 4.2, with three headed bars on each side of the repaired section.

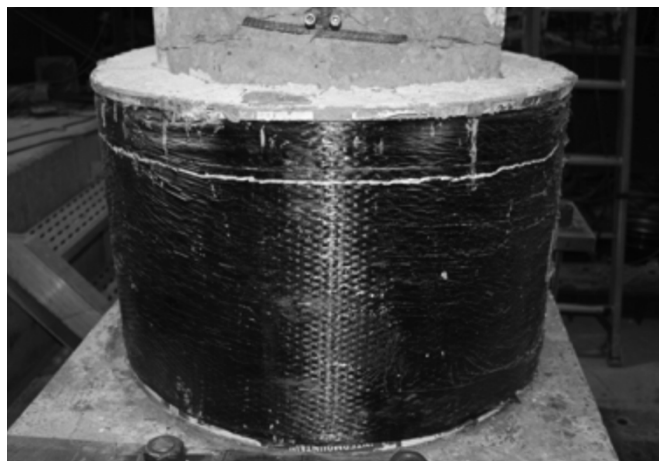
Transverse cracking of the CFRP shell was observed during the test of specimen NM-R, as shown in Figure 4.10. The crack began during the 4-in. displacement step and grew during each subsequent displacement step. At completion of the test, the crack extended halfway around the circumference of the CFRP jacket. The hysteretic response of the specimen was unaffected by the transverse CFRP crack, which was located 3 to 4 inches below the top of the repair, corresponding to the top of the internal headed rebar. The onset of transverse CFRP cracking can be seen from the curvature profile obtained from the experiments in Figure 4.11, which shows the maximum and minimum curvatures during the 0.5-in. to 4-in. displacement steps. There are two curvature values plotted for each displacement step in the east and west directions. The first value is an average curvature value from the top of the footing to the top of the repair. The second value is an average curvature value from the top of the repair to 9.56 inches up the column. From this plot, it can be seen that the curvature of the wrapped section is very small when compared with the column, indicating plastic hinge formation in the column. Also, the onset of the CFRP crack can be seen by the increase in curvature of the repaired specimen when it was displaced to the west during the 4-in. displacement step.

**Figure 4.10** Transverse CFRP crack at white line 3 inches below top of CFR shell

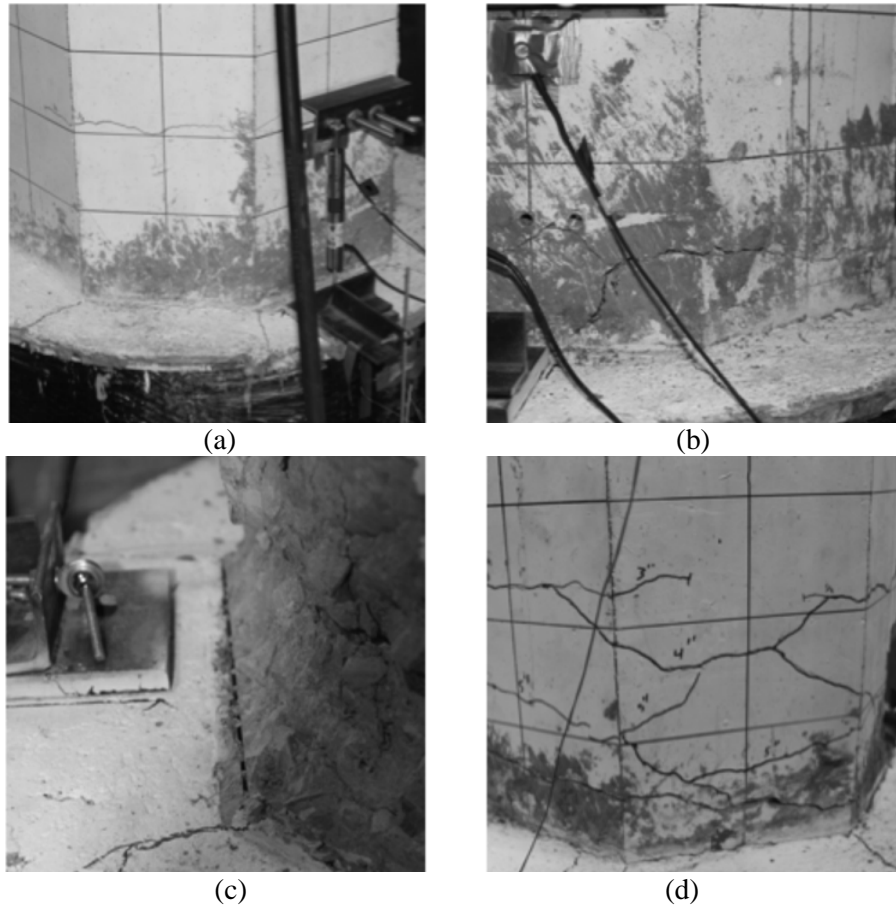
During the 5-in. displacement step, a new flexural crack was observed 10 inches above the top of the repair. When the crack was measured at rest it was hairline. The radial cracks grew considerably during this displacement step from 0.005 in. to 0.025 in. The largest radial cracks were located on the west side of the repaired section. Spalling continued during this displacement step and the shear x-cracks grew in length, as shown in Figure 4.13(a).

**Figure 4.12** NM-R test through the 6-in. displacement step: (a) radial cracks after 1-in. displacement step, (b) first crack during 2-in. displacement step, (c) gapping at repair-column interface during the 6-in. displacement step, (d) shear x-crack after the 4-in. displacement step

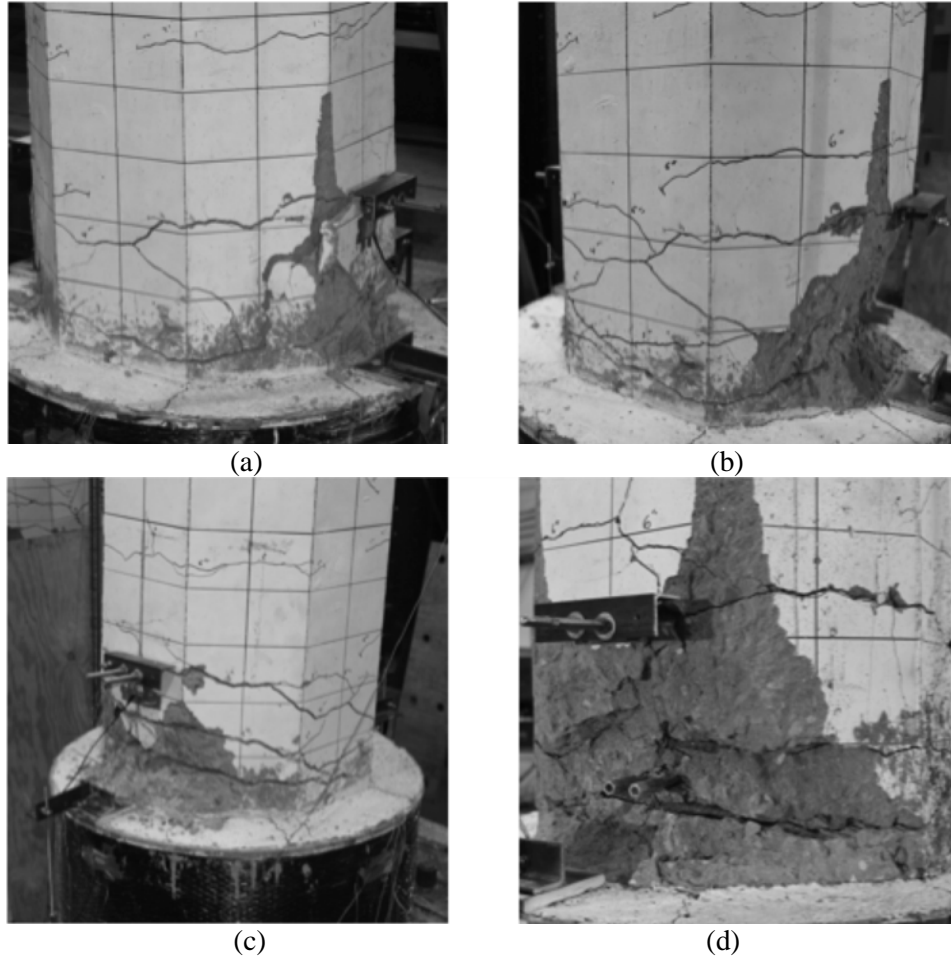
During the 7-in. displacement step, both the west and east extreme longitudinal bars fractured. The west longitudinal bar fractured during the first cycle, and the east longitudinal bar fractured during the second cycle. In addition to bar fracture, the shear x-cracking grew on the north and south faces, measuring 0.06 inches at pause. NM-R at maximum displacement is shown in Figure 4.13(c). The final damage state of NM-R is shown in Figure 4.13(d).

**Figure 4.13** NM-R test through final damage state: (a) major spalling during 5-in. displacement step, (b) damage level after 6-in. displacement step, (c) damage state during 7-in. displacement step, (d) final damage state

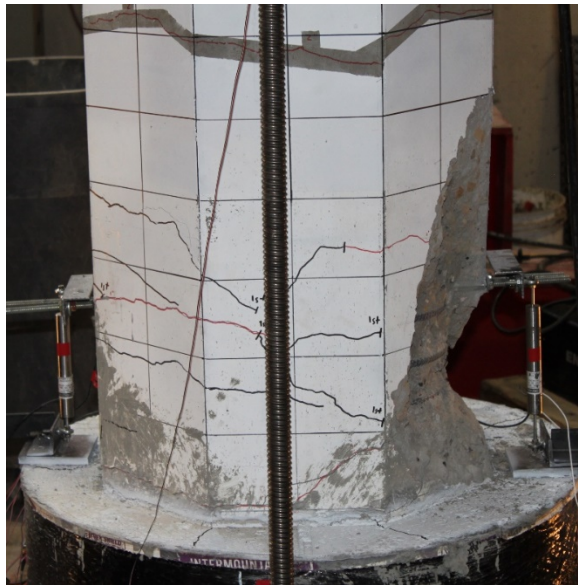
**Figure 4.21** Specimen LE-R monotonic pushover damage

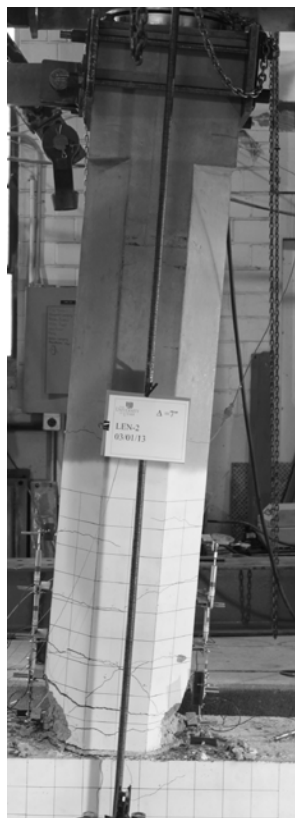
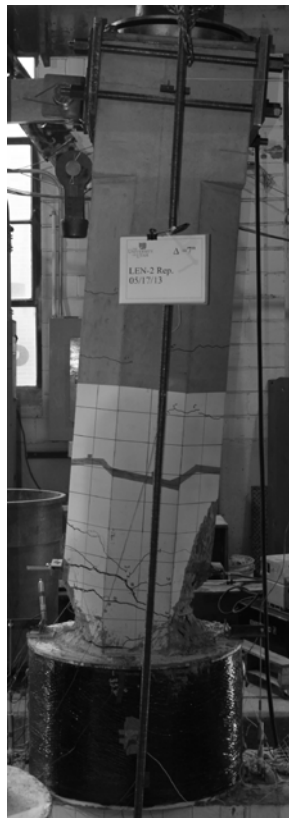
Repaired specimen LE-R, which was already damaged from the monotonic pushover test, was retested using the loading protocol shown in Figure 2.7. Even with the initial damage from the monotonic pushover, the column was able to reach a maximum drift of 7.2% and a maximum lateral load of 40.5 kip before fracturing the extreme east longitudinal column bar just above the repaired section. To clearly see the relocation of the plastic hinge in LE-R, Figure 4.26 compares specimens LE-O and LE-R at maximum drift. In Figure 4.26(a), the plastic hinge formed just above the pier cap while in Figure 4.26(b), the plastic hinge was relocated to a position just above the repair. Figure 4.27 shows the final damage of the west side and east side of the column. The west face of the column had spalling that went 10 inches up the face of the column, exposing transverse reinforcement. On the east column face, additional spalling of the concrete occurred, exposing more of the column reinforcement; ultimately the extreme longitudinal bar on this side fractured. No additional flexural cracks developed during the test. The cracks that developed from the monotonic pushover test just continued to widen from 0.05 to 0.125 inches by the end of the cyclic test.

**Figure 4.26** Test Comparison: (a) LE-O at maximum drift, (b) LE-R at maximum drift

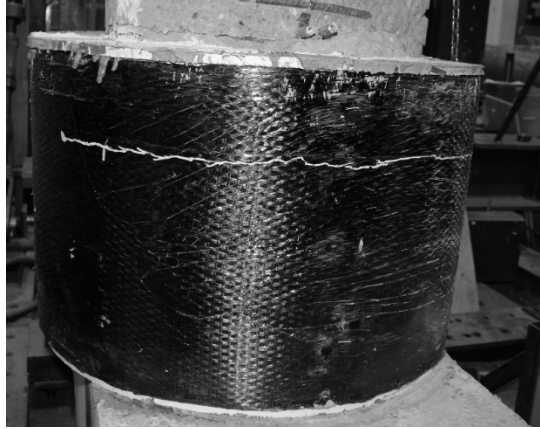
Two notable observations during the cyclic test are marked on the hysteresis in Figure 4.28. The square symbol marks the cycle in which transverse cracking of the CFRP jacket began to occur and the circle symbol denotes fracture of the column longitudinal reinforcement. Note that there is no apparent change in the hysteresis curve due to the transverse CFRP crack. The cracking of the CFRP jacket occurred just above the top of the headed bars and is shown marked by a white line in Figure 4.29. The crack in the CFRP had a final width of 0.125 inches, a length of 38.75 inches, and only existed on the west side of the jacket. The crack was caused by an increased curvature demand on the repaired section when the column was pushed to the west.

**Figure 4.29** LE-R transverse CFRP crack
