**GORDONS CORNER ROAD OVER ROUTE 9  
SUPPLEMENT TO "PHASE 1 REPORT - BRIDGE DECK REPLACEMENT STUDY"  
DATED JULY 9, 2008**

Prepared by: Gregory D. Bitsko, P.E., P.P.  
Date: January 29, 2009

PROJECT NUMBER: 070804502

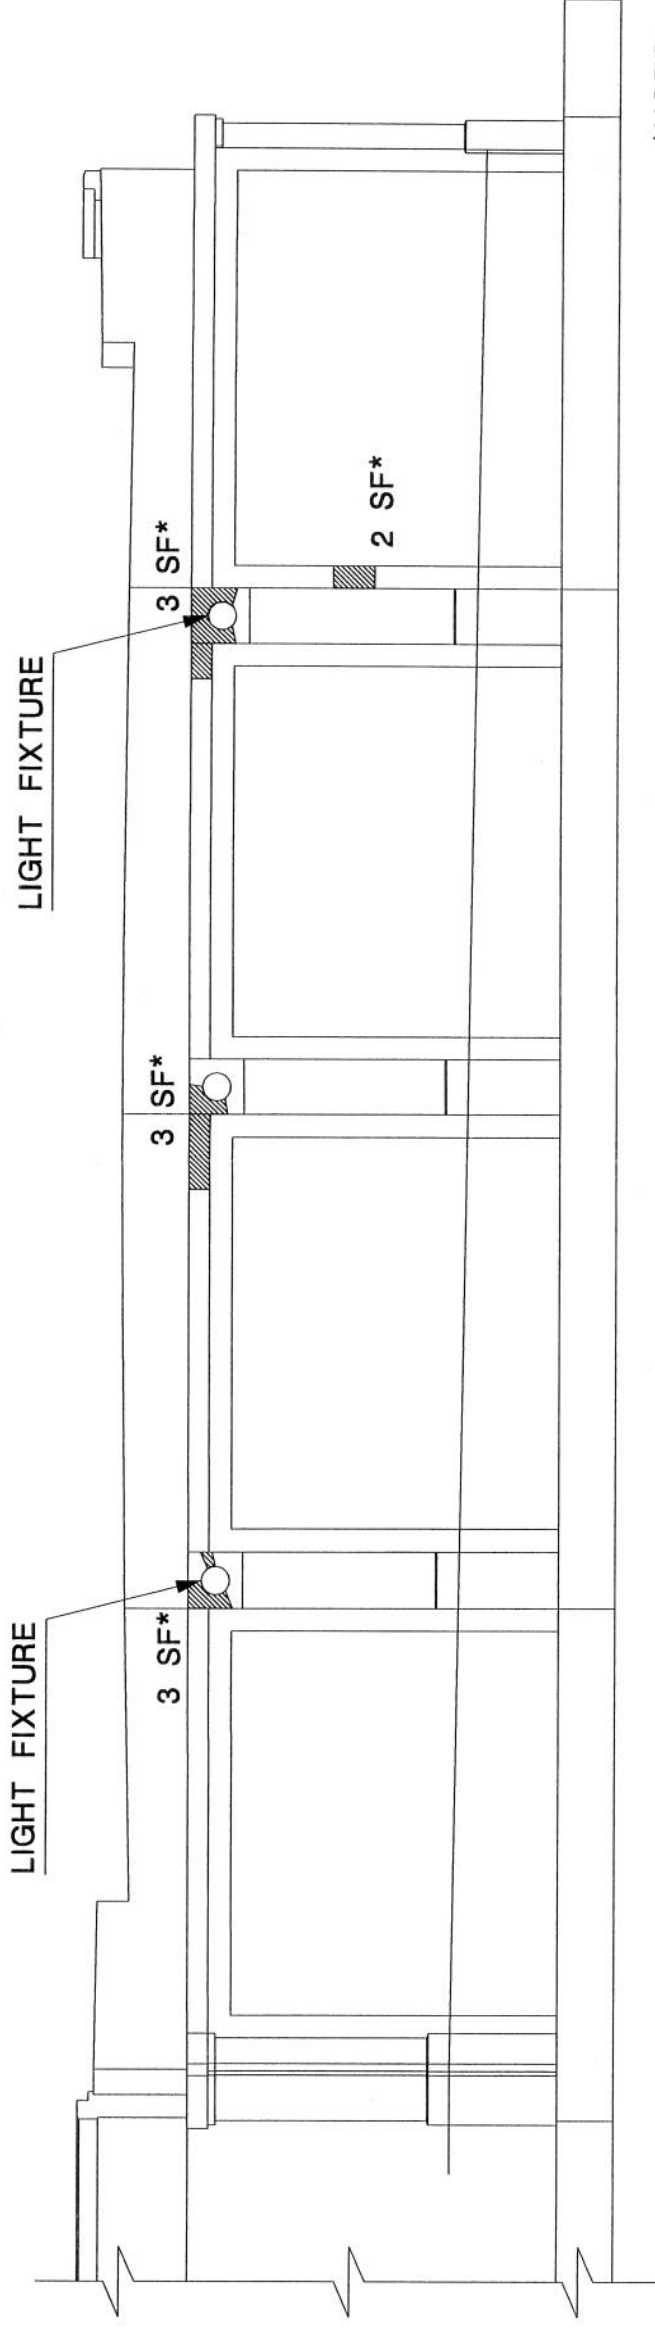
### WEST ABUTMENT ELEVATION

**\*NOTE:**  
 SPALLED AND UNSOUND  
 CONCRETE CAUSED BY  
 LIGHT FIXTURES AND STEEL  
 CONDUIT IN ABUTMENT.

- AREA OF SPALLED/ UNSOUND CONCRETE

Based on the results of the supplemental evaluation and testing program, it is our recommendation that the existing pier cap be retained and that spot repairs be performed in conjunction with the superstructure replacement to remove existing chlorides, patch the spalls and unsound concrete and seal all the existing cracks. We also recommend that the superstructure and deck be replaced using Inverset panels erected using SPMT's.

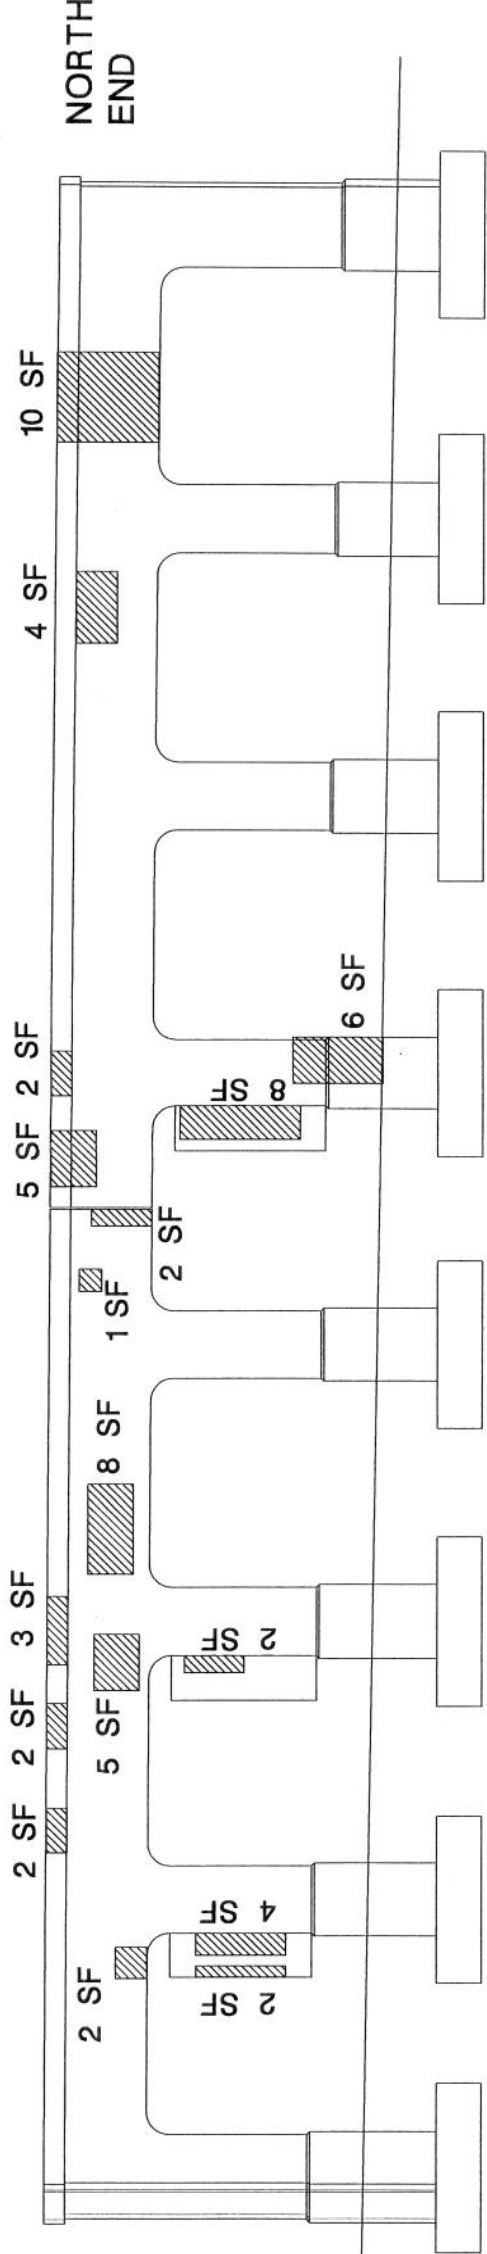
## EAST PIER ELEVATION

- AREA OF SPALLED/ UNSOUND CONCRETE

After reviewing the results of the coring program and conducting the field inspection, it is our opinion that the pier cap can be rehabilitated for use in this project without any significant reconstruction. It is recommended for consideration by NJDOT that chloride extraction measures be incorporated into the proposed design following the procedures of the Norcure system or other alternative systems.

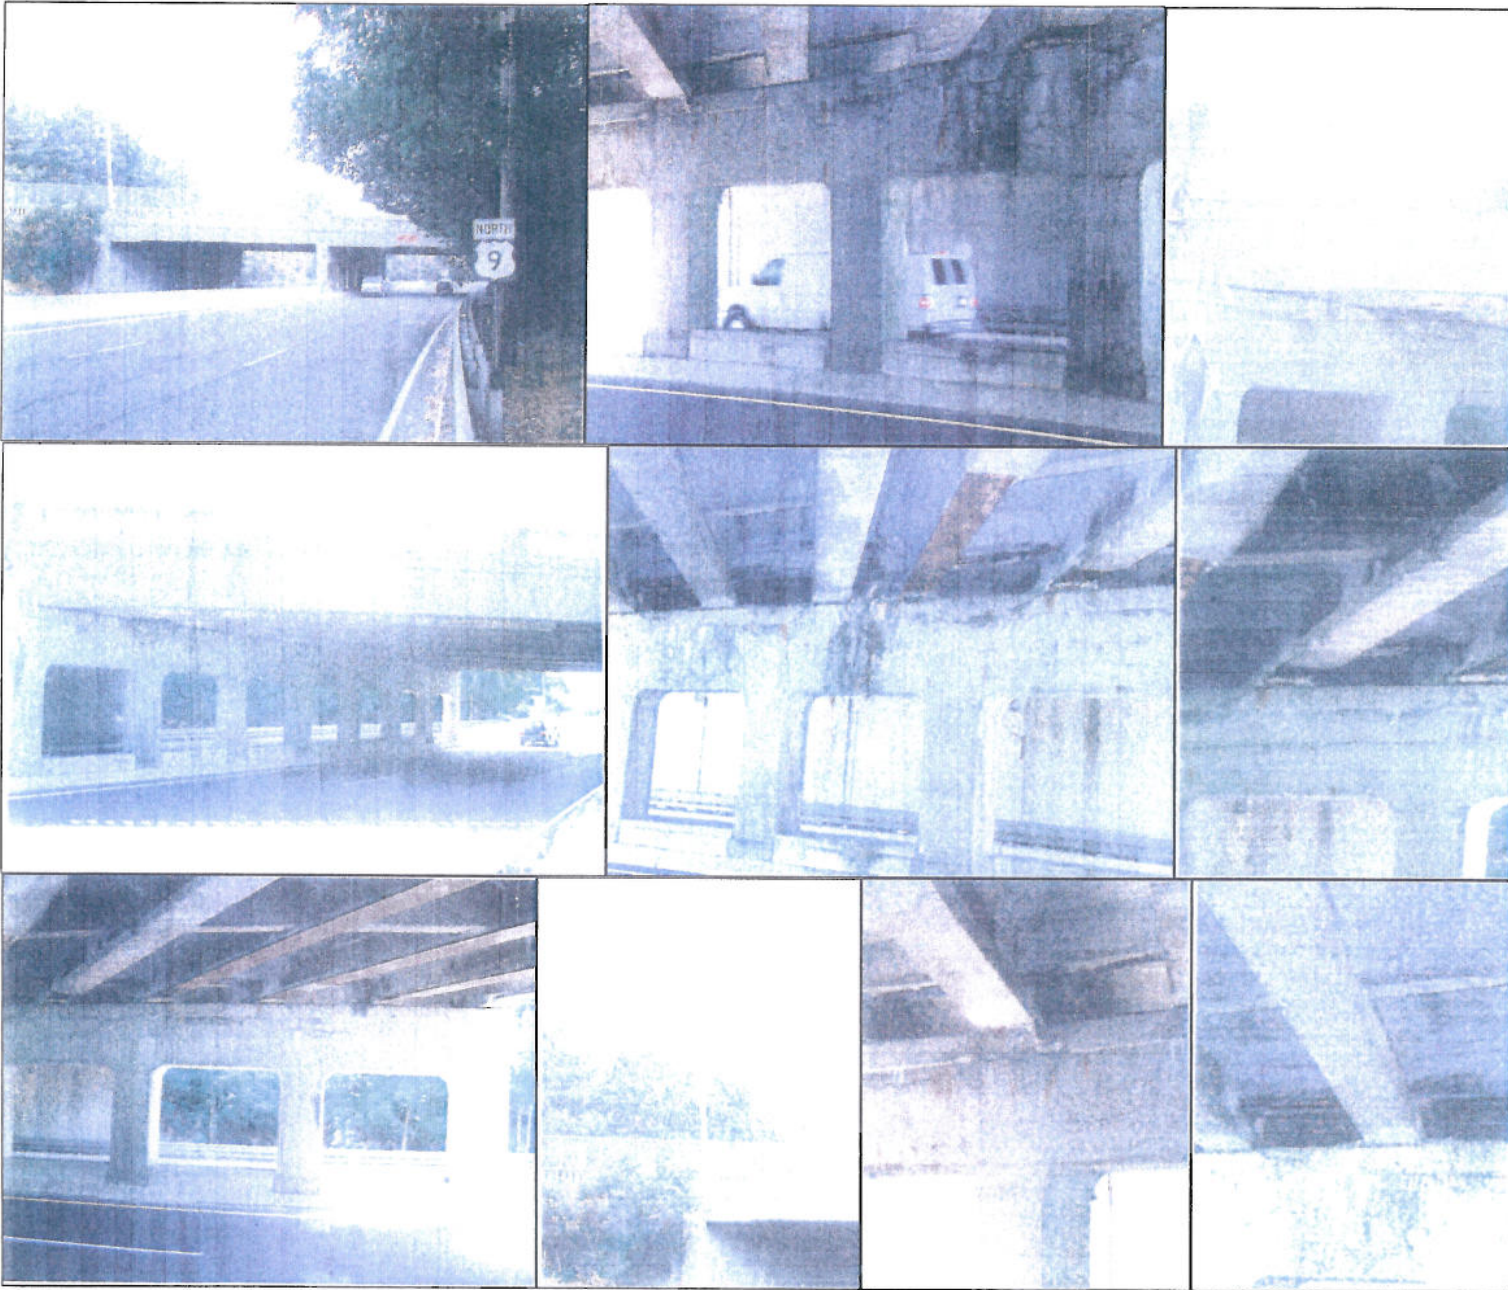
**Figure 1:** Field photographs showing the condition of the concrete overpass along with cracking at various locations of concrete.

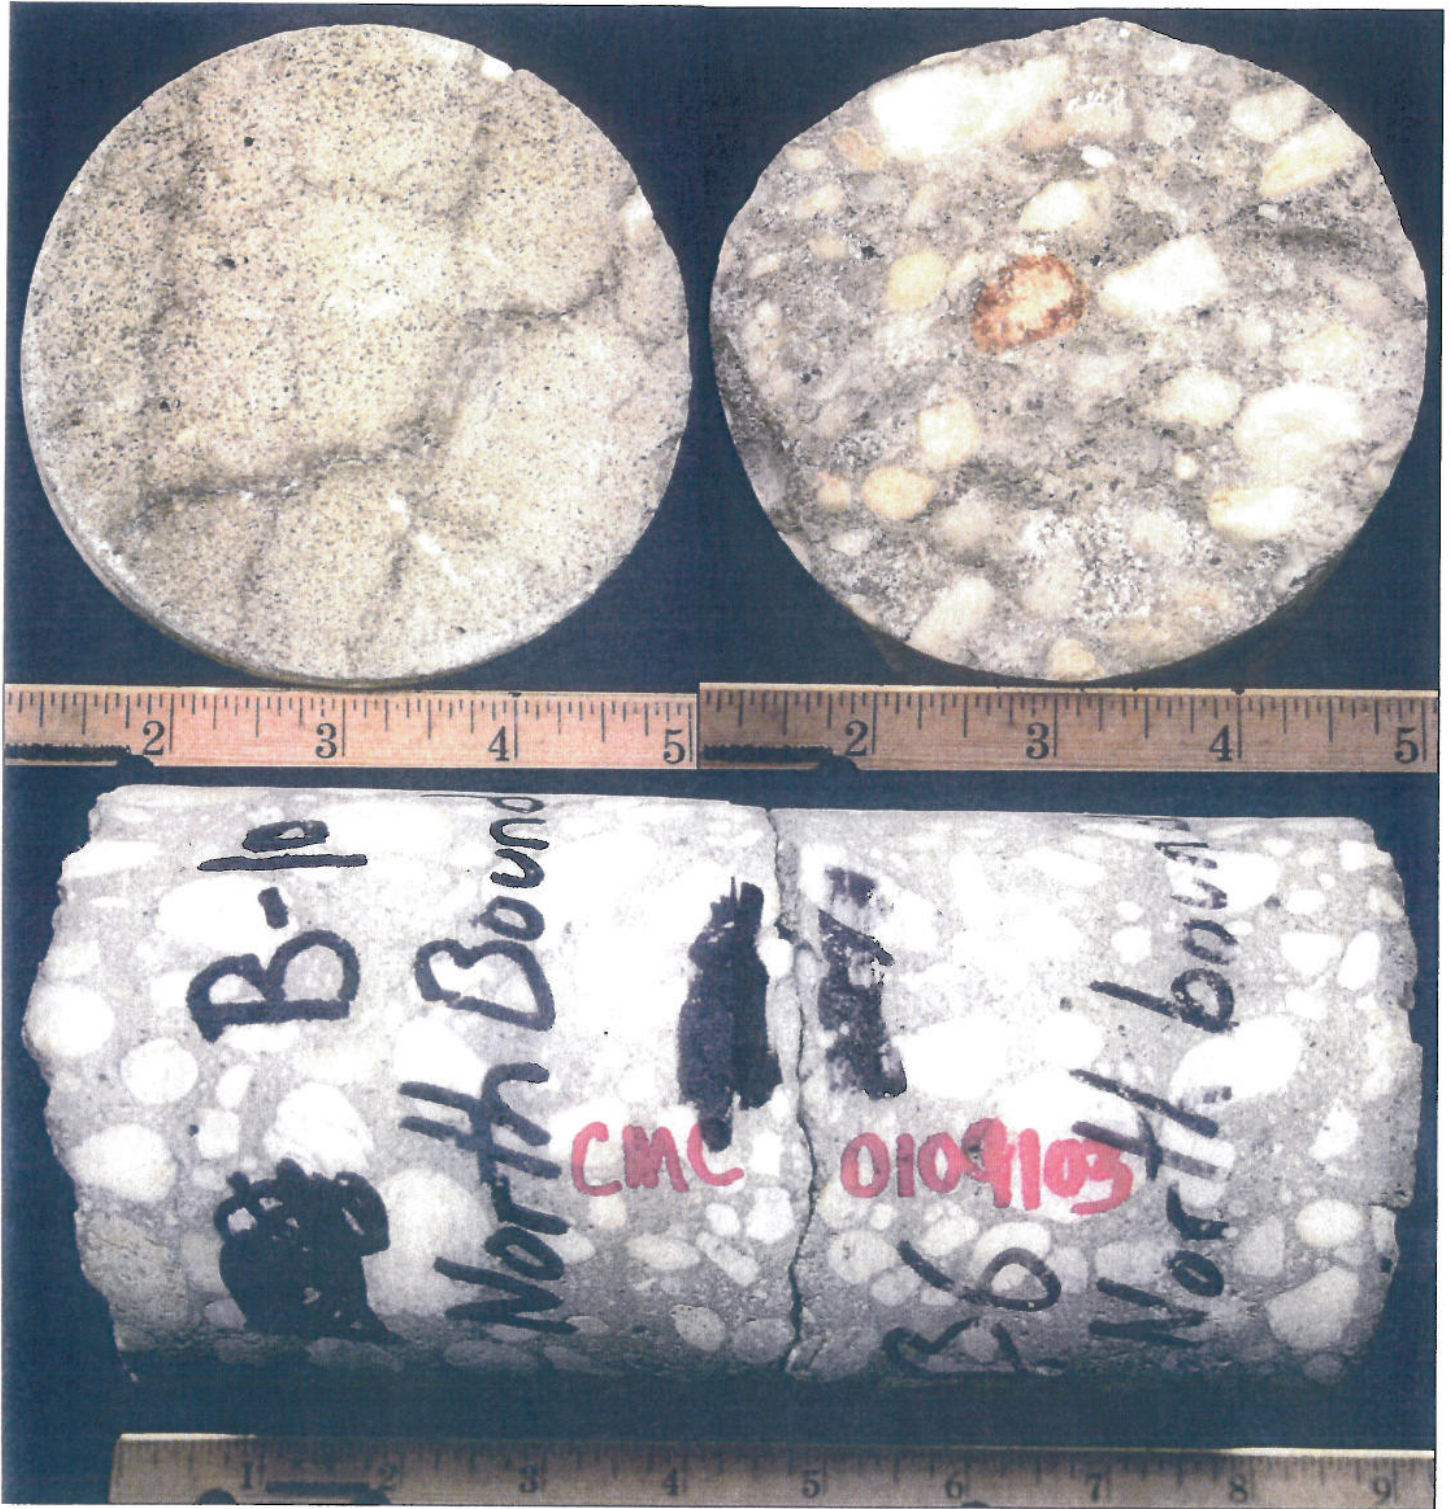
Surfaces – Figure 2 shows the exposed end surface of the core containing closed polygonal shaped map cracking (also notice in Figure 5) and fresh fractured opposite end.

**Figure 2:** Shown are: (a) the top, exposed surface of concrete with map cracking (top left); (b) the bottom fresh fractured surface of concrete, (top right); and (c) the side view of Core B-10 showing a crack at mid-depth location that broke the core into two halves (bottom photo).

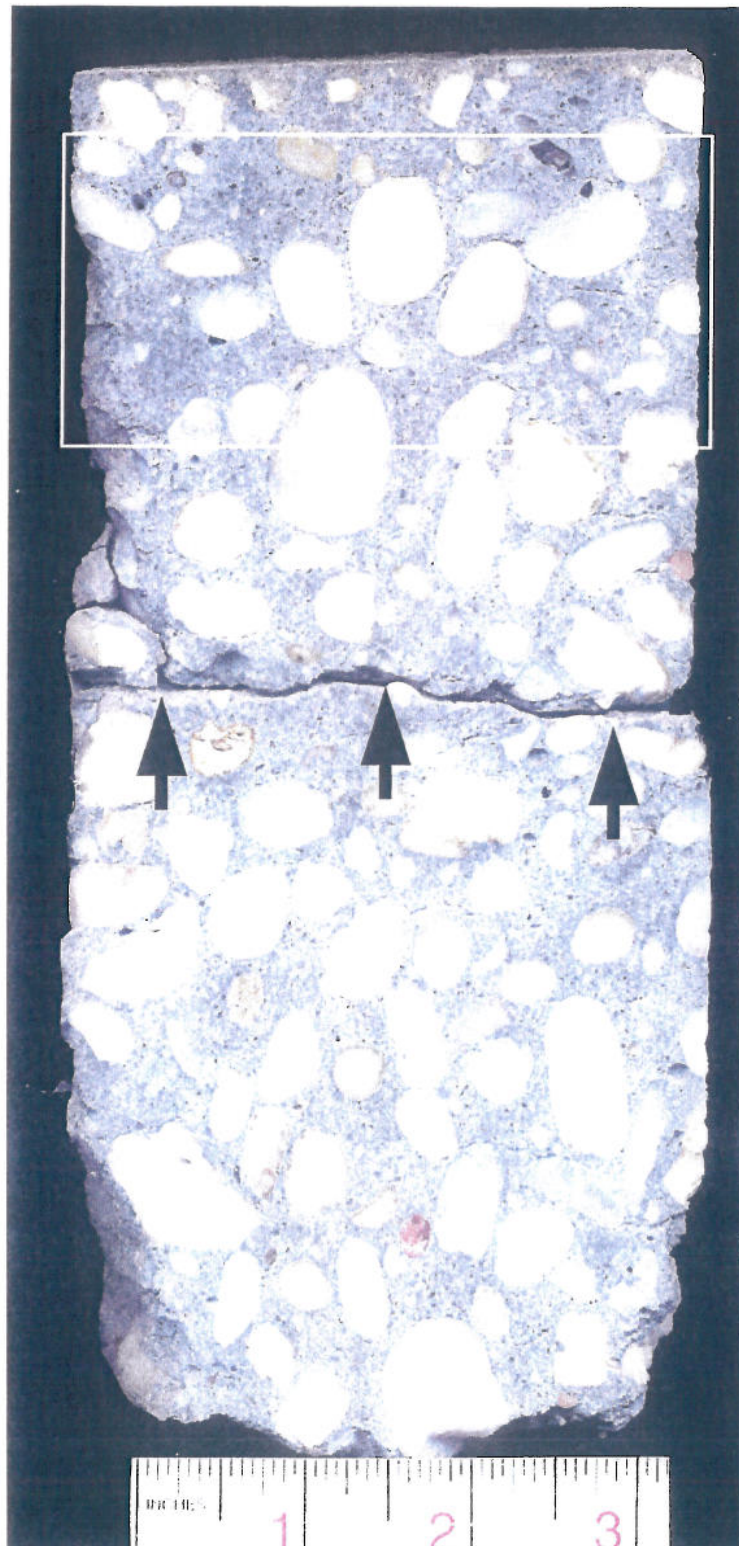
the core into two halves. This major crack occurs at the depth of the reinforcing steel in the concrete – where the major crack may have formed by corrosion of reinforcing steel in concrete and/or during the core removal process.

**Figure 3:** Lapped cross section of Core B-10 showing: (a) the well-distribution and overall good grading of the aggregate particles; (b) a crack at a depth of  $3\frac{3}{4}$  in. (arrows), which broke the core into two pieces. The boxed area is enlarged in the next figure.

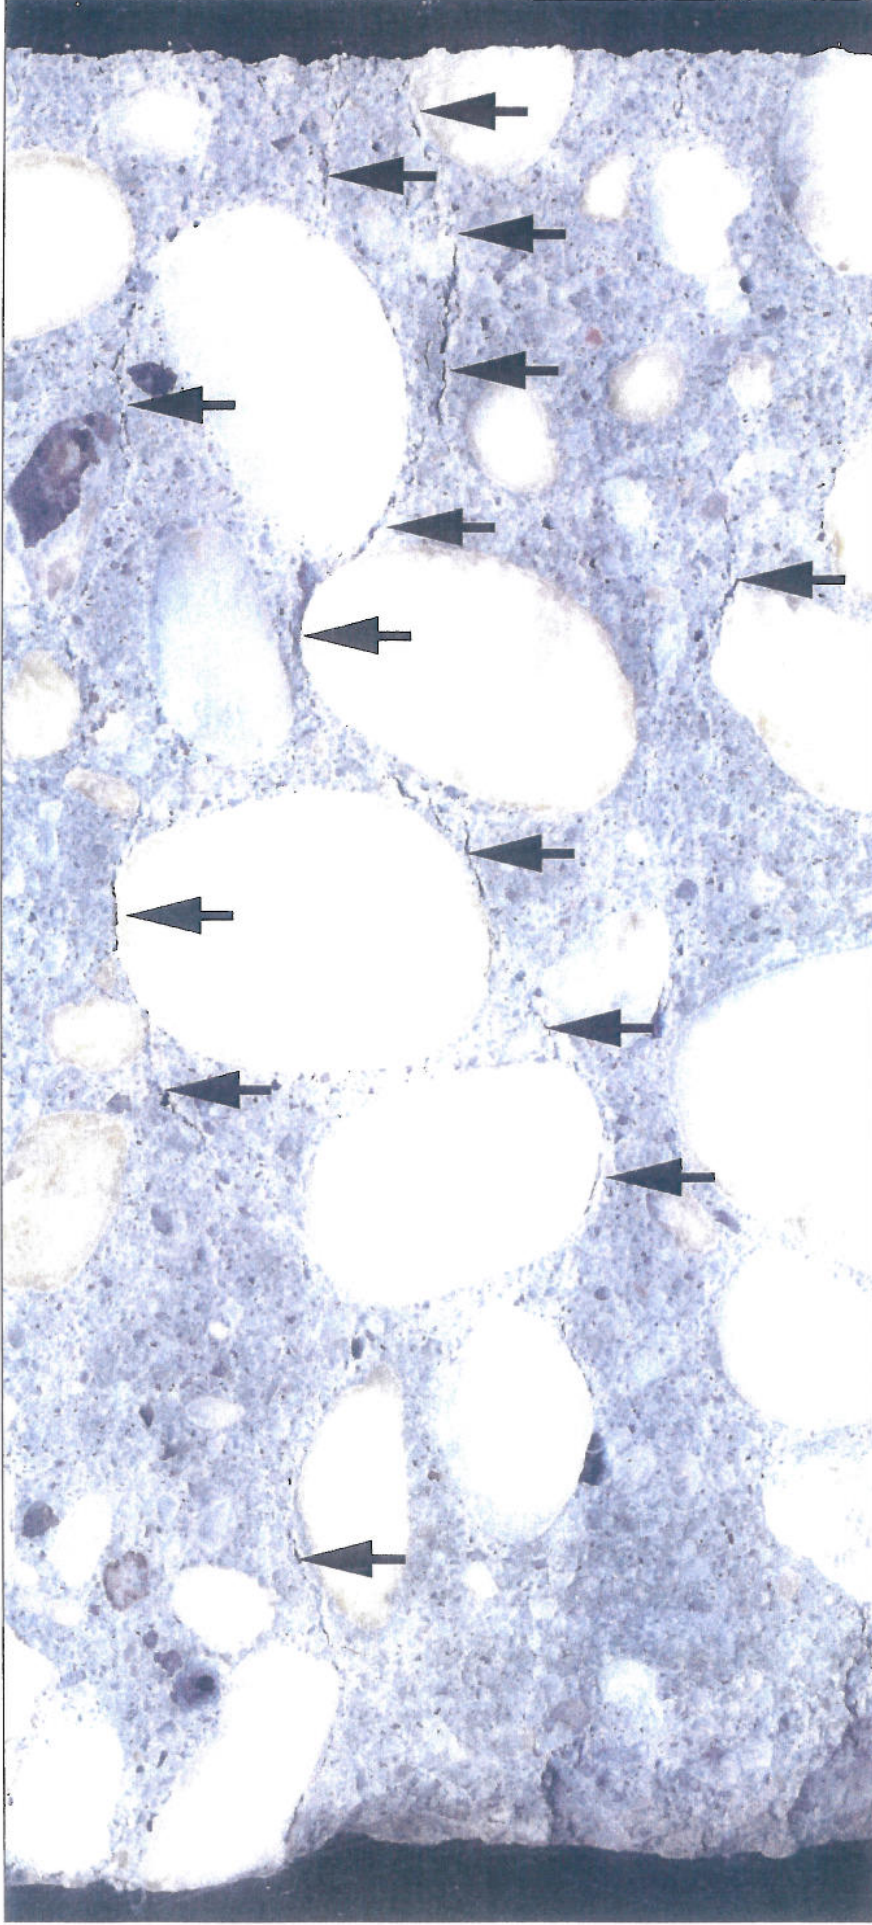
**Figure 4:** Enlarged view of the boxed area in Figure 3 showing macro and microcracking (arrows) through out the top half to the mid-depth location of the concrete core, and the resulting weak aggregate-paste bonds.

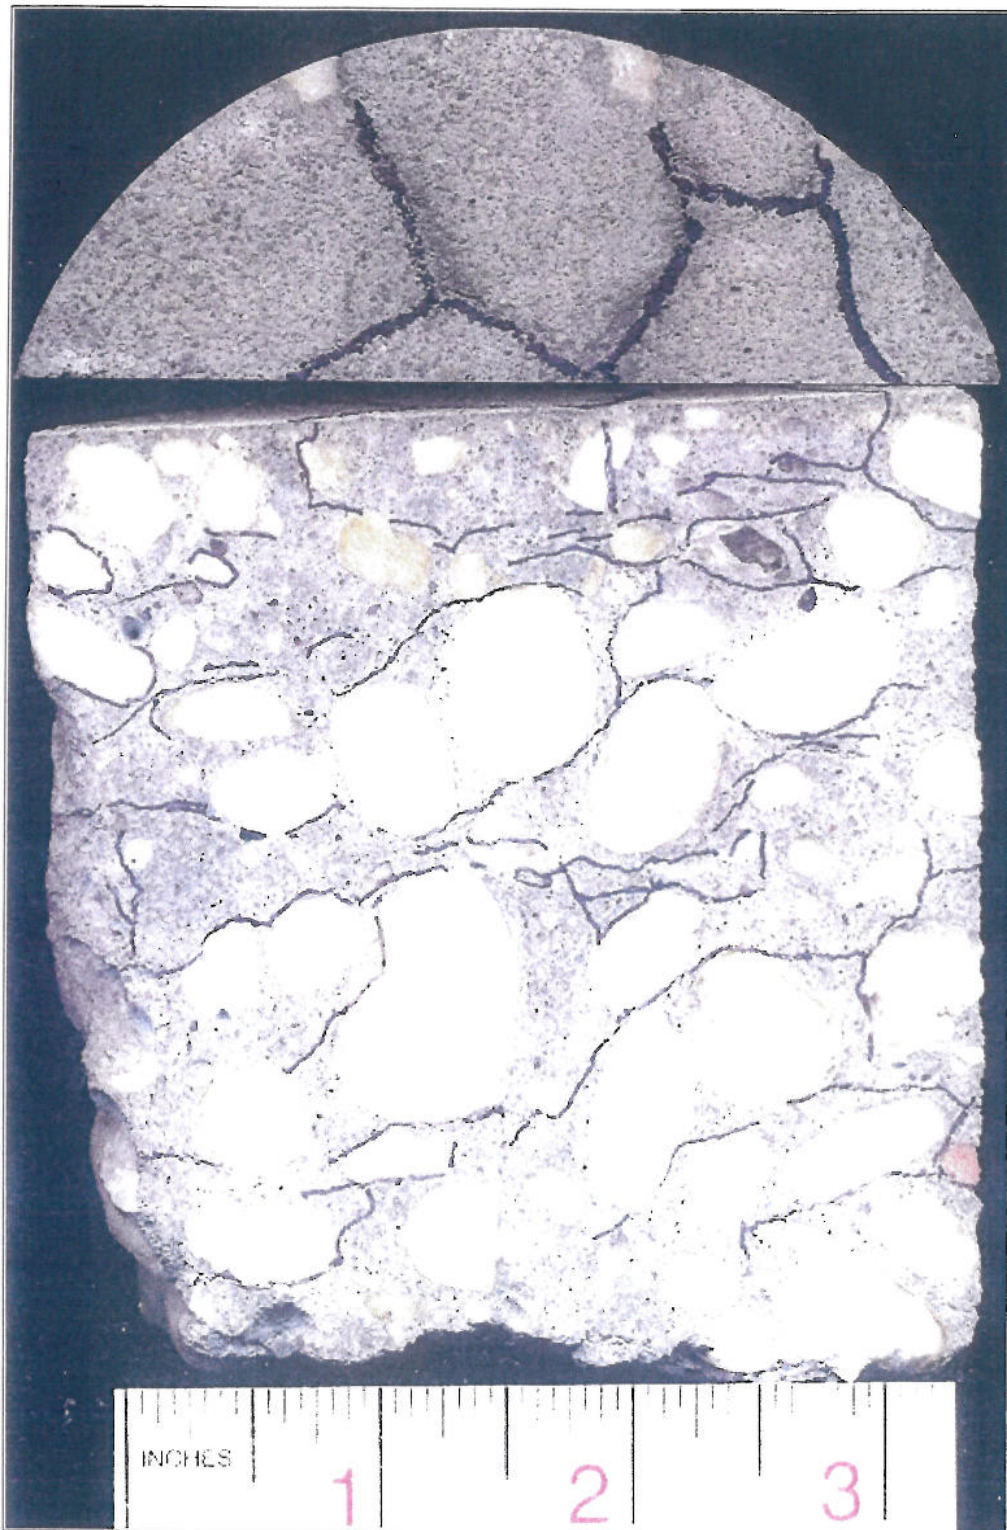
**Cracking Due to Cyclic Freezing and Thawing** – Due to the non-air-entrained nature of the concrete, and its reported exposure to an outdoor environment of cyclic freezing and thawing, and the configuration of the map cracks on the surface and parallel severe cracking within the body from near the exposed surface region to a depth of 4<sup>1</sup>/<sub>2</sub> in – are all indicative of concrete deterioration (cracking) by cyclic freezing and thawing at critically water-saturated conditions.

**Figure 5:** Plan view (top photo) and corresponding cross sectional view (bottom photo) of the core showing the pattern of map cracking at the surface and subparallel cracks in the body of the concrete transecting and circumscribing the aggregate particles.

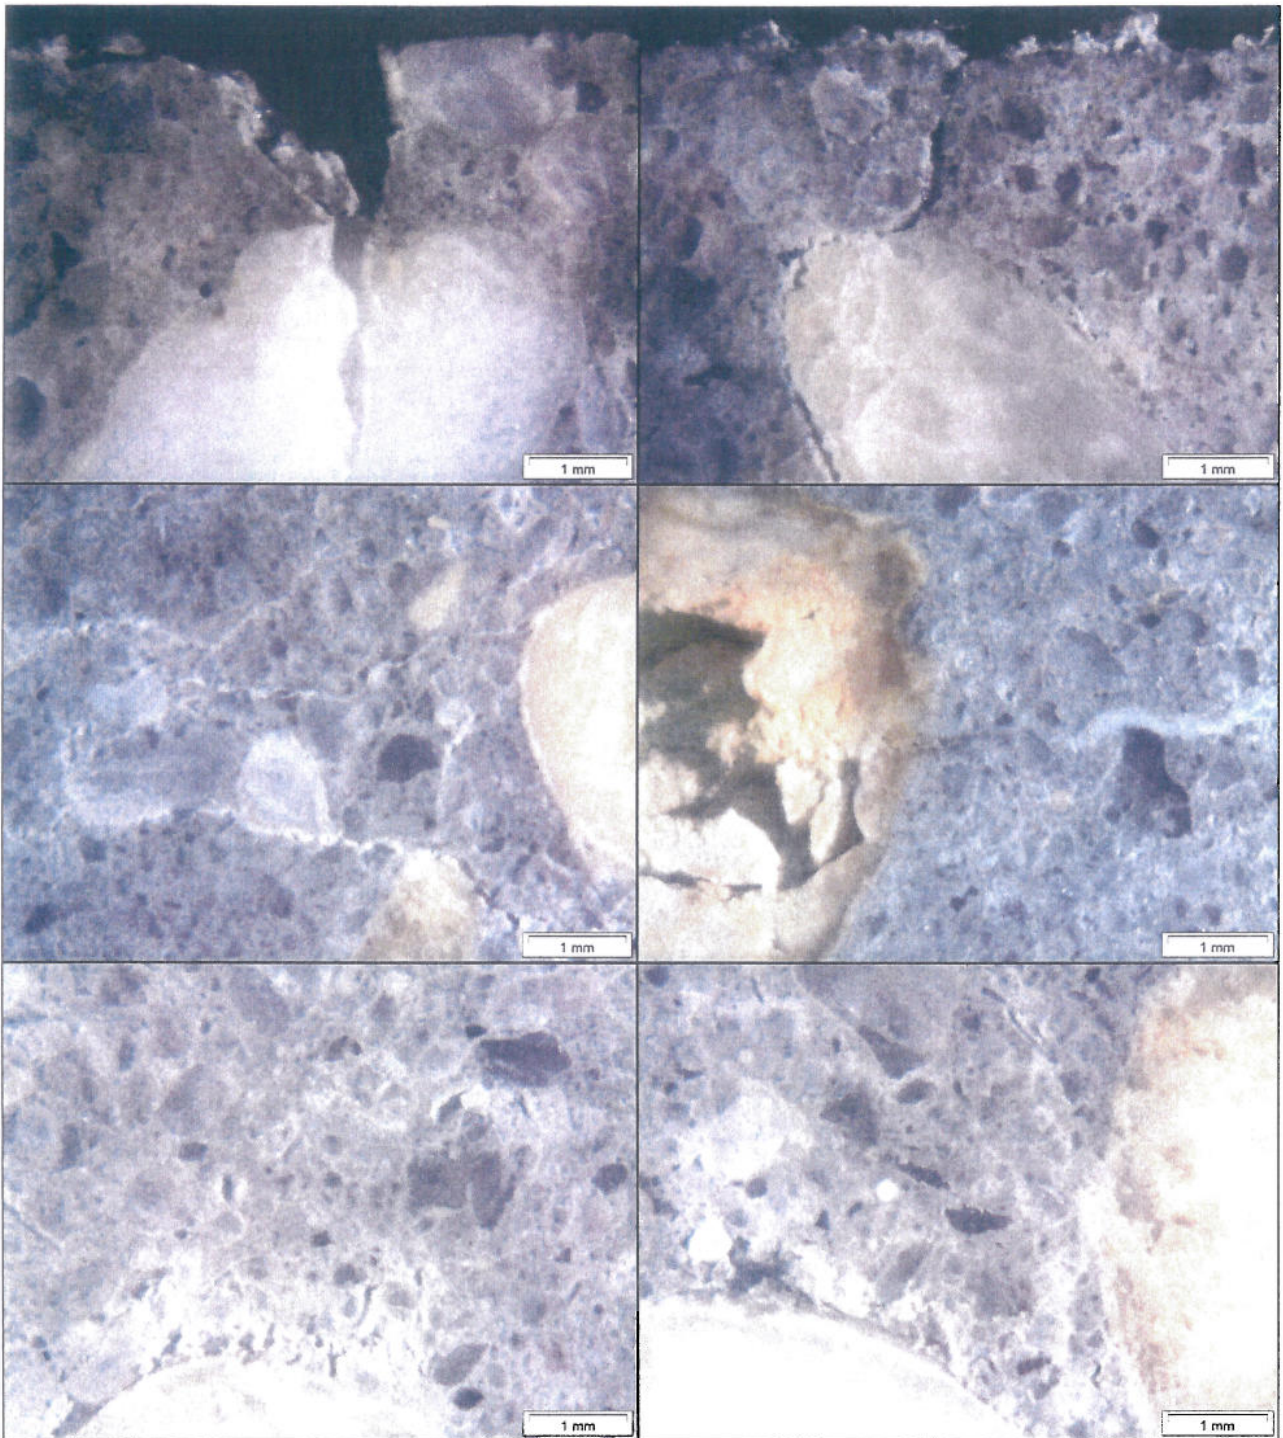
**Figure 6:** Photomicrographs of lapped cross section of Core B-10 showing: (a) micro and macrocracks at the top surface region, which have transected and circumscribed the aggregate particles (top photos); (b) micro and macrocracking throughout the core (middle photos); (c) the weak aggregate-paste bonds; and (d) the non-air-entrained nature of the concrete (all photos).

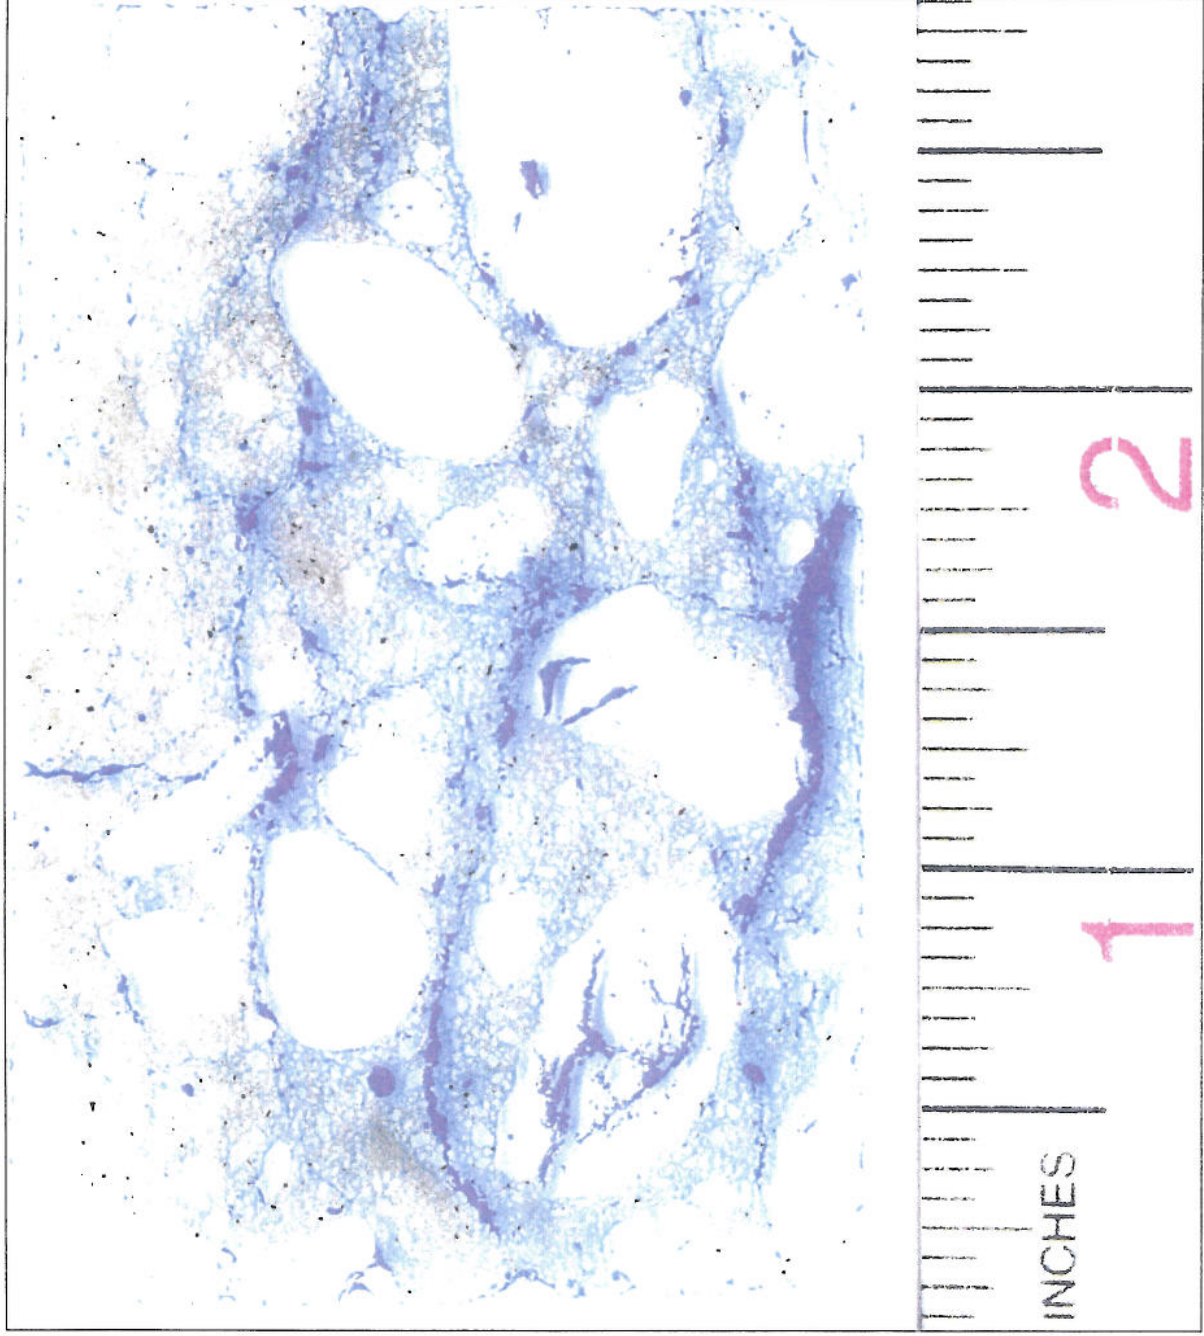
**Figure 7:** Blue dye-mixed epoxy-impregnated thin section of Core B-10 showing severe microcracking at the top surface region and in the body, as highlighted by the blue dye-mixed epoxy used to impregnate the sample.

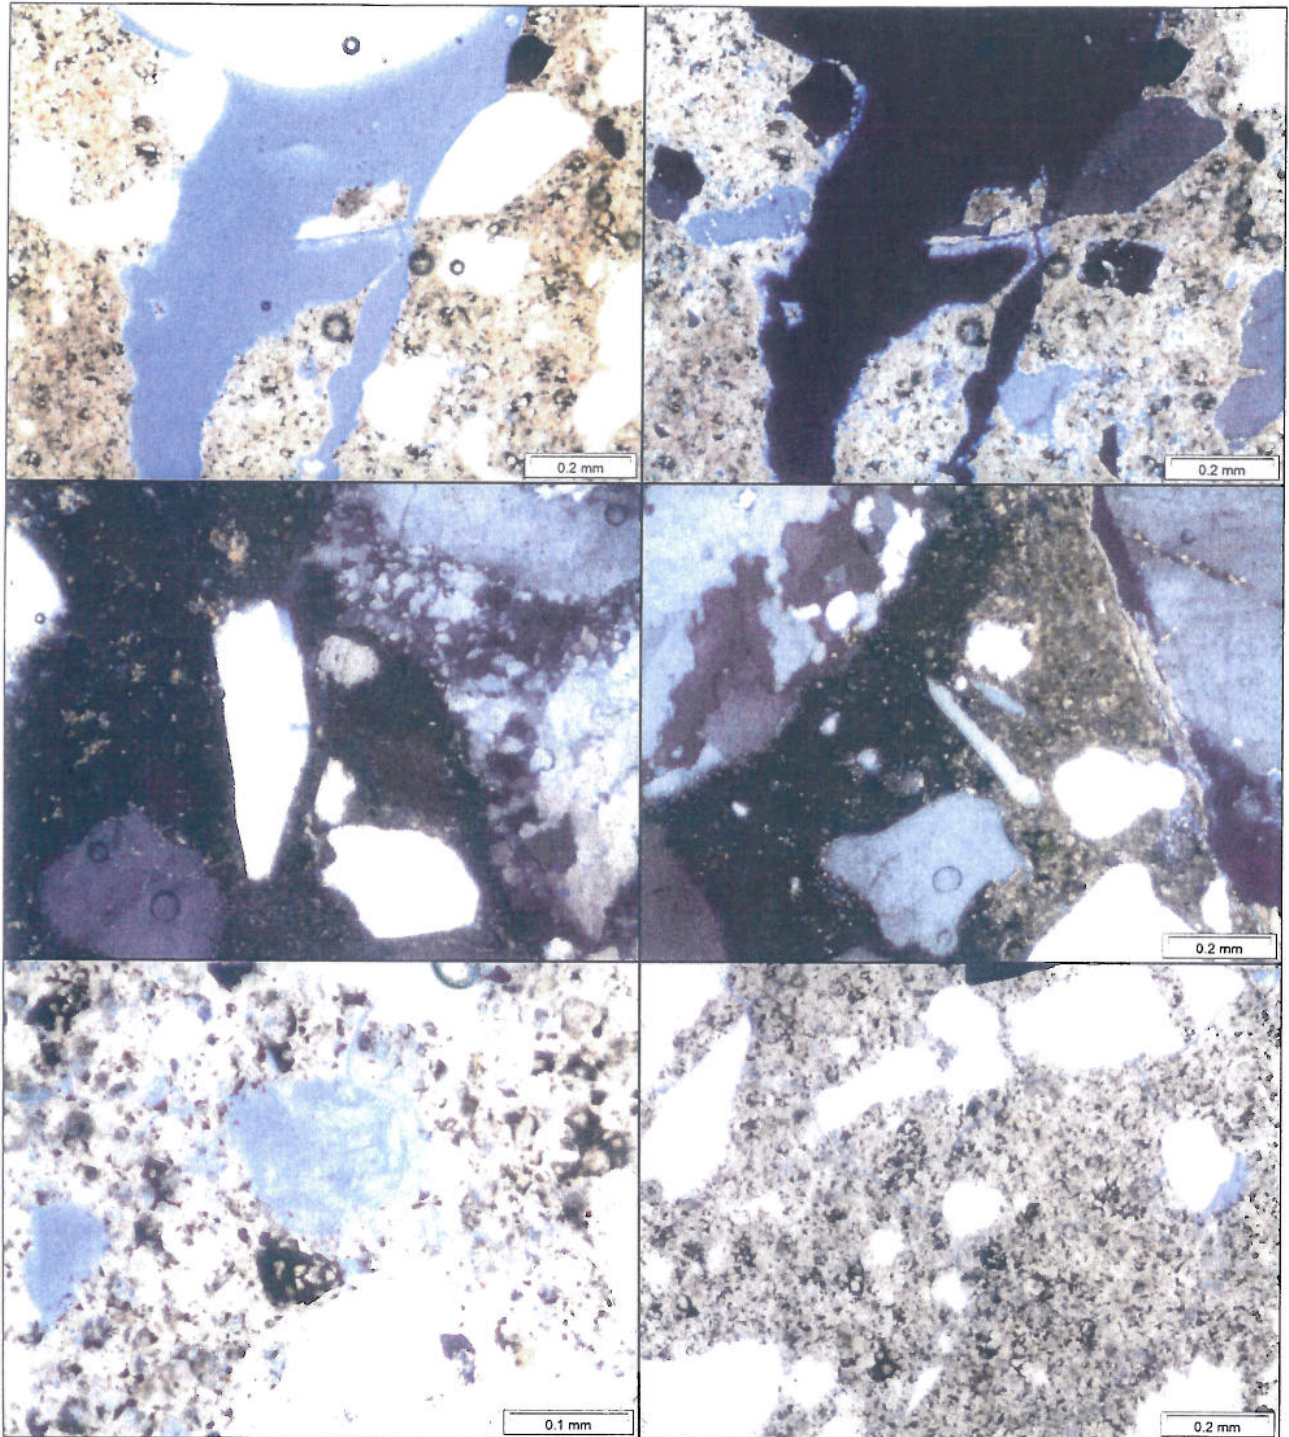
**Figure 8:** Photomicrographs of blue dye-mixed epoxy-impregnated thin section of Core B-10 showing: (a) microcracking at the top carbonated surface region (top photos); (b) the gravel coarse aggregate and natural silicious sand fine aggregate (middle photos); (c) the non-air-entrained nature of the concrete (bottom left); and (d) residual portland cement particles present in the paste (bottom right).

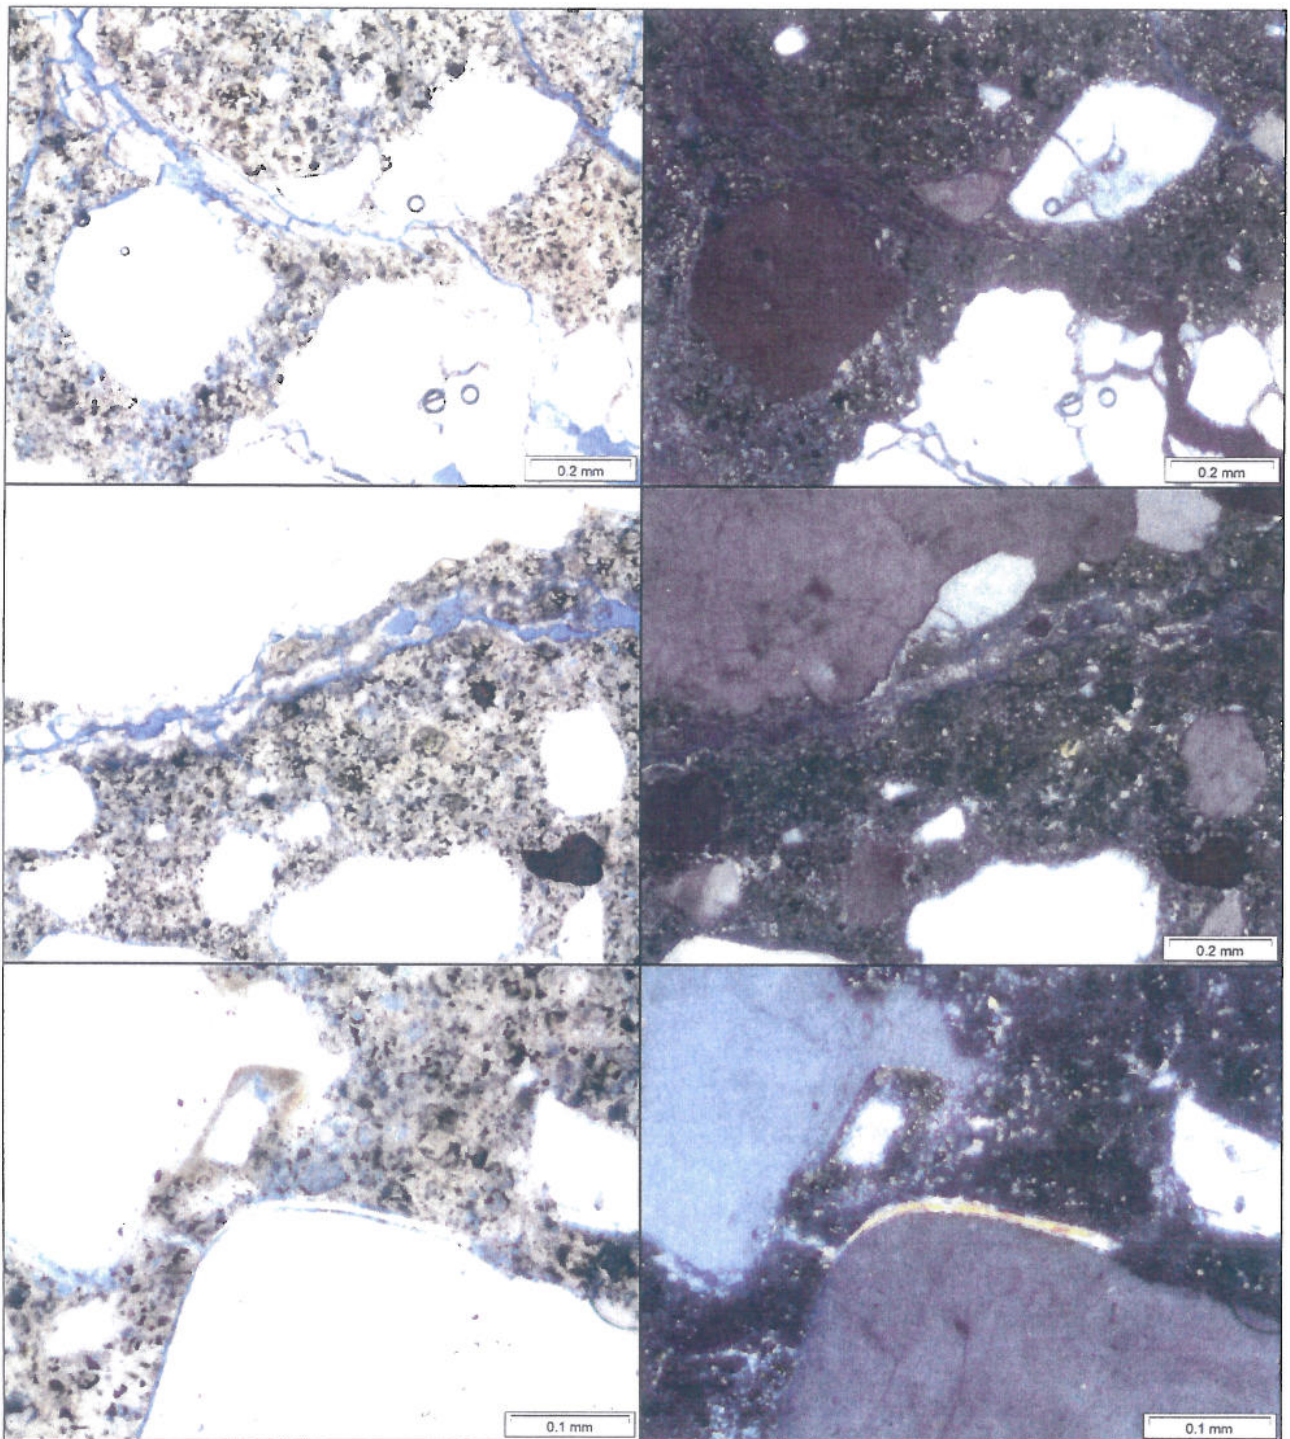
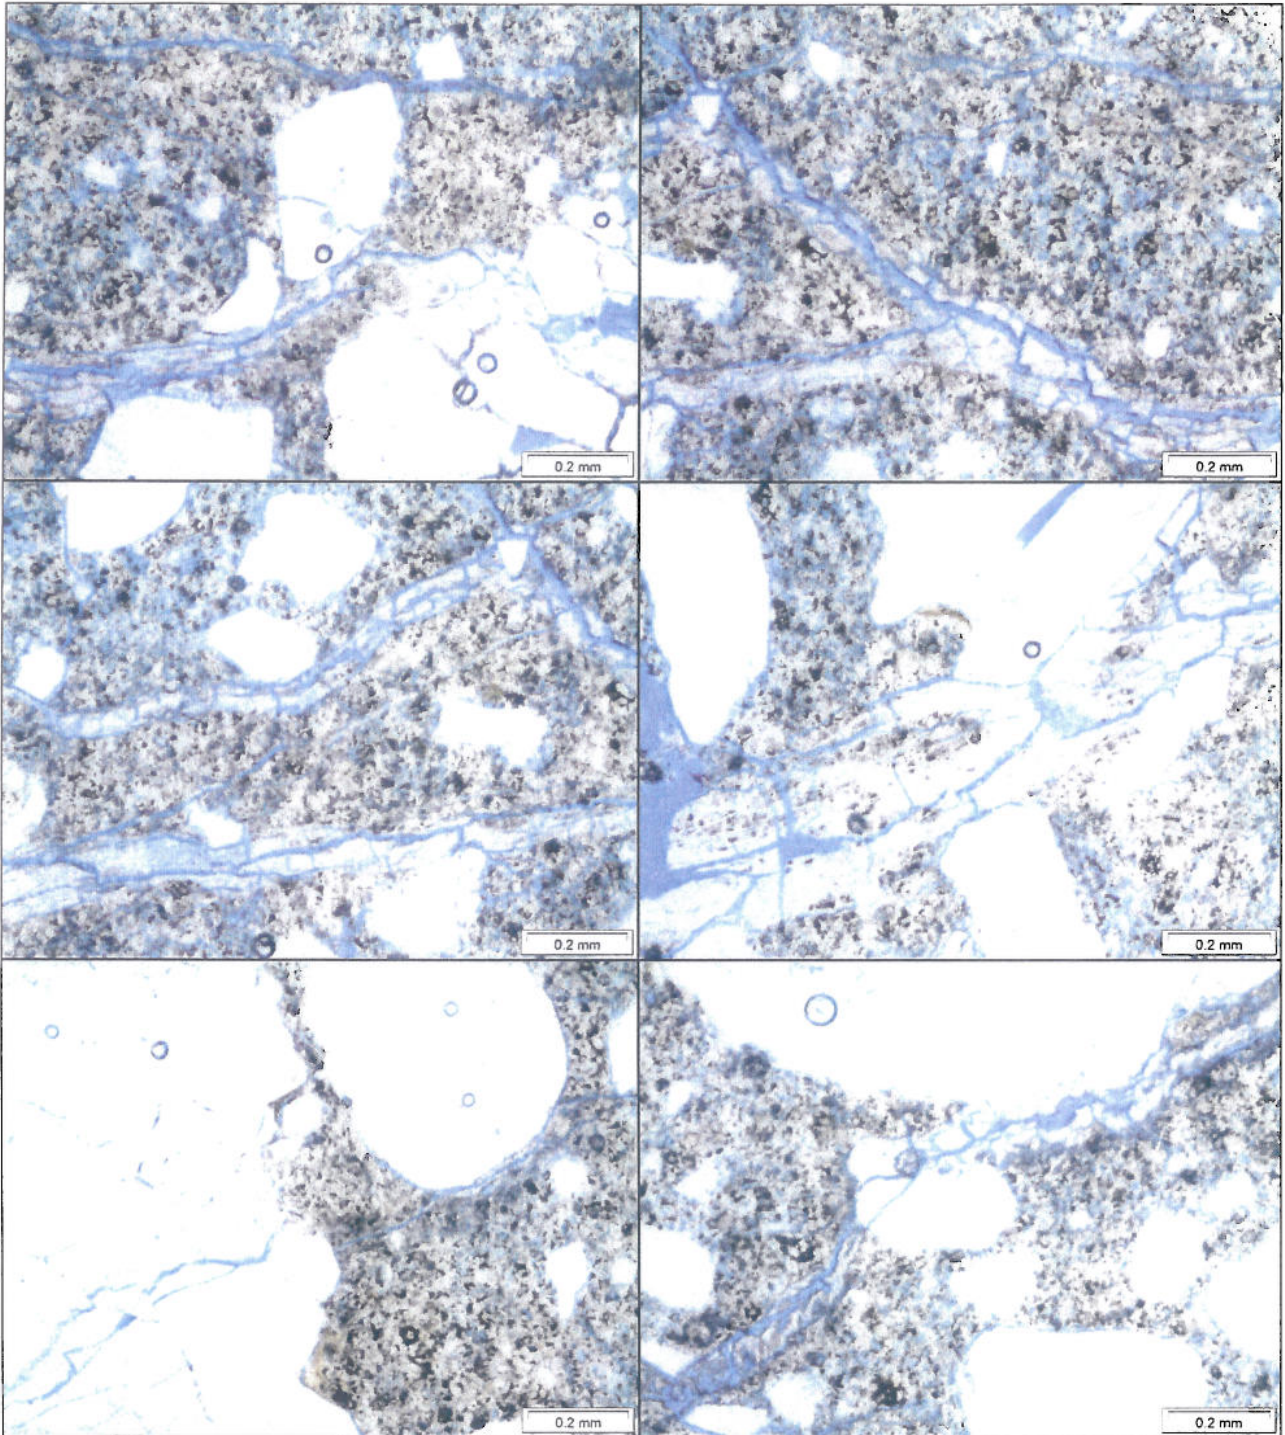
**Cracking Due to Deleterious Alkali-Silica Aggregate Reaction** – A secondary mechanism of cracking, at local scale is detected as potentially expansive alkali-silica aggregate reaction, as mentioned before, which is associated with a few strained quartzite gravel coarse aggregate particles that are cracked and generated alkali-silica reaction gels which were deposited within those cracks either within the reactive particles or in cracks extended from the particles into the neighboring paste. The extent, abundance and severity of cracking due to alkali-silica reaction is determined to be significantly lower than cracking formed by cyclic freezing and thawing of a non-air-entrained concrete at critically water-saturated conditions.

**Figure 9:** Photomicrographs of blue dye-mixed epoxy-impregnated thin section of Core B-10 showing microcracking throughout the core associated with alkali-silica reaction gel within the cracks.

**Figure 9 (Cont'd):** Photomicrographs of blue dye-mixed epoxy-impregnated thin section of Core B-10 showing microcracking throughout the core associated with ASR within the cracks.
