HAWAIIAN CONNECTIONS

NEWSLETTER OF THE HAWAII LOCAL TECHNICAL ASSISTANCE PROGRAM

KEAIWA STREAM BRIDGE BACK IN OPERATION IN 7 MONTHS!!

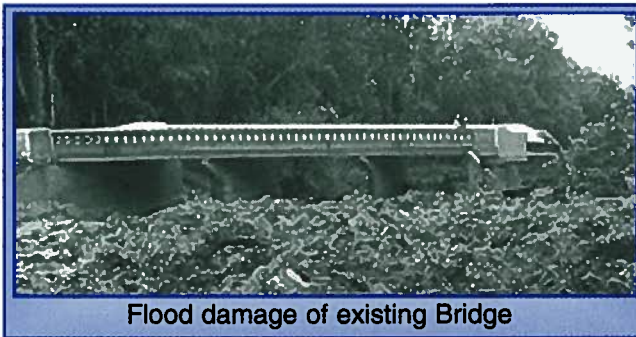
Flood damage of existing Bridge

The abutment and approaches on the south end (Pahala side) of the existing bridge were entirely washed out. Residents going into and out of this quaint, peaceful town, were greatly inconvenienced. As a result, the government had to find a way to allow vehicles to cross the stream.

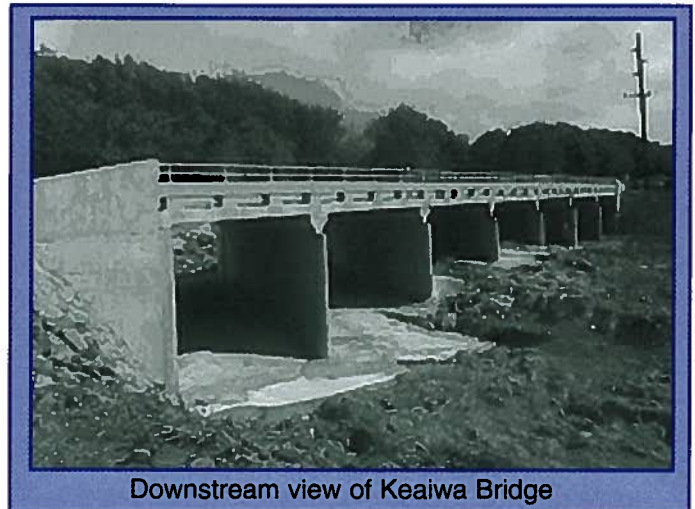
Downstream view of Keaiwa Bridge

A team consisting of Wesley R. Segawa & Associates, Inc., KSF, Inc., GeoLabs, Inc., Mitsunaga and Associates, and M&E Pacific was hired in 6 days and the design commenced November 15. The new reinforced concrete bridge consists of two abutments and seven continuous spans with expansion joints at the abutments. It is 230 feet long and has a 40-ft wide roadway with two (2) 11-ft lanes, and two (2) 9-ft shoulders. The bridge approaches, reinforced concrete wing walls and concrete rubble masonry (CRM) walls were designed to stabilize the stream's banks.

The superstructure consists of 11-inch thick prestressed-precast planks composite with six (6) inches of cast in place concrete topping. Precasting was selected to expedite the construction time. The substructure consists of six wall piers on narrow continuous footings, embedded in the basalt subgrade. The wall piers are skewed 42.5 degrees, i.e., 47.5 degrees from the longitudinal axis.
