ABC Innovative Projects

OR 47 Bridge over Dairy Creek Overflow					
Location	Oregon Route 47 (Nehalem Highway 102) at Milepost 81.94 over Dairy Creek Overflow in Washington County between the town of Banks and Highway 26				
State	Oregon				
Owner	State				
Year ABC Built	2007				
State ID #	20316				
NBI #	20316				
Coordinates	Latitude: 45.6341		Longitude: -123.1256		
Contact Person	Bruce V. Johnson, P.E. State Bridge Engineer Oregon Department of Transportation Phone: 503-986-3344 Email: bruce.v.johnson@odot.state.or.us				
Mobility Impact Time	ABC: 14 days		Conventional: four months		
Impact Category	<i>Tier 1</i>	<i>Tier 2</i>	Tier 3	<i>Tier 4</i>	<i>Tier 5</i>
			X		
Primary Driver(s)	<ul style="list-style-type: none"> • reduced traffic impacts • reduced onsite construction time • improved work-zone safety • improved site constructability • minimized environmental impacts • reduced life-cycle cost 				
Description	<ul style="list-style-type: none"> • 45-ft-long and 40-ft-wide single-span prestressed adjacent box beam bridge • Rural location • Average Daily Traffic count: 4,000 (2010) • Traffic management alternative, if constructed conventionally: extended use of 3.75-mile d

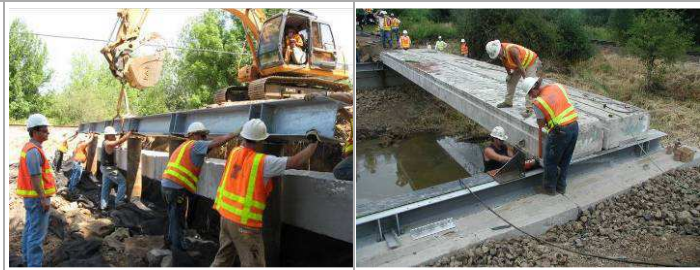
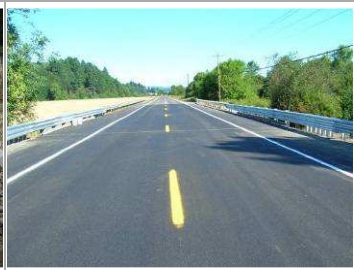
<p>Traffic was detoured and the existing bridge was demolished. At each abutment the piles were exposed, cut to grade, and capped with a galvanized steel pile cap. A crane was used to erect the caps and beams. The cap was bolted to a steel plate welded to each pile. The beams were erected onto elastomeric bearing pads, and their ends were bolted to the caps. The shear keys between beams were grouted. The 7/8-inch-diameter galvanized tie rods were threaded through the beams at ends and third points and stressed using the turn-of-the-nut method. The tie rod galvanized ducts were ungrouted. The bridge was paved with an asphalt overlay without the use of a waterproofing membrane.</p> <p>Construction Schedule:</p> <ul style="list-style-type: none"> • Day 1-2 – Bridge removal and excavation • Day 3 – Finish removal of bridge and wood piles • Day 4-5 – Cutting piles to correct elevation • Day 6 – Finish setting caps • Day 7 – Off on Sunday • Day 8-9 – Setting slabs and grout keyways • Day 10 – Backfill, roadway grading, and paving preparation • Day 11-12 – Begin paving, shoulder material, and site cleanup • Day 13 – Finish guardrail and pavement markings • Day 14 – Finish cleanup and open road <p>All construction work except the pile foundation was done by in-house bridge maintenance forces.</p> <p>Stakeholder Feedback: Successful bridge replacement was accomplished in two weeks. The 14-day bridge closure allowed the owner to save \$120,000 by omitting the traffic control signal cost that would have been required for conventional staged construction over a four-month period. Coordination with other disciplines saved more time and money; for example, the permitting process were streamlined to address adding some fill to a wetland for the approach transition guardrail; and use of existing beams salvaged from another project in Region 5. Use of steel bent caps and field welding in lieu of cast-in-place concrete reduced much of the delay time.</p>
