# First Fully Prefabricated Full-Depth Deck Panel Bridge System in Michigan: Challenges & Lessons Learned

TRB 91<sup>st</sup> Annual Meeting Session 442

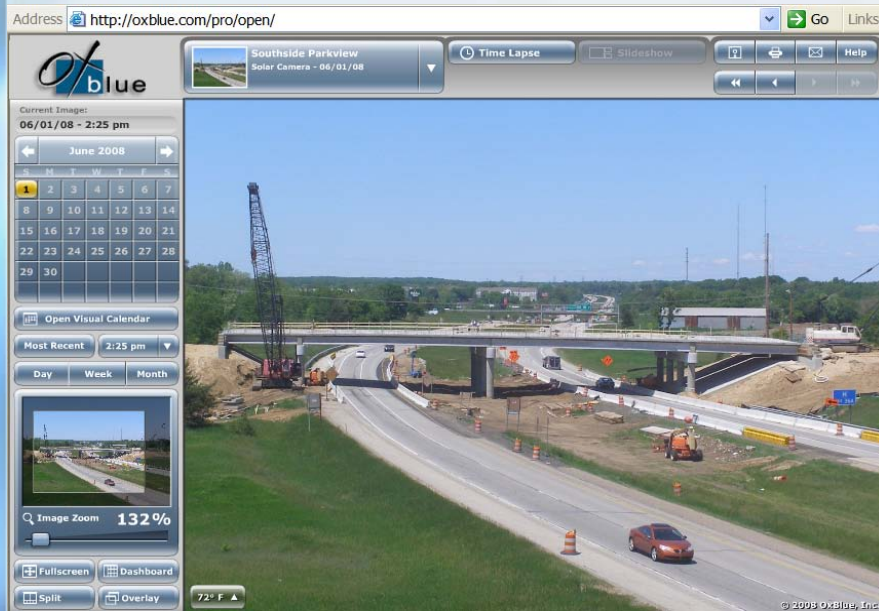
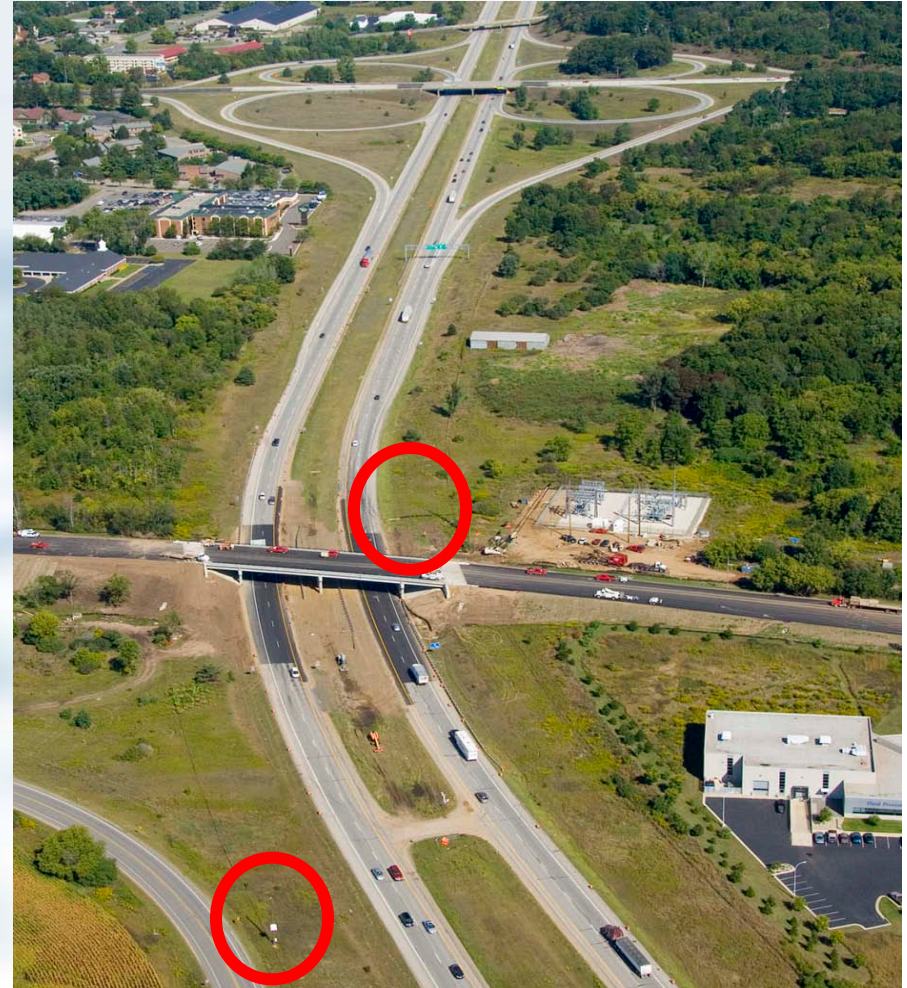
- Progress monitoring: field visits, google earth, and two cameras
- Same cameras were used for traffic monitoring

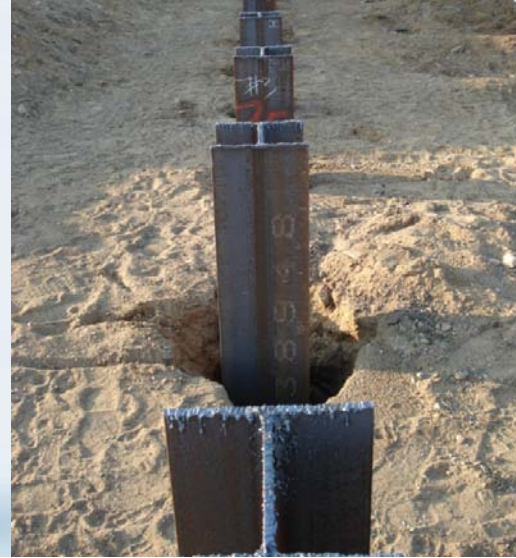
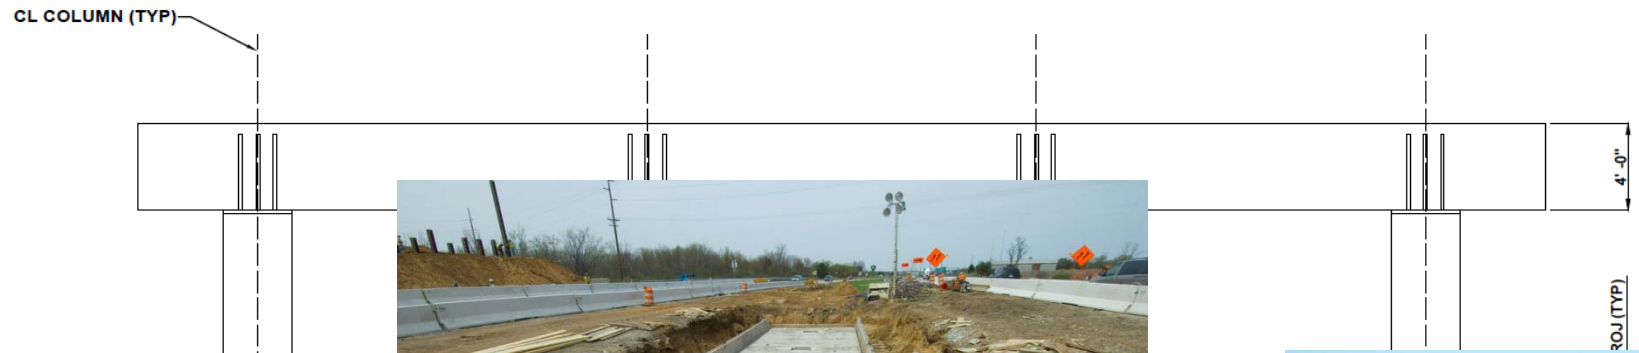
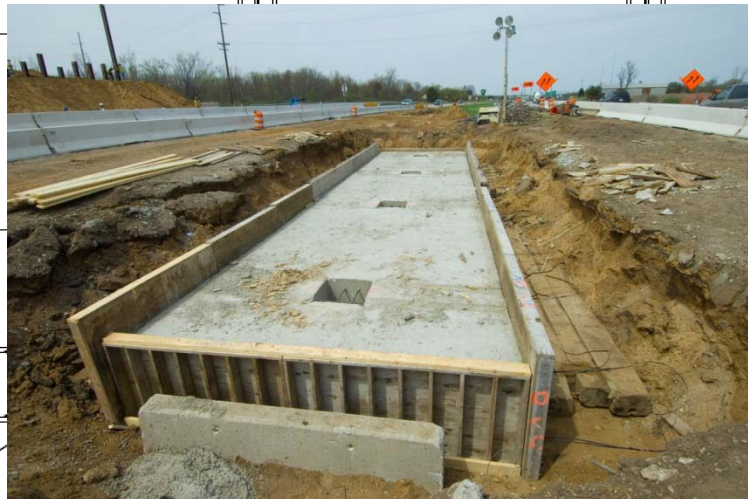
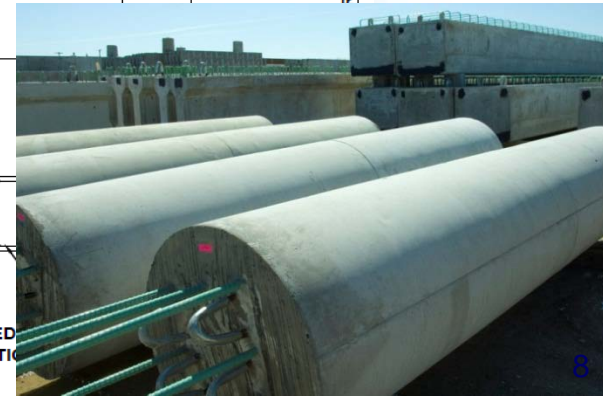
- 16 H-piles
- Cast-in-place footing for piers
- Four precast concrete columns / pier
- Precast pier cap

VOID FOR GROUTED  
COLUMN CONNECTION  
(TYP)

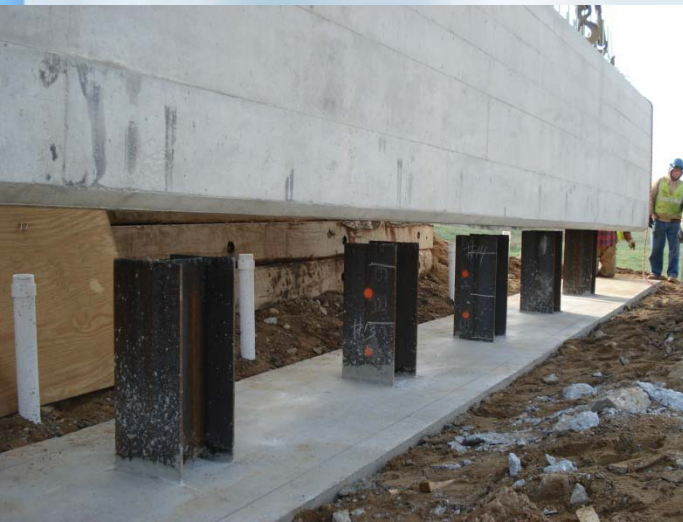
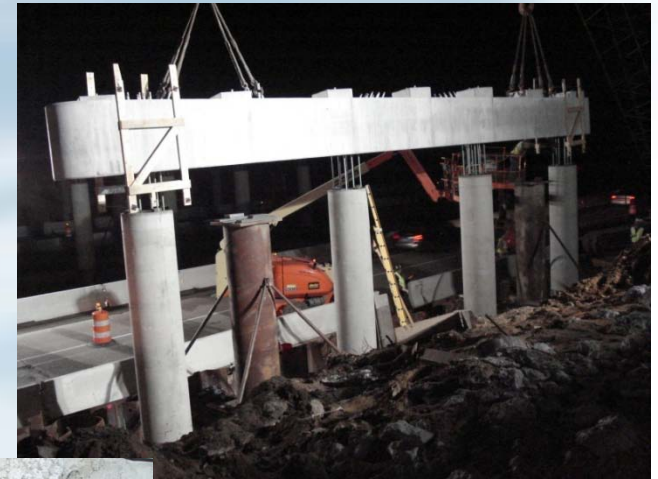
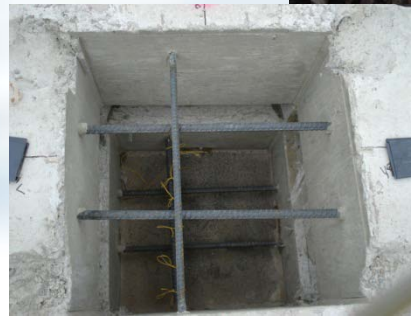
- Non-shrink grout to be used for all grouting procedures
- Non-shrink grout technical assistance from grout manufacturer
- Abutment to be on grade level and pile embedment of 30 in. into the abutment
- Fill 30 in. pile sleeve with non-shrink grout
- Connect pier columns to footing using square pockets in the latter
- Connect pier columns to pier cap using 8 – #9 bars from each column into 4 in. diameter corrugated ducts in the pier cap

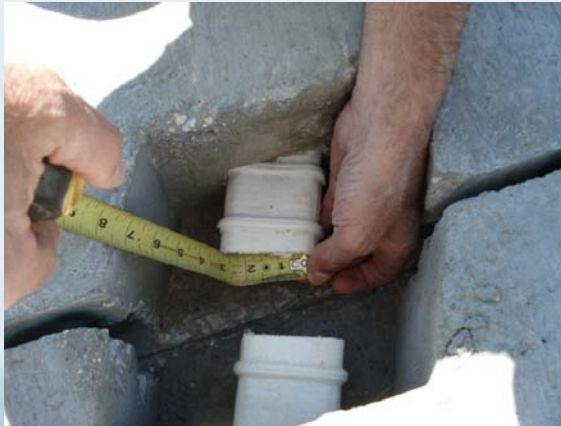
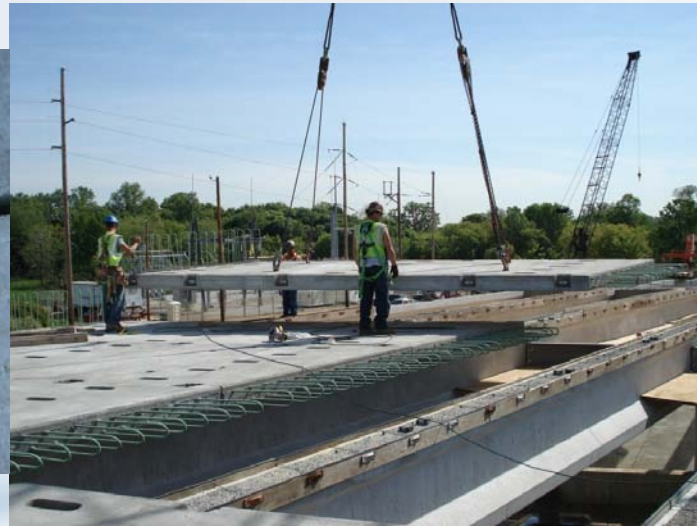
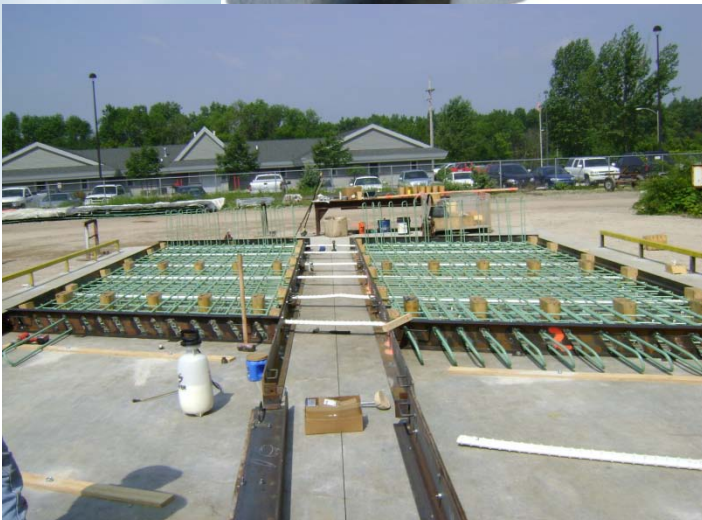
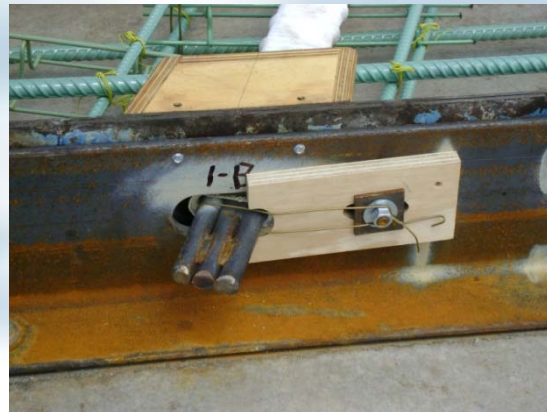
- Longitudinal post-tensioning duct misalignment
  - Due to calculation error (skew misinterpretation)
  - Contractor chose to re-cast all panels
  - “Cast-Match” technique used (different from “Match-Cast” technique)

- **Longitudinal post-tensioning duct misalignment**
  - Require a stringent quality control and quality assurance program with a detailed check list

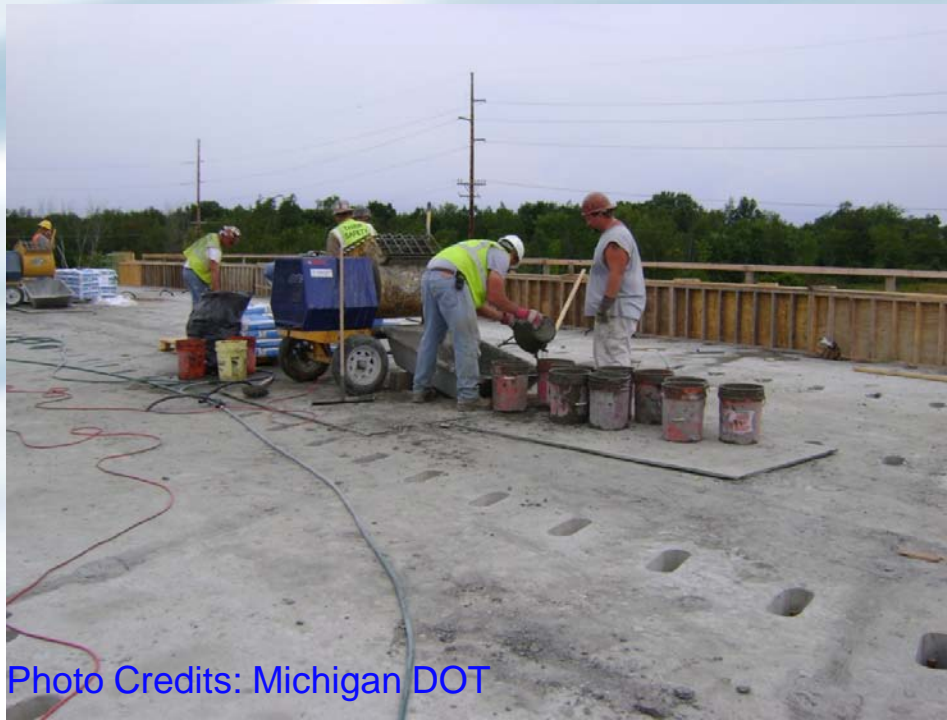
- Due to lack of grouting procedures in the specifications
- Contractor used shim packs for deck super-elevation
- Formwork installation - a major challenge
- Grout flow under gravity
- Voids were observed in haunches after removing the formwork
- Contractor was allowed to patch the voids in haunch

- *State-of-the-Art Report on Full-Depth Precast Concrete Bridge Deck Panels* (PCI 2011) –
  - Leveling device for deck panels should be embedded during prefabrication
  - Formwork for haunches range from removable formwork to stay-in-place compressible backer rod
- Specifications should require contractor to build a mock-up of the joint to demonstrate proficiency of the methods planned for placing grout
- Specifications should include material types and application procedures after carefully reviewing the manufacturer requirements

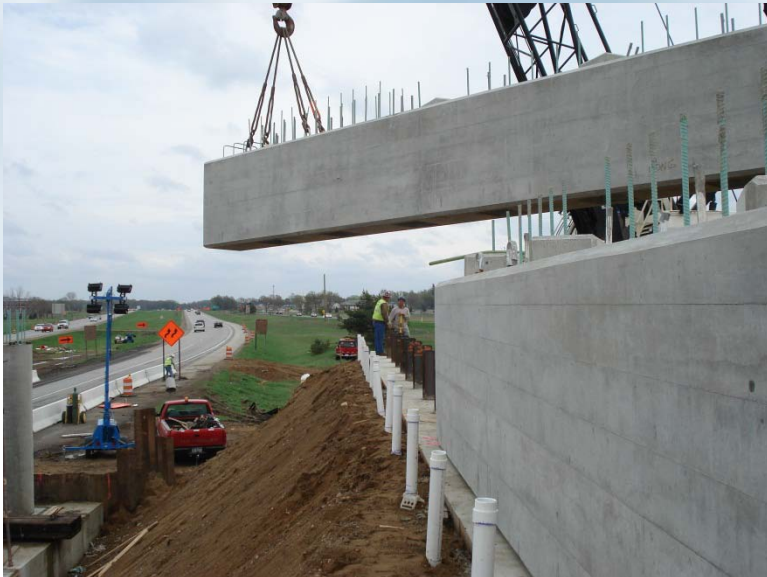
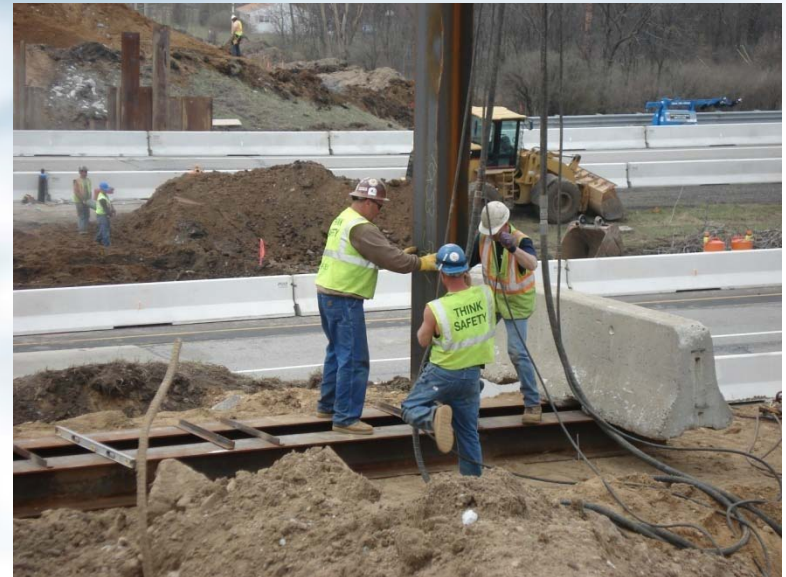
- Maintaining tolerances – contractor used a steel template
- Grout lift limit of 6 in. was imposed by manufacturer but pile embedment of 30 in. was specified in the project specifications.
- 4 in. diameter plastic tubes fitted in 4 in. thick concrete slab placed under the abutment stem were used to fill abutment-to-pile connection with latex concrete leaving 6 in. to be filled with grout.

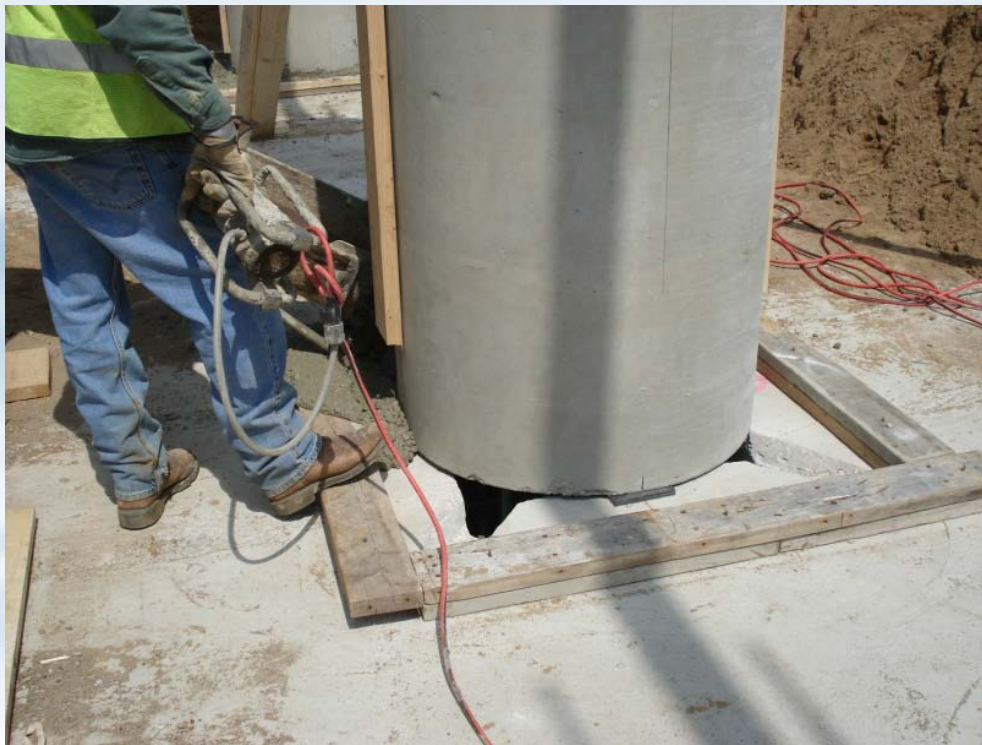
- 6 in. grout lift limit constrained filling the square pocket with grout
- Contractor beveled corners of the pocket and placed grade D concrete (658 lb/yd<sup>3</sup> cement + 70% of 6AA coarse aggregate per unit volume of concrete + sufficient water to produce a 3.5 in. high slump).

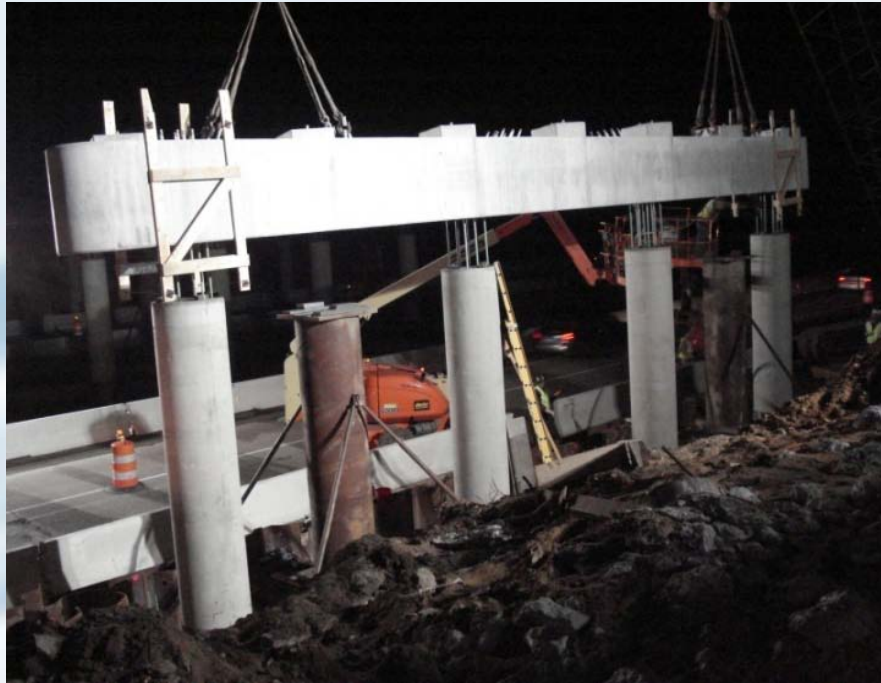
- **Pier column-to-pier cap connection**
  - Pier cap lifted by two cranes of 110 t and 150 t capacities
  - Difficulty in aligning total of 32 bars from four columns into corrugated ducts of 60 t pier cap

- Substructure size should be optimized considering crane capacity
- Abutment stems, pier columns, and pier caps – large components and less complicated details could prompt for fabrication at construction site or at nearby location owned by DOT
- Template used by Iowa DOT may be an alternate to alleviate rebar alignment issues at pier column-pier cap connection
