Development of Manual for Enhanced Service Life of ABC Projects

QUARTERLY REPORT

Period ending March 31, 2016

Quarterly Research Progress Report

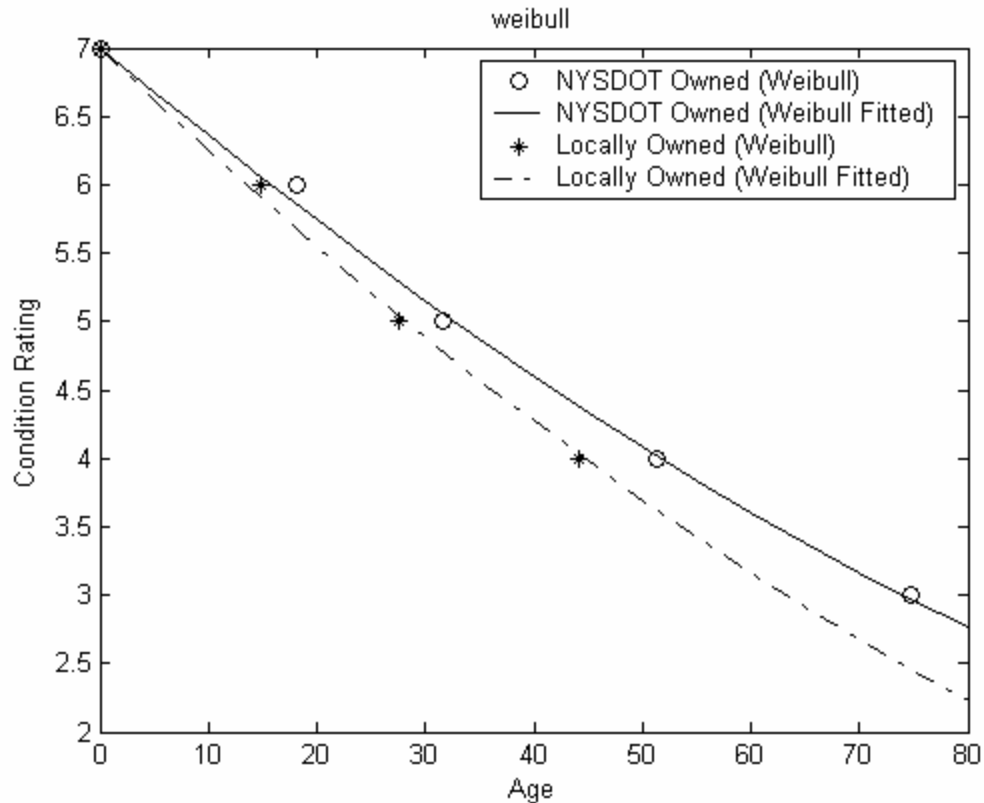
Fig. 1. Taken from Ref. 16, showing the degradation of the condition rating with age.

A number of models to predict service life have been proposed and developed. Bridge Deck Service Life Prediction and Costs, (Ref 14) attempted to develop an effective model to estimate service life of bridge decks with probabilistic methods. While this particular model was not effective, the methods presented in references 15 and 16 claimed to have some success in predicting deterioration rates and choosing cost effective corrosion remedial measures. Results of a methodology presented in ref 16 are shown below, comparing the condition rating of the bridge to the age.

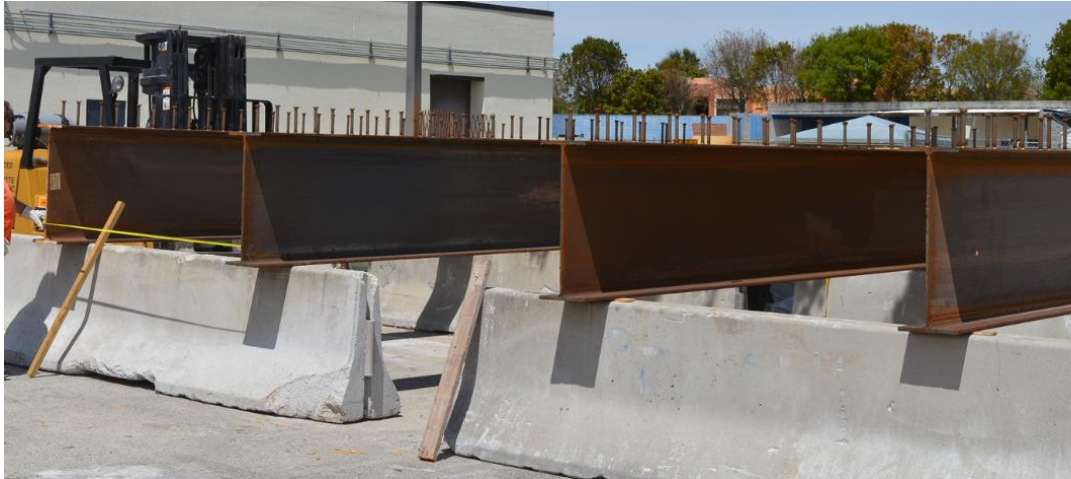
Fig. 2. Laboratory test specimens under construction, showing the girders and Nelson studs.

The second phase of the study includes construction of test specimens at the Structures Lab at FIU. Three (3) specimens have been constructed, each 15 feet long. The bridge girders are spaced 6 feet apart, and are WF 30 x 99 steel sections. Nelson studs are welded to the top flange. The girders are set on top of concrete jersey traffic barricades, and rest on elastomeric pads.

Each of the 3 specimens was constructed with a different closure pour detail. These include the 2 details discussed above, and the third will have a closure pour about 3 feet wide. This third detail is modeled after closure pour details implemented in the MASS 14 projects. The test specimens are complete. IR testing of the specimens has commenced.

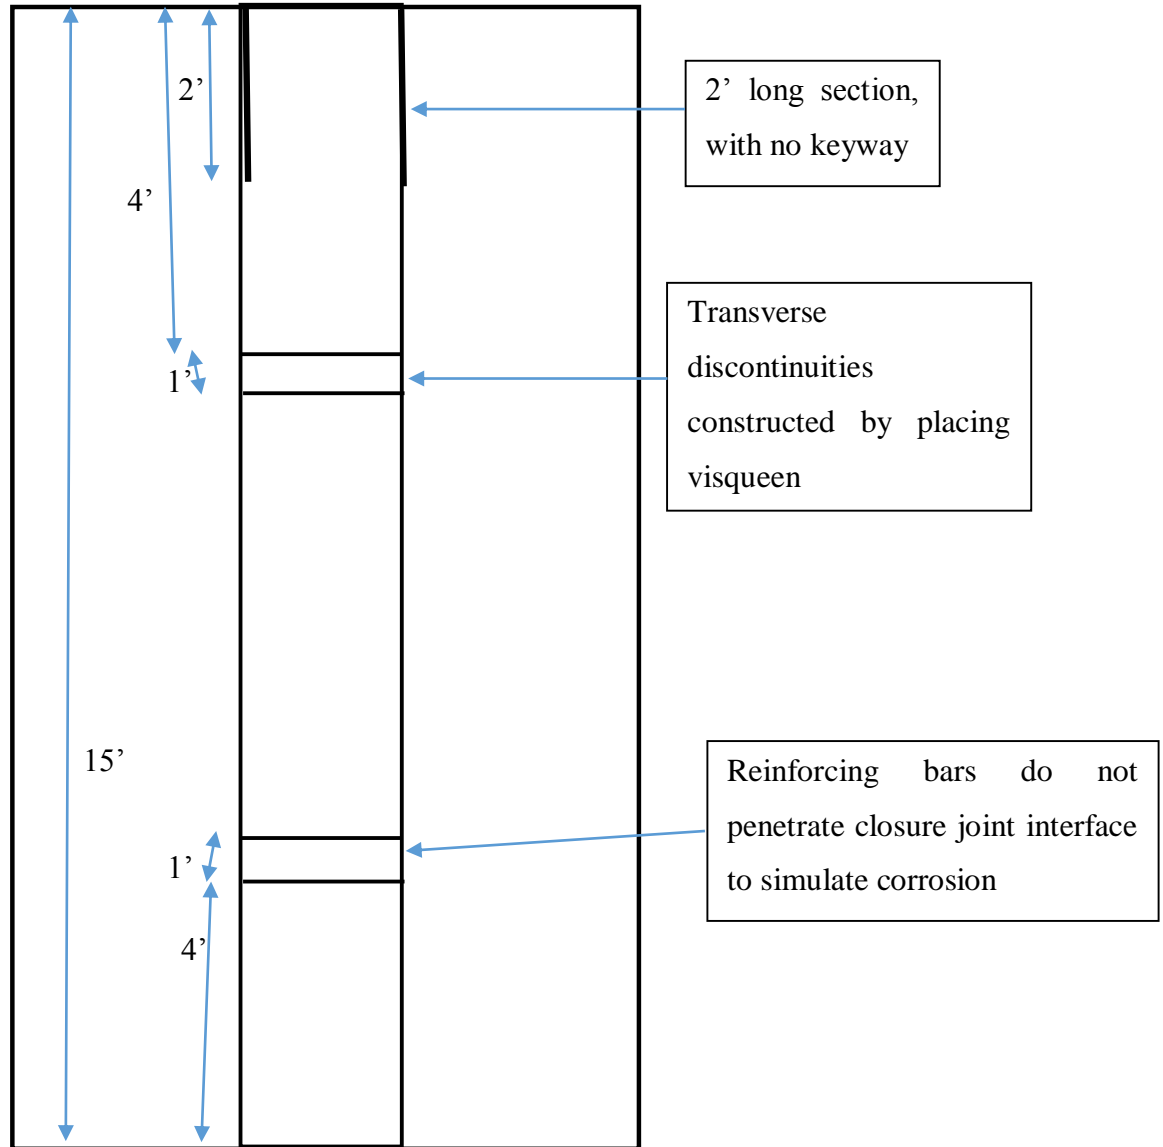
Fig. 3. Schematic of Laboratory Test Specimens

Construction of the lab specimens included simulated cracks, de-bonding and missing (or corroded) reinforcing steel. The following features were included in each section.

- a short section with a transverse discontinuity;
- a discontinuity at the joint between the closure pour and the adjacent deck; and,
- a short section where the reinforcing steel is not continued through the joint between the deck and the closure pour.

The locations of these manufactured discontinuities are shown schematically below.

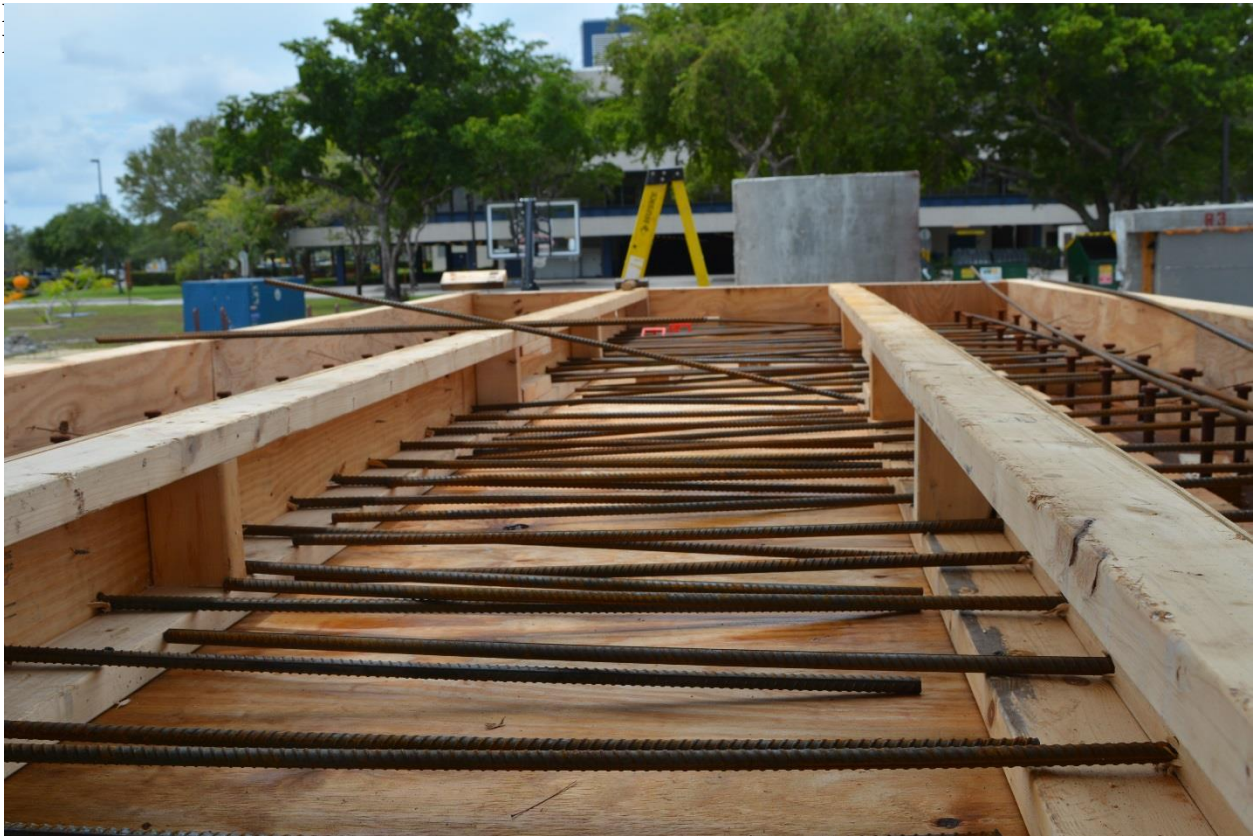
Fig. 4. Showing the Mass 14 closure detail under construction.

- An 8-inch wide, with hairpin shaped reinforcing bars forming overlapping loops in the closure pour. Longitudinal bars will then extend through the loops. The pour will consist of ultra-high performance concrete. (UHPC). This is similar to the detail in Bridge B.
- A 12-inch wide pour reinforced with headed rebar extending into the closure pour. The concrete strength will match the concrete in the adjacent deck section. This is similar to the detail in Bridge A.
- A 3-foot wide closure pour with standard overlapped reinforcing bars. The concrete strength will match the concrete in the adjacent deck section. This is similar to the closure pour detail constructed in the MASS 14 projects in Massachusetts.

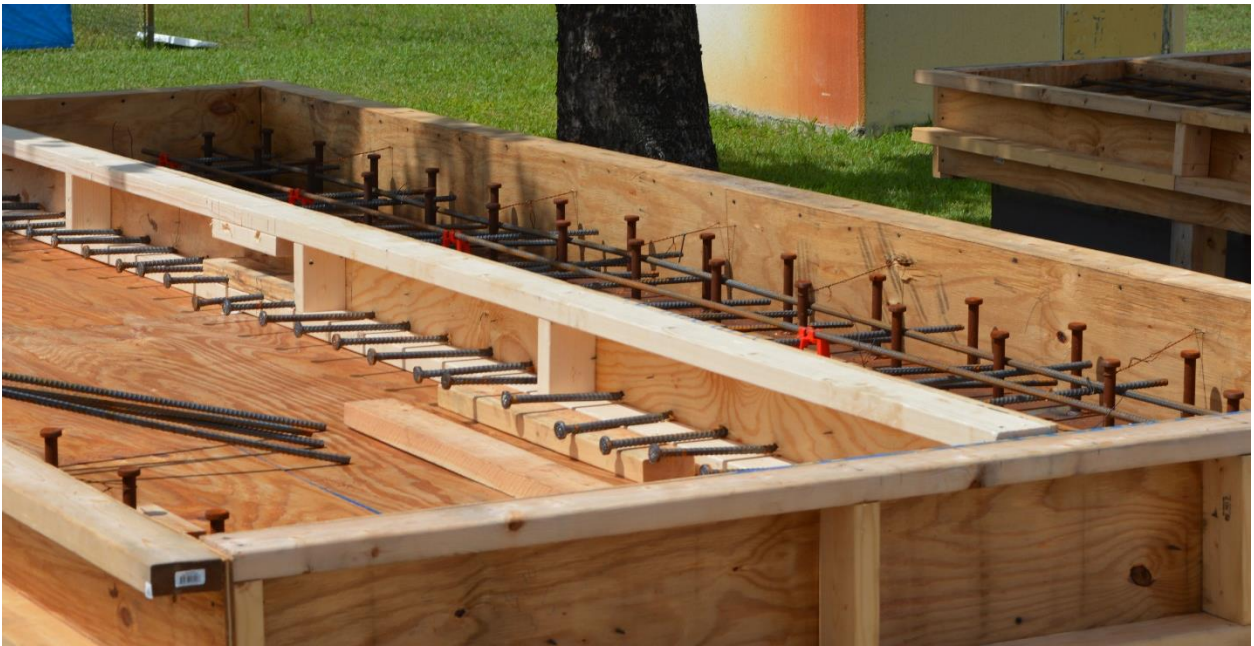
Fig. 5. Showing construction of the headed bar closure pour detail, modeled after Bridge A.

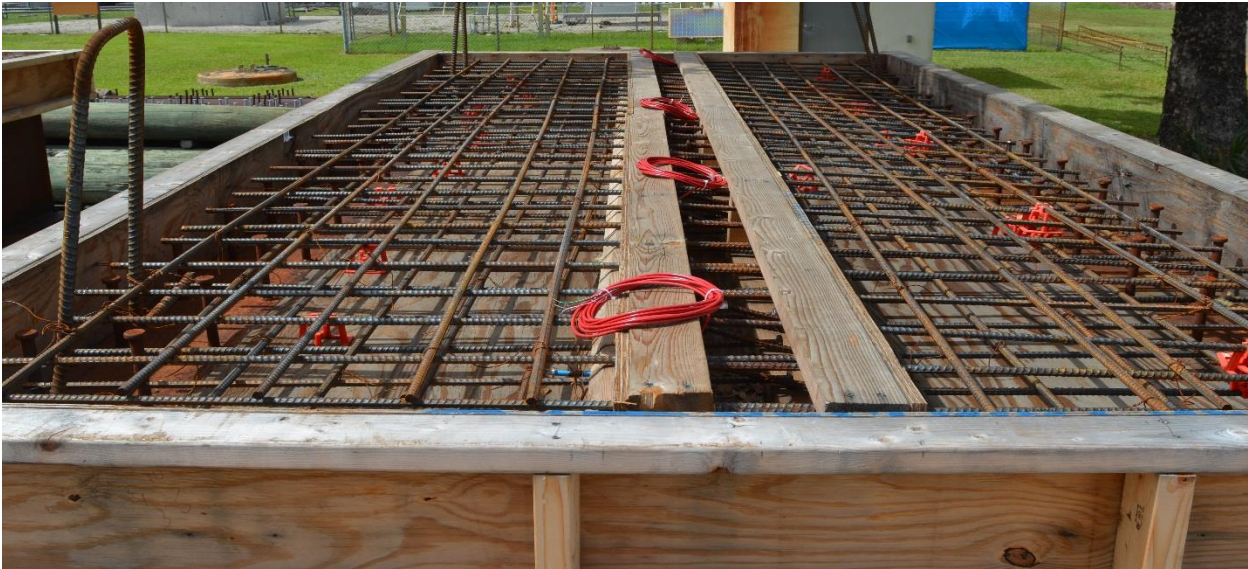
Fig. 6. Showing construction of the closure pour detail with hairpin bars, modeled after Bridge B.

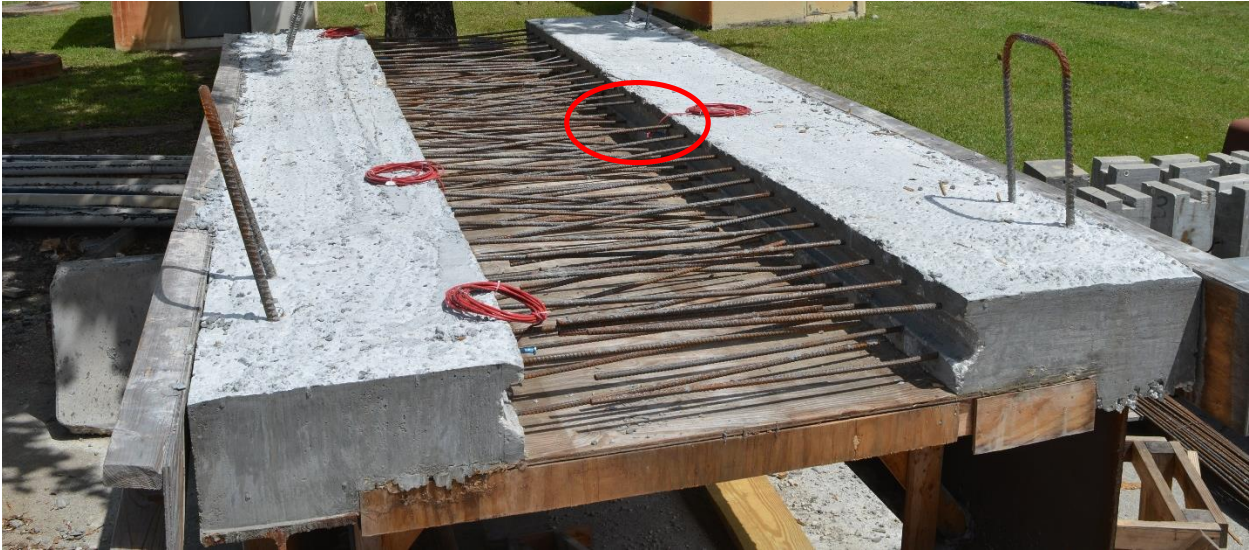
Fig. 8. Mass 14 detail, note bars are not extending through joint.

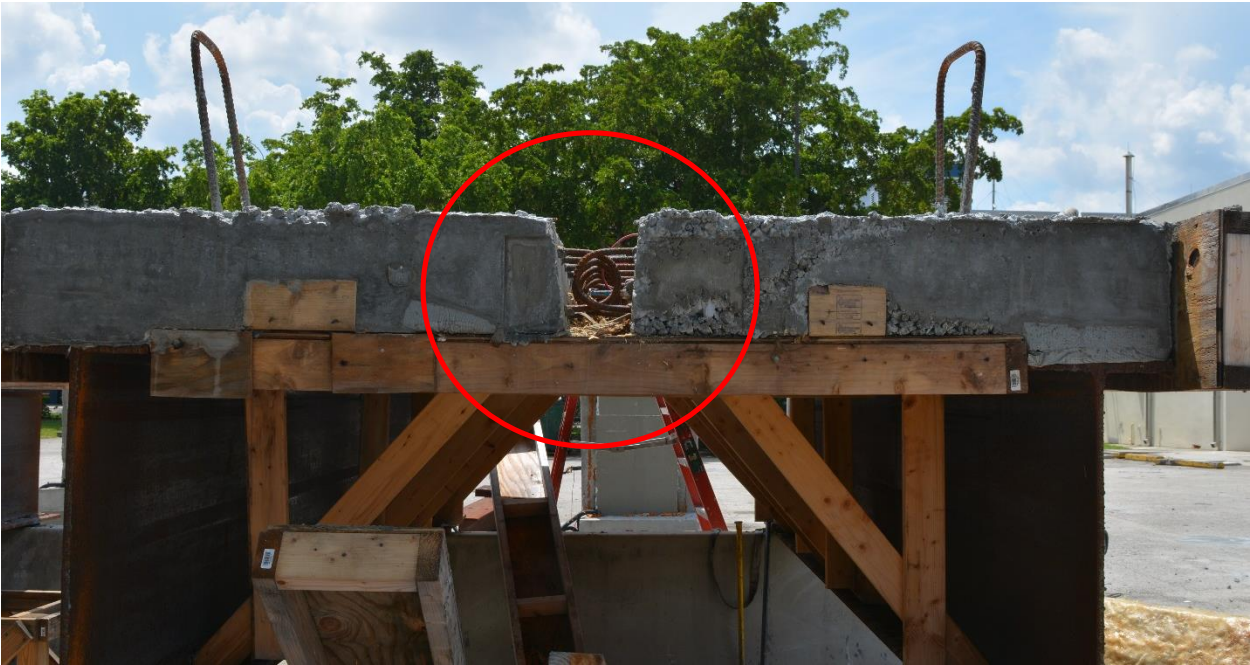
Fig. 9. Hairpin detail, note lack of keyway on this end.

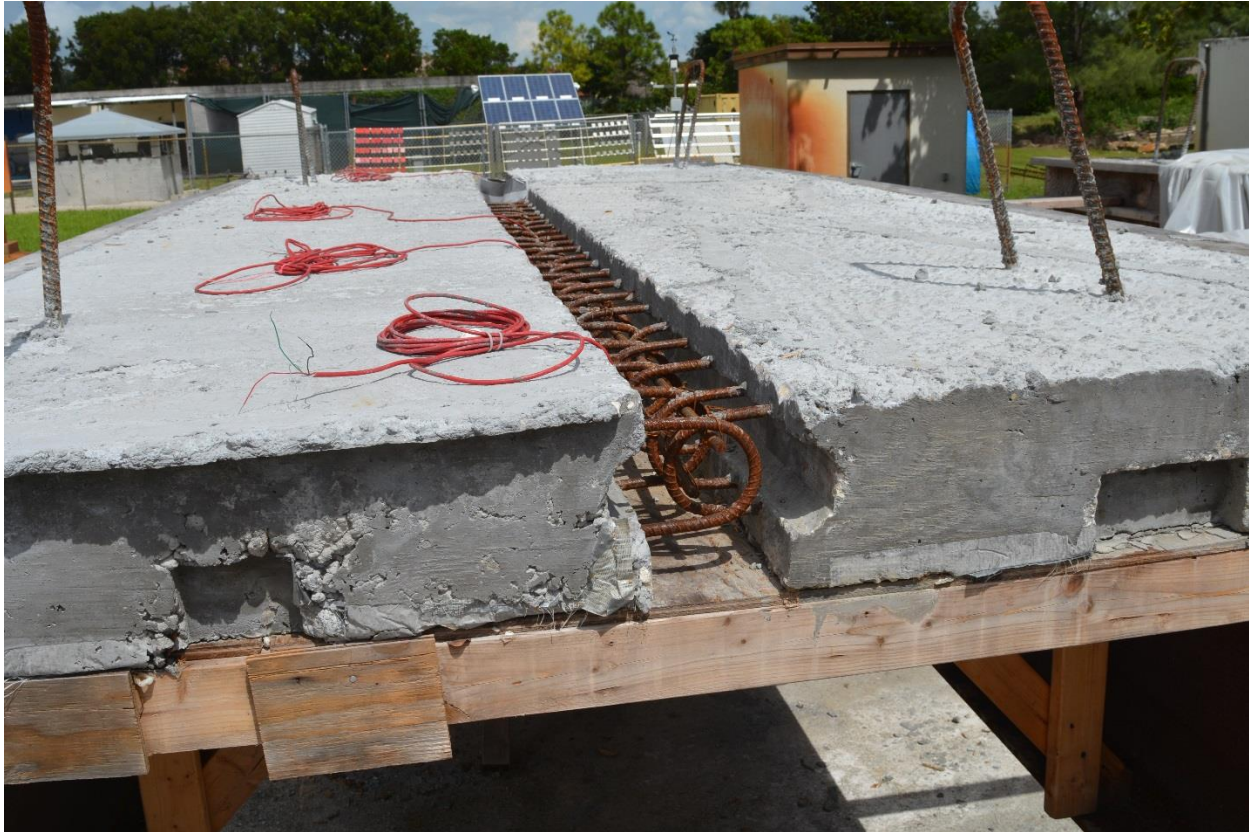
Fig. 10. Hairpin detail, note the keyway is present on this end.

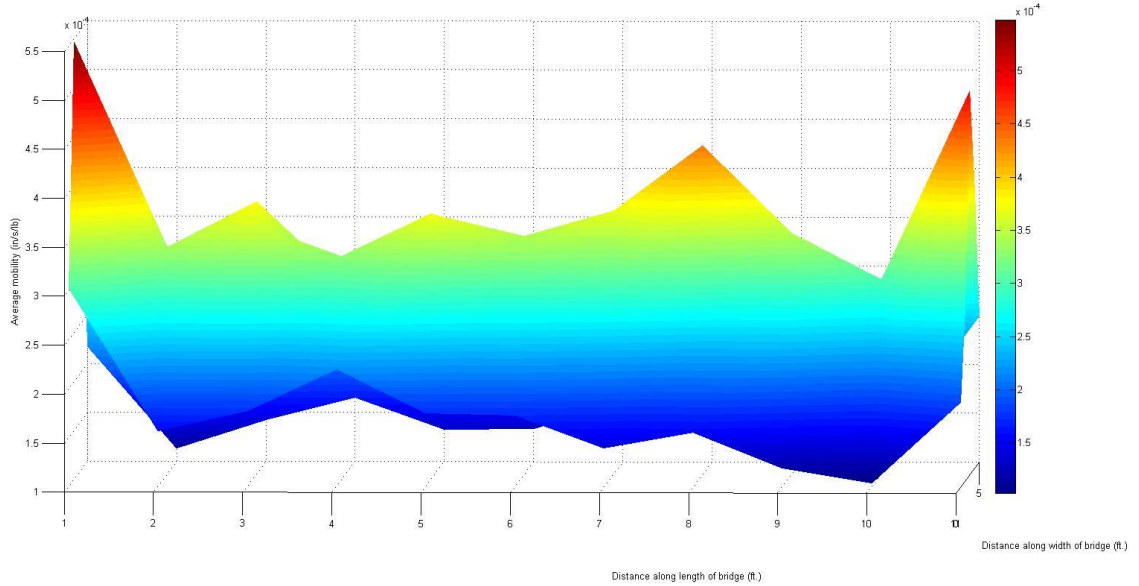
The measured mobility values are shown graphically in a 3-D representation on figures 11. Figure 12 shows a 2-dimensional plot of the measured values for the section shown longitudinally. The test values were normalized to the average of the mobility values measured at the steel beam.

Fig 11. 3-D Mobility Plot, Mass 14 detail.

Several items can be noted in the initial review of the data obtained in this first round of testing. Note that the 2 lines across the bottom of the plot represent the test values obtained at the steel beam (series 1 and 5). The other 3 lines include the centerline (gray, series 3), and the closure joints (yellow and orange, series 2 and 4).

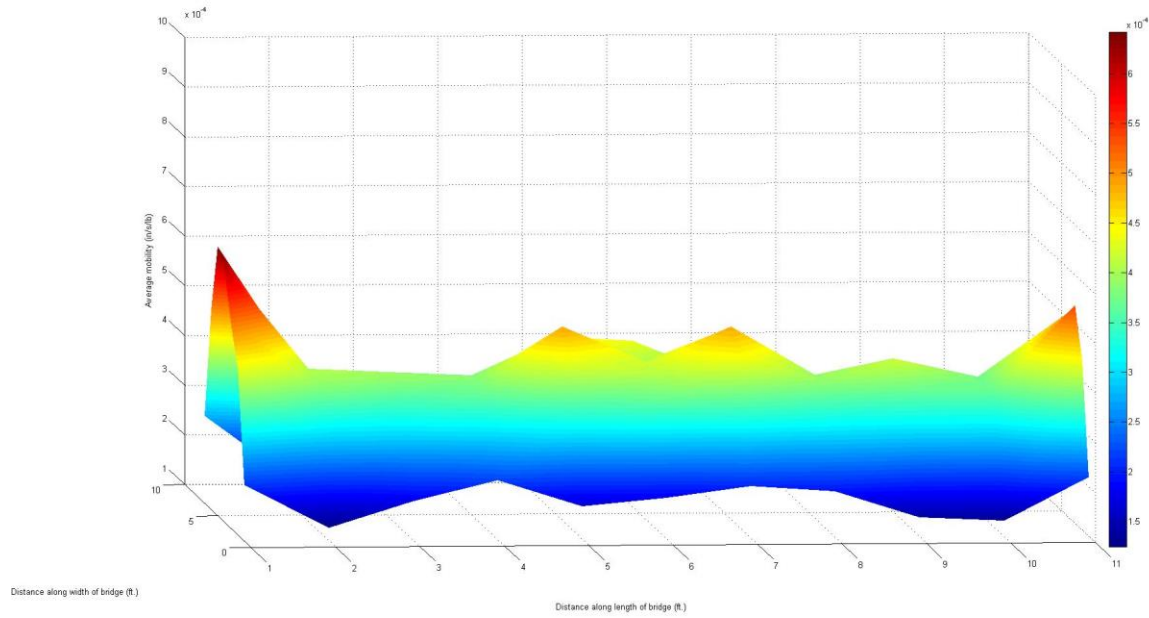
The measured mobility values are shown graphically in a 3-D representation on figures 13, Figure 14 shows a 2-dimensional plot of the measured values for the section shown longitudinally. The test values were normalized to the average of the mobility values measured at the steel beam.

Fig. 13.. 3-D Mobility plot, Specimen 2

Again, several items are observed in the initial review of the data obtained in this first round of testing. Note that the 2 lines across the bottom of the plot represent the test values obtained at the steel beam (series 1 and 7). The other 3 lines include the centerline (yellow, series 4), and the closure joints (gray and blue, series 3 and 5). The 2 lines (green and orange, series 6 and 2)

between the beams and the closure joint lines represent the lines between the beams and the closure pour.

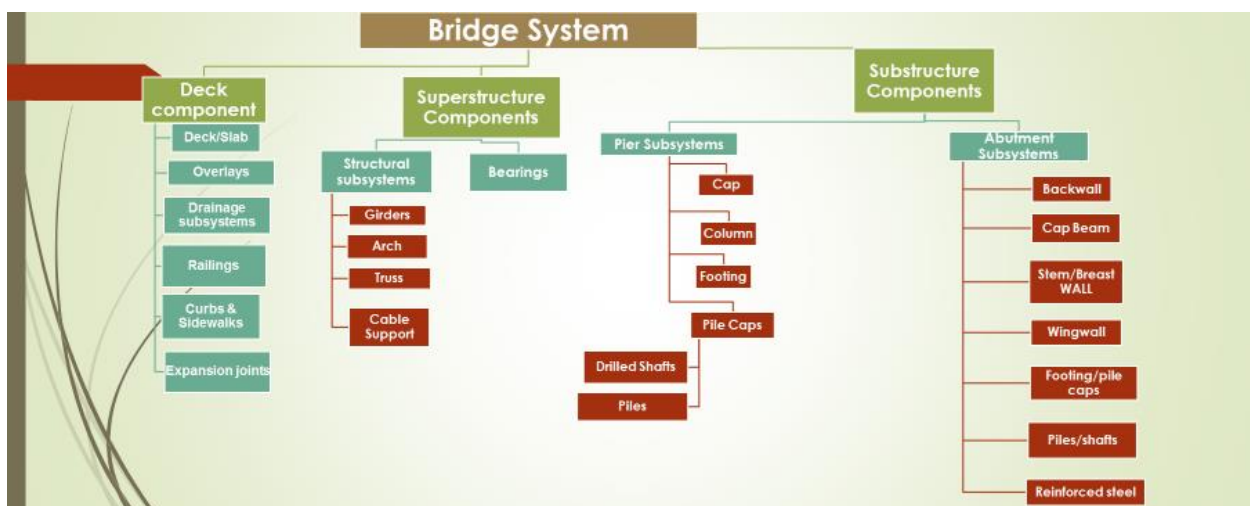
The fault tree is a systematic method to identify the factors that can affect service life of a particular bridge element, component, or subsystem. A general, yet comprehensive fault tree is presented in Appendix A. The fault tree methodology begins with identification of major factors that can reduce service life. The process begins with the selection of a major bridge system such as the deck, superstructure or substructure. Each system consists of subsystems, which in turn are made up of the various elements. This is shown below.

Fig. 17. Bridge System and Components

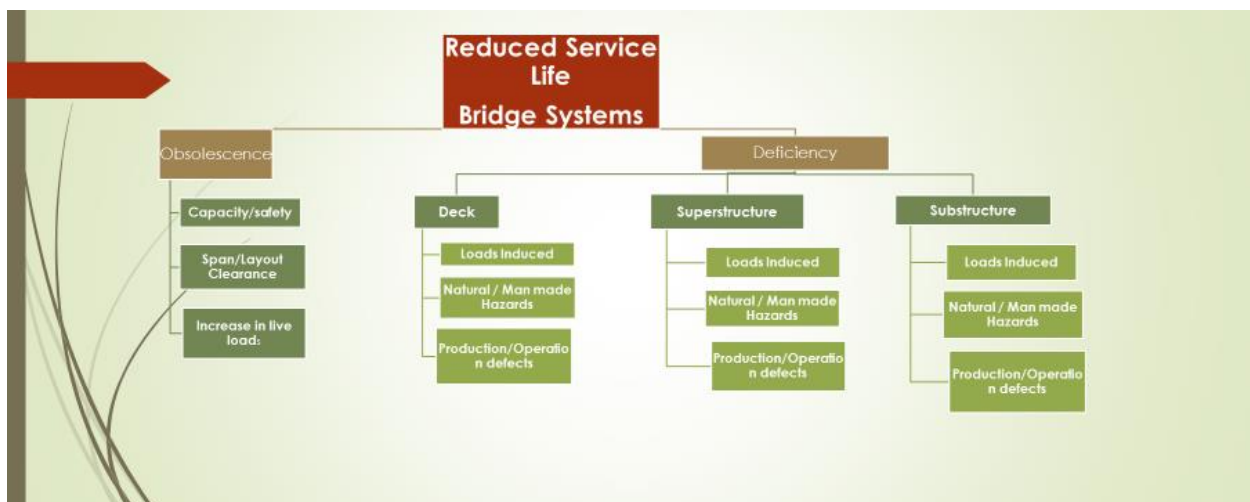
reductions in service life can be caused by obsolescence or deficiency. Obsolescence factors include capacity, geometry and other types of factors in which current traffic patterns have changed to point that the bridge is no longer functioning as needed. These issues should be addressed in planning stages of the bridge during the design phase, and are beyond the scope of this study. This study will focus on service life issues related to deficiency. These can be subdivided into additional sub categories, including

- 1) load-induced,
- 2) Hazards (natural or man-made), and;
- 3) Defects resulting from production or operation.

These sub categories then need to be applied to each system, again as shown below.

Fig. 18. Initial branches of Fault Tree.

As the user progresses through the fault tree, the tree becomes more and more detailed and specific. This allows the user to then identify which elements should be addressed to enhance the service life of the bridge to meet the operational goals. As the specific items are identified, deficiency tables can be consulted to aid in selecting options that can enhance the service life. Detailed tables are under development, but will be similar to those presented in The Guide.
