Development of Prefabricated Concrete Bridge Railings

QUARTERLY PROGRESS REPORT

ABC-UTC
Quarterly Research Progress Report
Title: Development of Prefabricated Concrete Bridge Railings
June, 2016

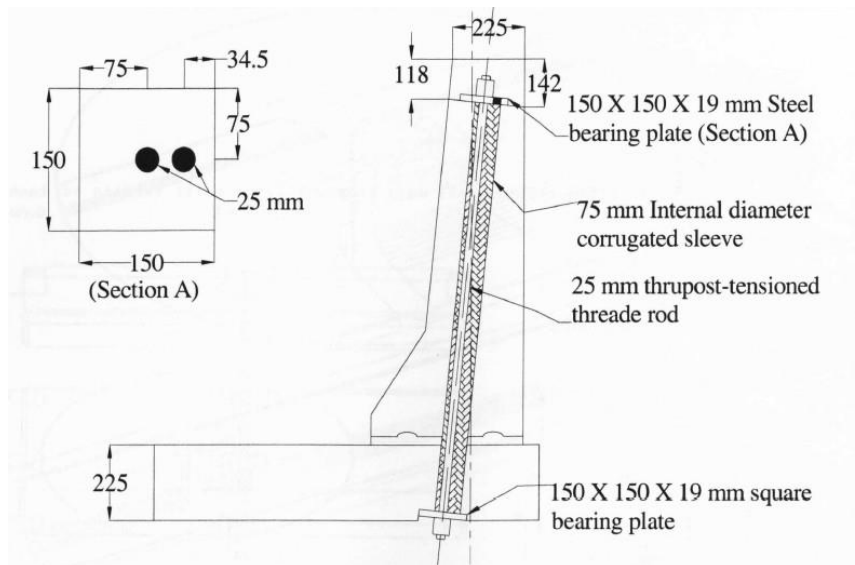
A different way of connecting a barrier with the through-deck method is by pretensioned rods that are inserted all the way through the wall and the deck slab. They are then anchored to the bridge deck by end plates, washer, and nuts. An example of this can be seen in Figure 2.

Figure 2 Barrier to deck Slab Connection (Source: Patel Dissertation, Fig 3.1)

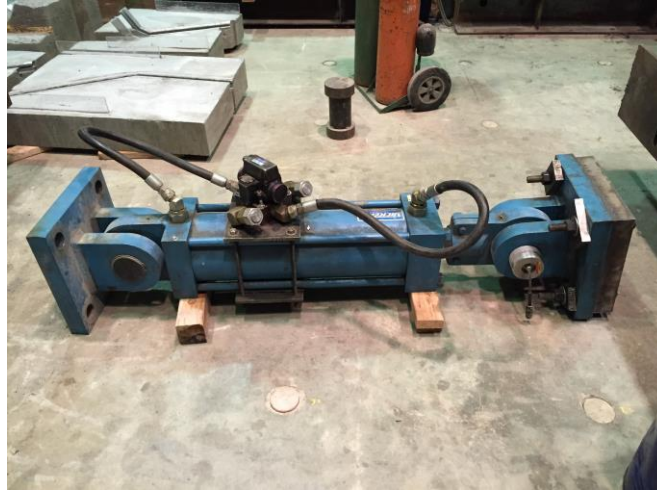
Task 3: The two barrier connection systems shown above have been tested in the laboratory with quasi-static testing. The loads were applied cyclically using a hydraulic actuator. The systems will be evaluated based upon how they impact their individual strengths and how they impacted the performance of the deck overhangs used to support the railing. The actuator that will be used in shown in Figure 9.

Figure 9 Hydraulic Actuator

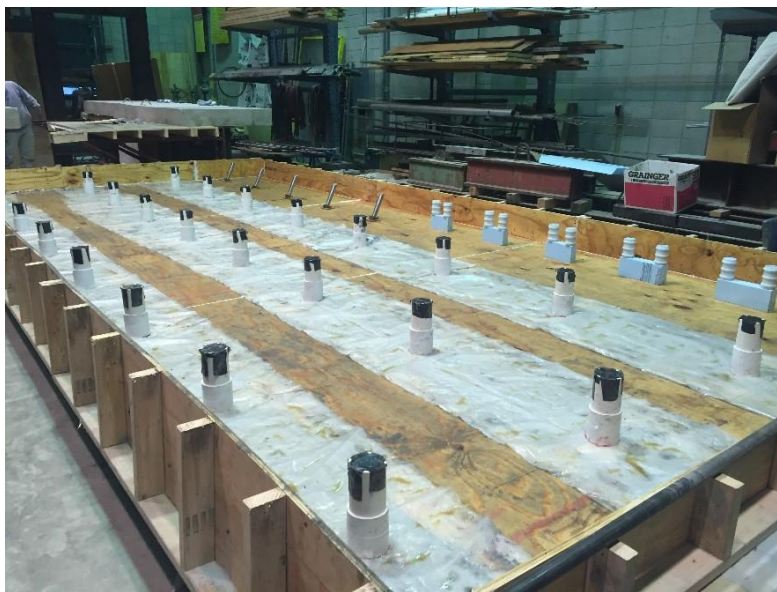
Three concrete beams support the deck slab. The deck slab will have an overhang of 3.5 feet. The hydraulic actuator was mounted onto the concrete block to apply load along the precast barrier segments. The concrete blocks are anchored into the lab floor. The concrete beams and the formwork for the suspended deck slab are shown in Figure 12.

Figure 12 Concrete Beams with Deck Slab Formwork

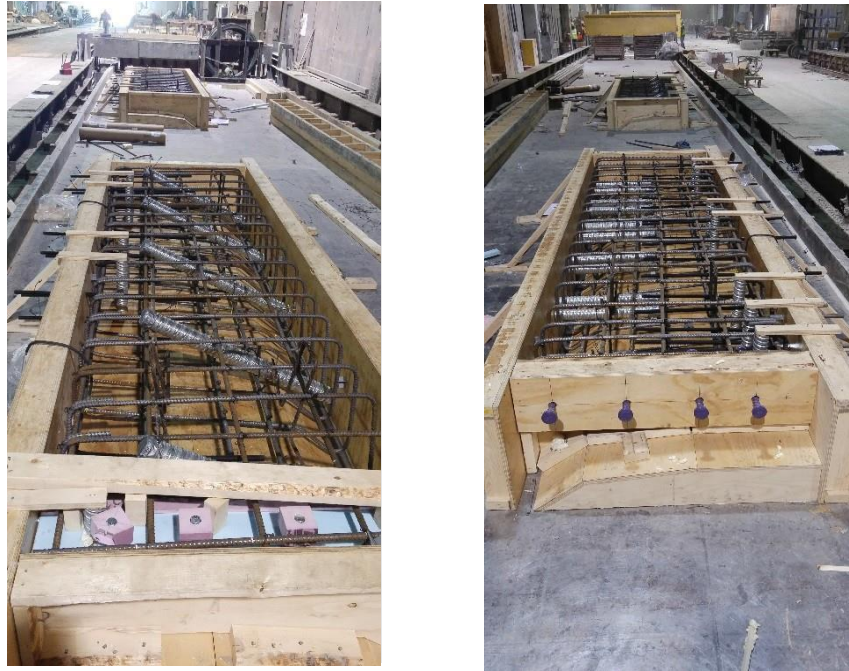
The construction of the barrier rails was fabricated by a precast plant in Omaha. They were delivered to the Iowa State Lab February of 2016. Images of the precast construction are shown in Figure 13.

Figure 13 Precast Barrier Fabrication

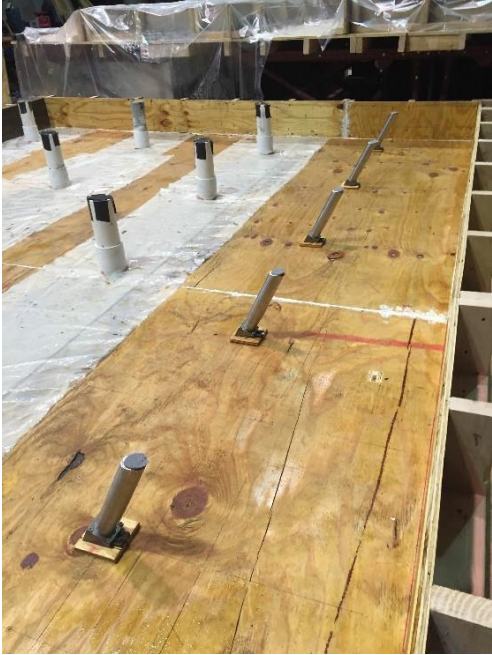
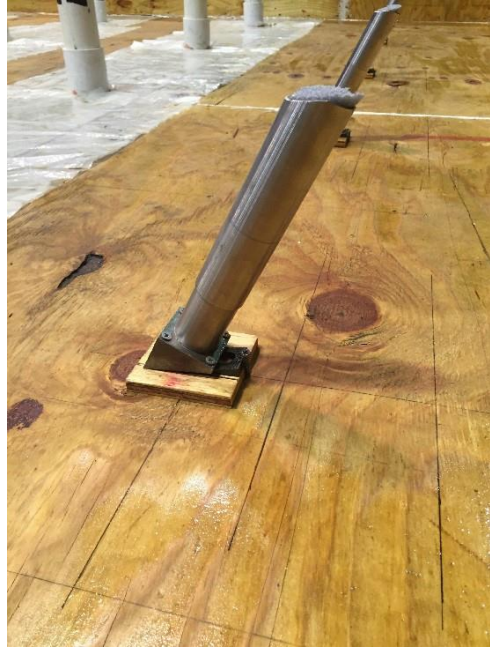
Figure 14 Inclined Bar Connection in Bridge Deck

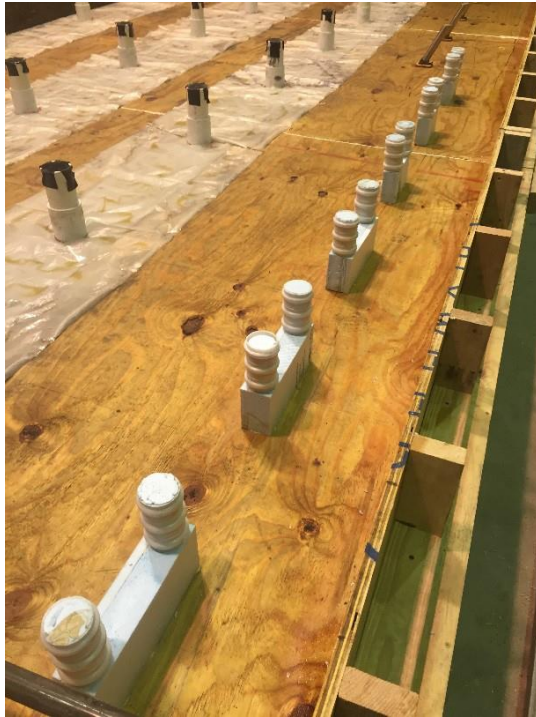
Figure 15 Pockets for U-bar Connection in Bridge Deck

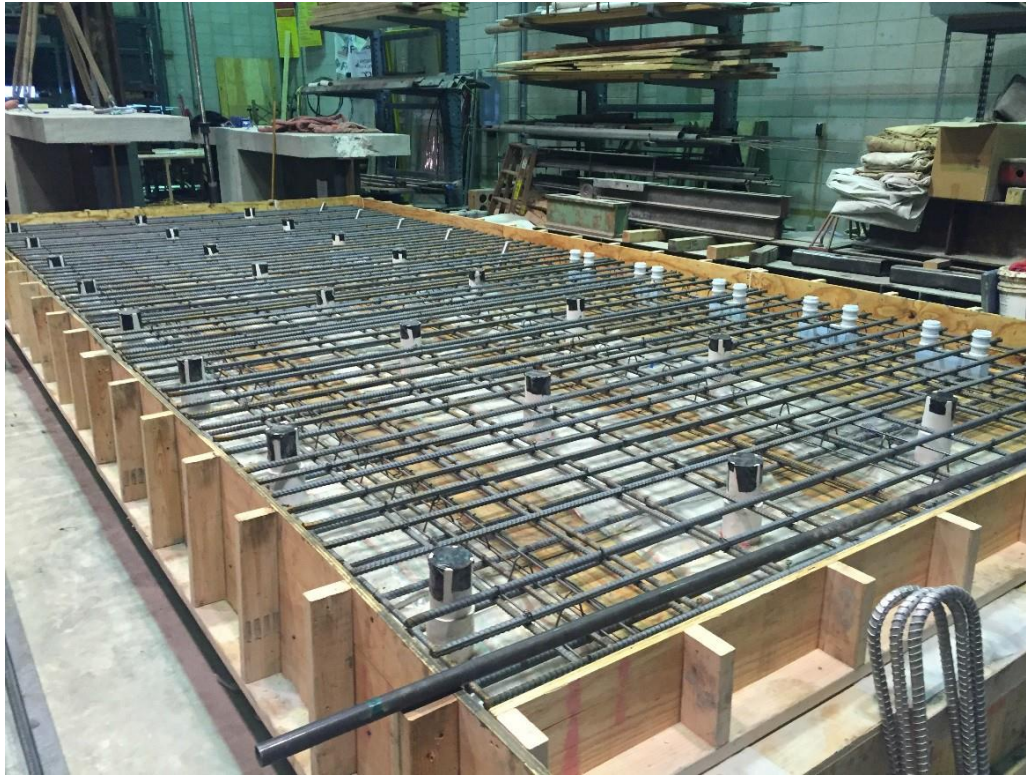
Figure 16 Bridge Deck Prior to Concrete Pour

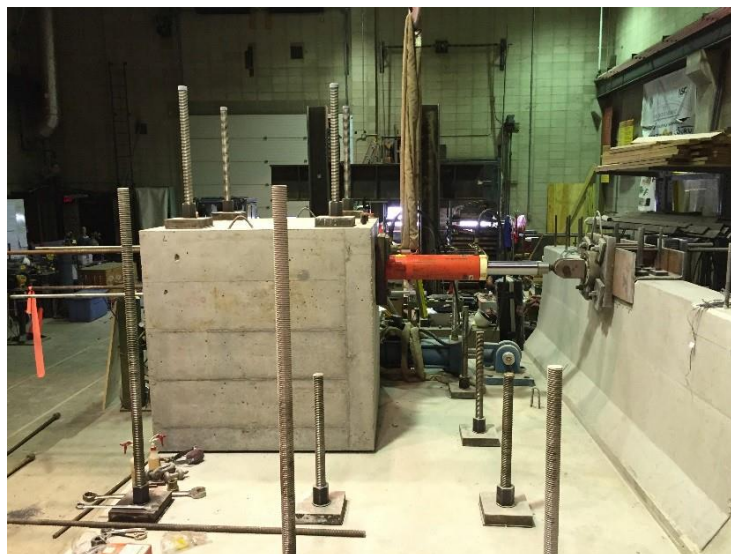
Laboratory testing began March of 2016. The first laboratory test was conducted on the precast barrier with the inclined rod connection, PBI. The loading block and actuator were set up to apply loads to the center of PBI. The test setup is shown in Figure 17. The push load was applied incrementally up to 54 kips. It was applied in six kip increments.

Figure 17 Test 1 (PBI Middle) Setup

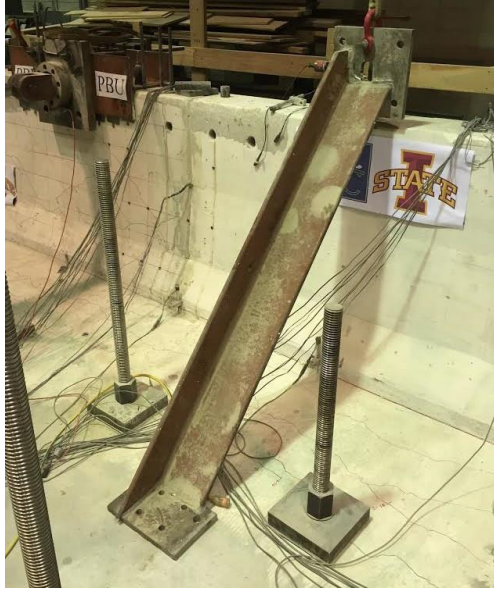
For Test 4, the loading beam was placed to the inclined connection side of the barrier-to-barrier connection. The center of the load was about three feet from the barrier-to-barrier connection. The purpose of the test was to observe the force distribution about the barrier-to-barrier connection and to fail the center connection. Before this test was performed, a beam was placed on the u-bar side to brace the barrier and keep it from deflecting. This brace beam can be seen in Figure 22.

Figure 22 Beam used to brace the u-bar connected barrier during Test 4

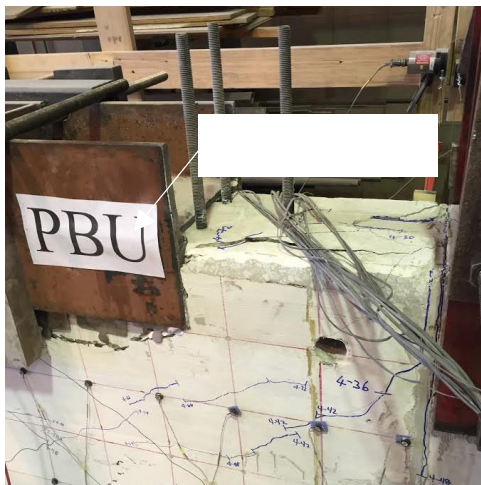
Hairline cracks didn't form on the grout between the barrier until 24 kips was applied. Other previous cracks just extended and opened up. At 48 kips, a crack developed on the front face of the grout between the barriers. A crack formed on the back of the barrier-to-barrier grout at 54 kips. This crack started at the bottom of the barrier. As the loads were increased, cracks continued to extend. At 72 kips, new cracks developed on the top of the barrier-to-barrier grout. The load was increased up to 81 kips before it started dropping. The test continued until the deflection was measured at 1.5 inches. Large cracks developed along the barrier under the loading beam, see Figure 23, and the barrier-to-barrier grout broke all the way along the top to the back, see Figure 24.

Figure 23 Cracking on barrier due to loading during Test 4
