Rapidly Constructible Large-Bar Precast Bridge-Bent Seismic Connection

WA-RD 684.2

October 2008

RESEARCH REPORT

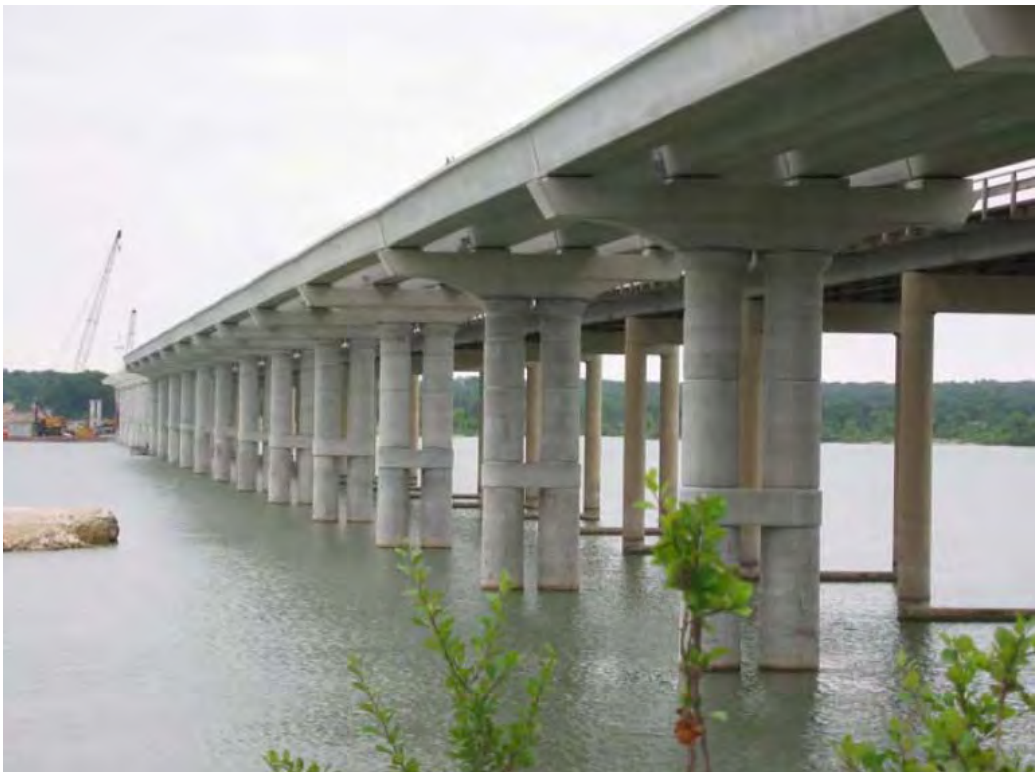
Figure 2-3: Construction of Lake Belton Bridge (Brenes 2006)

The original 50-year-old, two-lane Lake Belton Bridge on SH 36 had numerous problems, including a deteriorating superstructure, narrow travel width, and guard rail damage (Brenes et al. 2006). Therefore, it was replaced in 2004 with a 3,840-foot long bridge structure, adding two additional lanes of traffic. Construction of the bridge is shown in Figure 2-3. The bridge superstructure was constructed of prestressed U-beams with typical spans of 120 feet. The substructure comprised twin circular cast-in-place columns supporting a massive precast hammerhead bent-cap. Sixty-two identical bent caps were precast.

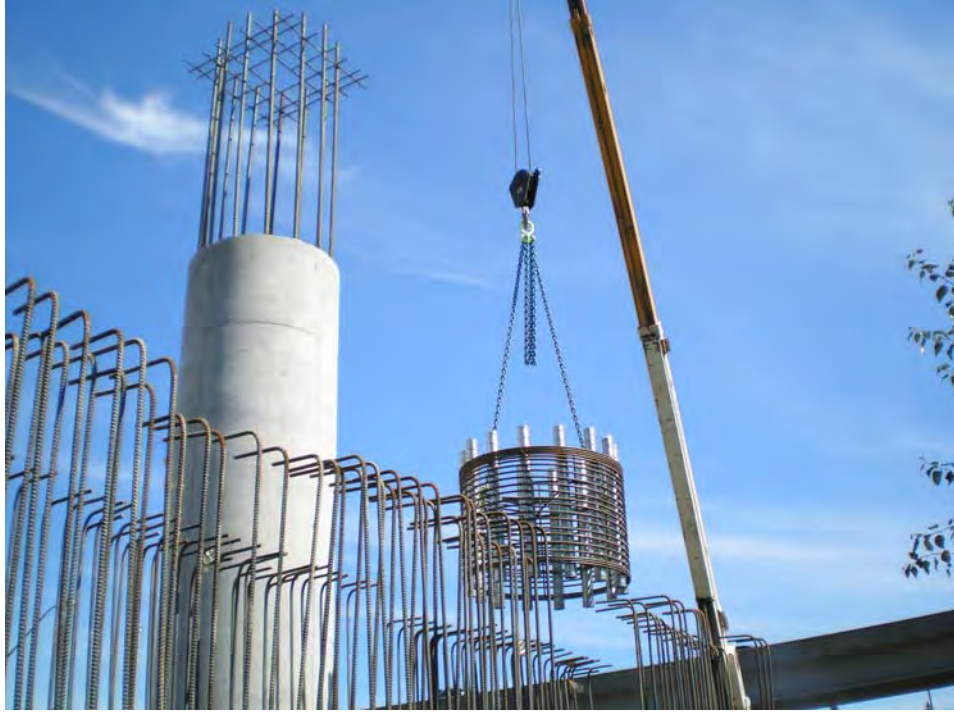
Figure 2-7: Template used to align the ducts and bars (WSDOT 2007)

The design of the bent cap was accepted on the condition that the arrangement of bars in the original cast-in-place design was not altered and that AASHTO and ACI development length requirements were met. These requirements made it necessary to use small diameter ducts and to continue the column longitudinal bars high up into the superstructure. Until then, WSDOT had never used precast bent-caps to construct the substructure because no formal design guidelines or detailing requirements have been established for this type of application, and limited information about its seismic performance exists.

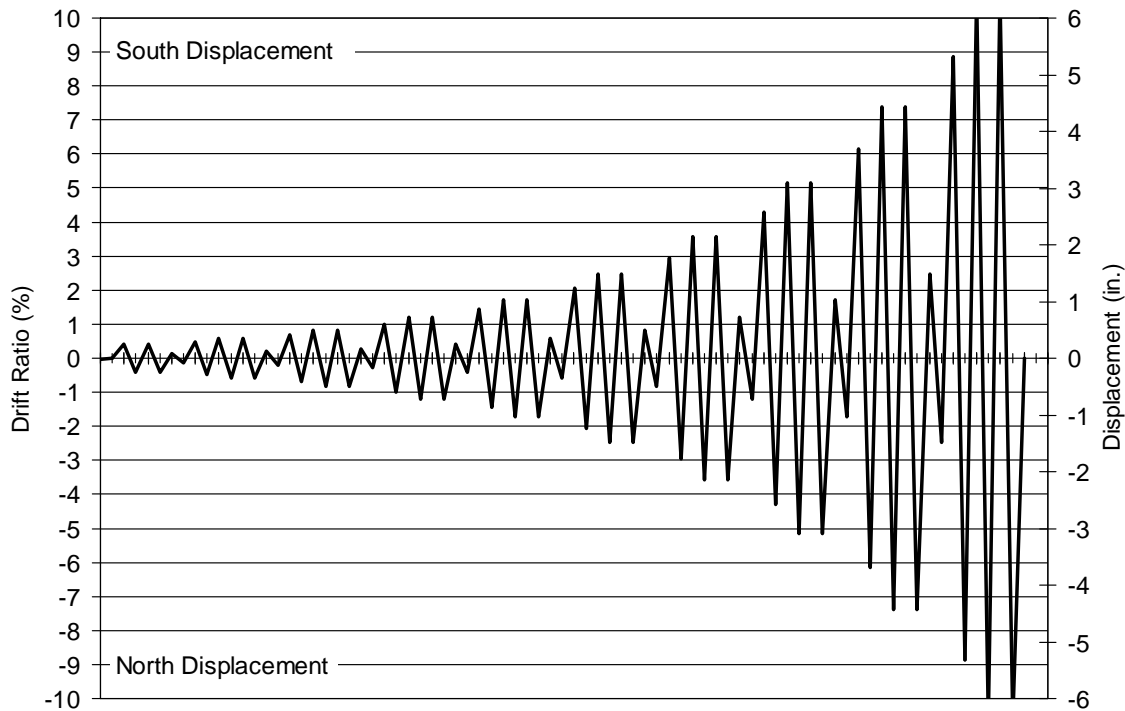
Figure 3-4: Lateral loading displacement history

Each subassembly was subjected to a sequence of displacement controlled cycles, shown in Figure 3-4 and Table 3-4. The selected loading displacement history is a modification of that recommended in NEHRP Recommended Provisions – FEMA 450-1/2003 Section 9.6.7 (Building Seismic Safety Council 2003). Testing started with a preliminary cycle of 0.05 percent drift to conduct a diagnostic check of the test set-up and data acquisition. The first group of cycles began with two cycles at 0.4 percent drift, followed by a reduced cycle of 1/3 of the initial drift level. The subsequent groups of cycles included one cycle at 1.2 times the previous drift level, followed by two cycles of 1.2 times that drift level, and ending with 1/3 of the previous level.

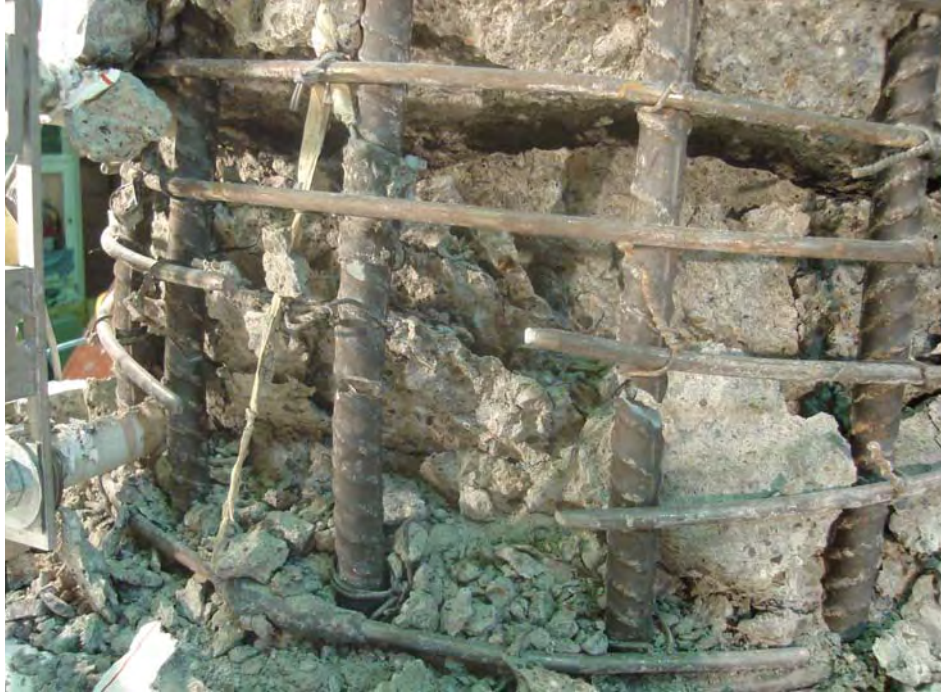
Figure 4-11: Bars 1, 2, and 16 fractured in Specimen DB5-RE at Cycle 36 (8.83%/-8.44%)

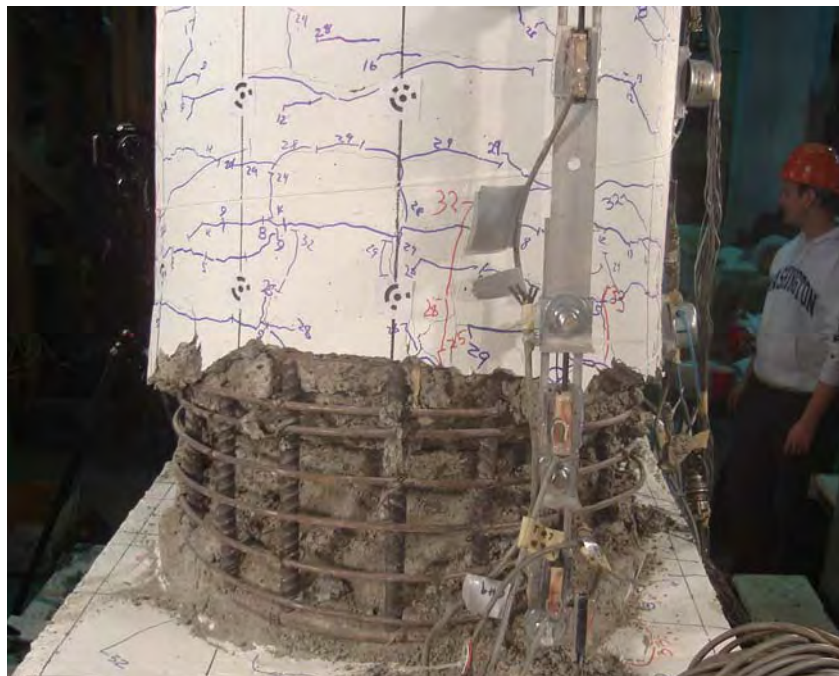
Figure 4-14: Damage in Specimen DB5-RE at the end of testing

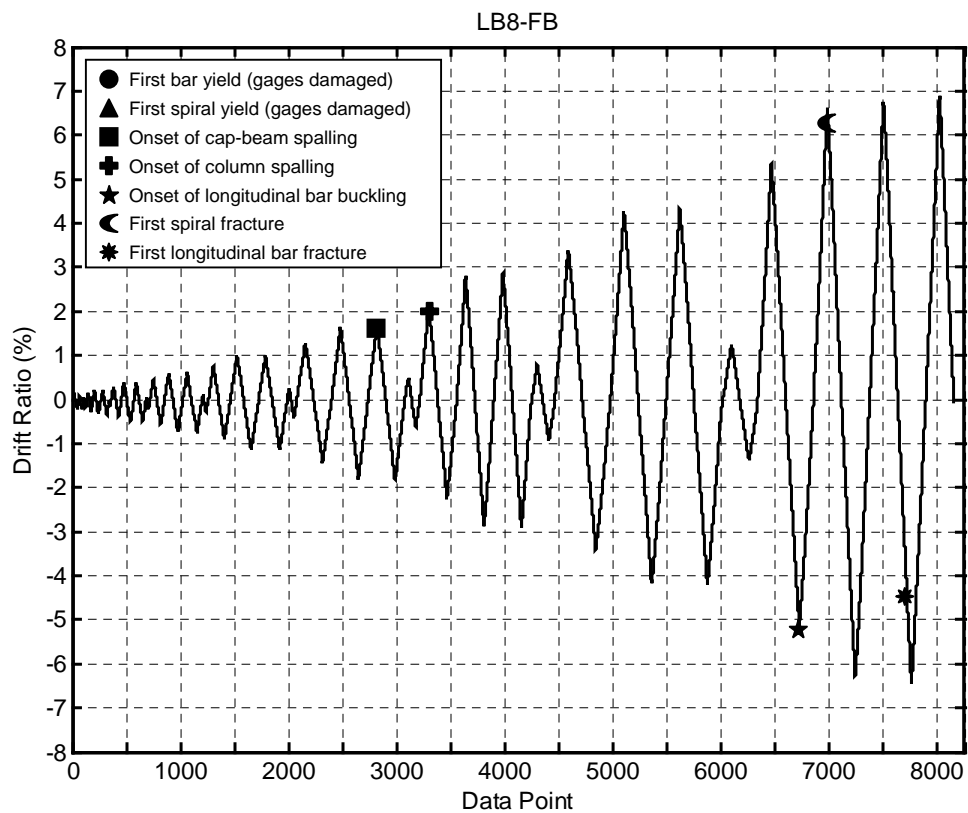
Figure 4-15: Drift history for Specimen LB8-FB with damage milestones

Specimen LB8-FB was a precast specimen, which was reinforced with six #8 bars anchored in grouted ducts embedded in the cap-beam and in concrete within the diaphragm. The column was also reinforced with 12 #3 bars that stopped at the interface. The drift history through which it was cycled is shown in Figure 4-15, and the moment-drift response is shown in Figure 4-16. Both figures indicate the occurrence of important damage events. Strain gages in the specimen were damaged early in the test and gave unreliable data, so the yield points of reinforcement could not be determined. A summary of damage events and the cycle and the drift level at which they occurred is contained in Table 4-4.

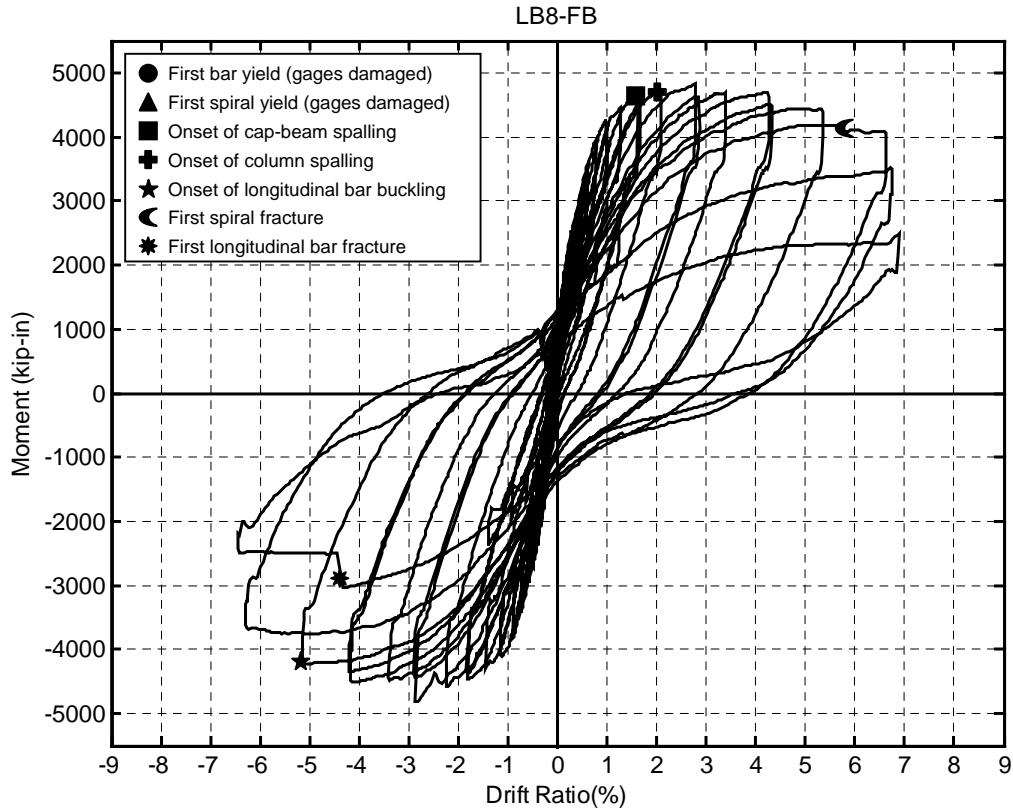
Figure 4-16: Moment-drift ratio response for Specimen LB8-FB with damage milestones

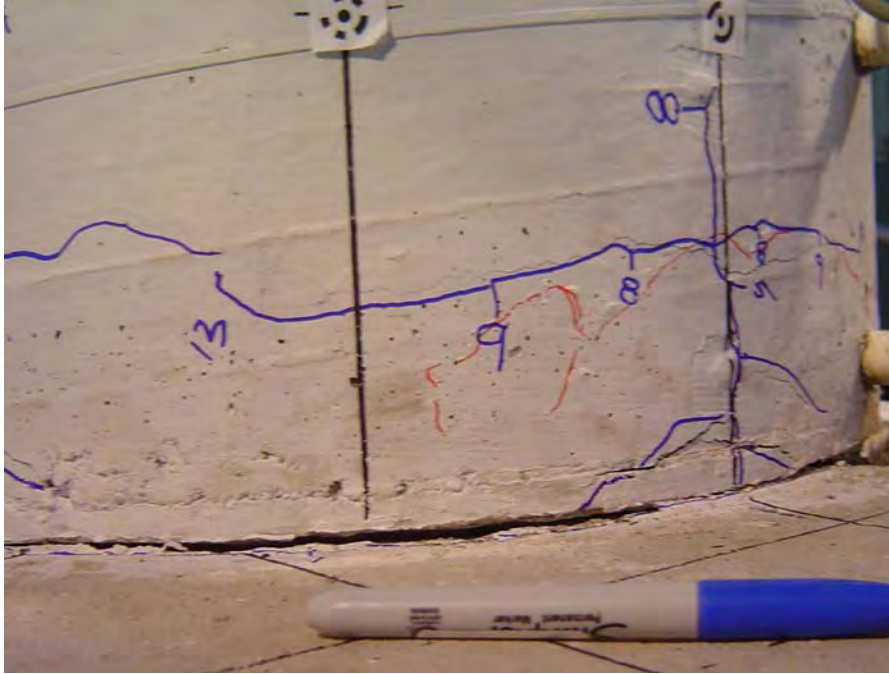
Figure 4-18: Concentrated deformation at the interface in Specimen LB8-FB at Cycle 21 (1.69%/-1.76%)

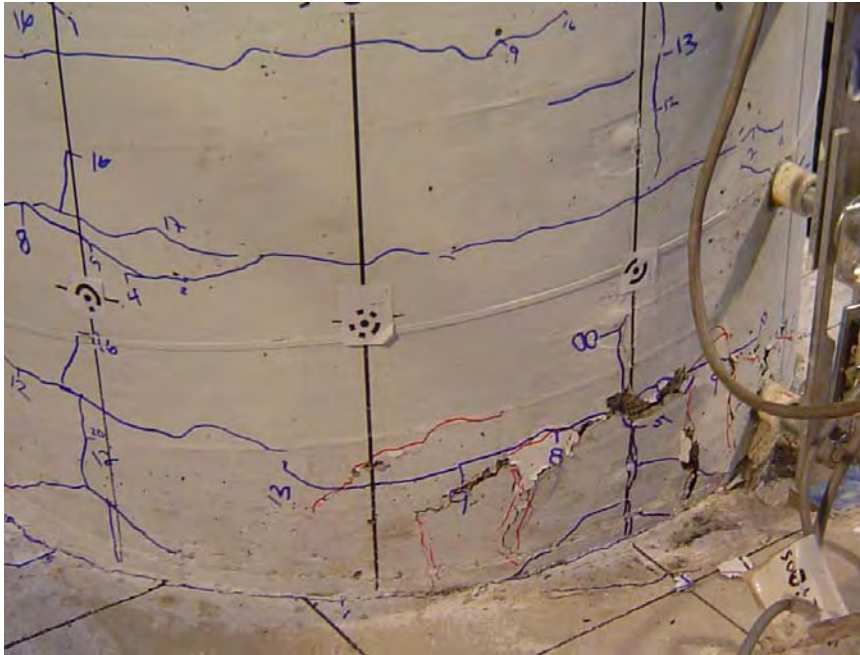
Figure 4-21: Spalling on the south side in Specimen LB8-FB during Cycle 24 (2.15%/-2.20%)

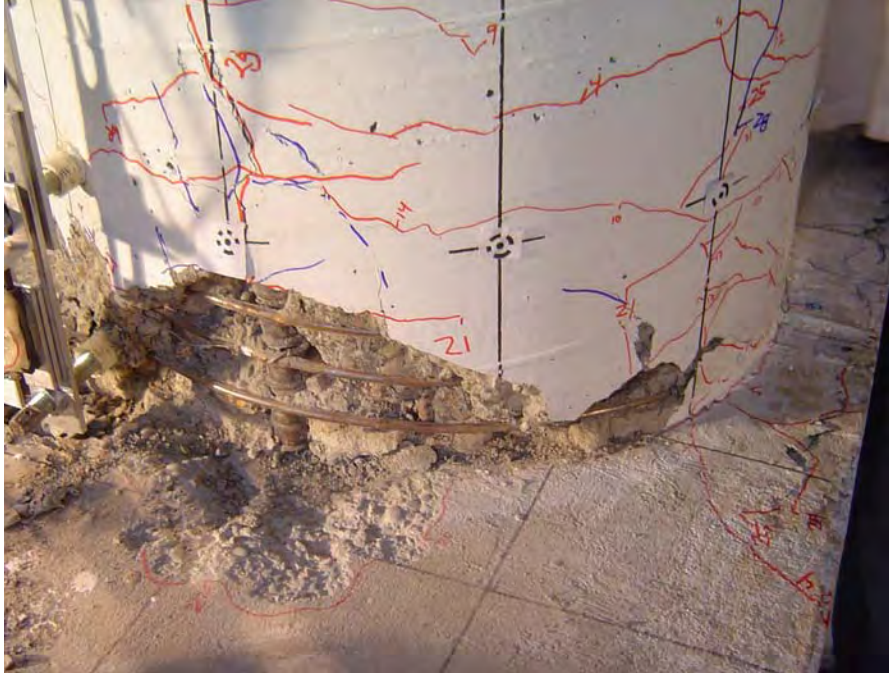
Figure 4-22: Spalling in the cap-beam and column in Specimen LB8-FB at Cycle 26 (2.92%/-2.85%)

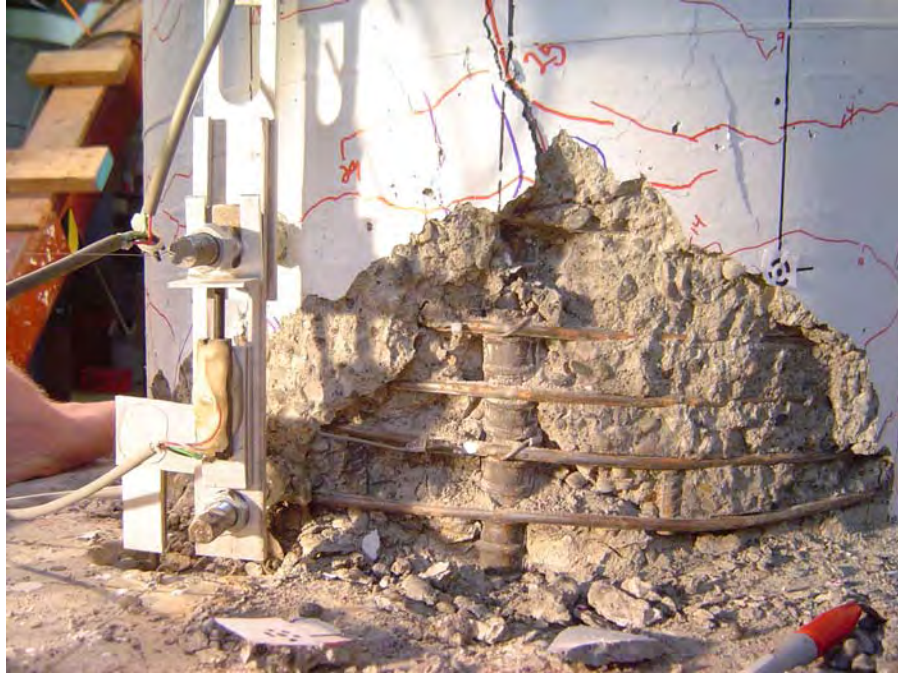
Figure 4-24: First observation of bar buckling of Bar 1 on the north side with two spirals necked in Specimen LB8-FB at Cycle 32 (5.42%/-5.10%)

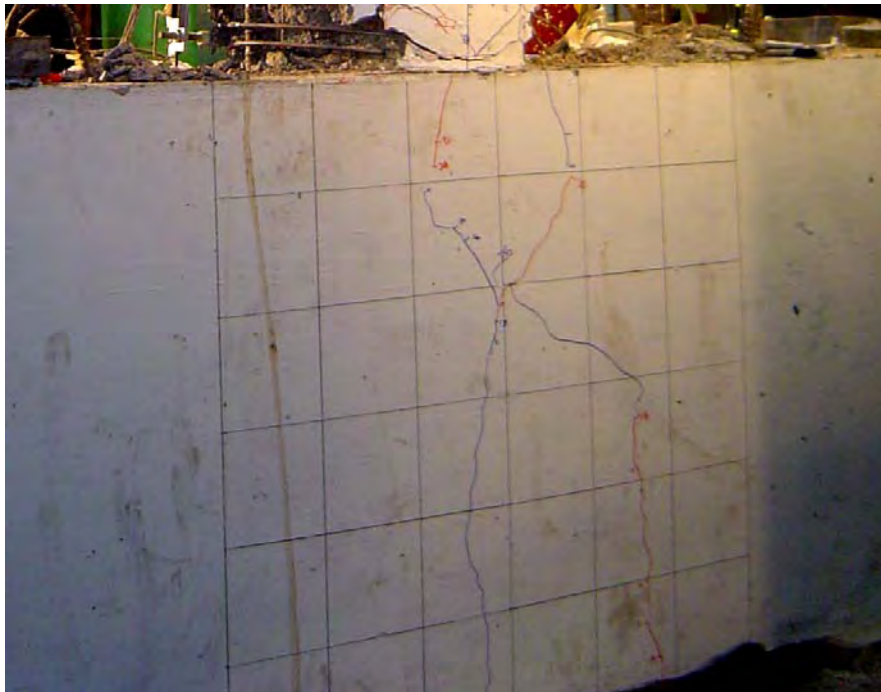
Figure 4-27: Cracking in the cap-beam in Specimen LB8-FB after Cycle 34 (6.81%/-6.40%)

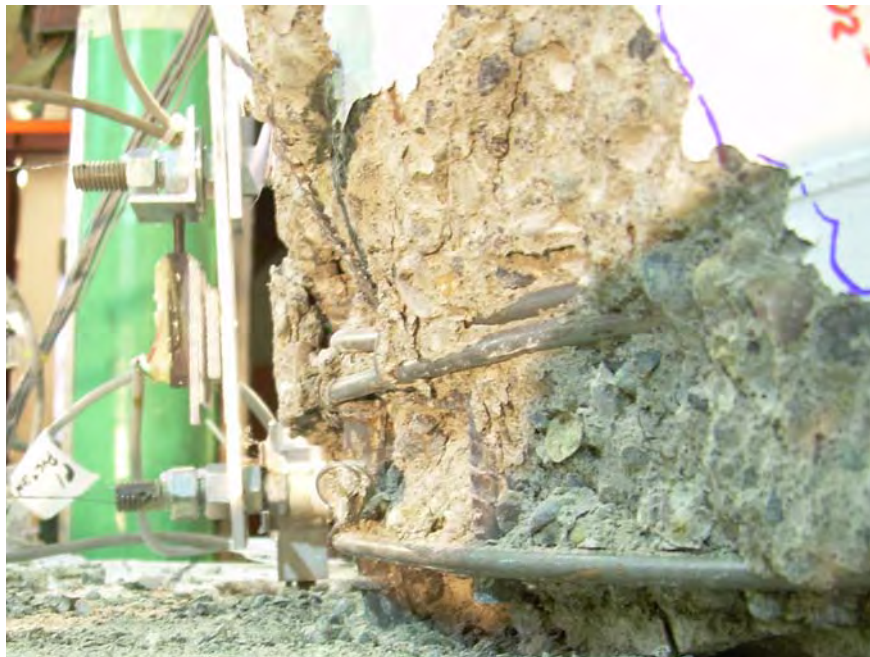
Figure 4-36: Bar 1 buckling in Specimen LB8-D1 during Cycle 32 (5.77%/-5.67%)

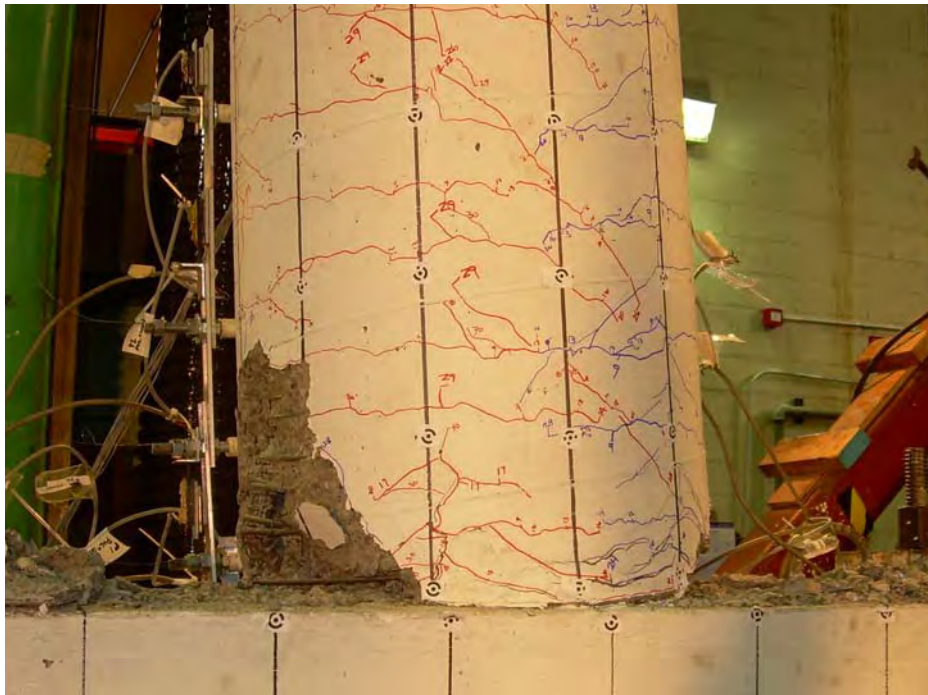
Figure 4-38: Fully spalled (10 inches) on the north face in Specimen LB8-D1 at Cycle 33 (7.11%/-6.93%)

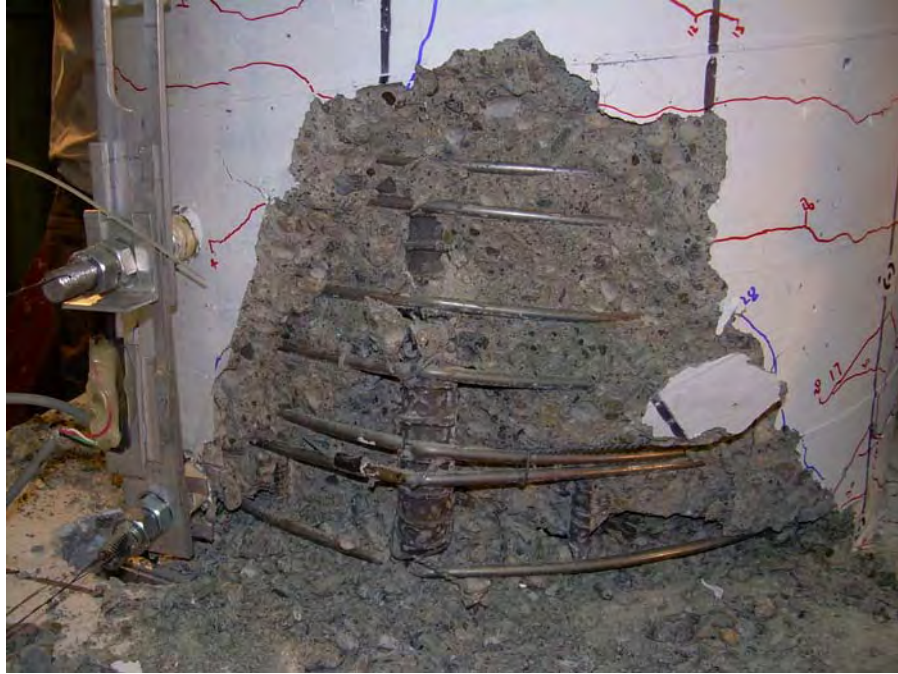
Figure 4-39: Bar 1 buckled and spirals fractured in Specimen LB8-D1 during Cycle 33 (7.11%/-6.93%)

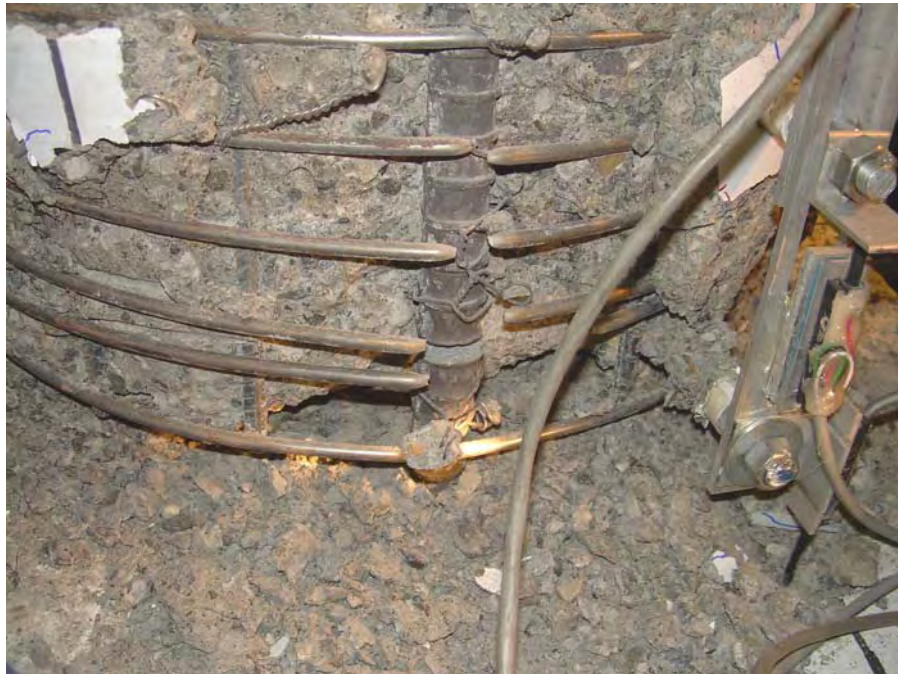
Figure 4-40: Bar 4 fractured in Specimen LB8-D1 during Cycle 34 (7.20%/-7.06%)

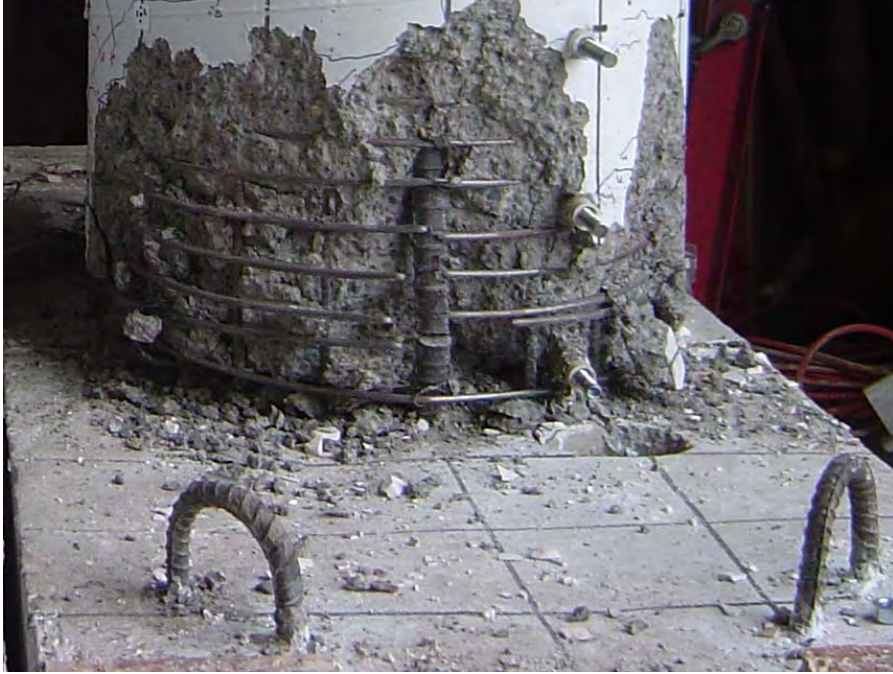
Figure 4-43: Damage to Specimen LB8-D1 at the end of testing

Damage to the joint region and cap-beam was minimal, consisting of diagonal cracks on the east and west faces. After the axial load had been applied, two off-center cracks formed on the bottom on each side of the cap beam. The cracks propagated diagonally to the top of the cap-beam, as seen in Figure 4-42. No damage or cracking occurred on the surface of the cap-beam or in the grouted ducts. The final damage state of Specimen LB8-D1 is shown in Figure 4-43.

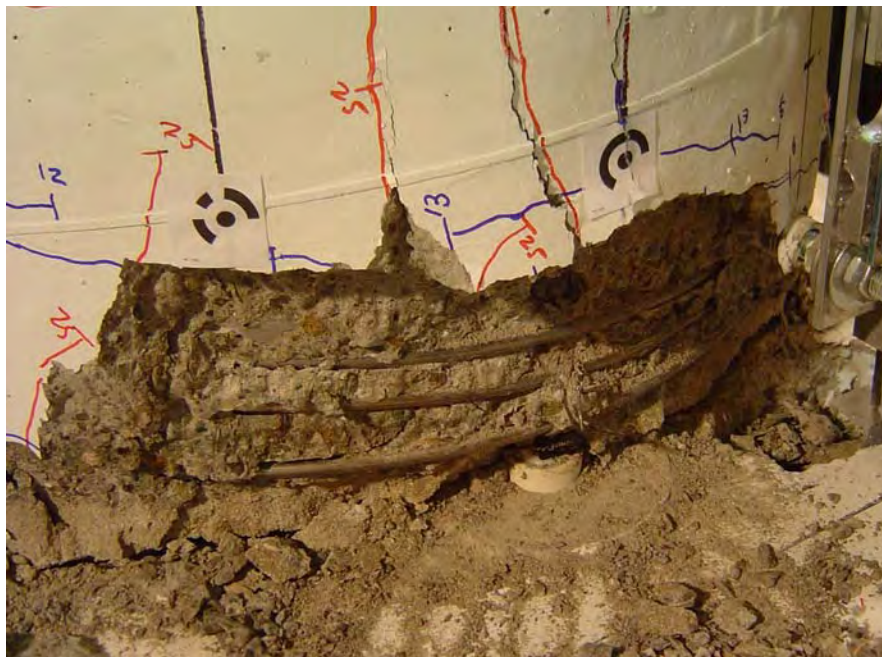
Figure 4-40: 5 inches spalled on the south face in Specimen LB8-D2 at Cycle 29 (4.70%/-4.63%)

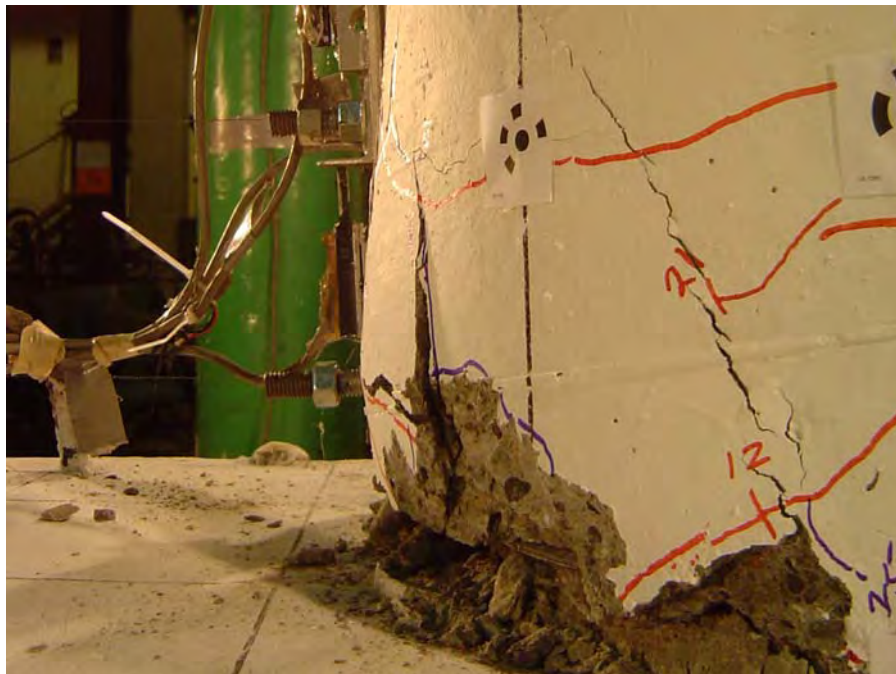
Figure 4-52: A bulge in the concrete cover indicates possible bar buckling in Specimen LB8-D2 during Cycle 30 (4.73%/-4.66%)

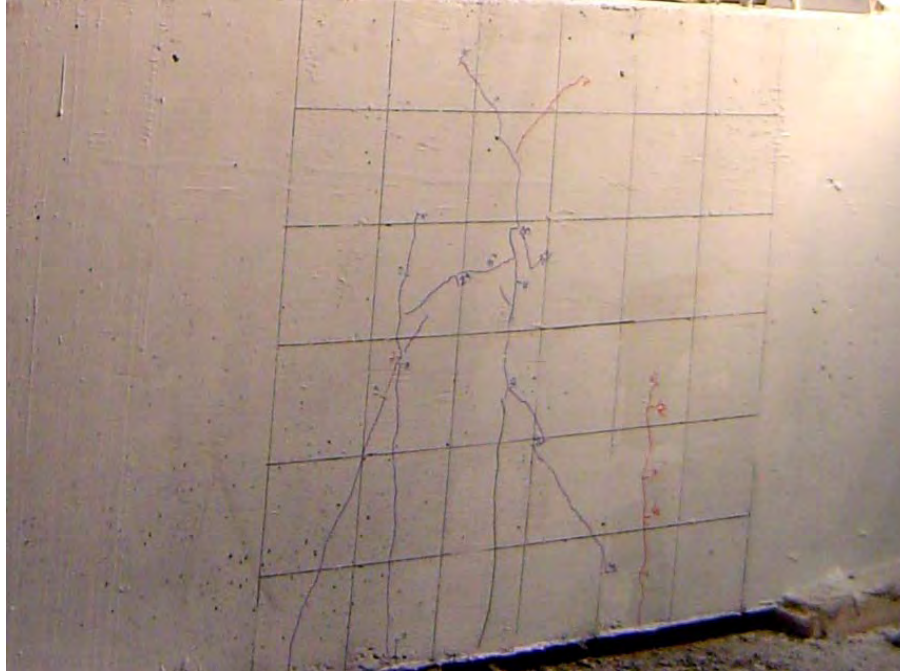
Figure 4-57: Damage to the cap-beam in Specimen LB-D2 after Cycle 34 (7.41%/-7.17%)

Damage to the cap-beam and diaphragm was minimal, consisting of diagonal cracks on the east and west faces (see Figure 4-57). After axial load had been applied, two approximately centered cracks formed on the bottom on each side of the cap beam. Cracks formed on the bottom of the beam roughly 12 inches from the center. These cracks propagated diagonally to the top of the cap-beam through the test. The crack widths did not exceed 0.007 inches. No damage or cracking occurred on the surface of the cap-beam or around the grouted ducts (see Figure 4-58 and Figure 4-59). Cracks formed in the grouted duct (see Figure 4-58) from the buckled bars pushing laterally against the grout in the debonded region. The final damage state of Specimen LB-D2 is shown in Figure 4-59.

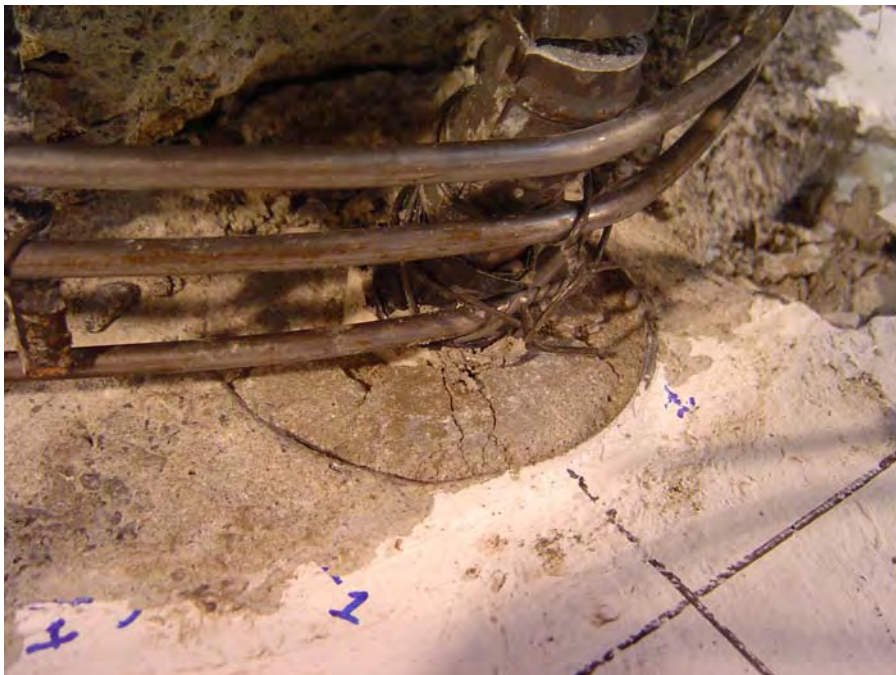
Figure 4-58: Specimen LB8-D2 with no spalling in the cap-beam; radial cracks in the grout at the end of testing

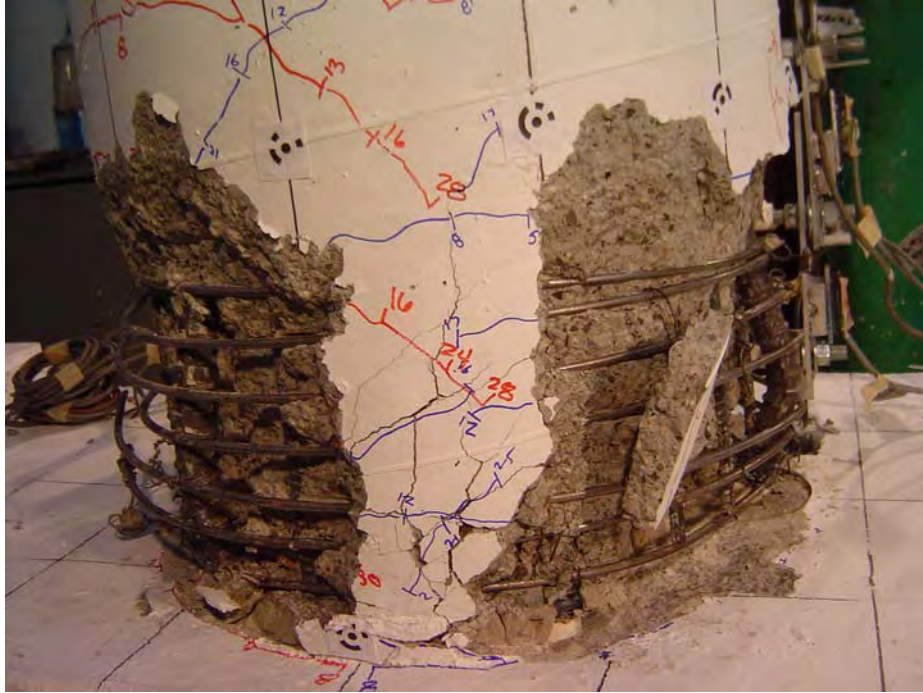
Figure 4-59: Damage in Specimen LB8-D2 at the end of testing

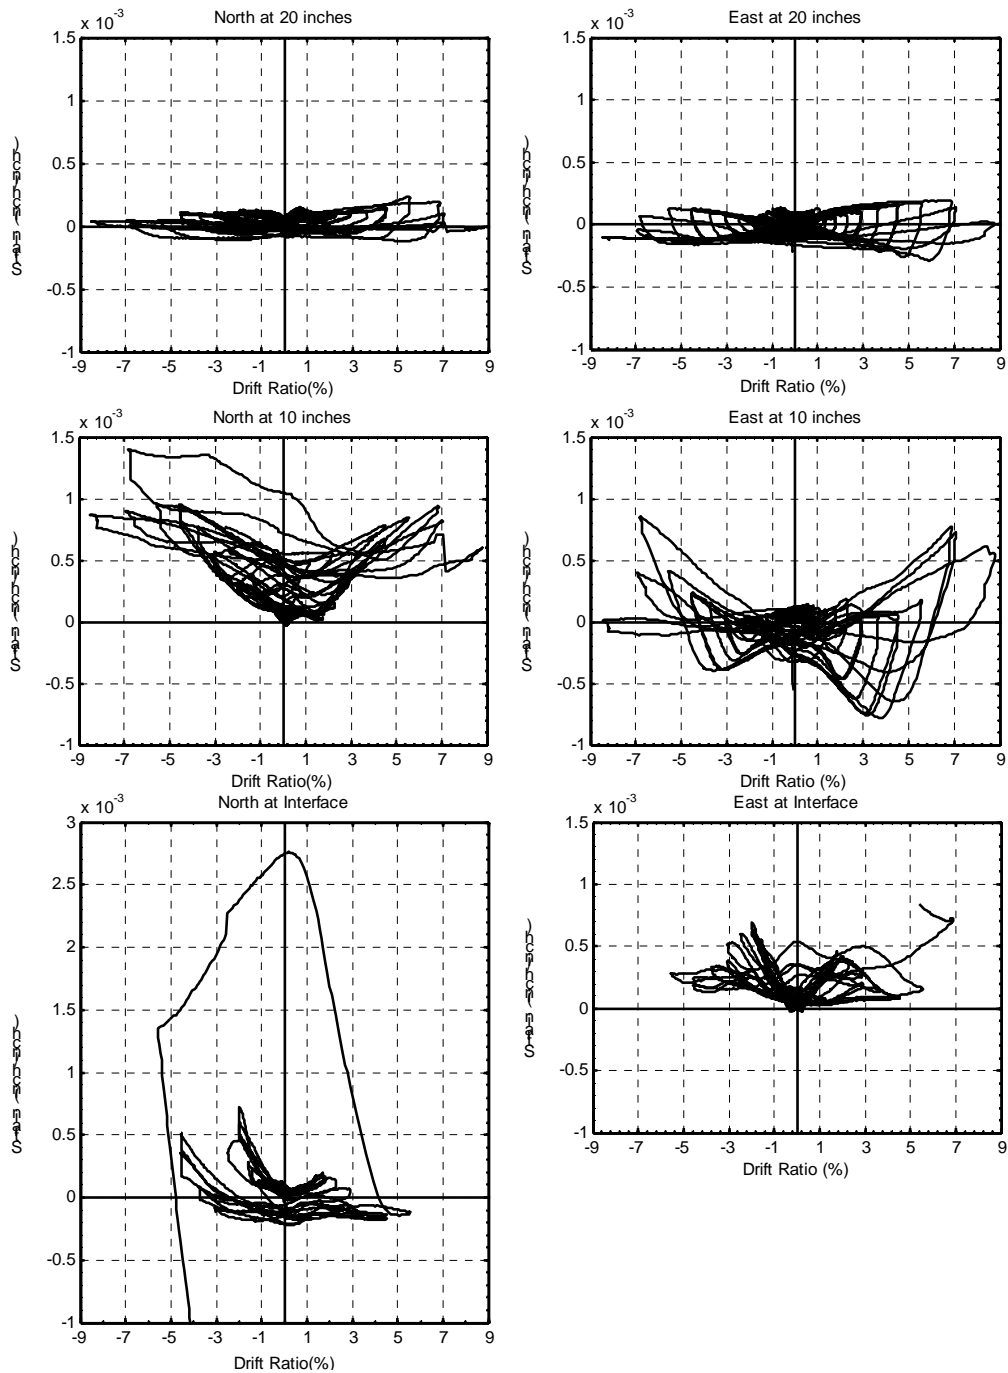
Figure 5-31: Spiral reinforcement strains-drift ratio for specimen DB5-RE

The fact that spiral strains at locations away from a kink were about one half of yield at the same time that the spiral fractured suggests that spiral kinking, as a result of bar buckling, has a significant effect on the spirals' ability to confine the concrete through hoop tension. This fact is seldom accounted for in models of core confinement.
