Laboratory and field testing and evaluation of precast bridge elements

A thesis submitted to the graduate faculty
in partial fulfillment of the requirements for the degree of
MASTER OF SCIENCE

Major: Civil Engineering (Structural Engineering)

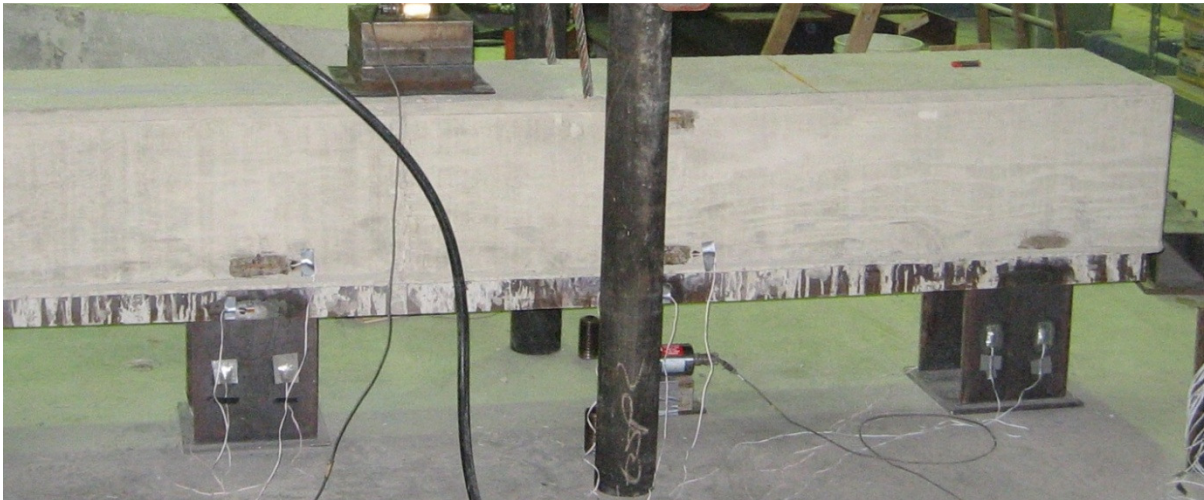
Figure 5. Precast abutment caps.

The abutment caps designed by Black Hawk County Engineering Department were fabricated at the Black Hawk County yard by county forces. After fabrication, the abutment caps were shipped to the ISU structures laboratory for service and ultimate strength testing. Two abutment caps were tested; the first abutment cap (Cap 1) was fabricated using a W12x65 steel section (Figure 5a), and the second abutment cap (Cap 2) was fabricated with a W12x26 section (Figure 5b).

a) Cap 1 fabricated with W12x65

b) Cap 2 fabricated with W12x26

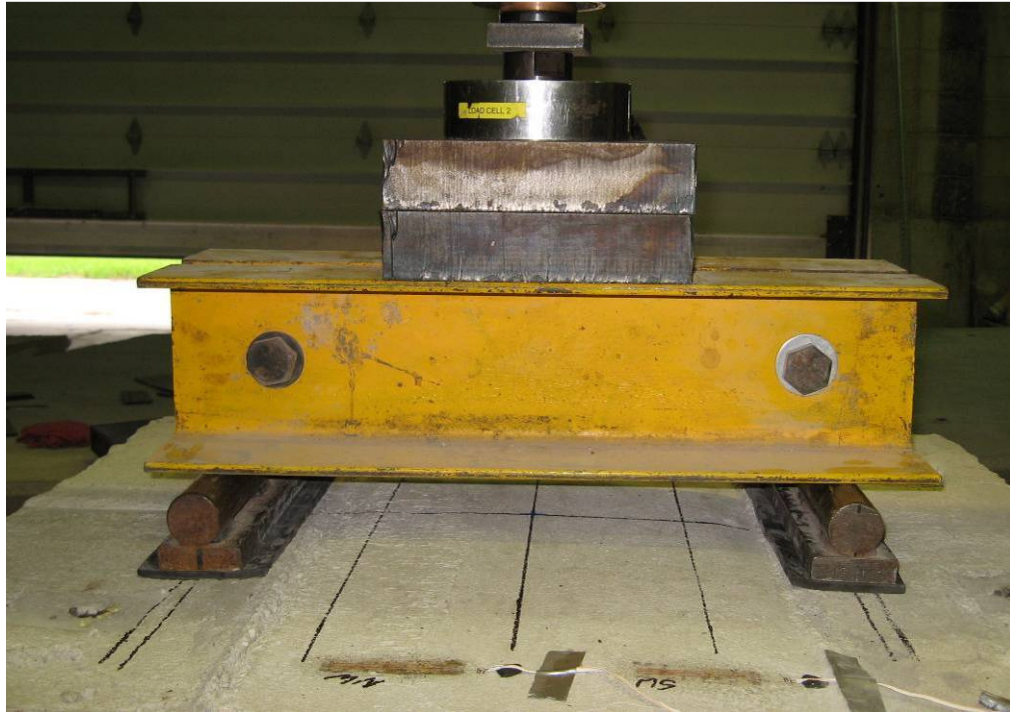
Figure 35. Ultimate load test set-up.

After a specimen was loaded at all five load positions, the specimen was set-up for ultimate load testing. To load the specimen at two locations, a beam was used to span the distance between the load points shown in Figure 35. By loading the midpoint of the span of the load beam, equal force was applied at each load position. Force was applied until failure

of the specimen occurred. Strain and deflection data were recorded at 1000 pound increments. After failure, the broken specimen was examined, removed from the testing area, and then the next specimen was set in place.

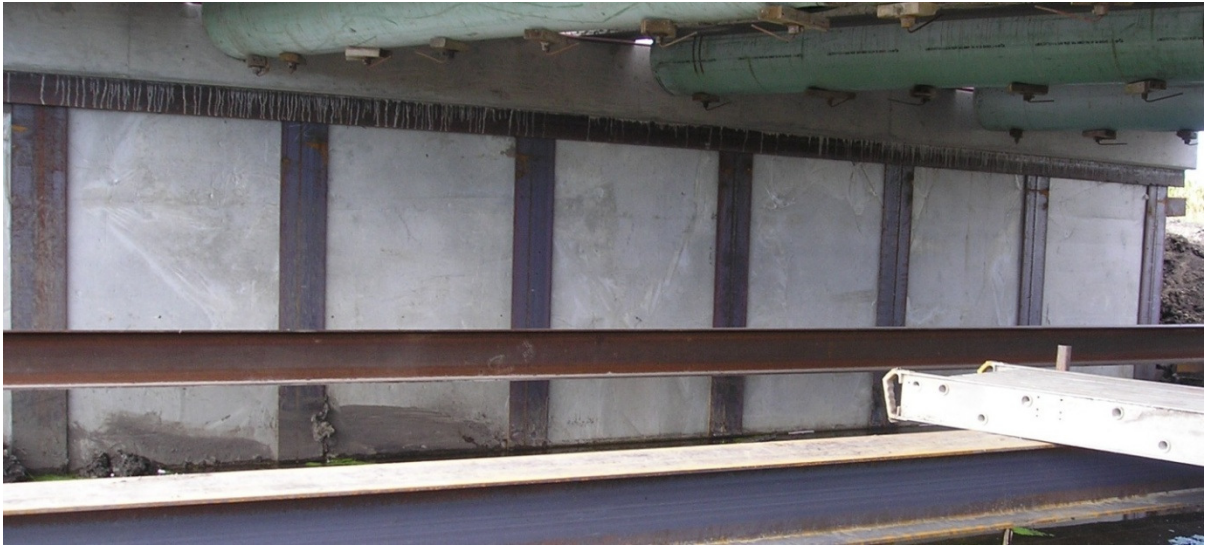
Figure 37. Abutment backwalls in the field.

that run the entire length of the slab, as shown in Figure 36. A drawing of the backwall system in the field, with the backwalls in place between the H-piles is presented in Figure 37.

a) Drawing of backwalls in field

b) Photograph of backwalls in field

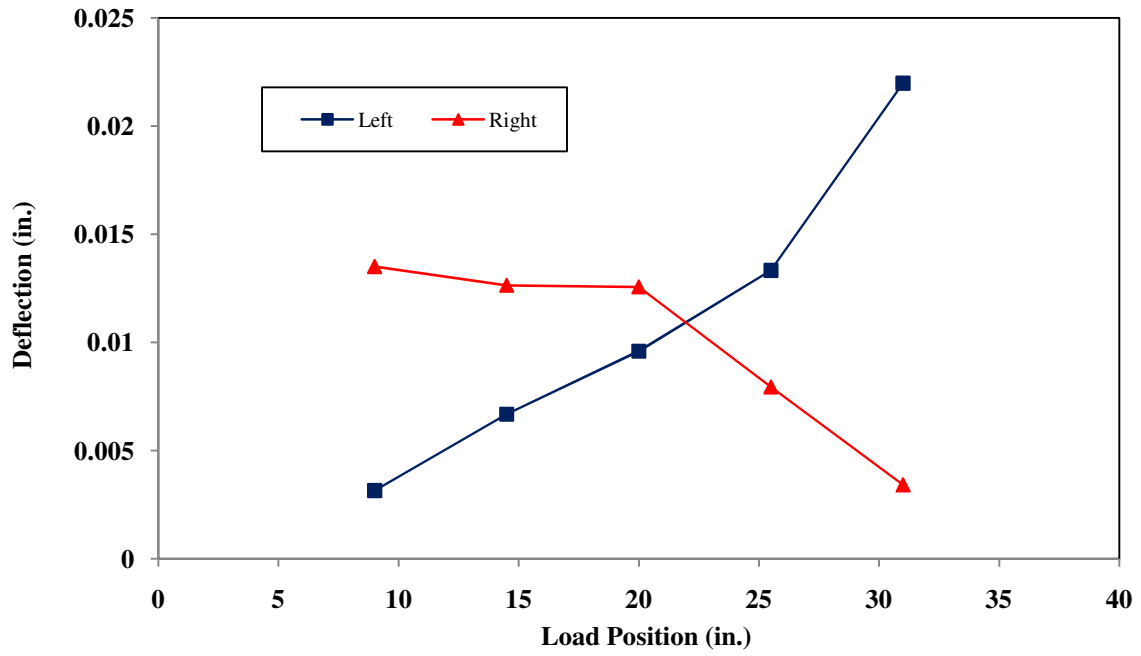
Results from the service level testing show that all three connection details were able to transmit the 5 kip load across the joint. Figure 58, Figure 59, and Figure 60 show deflections for each connection type for both the left and right sides of the specimen. In these figures, the service loading started on the left side, and moved to the right side. For the Type 1 and Type 3 Connections, the side of the specimen that is carrying the load deflects more than the other side, as is expected since there is no positive connection between the instrumented areas (see Figure 32 for deflection instrumentation locations). The Type 2 Connection deflections show continuity between the two sides of the specimen. This was expected as the welded plates create a positive connection in the Type 2 Connection. The instrumentation labeling for the concrete gages on the top surface of the specimens is shown in Figure 61. Table 6 presents the highest compressive strains that occurred in these strain gages for all three connection types.

Figure 58. Type 1 Connection service deflections.

Figure 59. Type 2 Connection service deflections.

Figure 60. Type 3 Connection service deflections.

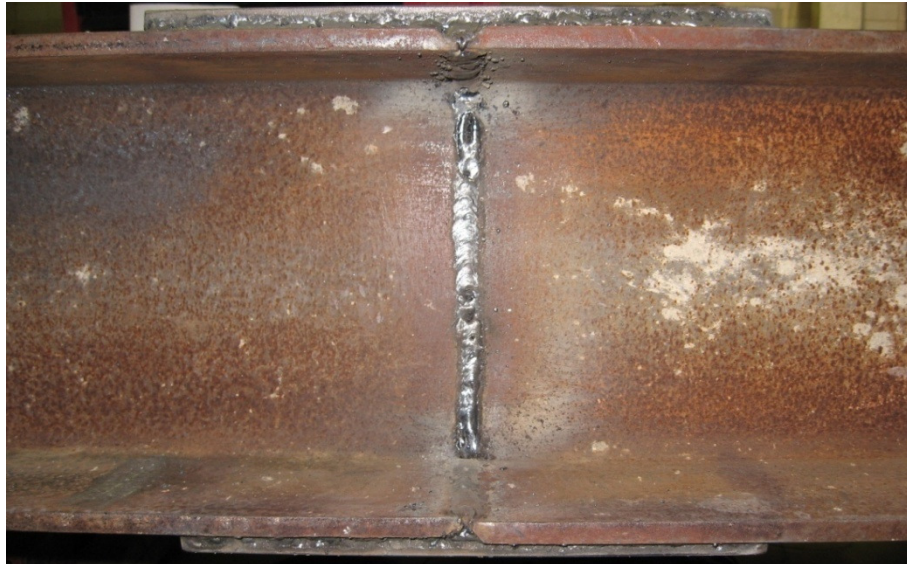
Figure 64. Repaired H-pile splice.

After the repair, the test was performed again, and the slab was still able to resist a point load of 100 kips. The load-deflection curves at DC2, both before and after the H-pile break, are shown in Figure 65. The failed backwall specimen is shown in Figure 66; the pattern of the cracking suggests that punching shear was the mode of failure. During the strength testing, the stress induced in the steel straps was less than 2.7 ksi for the top straps and less than 1.1 ksi for the bottom straps. The expected resultant load from both a 5-axle, 10 tons per axle truck over the abutment and the lateral earth pressure from an undrained clay under worst-case conditions is approximately 63 kips. Even in its weakened state, the backwall system provided a factor of safety of 1.6 against failure.

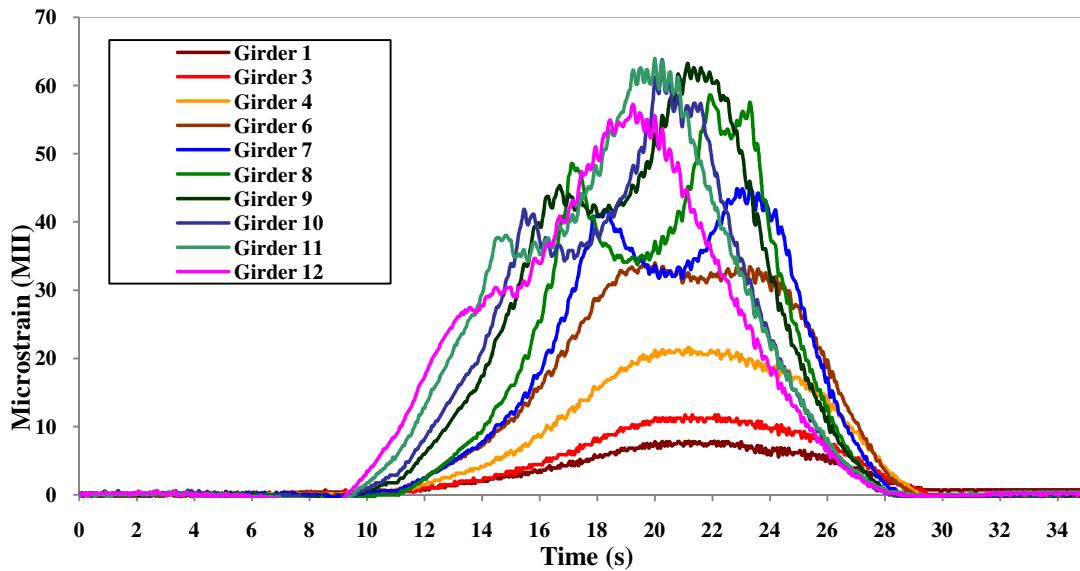
Figure 85. Midspan strain history for Test 4.1.

The bridge on Mt. Vernon Road was tested as described in Section 4.1. The 10 rolling tests will be referred to as Test X.Y, where X is the lane number ($X = 1, 2, 3, 4, 5$), and Y designates whether it was the first crossing in that lane ($Y=1$), or the second ($Y=2$). A significant amount of strain and deflection data was collected during each of the individual tests. The data were reduced by plotting the midspan tensile strains versus time and determining the time when maximum strains occurred. As an example, the measured midspan strains for Test 4.1 are presented in Figure 85. For this case, the maximum effect occurred at approximately 20.6 seconds on Girder 11; hence all data readings taken at this selected time were used to evaluate the bridge behavior for this test. The data marks introduced during the rolling test were used to calculate the truck's location at the maximum strain effect. The calculated position of the rear tandem axle is 56 ½ in. before the bridge's midspan at the time of maximum strain effect (197 in. from the centerline of the East Abutment). As seen in Figure 5.1, the maximum strains in each girder do not occur at the same time; this is due to the skew of the bridge. The mispan strains for Test 5.1 are also presented in Figure 86 and also show the effect of the skew for when the maximum strains occur. For all test lanes, it was found that the maximum 1/4 span strains were always less than maximum midspan strains.

The maximum midspan tensile and compressive strains due to the field tests were converted to a stress (assuming $E_s=29,000$ ksi and $E_c=4,030$ ksi). The maximum tensile stress in the steel was 2.5 ksi and occurred during Test 5.1 in Girder 12, while the maximum compressive stress in the concrete was 0.27 ksi, also occurring during Test 5.1. Allowable stress for the steel used in the design of the panel was 27.5 ksi ($.55f_y$), and for the concrete was 2 ksi ($0.4f'_c$); these allowable values were determined from the AASHTO Standard Specification. Since the test vehicle isn't as heavy as the AASHTO vehicle (72 kips), the stresses need to be factored accordingly in order to compare to the AASHTO allowable stresses. After factoring, the maximum steel stress is 3.2 ksi and the maximum concrete stress is 0.35 ksi. Dead load stresses were determined from the BHC design spreadsheet, which shows the steel stress as 9.4 ksi and the concrete stress as 0.45 ksi. Therefore, the total steel stress is 11.9 ksi, and the total concrete stress is 0.69 ksi, which are much lower than what is allowed. Thus, the MVRB meets the AASHTO design criteria.

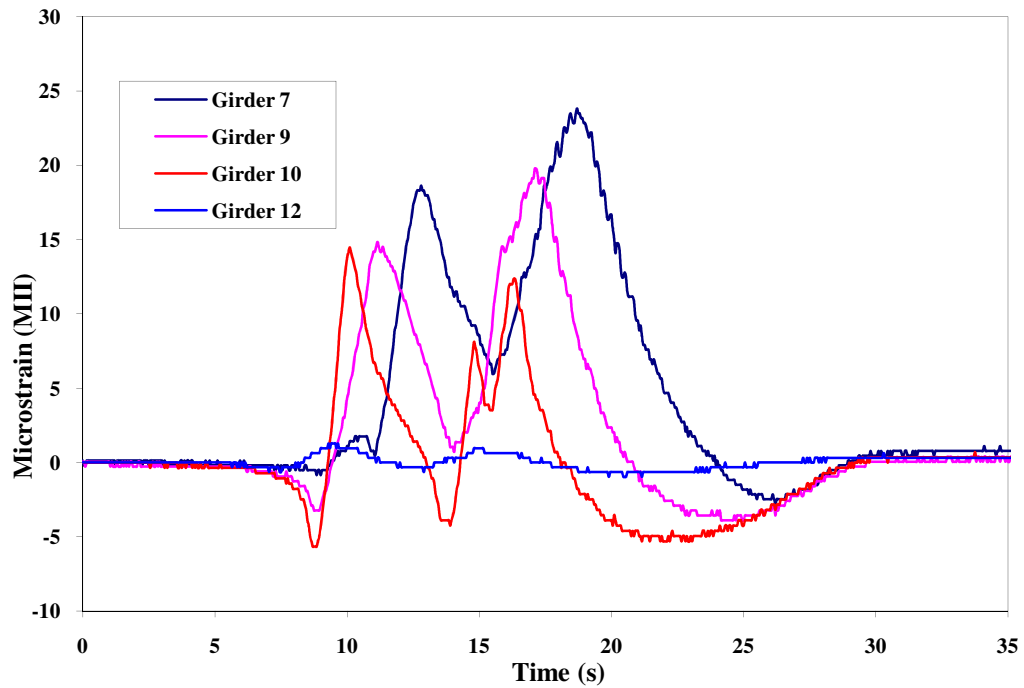
Girder strains at the abutments were evaluated to determine if end restraint was present. In Figure 90, the strains at the abutments in Girders 7, 9, 10, and 12 recorded during Test 4.1 are plotted versus time. The maximum compressive strains occurring in either abutment were less than 10 microstrain. Since compressive strains are recorded, the instrumentation is located in a negative moment region, indicating the ends are not purely simply supported. The area of the deck panels that rests on the abutment cap creates a semi-rigid condition at the abutments.

a) West abutment strains

b) East abutment strains
