STATE HIGHWAY ADMINISTRATION

Research Report

DURABILITY ASSESSMENT OF PREFABRICATED BRIDGE ELEMENTS AND SYSTEMS

**PROJECT NUMBER SP309B4E
FINAL REPORT**

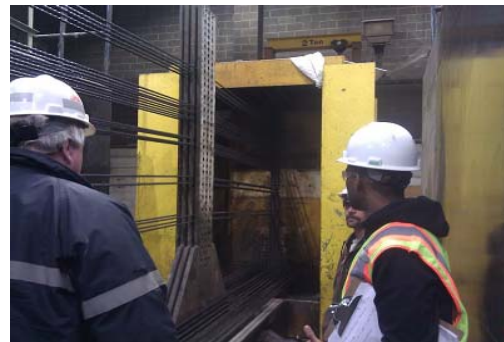
During the visual inspection process, it was noted that a few of the ties for the reinforcement strands had loosened before concrete pour. This issue was noted and corrected. A technician adjusted the beam along its length to ensure accurate cover was achieved. The reinforcement bars were all epoxy-coated and well placed within the lifters.

Figure 6: (a) Formwork, (b) Concrete test, (c) Concrete Pour, and (d) Strand Inspection at NPP

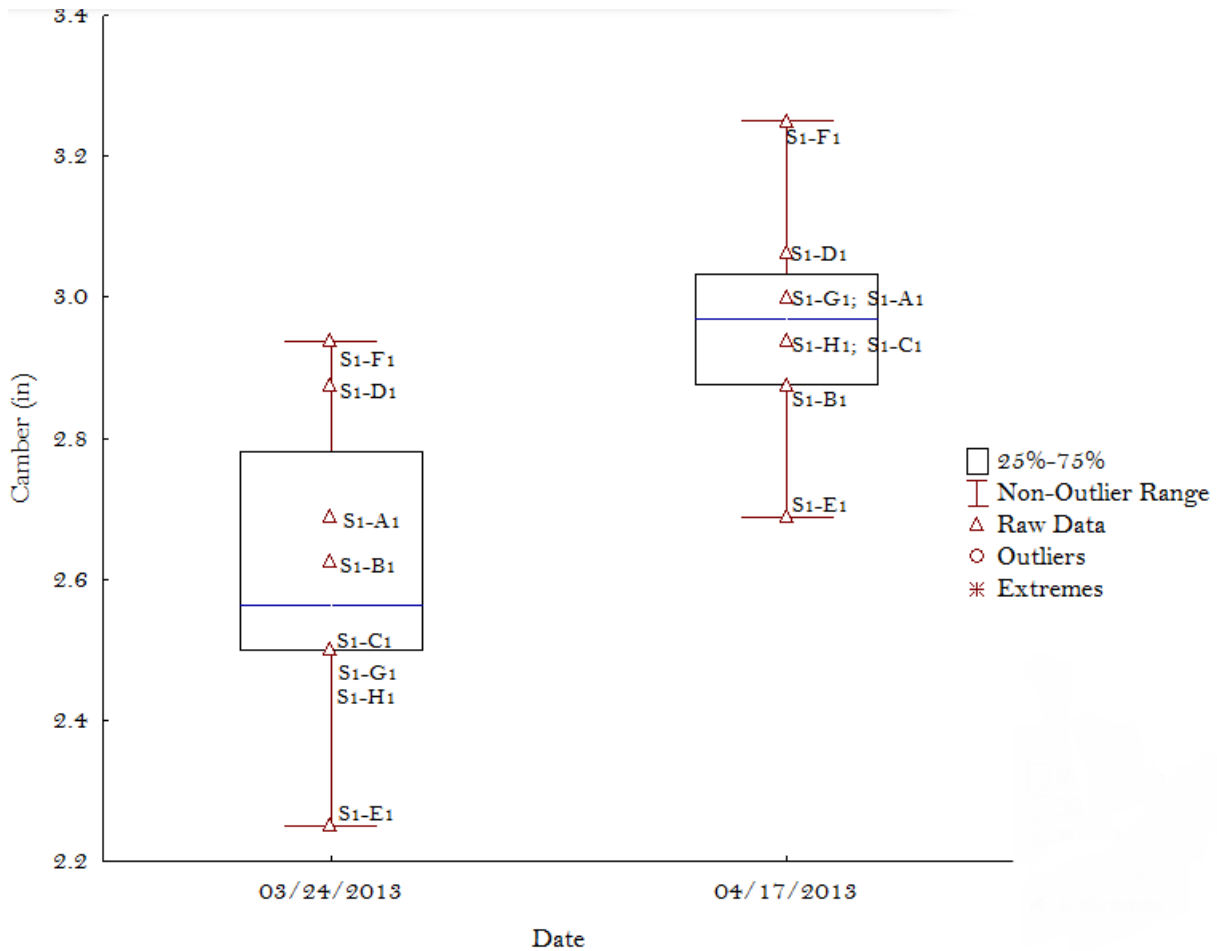
Figure 14 shows a box plot of the camber for the beam at release. On April 14, 2013, the box plot identifies the dispersion and skew of the camber values from the specified in the production detail drawings. It is represented by the green dotted line in the plot. As seen in Figure 13, there are no outliers represented on the plot, which means the camber values are not beyond normal.

Figure 14: Box-whisker camber plot of I-girder beams

At release, camber measurements showed that majority of the beams have values that are below the specified value as seen in Figure 14 above. The sway of the data is shown as having the bottom whisker higher than the top whisker. Camber values for beams S1-H1, S1-G1, S1-D1 and S1-F1 are above the specified value of 2.35-in. while the lowest camber value was recorded for beam S1-E1. Twenty-five percent (25%) of the camber values that lie below the specified value are represented by beams S1-C1, S1-G1 and S1-H1 in the plot. Seventy-five percent (75%) of the camber values which lie above the specified value are represented by beams S1-B1, S1-A1, S1-D1 and S1-F1. However, the camber measurement was taken 23 days after release, and showed that beams S1-G1, S1-A1, S1-D1 and S1-F1 values were above the specified value of 3.1-in. while the least value was recorded for beam S1-E1. 25% of the camber values which lie below the specified value are represented by beams S1-B1 and S1-E1 in the plot. 75% of the camber values that lie above the specified value are represented by beams S1-D1 and S1-F1. Beams S1-H1, S1-C1, S1-G1 and S1-A1 have values that are within close range (± 0.05 in) of the specified. The majority of the beams that have camber values that were below the specified value are seen in the bulk of the data, showing the bottom whisker higher than the top whisker. This implies that the beam cambers were within the expected ranges specified for their production.

- Storage/timing sequencing of beams that have been sitting at the precast plant long after being produced is longer than what is specified in the initial project documents. This can affect beam camber and potentially cause alignment problems on-site that are counterproductive for PBES and can lead to other expensive corrective strategies while in the field placing the beams.

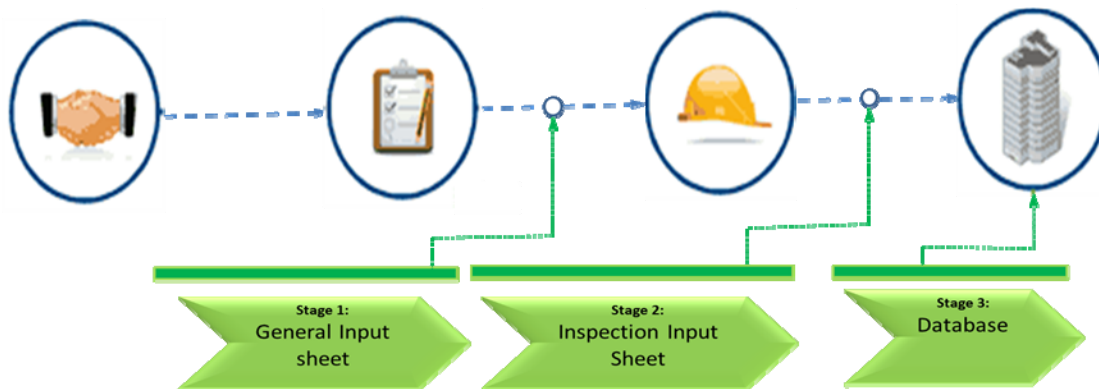
Identifying process improvements and methods to address quality control at the precast plants and in the field will help SHA meet its business plan performance measures. This can lead to the development of quality control practices based on the durability assessment described in this report for Maryland as well as other states. The flowchart and overall design process for how the database documents various information, is shown in Figure 17 below.

Figure 17: General flowchart and design process of database
