CHAPTER 3: TESTING & RESULTS

3.1 Introduction

This chapter presents the test methodology and the test results for the five control decked bulb T beams and the bridge model. The results are presented in the form of charts showing the relationship between the applied load and the response of the test specimens including deflection, strain of concrete, and strain in CFCC strands. In addition, for each test specimen, the ductility ratio was calculated to evaluate the failure mode analytically.

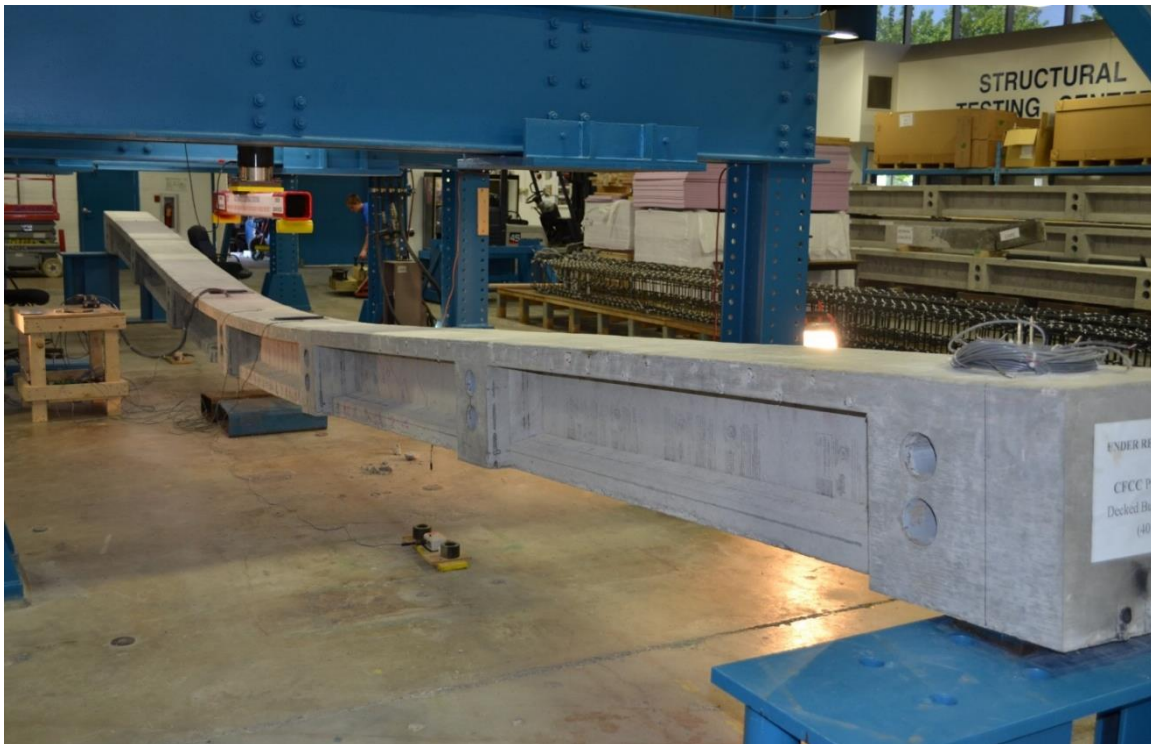
Figure 3.2-7 Beam C-S-F-U at failure

The last load cycle before failure reached 24 kip with a corresponding deflection of 9.11 in. After unloading, the residual deflection from all load cycles was 0.82 in. as indicated in Figure 3.2-6. The last load cycle included loading the beam to failure. The failure of this control beam took place at a load level of 32.47 kip with a corresponding deflection of 14.42 in. (not including the residual deflection of 0.82 in.). At this load level, a popping sound was heard and the load slightly dropped to 31.72 kip with a corresponding deflection of 14.61 in. Then the beam continued to resist the load and the load level increased again to 33.19 kip with a corresponding deflection of 15.62 in. At that point, the popping sound was heard again and the load decreased to 31.55 kip with a corresponding deflection of 15.83 in. The beam however continued to take more load and approached a load level of 32.07 kip. Finally, multiple popping sounds were heard and the beam lost its structural integrity and sustained a permanent deformation as shown in Figure 3.2-7.

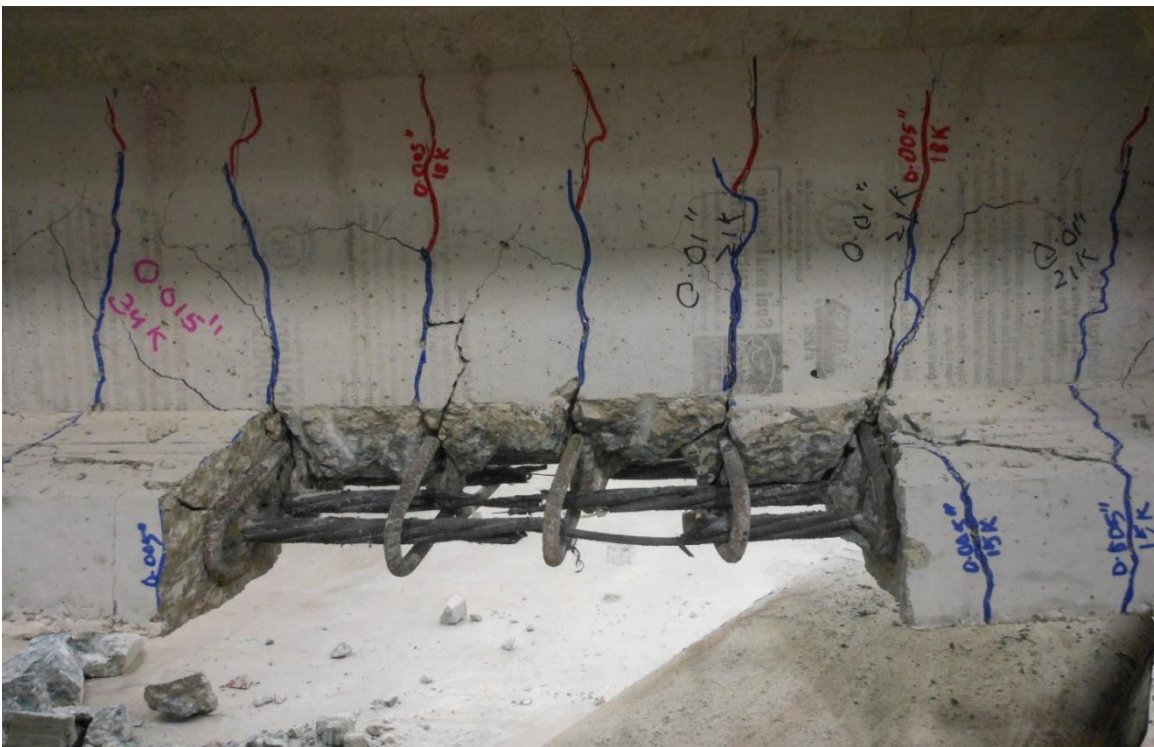
Figure 3.2-9 Rupture of prestressing CFCC strands in Beam C-S-F-U

After failure, the beam was inspected and it was found that there was a spalling of the concrete cover at multiple locations (Figure 3.2-8). Failure in the CFCC strands was also observed and was linked to the concrete spalling (Figure 3.2-9). It was determined that the popping sounds that were heard during the test were the sound of CFCC strands rupture. However, it should be noted that

due to the configuration of the CFCC strand, which encompasses seven wires, the tensile failure usually occurs on the wire level and not the strand level. In other words, every popping sound heard could have represented the rupture of single wire in the CFCC strand.

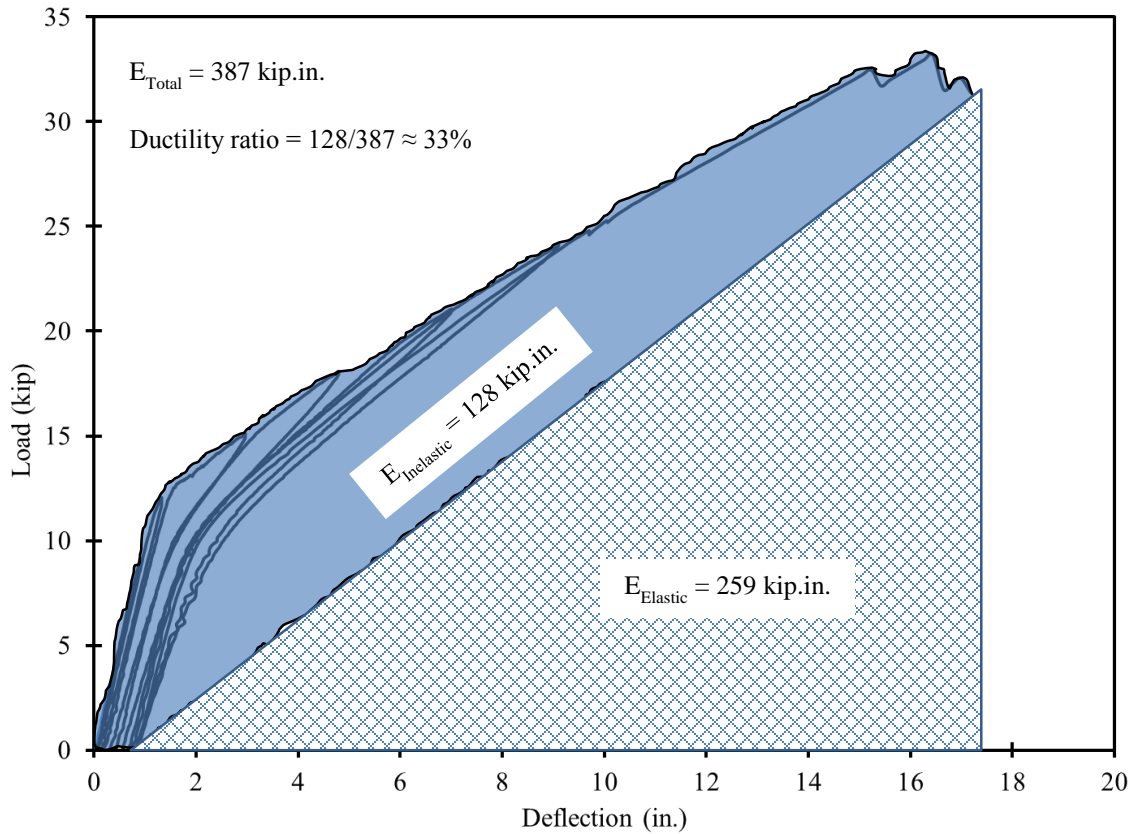
Figure 3.2-12 Ductility ratio in Beam C-S-F-U

Finally based on the load-deflection curves from all load cycles including the ultimate load cycle, the ductility ratio was calculated according to Grace et al. (2000). The area under the load-deflection curve is divided into two areas of elastic and inelastic energies. The elastic energy is the energy that can be retrieved once the load is removed from the beam, while the inelastic energy is the energy dissipated in the formation of cracks and for high concrete strain, the energy dissipated by the plastic deformation of concrete. According to Figure 3.2-12, the total energy absorbed by beam C-S-F-U at failure was approximately 387 kip.in. By following the last un-loading curve and

estimate the un-loading curve at failure, the total energy was divided into elastic energy of 259 kip.in. and inelastic energy of 128 kip.in. The ductility ratio was calculated as the ratio between the inelastic energy and the total energy and was estimated as 33%. It should be noted that the mode of failure slightly increased the ductility ratio.

As expected, the ductility ratio of the beam indicated a brittle failure (ductility ratio less than 70%, Grace et al. (2000)). However, the large deflection and the dense cracking patterns give a clear visual sign before failure. The failure mode by the consecutive rupture in the individual wires of the strands may also be regarded as a warning sign before complete failure.

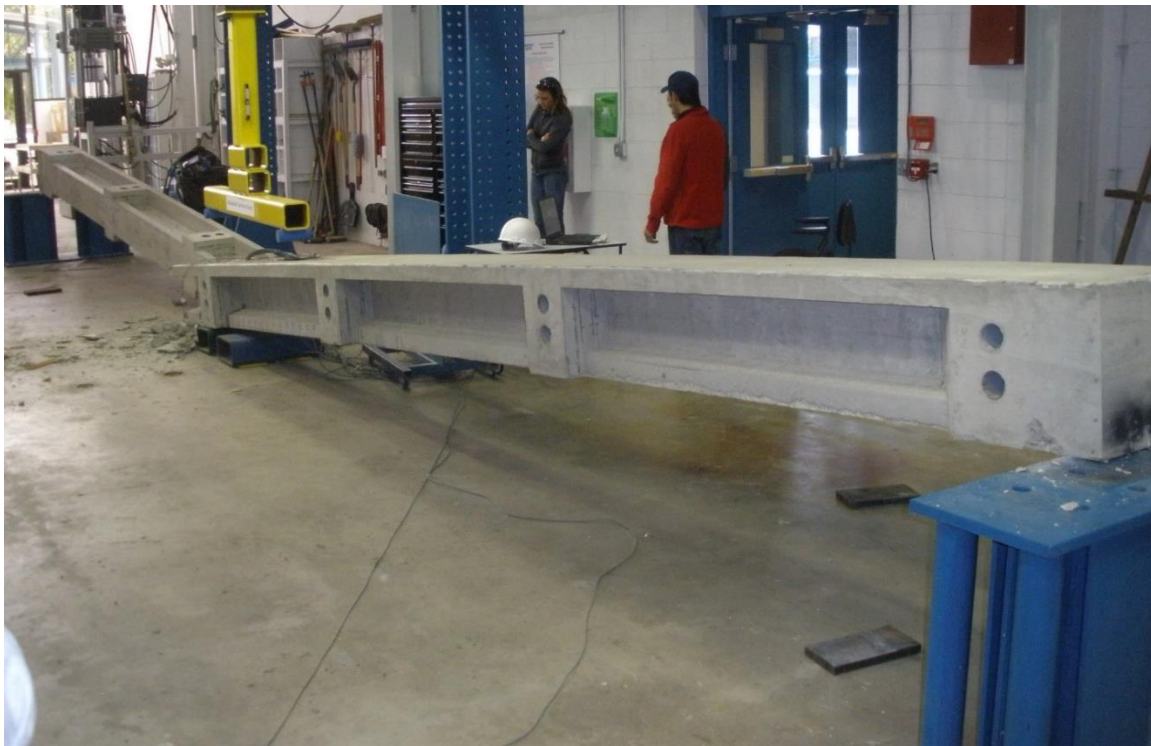
Figure 3.3-1 Balanced failure of Beam C-S-F-B

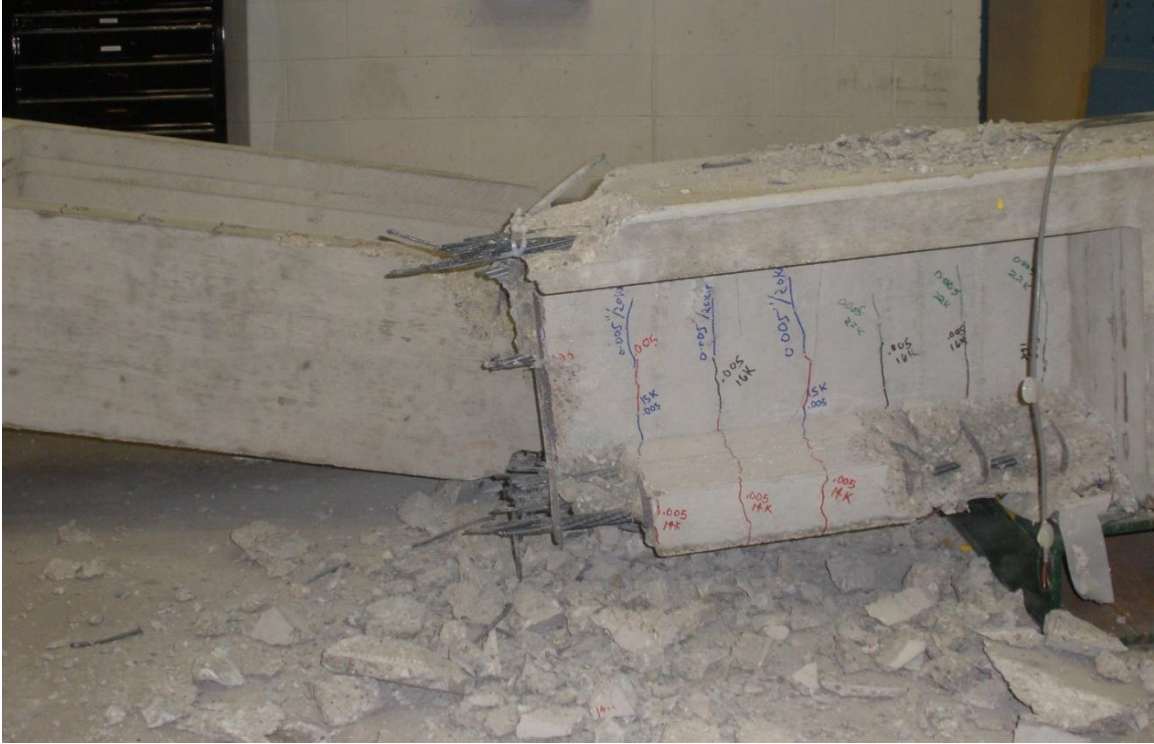
Figure 3.3-2 Balanced failure resulting in complete separation of Beam C-C-F-B

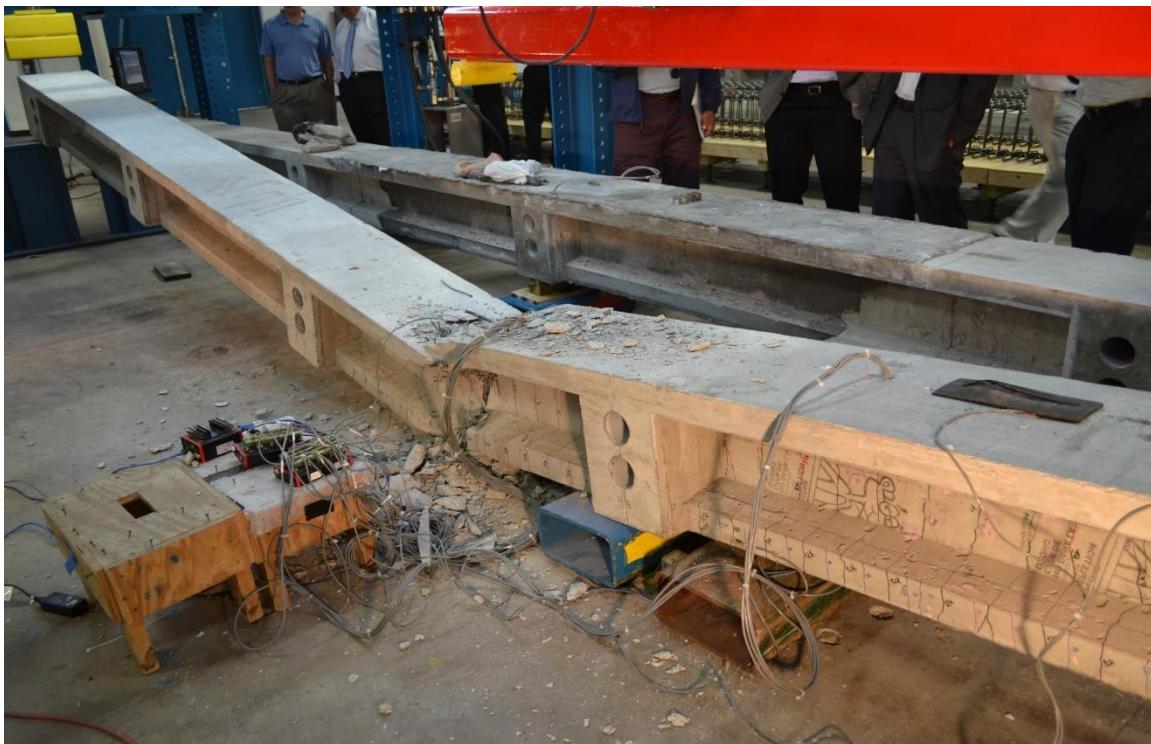
Figure 3.4-1 Beam C-S-F-O at failure

This control beam was provided with four bottom prestressing CFCC strands and five bottom non-prestressing CFCC strands. This amount of bottom reinforcement guaranteed the compression failure mode. As shown in Figure 3.4-1 through Figure 3.4-3, the failure of this beam was characterized by the crushing of the concrete in the top flange followed by shearing and rupturing of both prestressing and non-prestressing CFCC strands and breaking of the beam into two pieces.

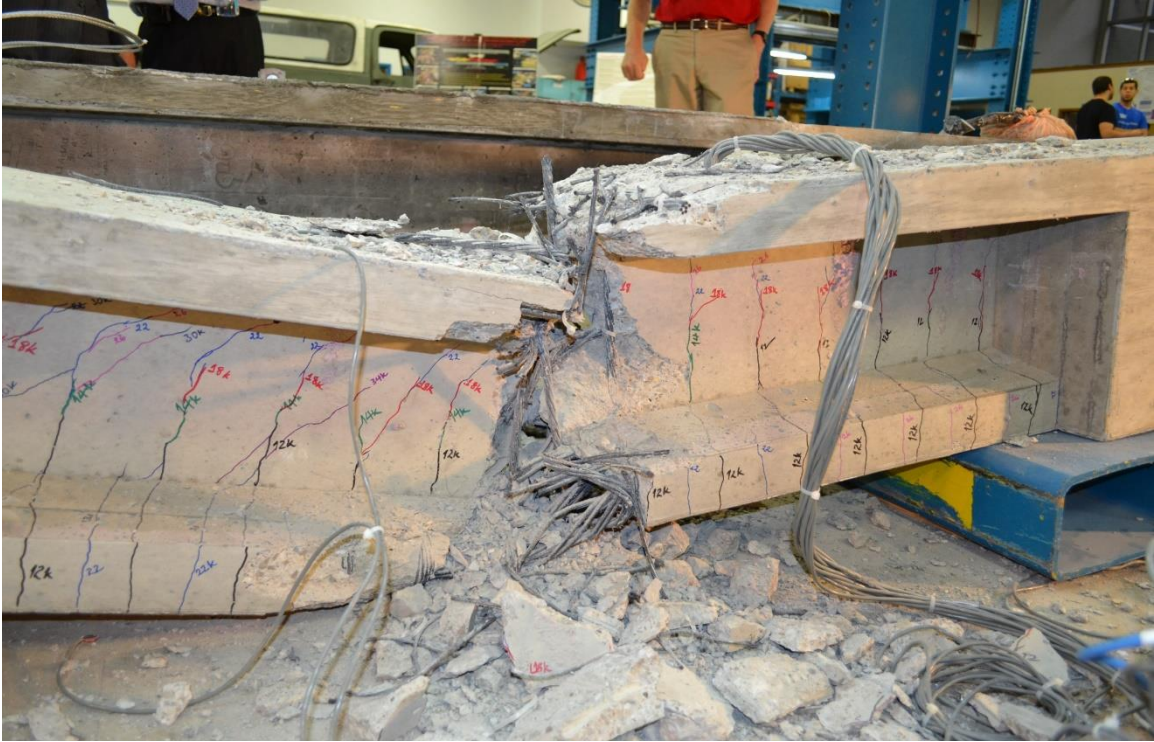
Figure 3.4-2 Compression failure followed by rupture of strands in Beam C-S-F-O

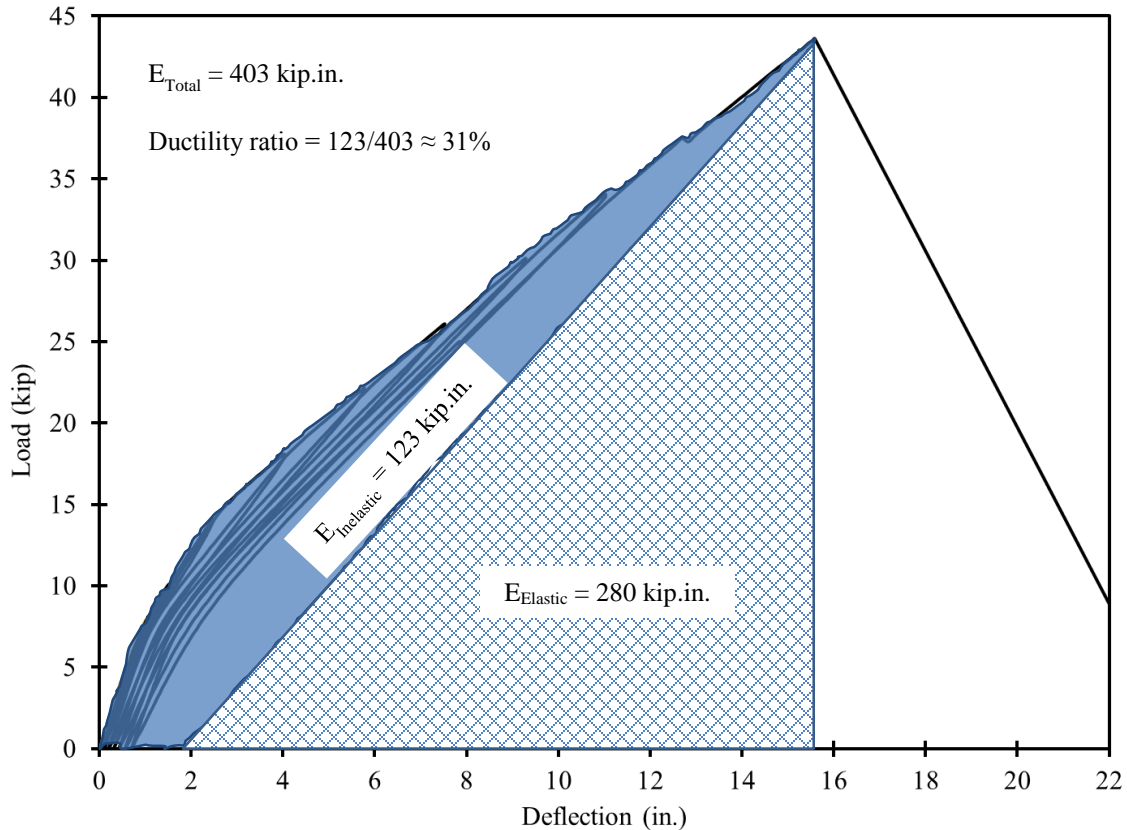
Figure 3.4-5 Ductility ratio of Beam C-S-F-O

Figure 3.4-5 highlights the elastic and inelastic energy absorbed by the beam before failure. The elastic energy was approximately 280 kip.in., while the inelastic energy was approximately 123 kip.in. with a total energy of 403 kip.in. and a ductility ratio of 31%. Similar to previous beams with CFCC reinforcement, from the aspect of ductility ratio, the failure of the beam falls under the brittle failure category but from a deflection and cracking perspective, the failure was accompanied by enough warning signs that indicated the overstressing.

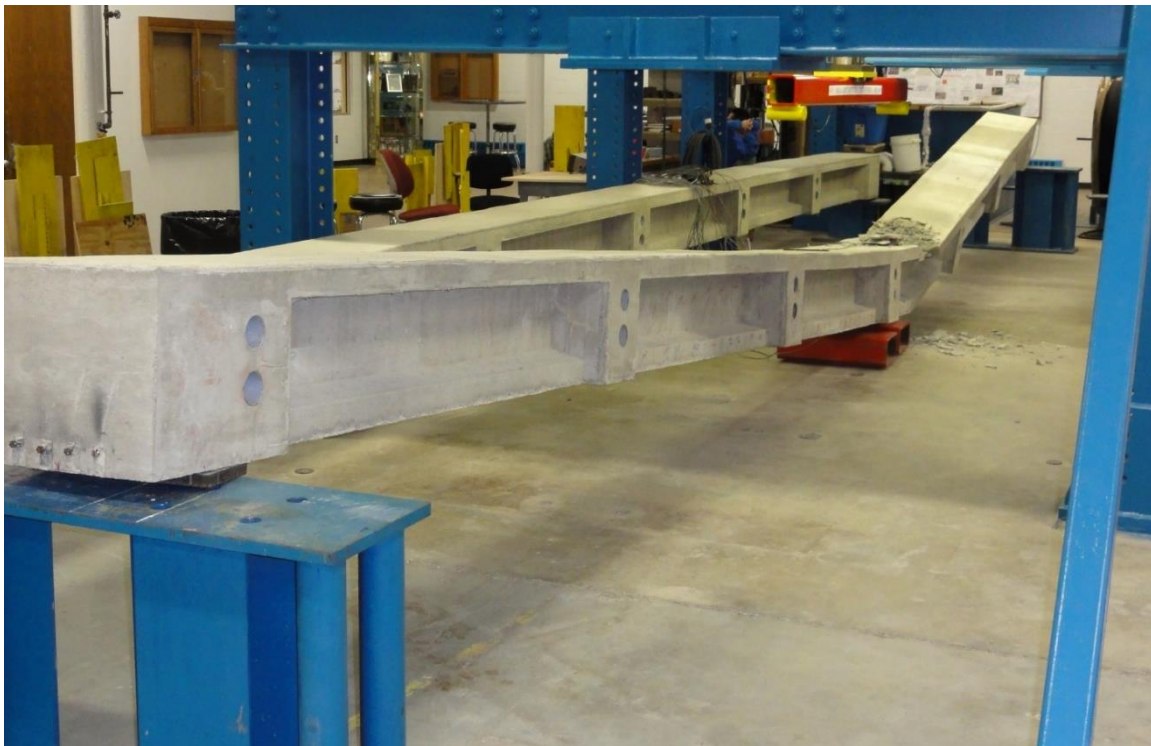
Figure 3.5-1 Flexural failure of Beam S-S-F-U

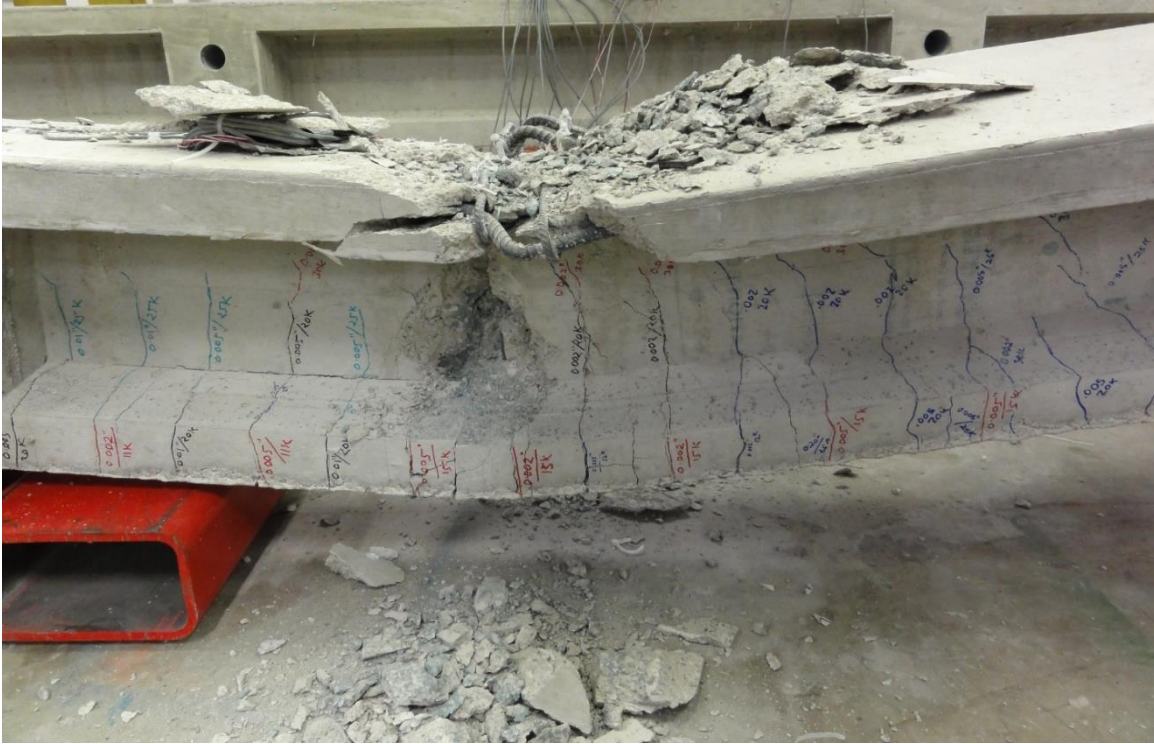
Figure 3.5-2 Failure of Beam S-S-F-U showing crushing of concrete after yield

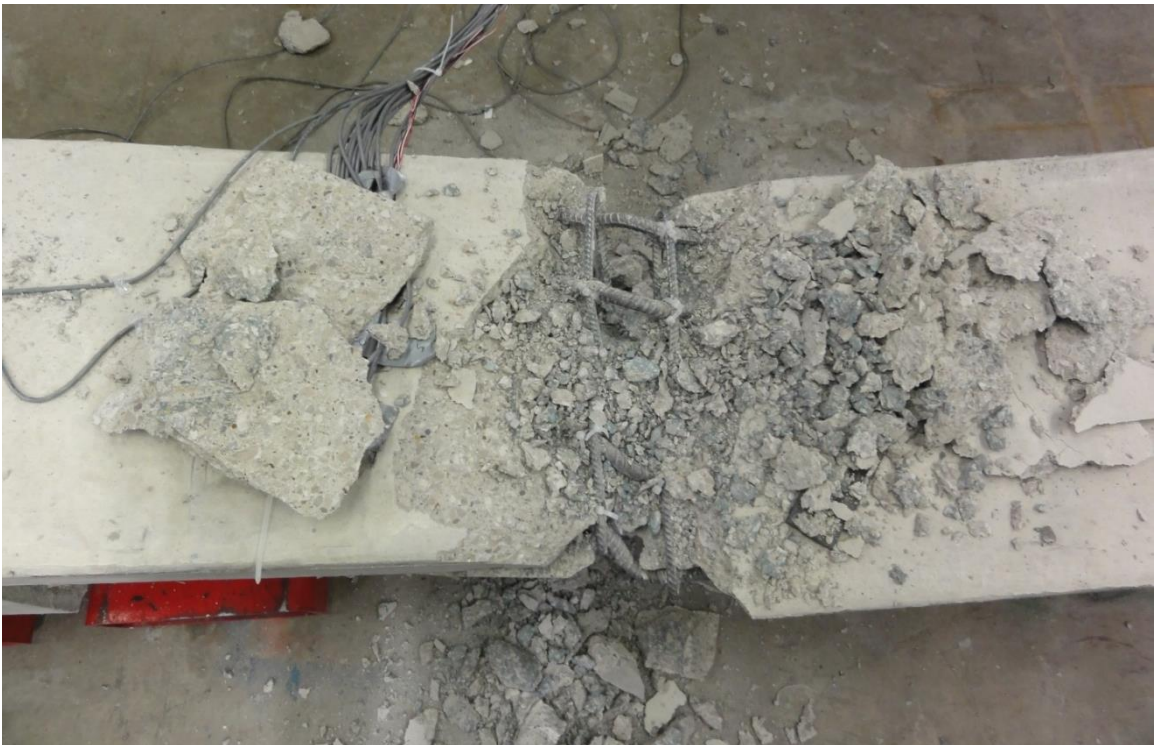
Figure 3.5-3 Buckling of top reinforcement in Beam S-S-F-U at failure

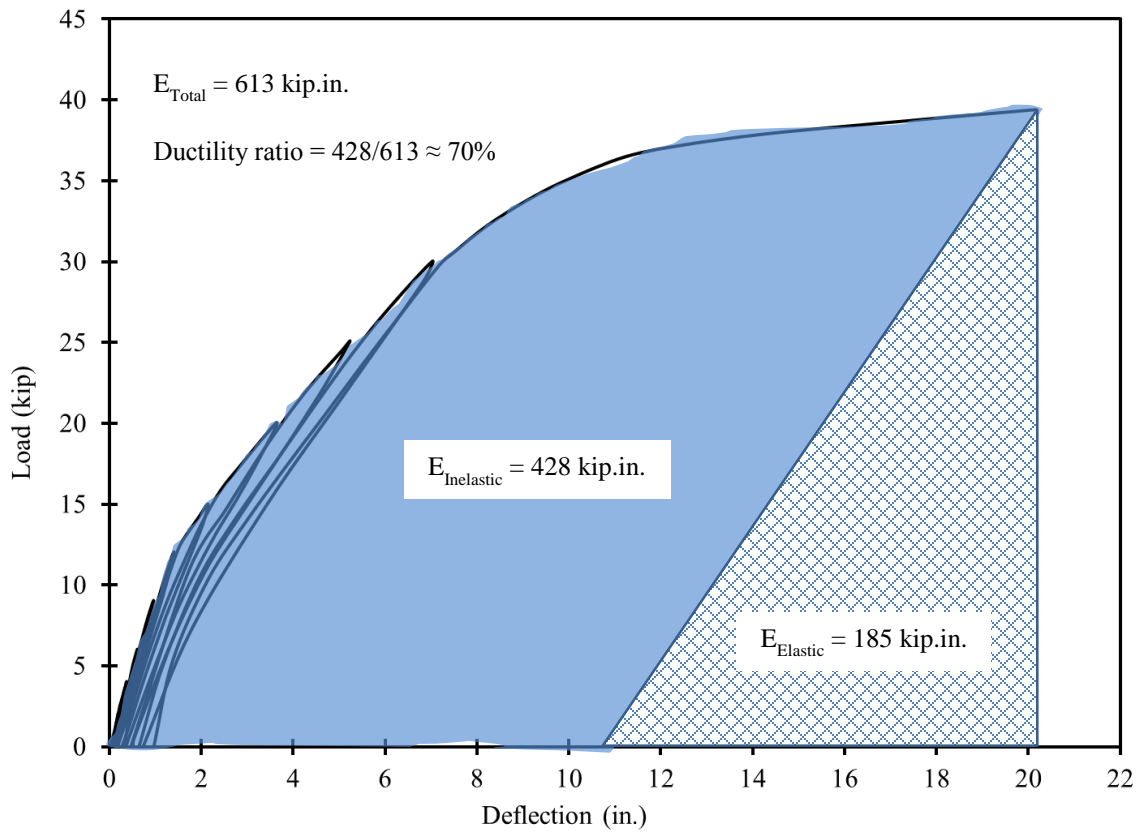
Figure 3.5-5 Ductility ratio in Beam S-S-F-U

Due to the yielding of prestressing strands, this control beam exhibited a high ductility ratio. As shown in Figure 3.5-5, the total energy absorbed before failure was estimated as 613 kip.in. The elastic energy was estimated as 185 kip.in, while the inelastic energy was estimated as 428 kip.in. Therefore, the ductility ratio was calculated as 70%, which places this failure within the ductile failure boundaries.

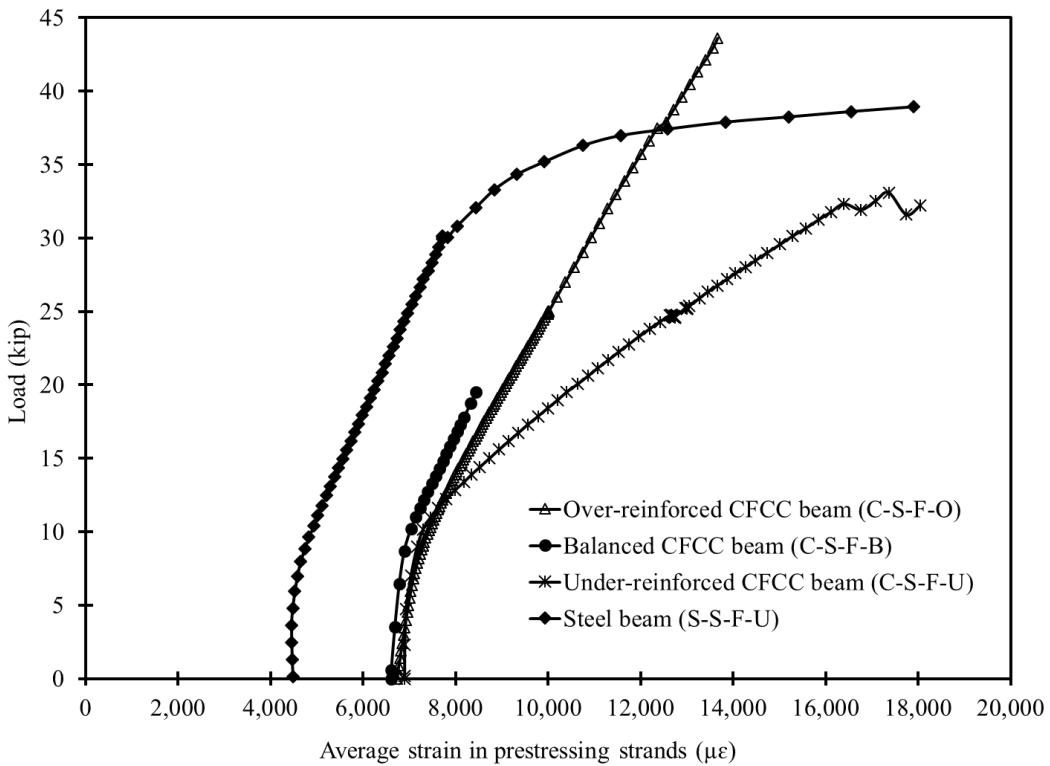
Figure 3.6-3 Load-prestressing-strain curves for control beams tested in flexure

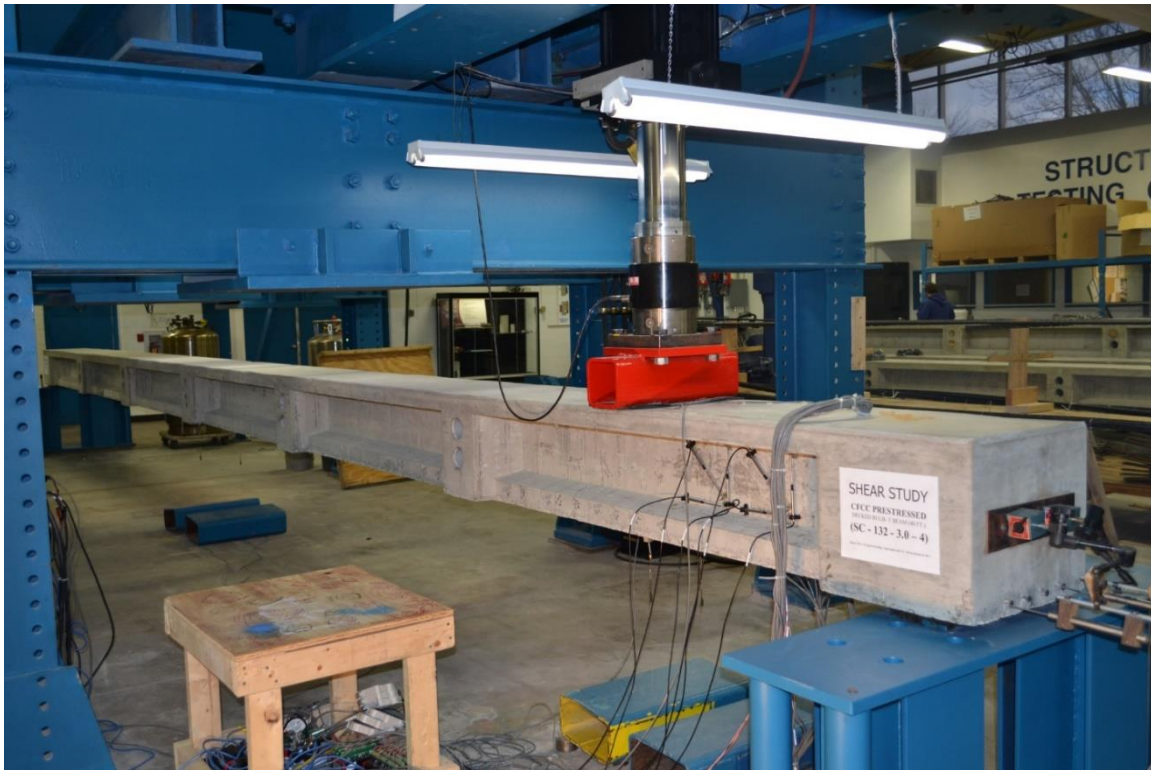
Figure 3.7-1 Test setup of Beam C-C-S-B

As shown in Figure 3.7-1, the load was applied near the end of the beam with an effective shear span of 45 in., which resulted in a shear-span-to-depth ratio of 3.0 and consequently promoted the shear failure in this control beam. To capture the shear loading mechanism and the shear failure mode, the beam was instrumented with multiple LVDTs to record the slippage of CFCC strands at the end of the beam as shown in Figure 3.7-2. The beam was also provided with a series of linear strain gages, rosette strain gages, and LVDTs through the shear span as shown in Figure 3.7-3 and Figure 3.7-4. In addition, strain gages were provided on the top flange near the loading point to record the strain in the concrete. LMTs were attached to the beam under the point of loading and under the mid-span section.

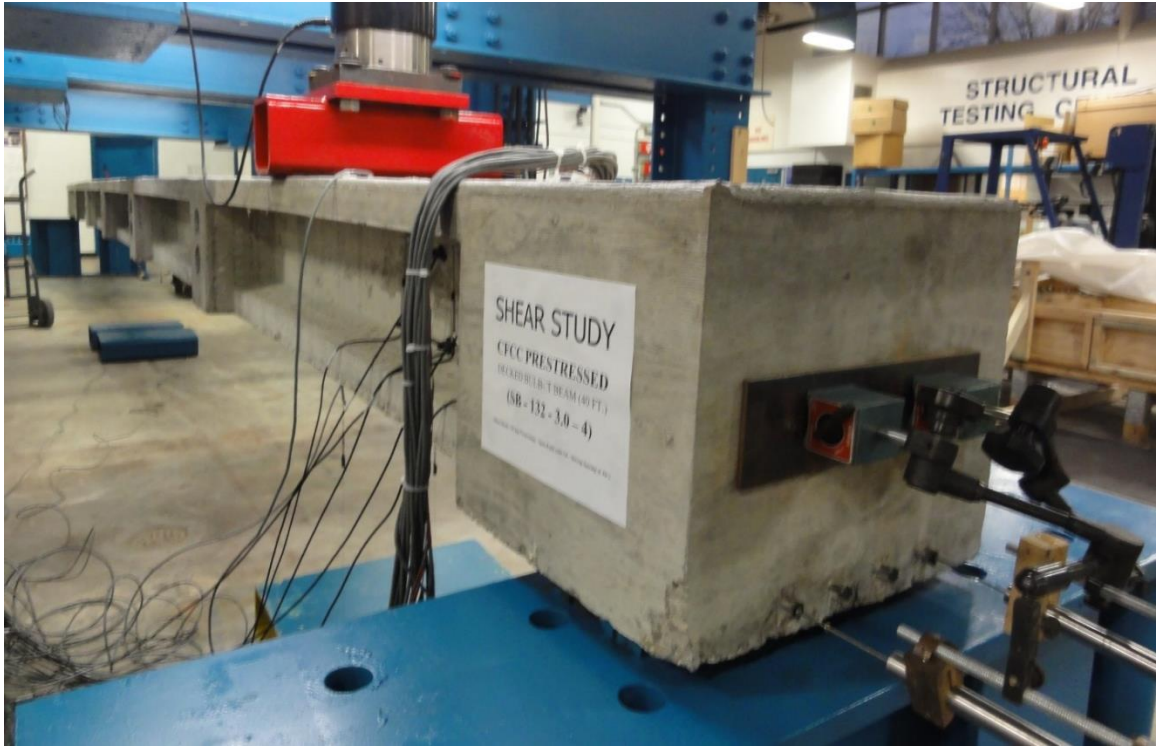
Figure 3.7-2 Monitoring slippage of prestressing CFCC strands using end LVDTs

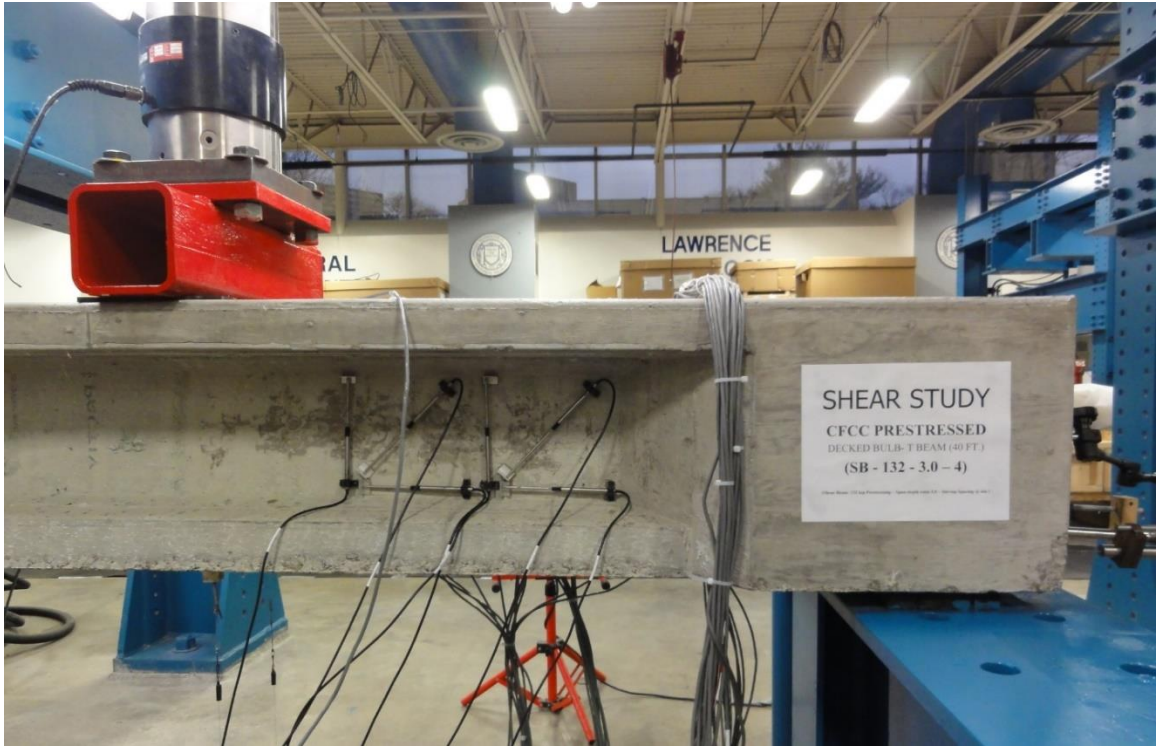
Figure 3.7-4 LVDTs at 0, 45, and 90° to evaluate shear cracking

On the other side of the beam, the LVDTs recorded significant relative displacements only after cracking. As the LVDTs crossed the shear cracks, the average crack width was determined by analyzing the readings from the LVDTs in three different directions 0, 45, and 90 degrees according to Shehata (2000).

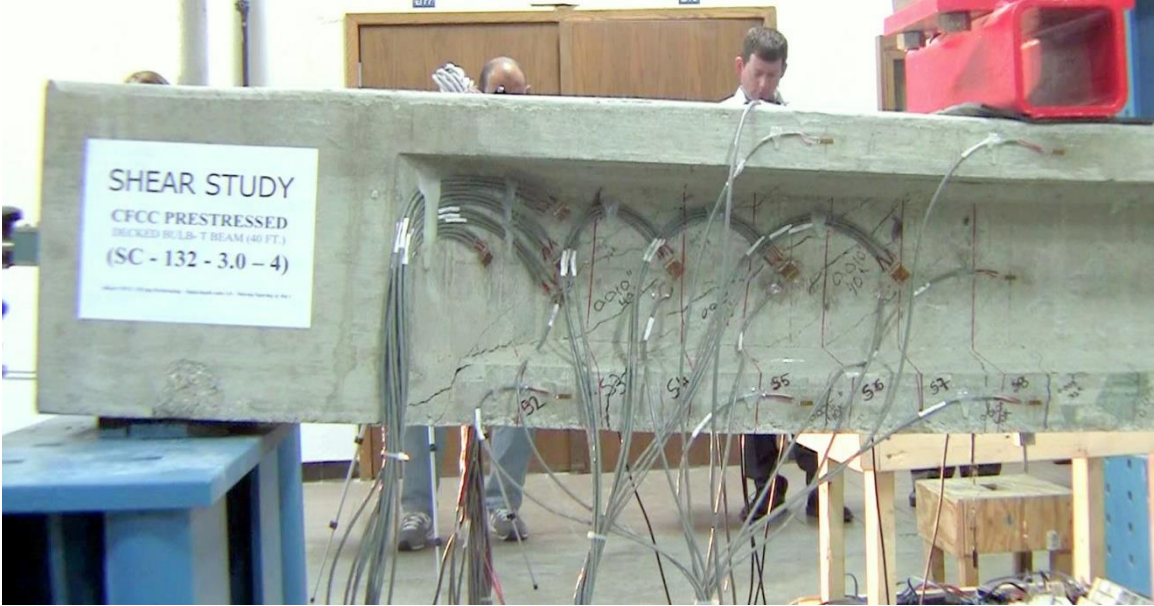
Figure 3.7-7 Development of main shear crack just before failure in Beam C-C-S-B

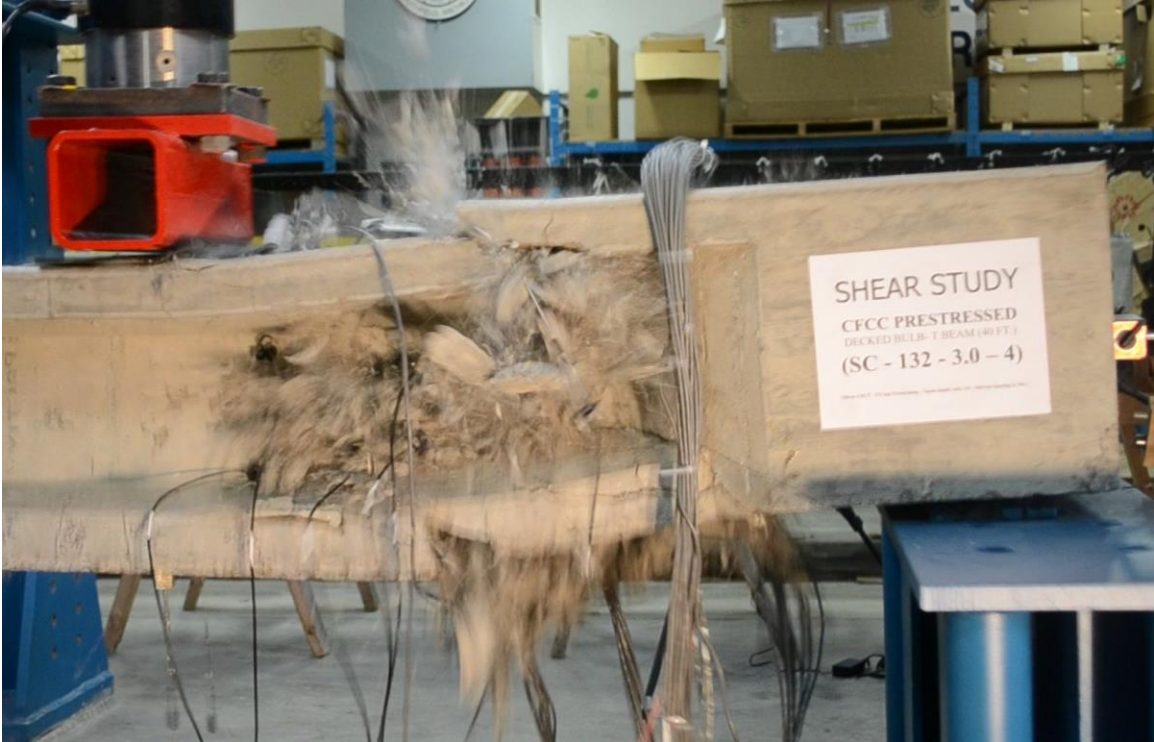
Figure 3.7-8 Explosive failure of Beam C-C-S-B

The failure of the beam took place at a shear force level of 41.24 kip. The failure was explosive in nature (Figure 3.7-8). The only warning sign was the development of a main diagonal shear crack extending from the support after the diaphragm and across the shear span to the loading point. The failure was characterized by the crushing of the concrete strut in the web and subsequently in the deck flange as shown in Figure 3.7-9. After failure, the stirrups were exposed and inspected for failure but no rupture of CFCC stirrups was observed (Figure 3.7-10).

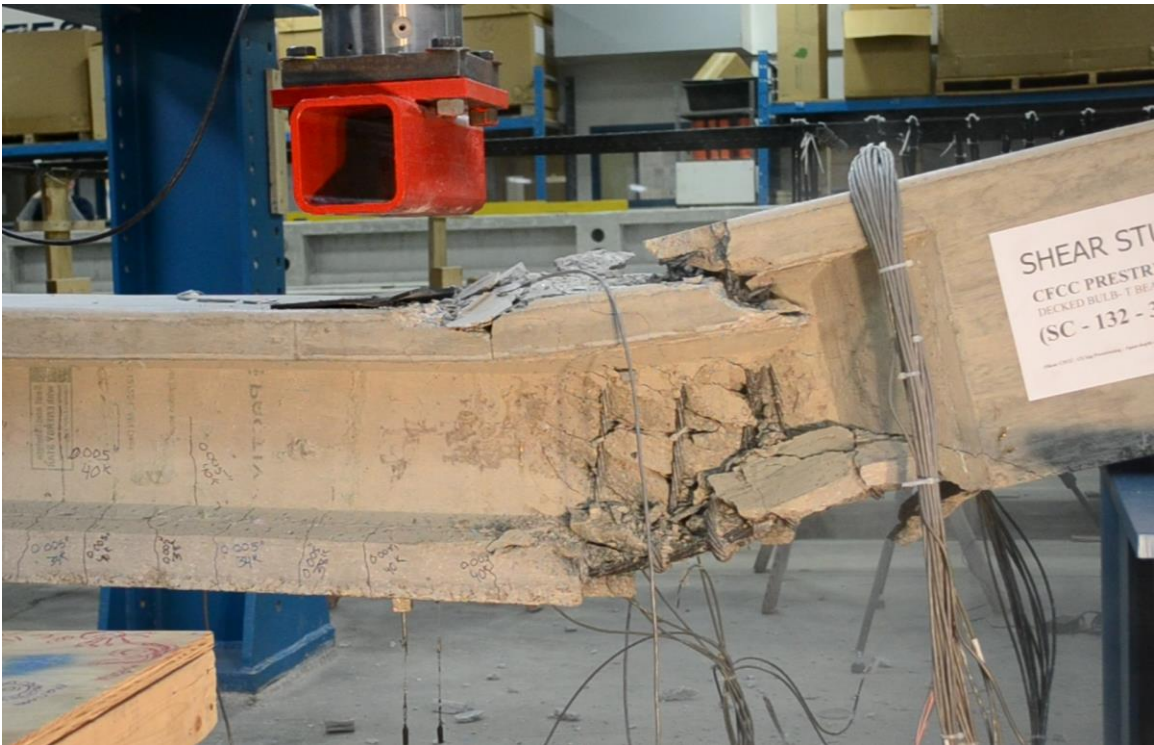
Figure 3.7-9 Beam C-C-S-B after failure

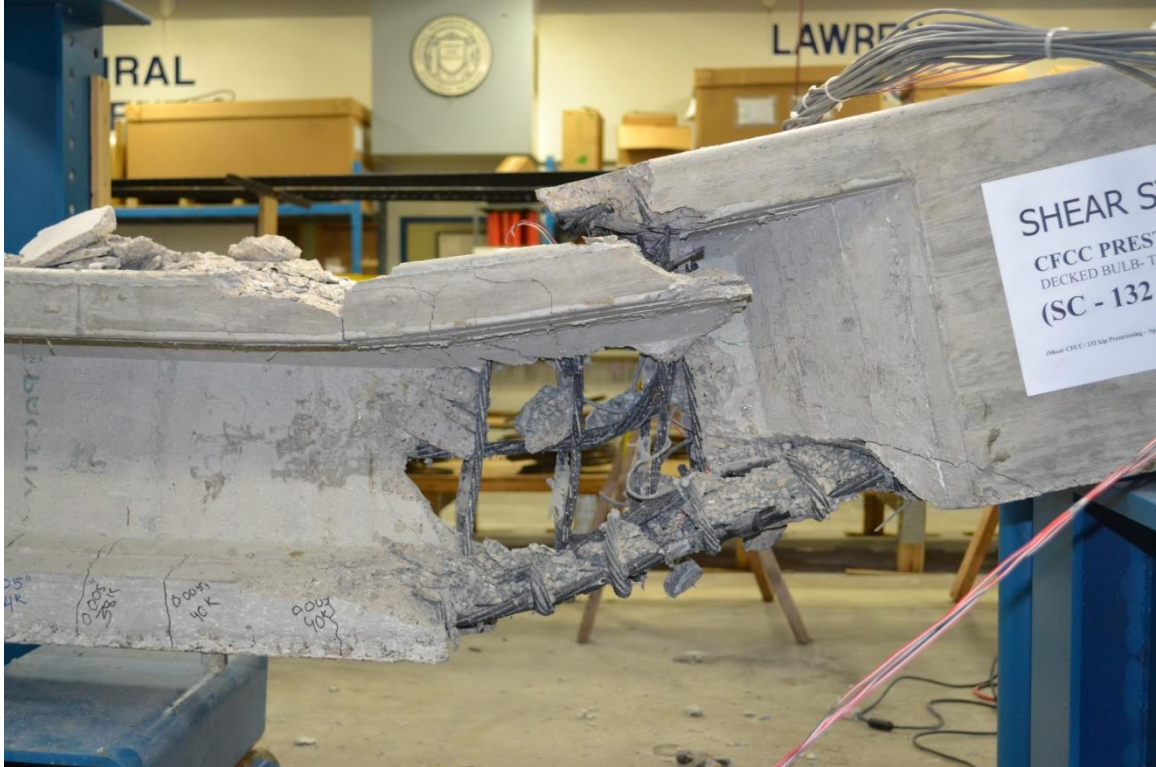
Figure 3.7-10 No rupture of CFCC stirrups was observed in Beam C-C-S-B

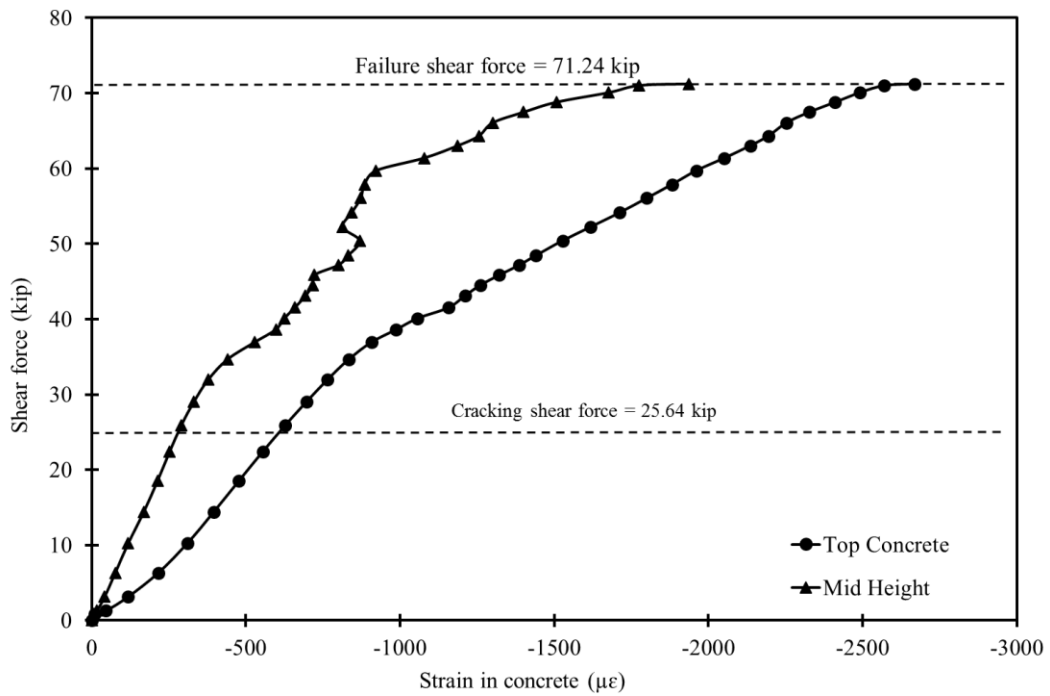
Figure 3.7-11 Recorded concrete strain under loading point of Beam C-C-S-B

As shown in Figure 3.7-11, the maximum recorded compressive concrete strain in the top flange under the load was approximately $2,668 \mu\epsilon$, while the maximum record strain in the web at 45° was approximately $1,935 \mu\epsilon$. On the other hand, the maximum deflection under load and at mid-span at failure was approximately 3.29 in. and 5.71 in., respectively. As shown in Figure 3.7-12, both deflection curves under load and at mid-span were bilinear curves with the decompression load marking the change of the slope between the two linear segments of each curve.

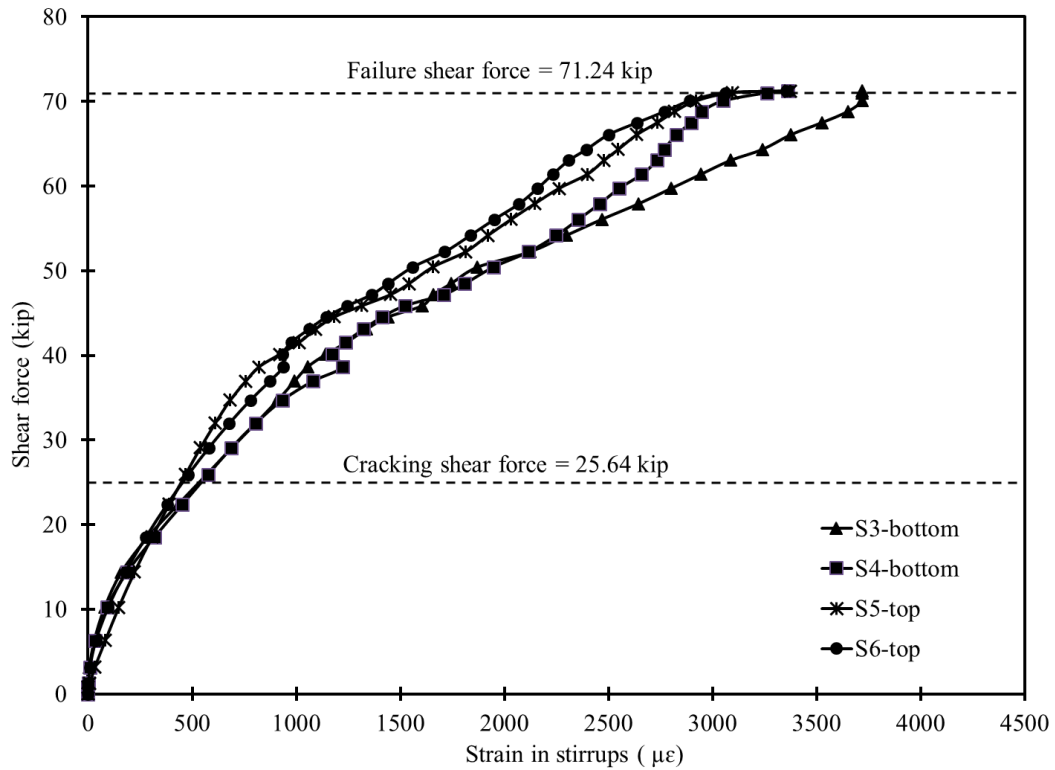
Figure 3.7-13 Shear force vs. stirrup strain in Beam C-C-S-B

Figure 3.7-13 shows the strain in selected stirrups during the ultimate load cycles. It should be noted that during initial load cycles, the strain in the stirrups was negligible until the development of first flexural crack. On crack development, stirrups intercepted by the crack showed a sudden increase in the strain, while stirrups not intercepted by cracks did not show any significant strain reading. The readings shown in Figure 3.7-13 represent the maximum recorded strain in stirrups as those stirrups were intercepted by shear cracks in previous load cycles. The maximum recorded strain in the stirrups at failure was that recorded by the bottom strain gage in S3 and was approximately $3,720 \mu\epsilon$. By looking at Figure 3.7-5, it can be seen that there was a major shear crack crossing near that particular strain gage and that shear crack developed to be the failure plane as shown in Figure 3.7-8 and Figure 3.7-9. Finally, Figure 3.7-14 shows the average shear crack width as calculated based on the readings from the LVDTs. The maximum recorded shear crack width was approximately 0.09 in. It should be noted that the maximum limit of the LVDTs was exceeded near failure and that was the reason for the constant crack width reading near the failure.

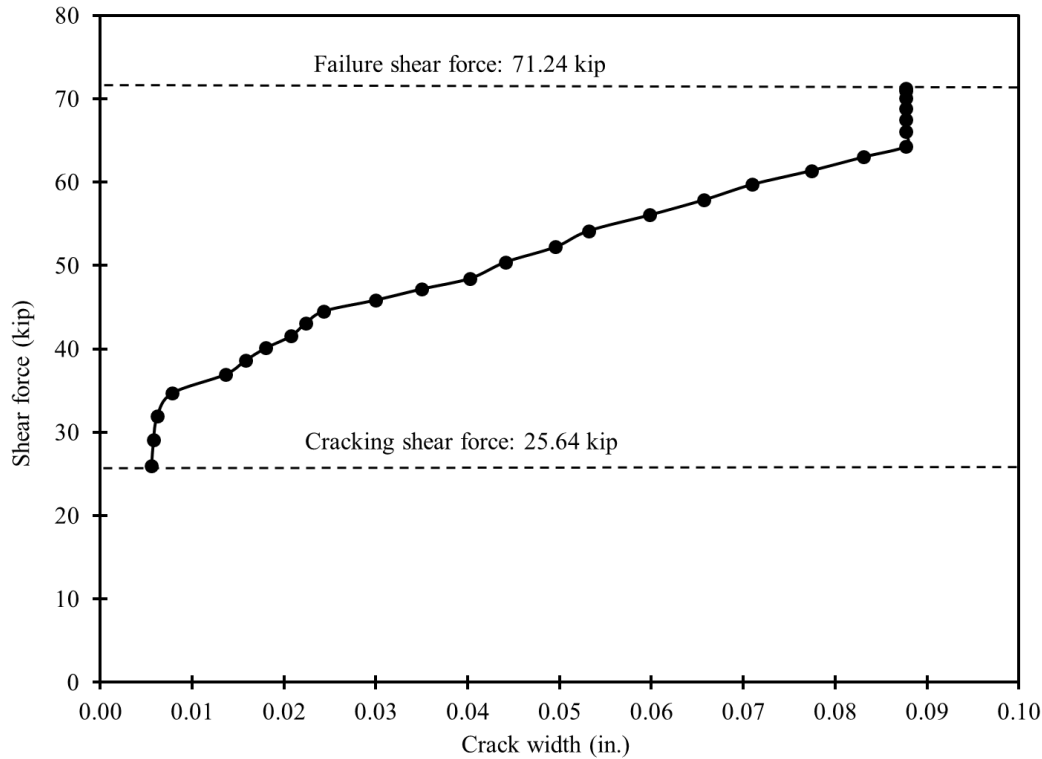
Figure 3.7-14 Shear force vs. calculated crack width in Beam C-C-S-B
