CHAPTER 3: TESTING & RESULTS

3.1 Introduction

This chapter presents the test methodology and the test results for the five control decked bulb T beams and the bridge model. The results are presented in the form of charts showing the relationship between the applied load and the response of the test specimens including deflection, strain of concrete, and strain in CFCC strands. In addition, for each test specimen, the ductility ratio was calculated to evaluate the failure mode analytically.

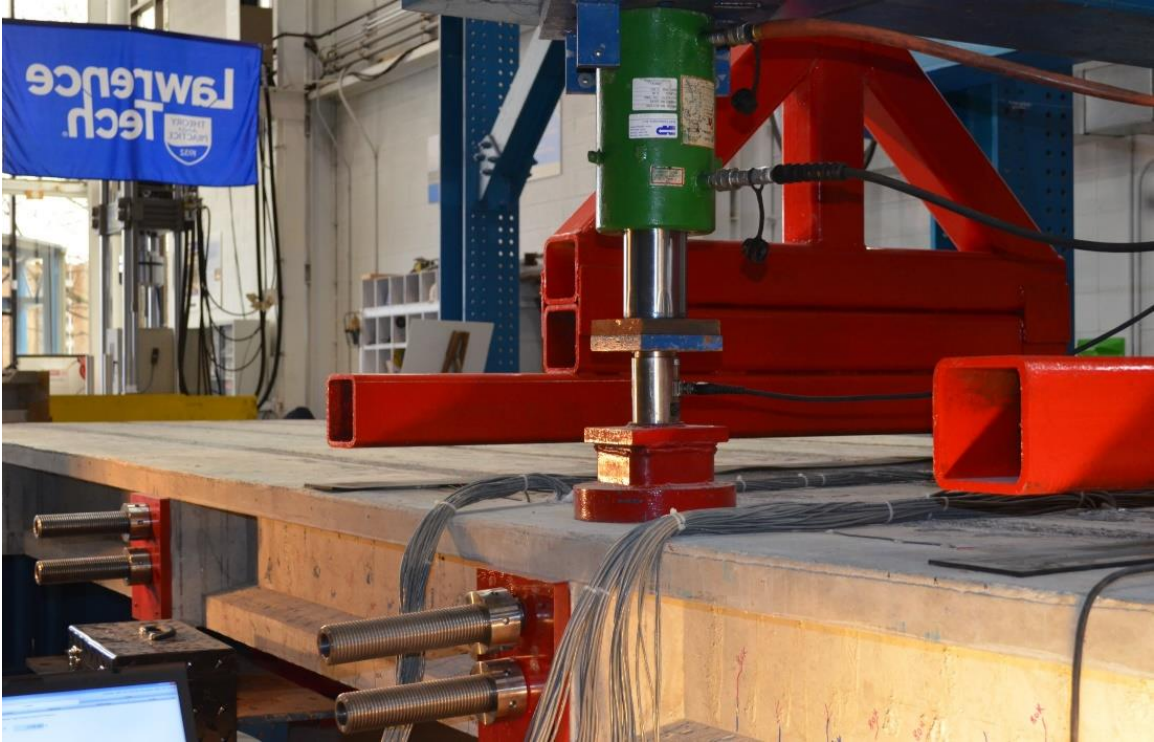
Figure 3.8-3 Service limit state testing of the bridge model

Figure 3.8-3 shows the test setup. The load was applied using a 200,000-lb hydraulic cylinder connected to a hydraulic pump. A load cell was provided to monitor the applied load and as shown in Figure 3.8-4, the load was applied first to the exterior beam followed by the interior beam, the intermediate beam, the second interior beam, and finally the second exterior beam. It should be noted that the response of the bridge model when the load was applied on one side was a mirror image to that when the load was applied on the opposite side. To avoid repetition, only the deflection curves obtained from loading one side (exterior, interior, and middle beams) are presented in the discussion.

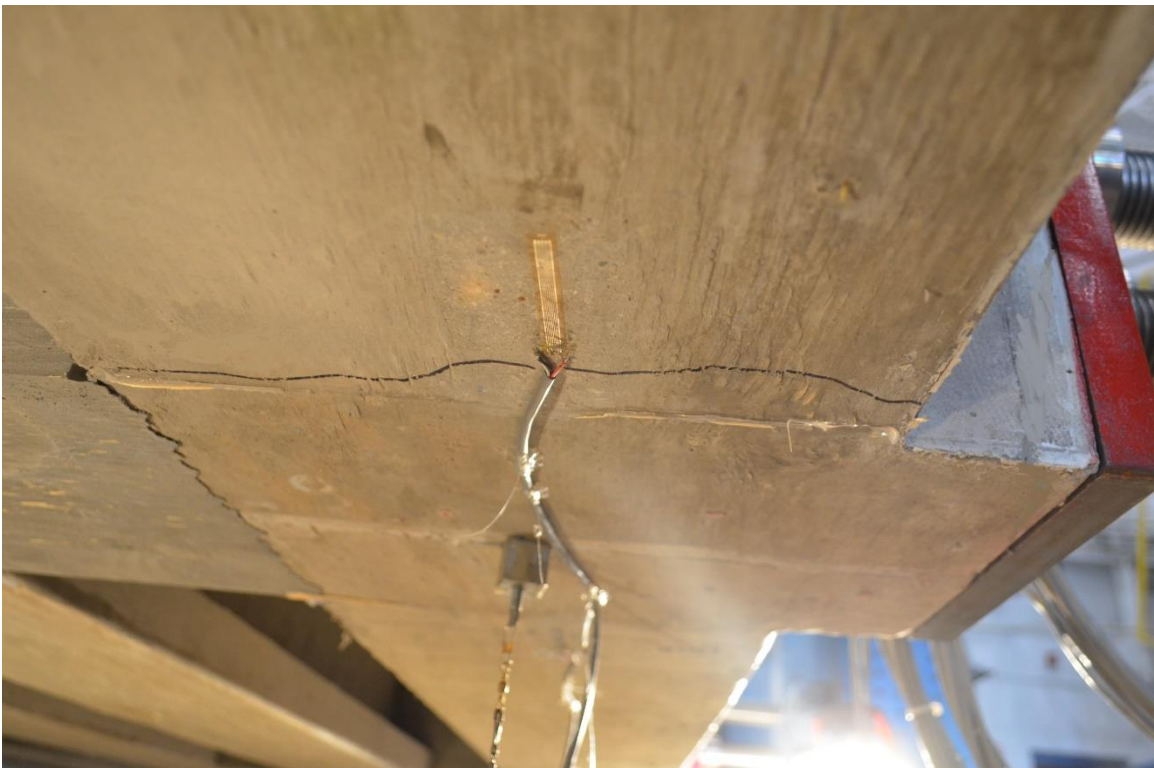
Figure 3.8-10 Development of first flexural crack in bridge model under four-point loading

Once the first flexural crack developed, a series of strain gages were attached to the soffit of the beams near the crack as shown in Figure 3.8-10. The reading from these strain gages were used later on to evaluate the decompression load of the bridge model and back calculate the effective prestressing force.

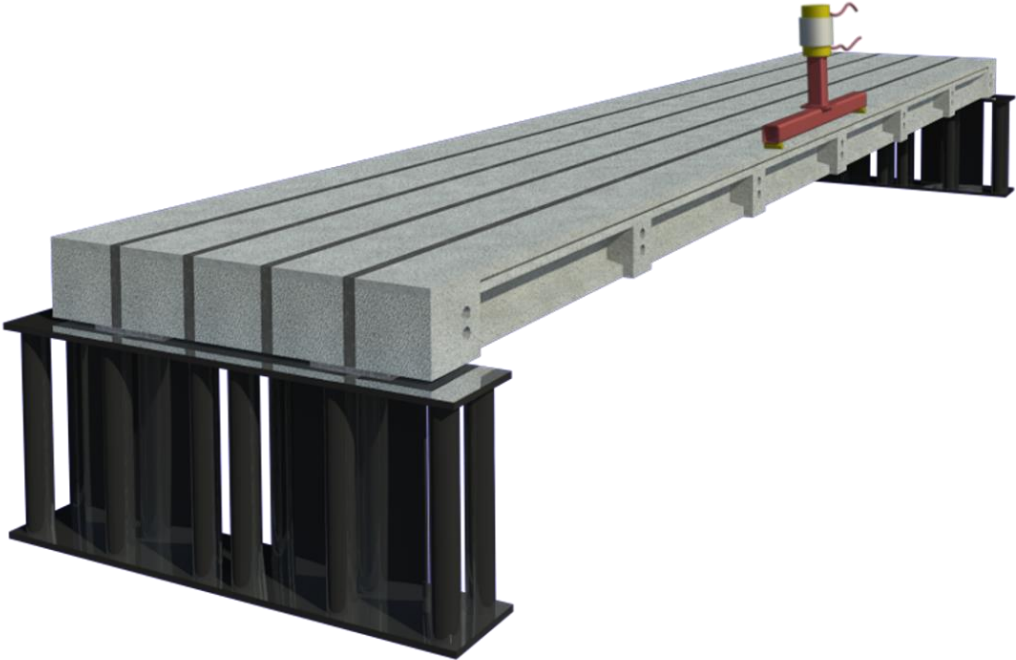
Figure 3.8-13 Schematic diagram showing testing of shear key joint

The testing scenario was developed to directly evaluate the performance of UHPC shear joints along with the transverse diaphragms. An exterior beam of the bridge model was loaded until localized shear key cracks were developed. As shown in Figure 3.8-13 and Figure 3.8-14, the exterior beam was loaded through a four-point loading setup with 78-in. distance between the two points of load. No TPT force was applied at any of the transverse diaphragms. The load was applied in cycles starting from 60 kip with an increment of 10 kip. The bridge model was inspected for cracks after each load cycle.

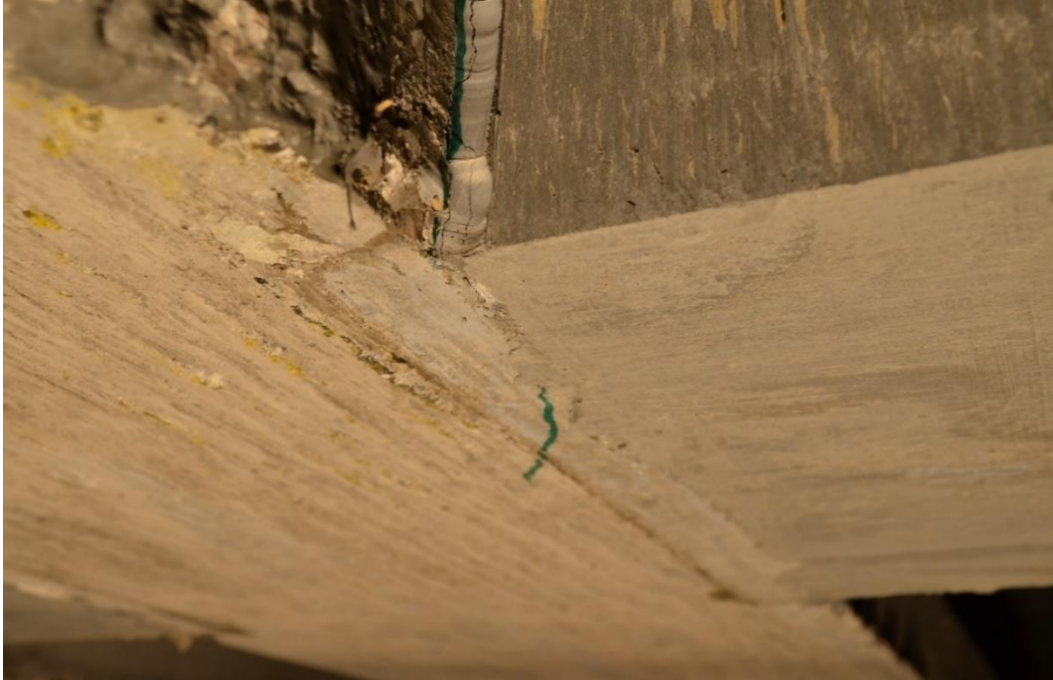
Figure 3.8-15 Bottom view of bridge model showing development of cracks at diaphragm

No cracks developed at a load level of 70 kip. At a load level of 80 kip, minor cracks developed around the three intermediate diaphragms in addition to a limited hairline crack at the shear key joint near the applied load as shown in Figure 3.8-15 through Figure 3.8-17. All cracks developed on the concrete side of the joint and not on the UHPC side. In addition, when the load increased to 90 kip, the cracks seemed to slightly propagate.

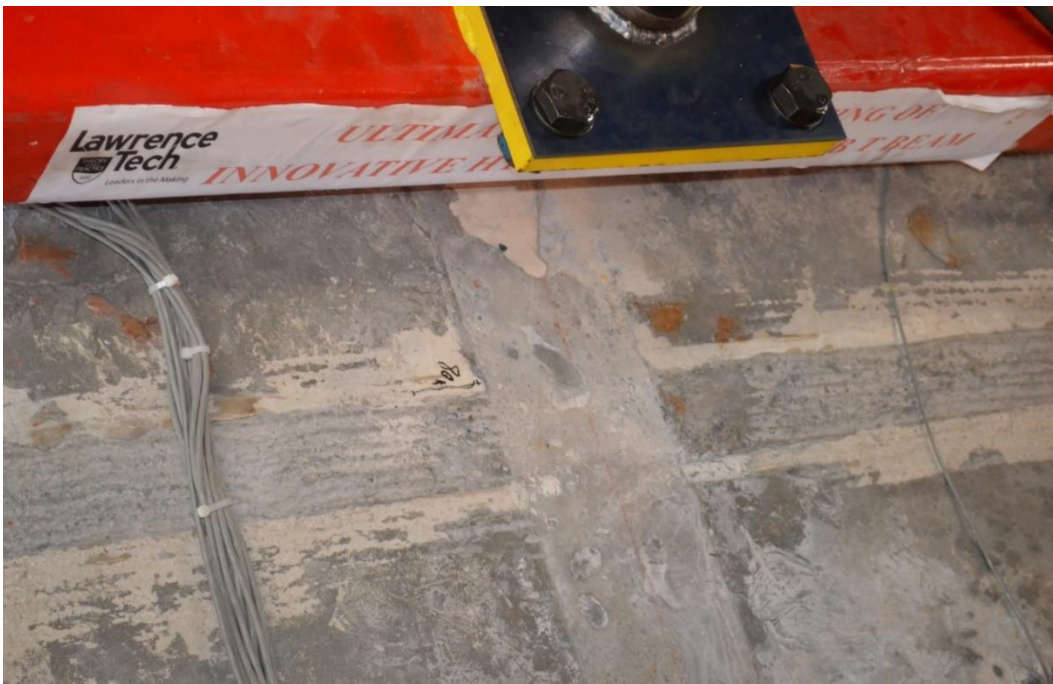
Figure 3.8-16 Localized shear key cracks at load level of 80 kip

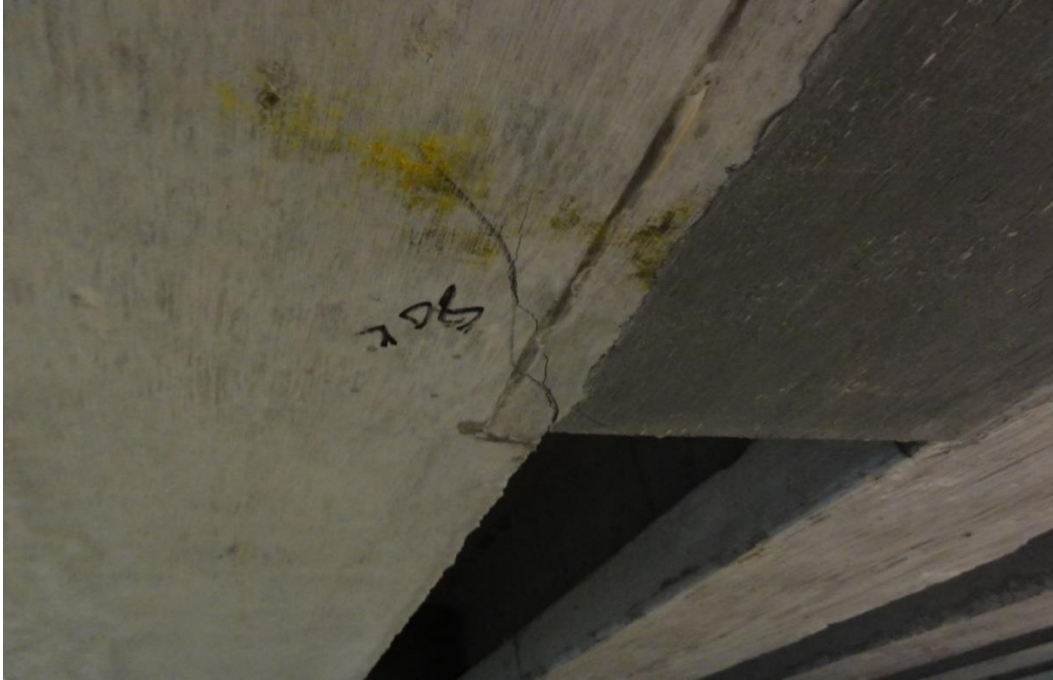
Figure 3.8-17 Cracks under a load of 80 kip near intermediate diaphragm

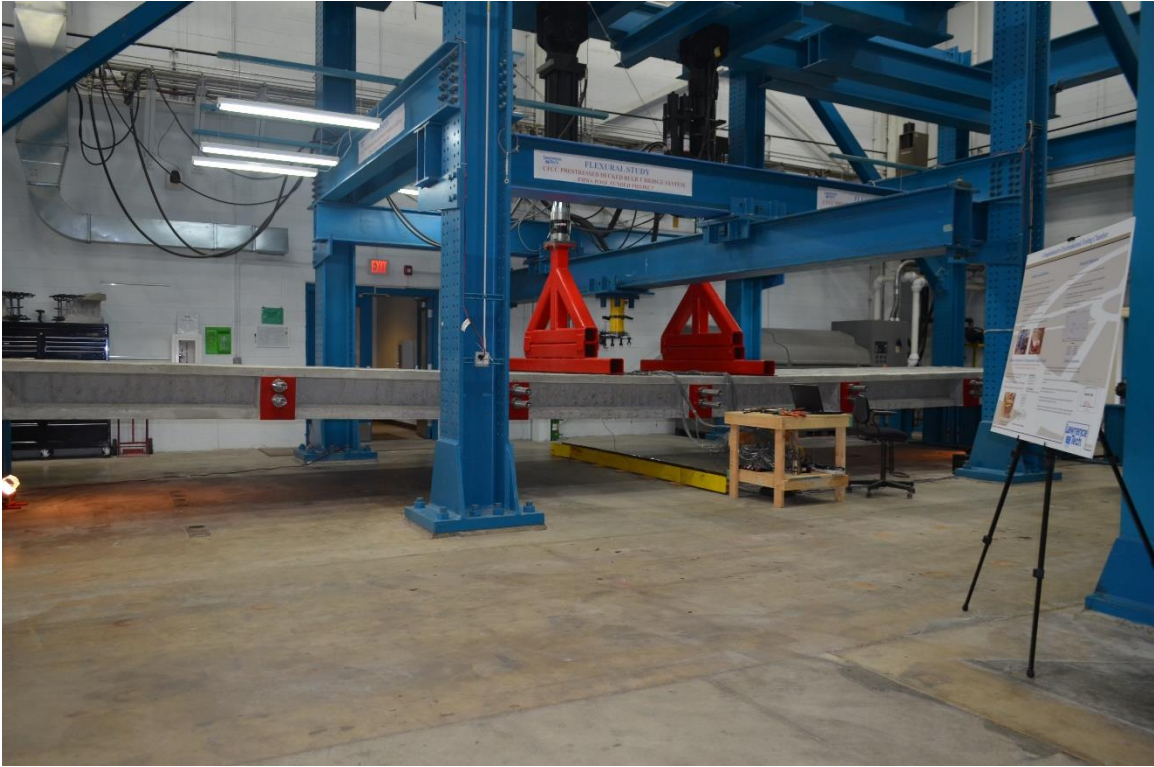
Figure 3.8-19 Load cycle test of bridge model

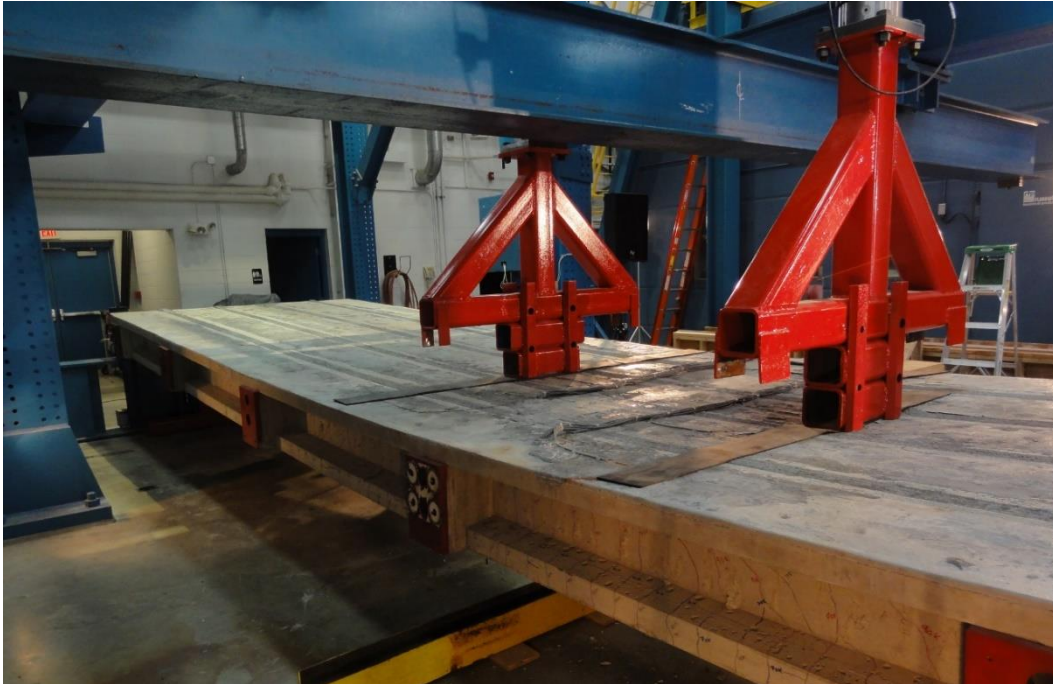
Figure 3.8-23 Four-point loading of intermediate beam at strength limit state testing

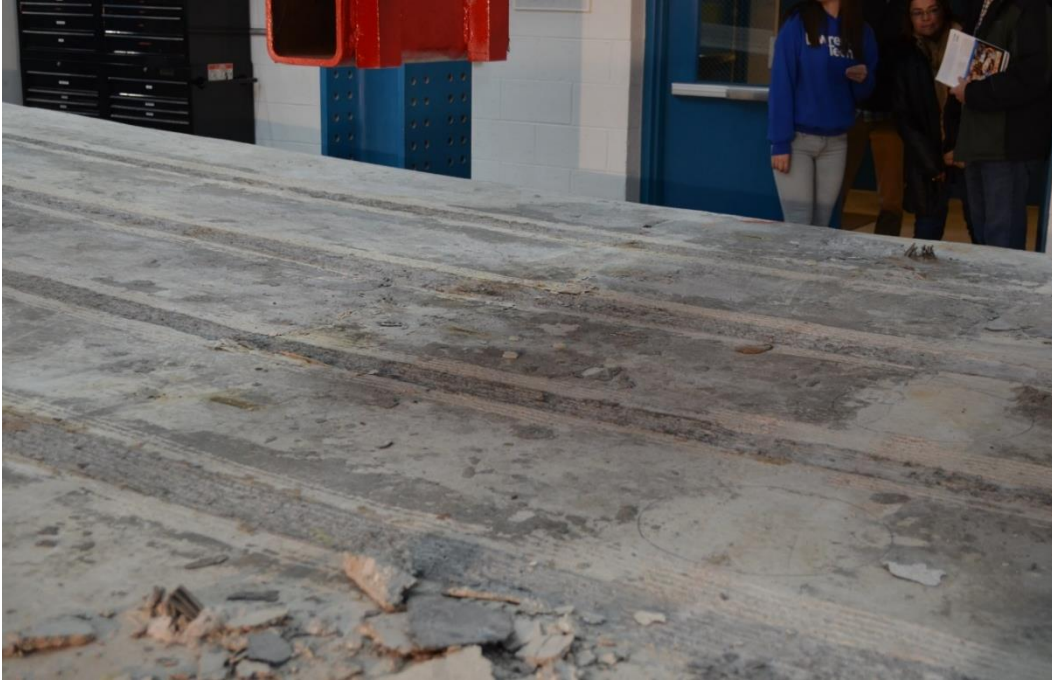
Figure 3.8-27 Partial concrete crushing in top flange after failure

The bridge model achieved a load level of 220 kip with a corresponding deflection of 18.14 in. With further increasing the load, a popping sound corresponding to rupture of CFCC strands was heard. With every strand rupture, spalling of concrete and sudden drop in the load were observed. Initially, the concrete in the top flange did not show any signs of crushing but after the rupture of a few CFCC strands, signs of partial concrete crushing at the exterior beam were observed (Figure 3.8-26 and Figure 3.8-27).

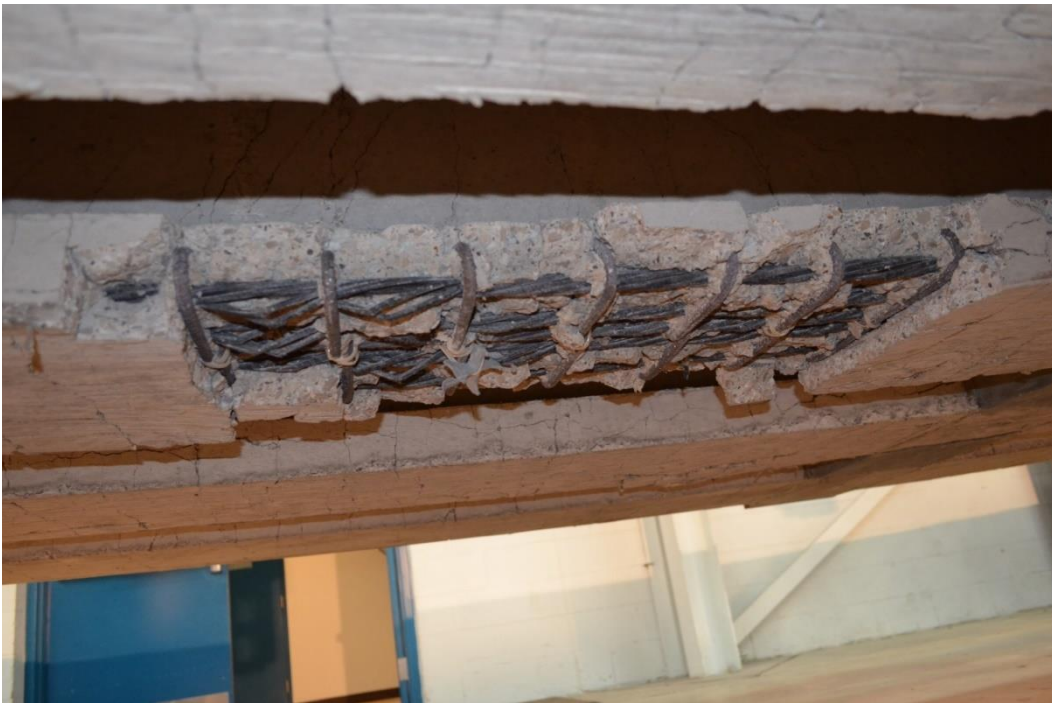
Figure 3.8-28 Spalling of concrete from bottom of loaded intermediate beam at failure

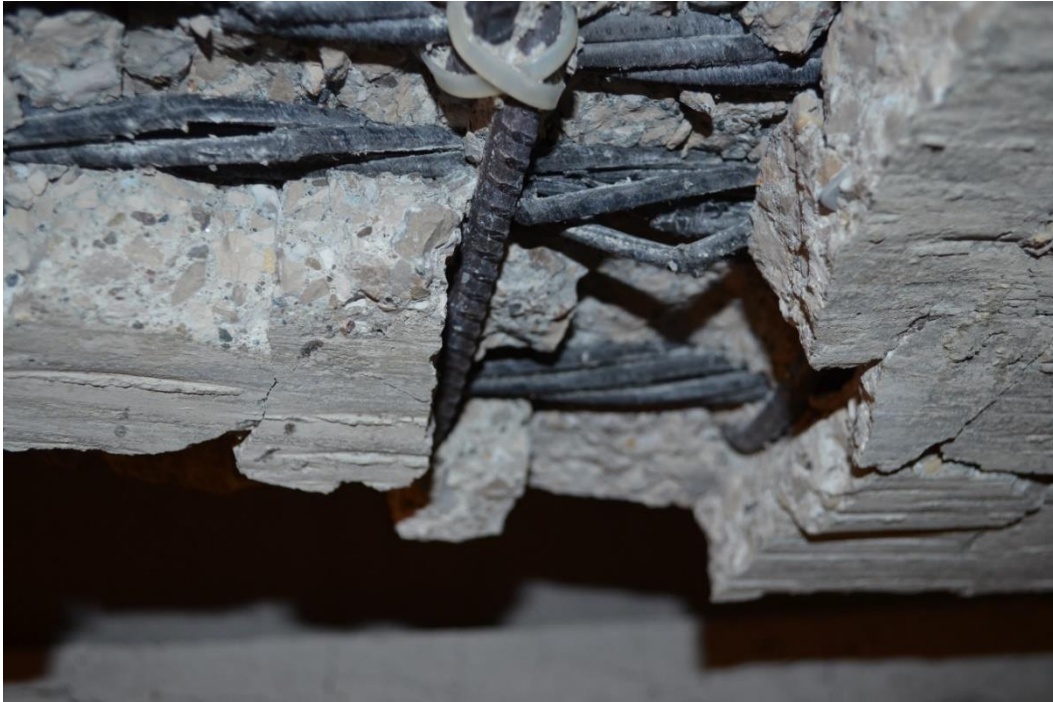
Figure 3.8-29 Rupture of prestressing CFCC strands in bridge model in intermediate beam

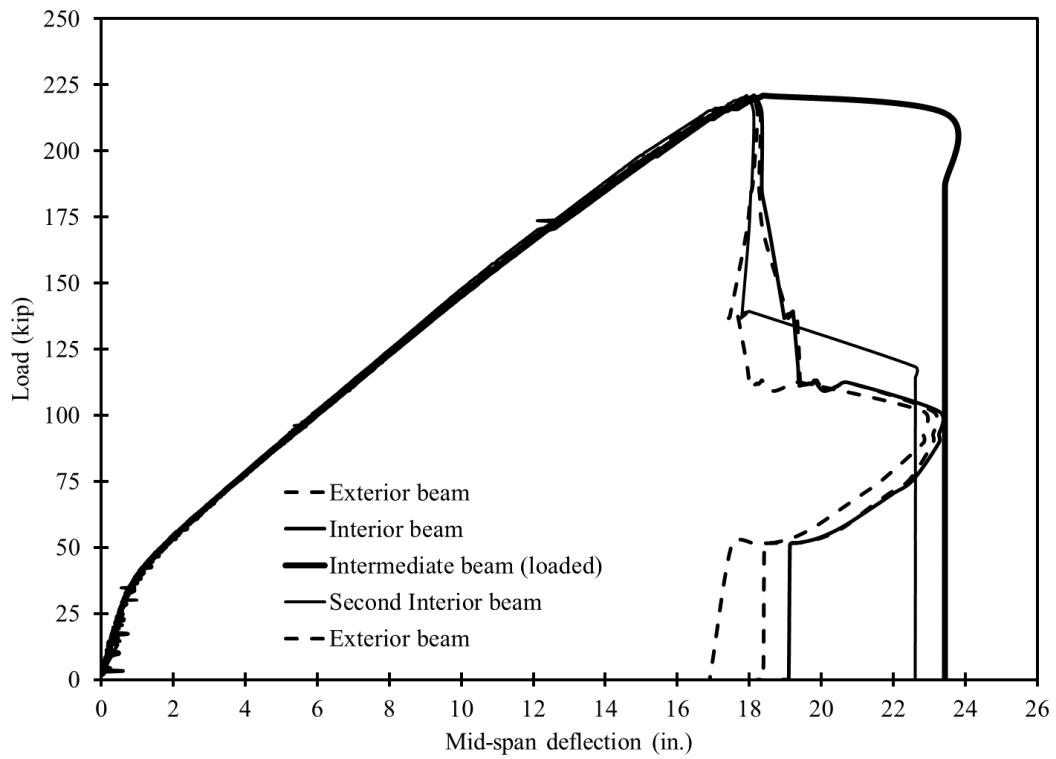
Figure 3.8-30 Load-deflection curves for all beams during ultimate load cycle

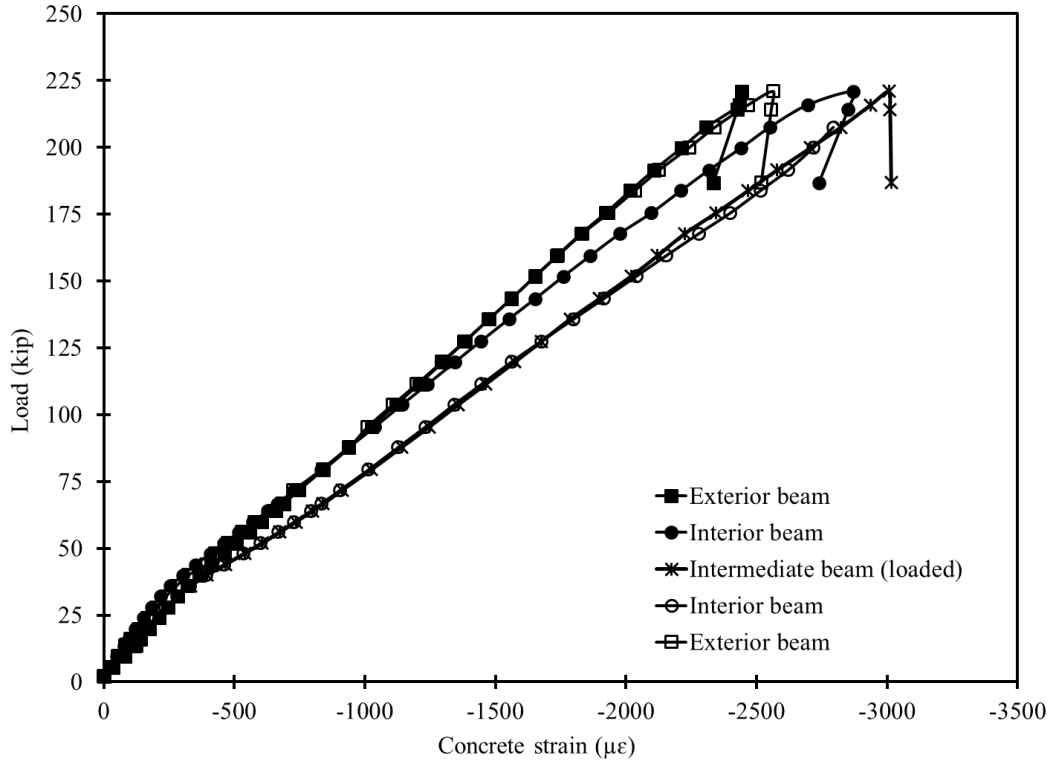
Figure 3.8-31 Load vs. average beam concrete strain during ultimate load cycle
