# Structural Characterization of UHPC Waffle Bridge Deck and Connections

**Final Report**  
**July 2014**

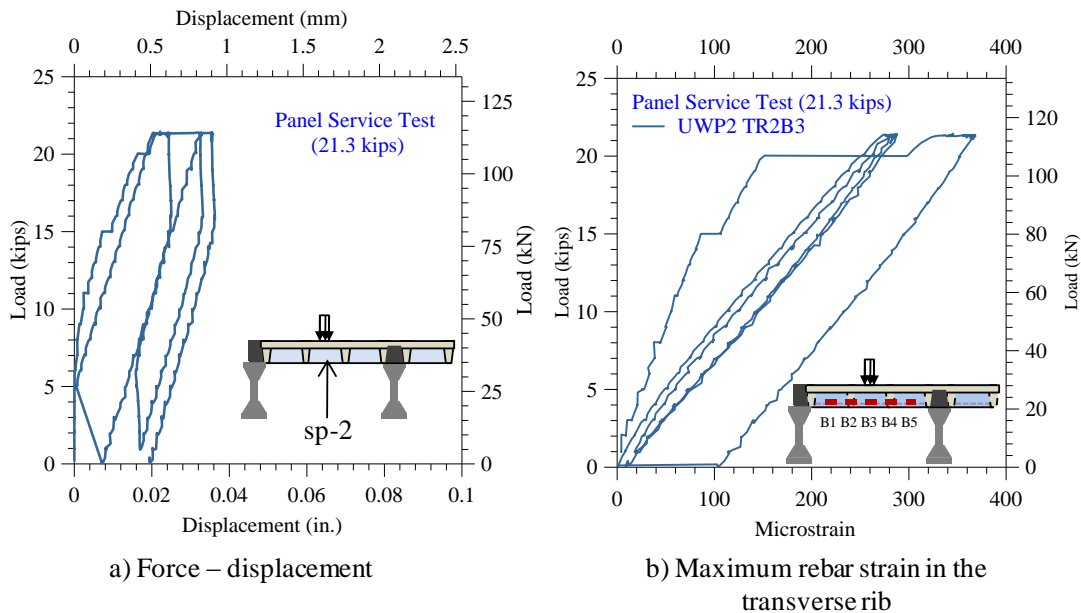
The peak recorded strain in the bottom reinforcement of the center rib running in the transverse direction is shown in Figure 2.16b, which reached a maximum strain of only  $375 \mu\epsilon$ , or 18% of the yield strain. The strain variations along the length of the bottom reinforcement in the transverse rib TR2 of panel UWP2 and the panel-to-panel joint are shown in Figure 2.17 and Figure 2.18, respectively. The maximum tensile strain in the joint reinforcement was  $40 \mu\epsilon$ , indicating no damage to the joint region. A single crack having a width less than 0.002 inch was observed on the transverse rib under the load and is identified in Figure 2.19. In comparison to traditional normal concrete, it is important to realize that the material behavior of UHPC is quite dependent on the crack width. Hence, it may not be appropriate to use the AASHTO crack width provisions to qualify the serviceability and durability considerations for the behavior of UHPC structural members. Because of the lack of any specific UHPC bridge design serviceability criteria available in the literature, the crack width limits suggested for UHPC to control the fiber pullout criteria are used to comment on the implication of the crack developed in this test. Based on the AFGC 2002 recommendations, the fiber pullout and strength degradation in UHPC initiate when a crack width reaches 0.0118 in. (0.3 mm) (see Figure 2.20). This limit is nearly more than six times the observed crack width during the service test, confirming that the overall behavior of the precast waffle deck system was outstanding. In addition, it is noted that the test results also confirmed that the system performance satisfied the deflection and crack width requirements recommended for the serviceability condition by AASHTO (AASHTO 2007).

**Figure 2.16. Measured force-displacement response and peak rebar strain from gauge B3 at the center of the transverse rib TR2 of panel UWP2**

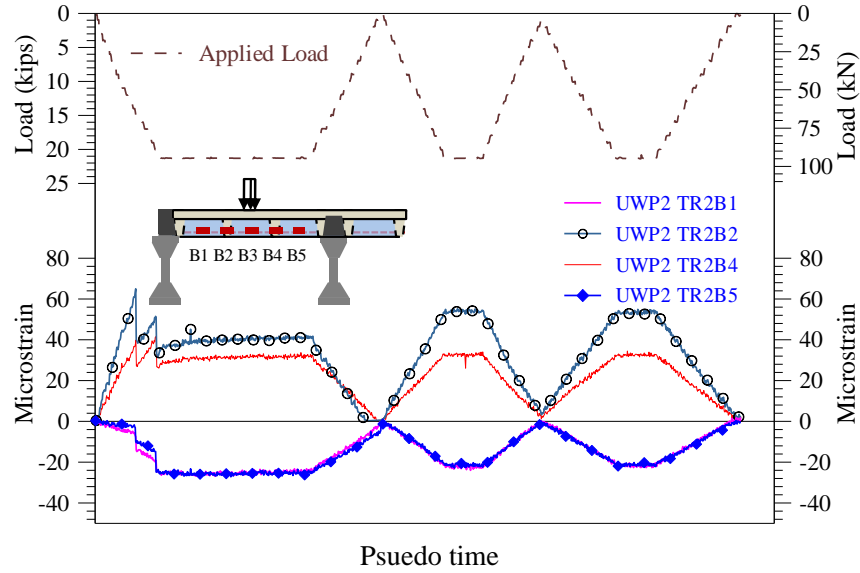
**Figure 2.17. Measured strains along the bottom reinforcement of the transverse rib TR2 of panel UWP2**

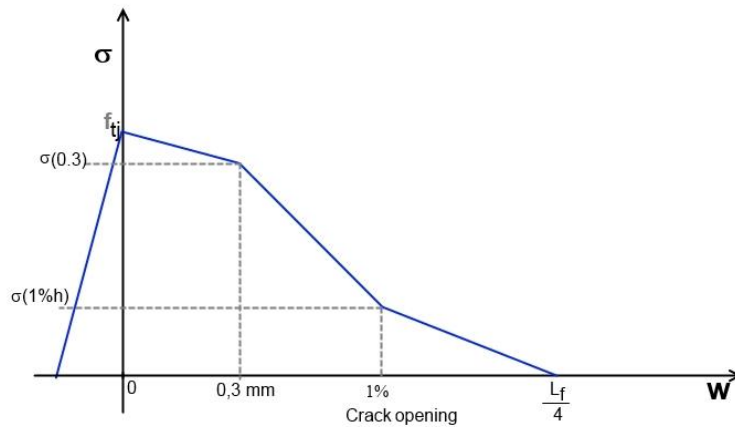
**Figure 2.20. A relationship proposed for the UHPC tensile strength variation as a function of crack width (AFGC 2002)**

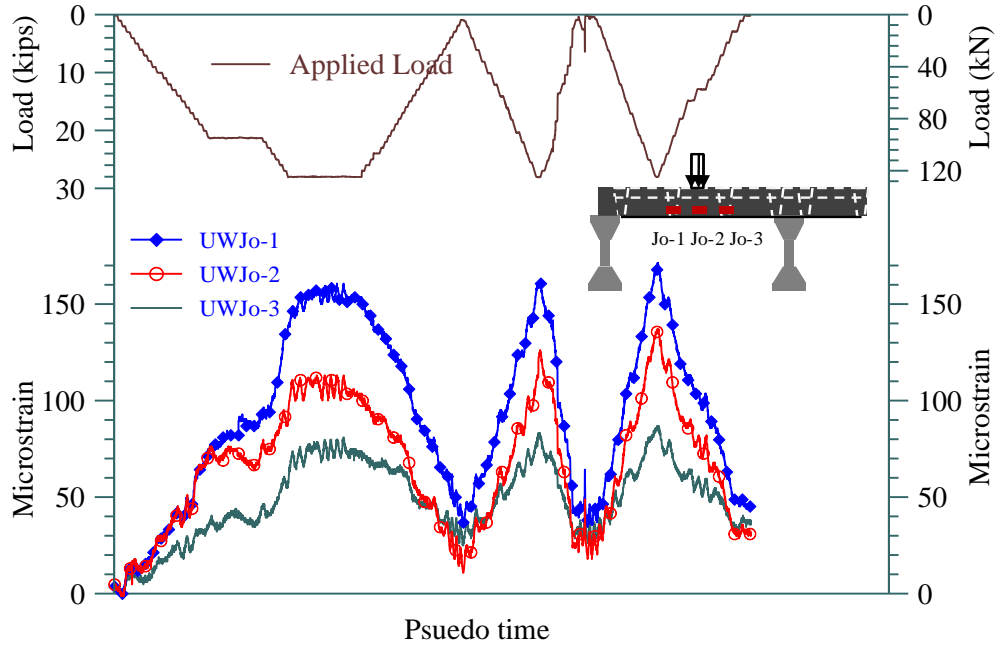
**Figure 2.22. Measured strains along the bottom reinforcement of the joint during the service load test**

The load vs. strain plot for the gauge recorded for the maximum strains and the strain variation along a bottom reinforcement in the joint are shown in Figure 2.21b and Figure 2.22, respectively. The peak recorded strain in the joint bottom reinforcement was  $17 \mu\epsilon$ , indicating significant reserve capacity of the joint. The strain variations obtained for the bottom reinforcement in the transverse rib TR2 of panels UWP2 and UWP1 are shown in Figure 2.23 and Figure 2.24, respectively. Both figures show comparable strain demands, indicating that the applied joint load was evenly distributed to both panels. Figure 2.25 shows the variation of strains at the center of the rib across the transverse ribs of panel 1, indicating their relative contribution. No cracking was observed at 21.3 kips load. At the peak load of 28 kips, however, a single hairline crack having width less than 0.002 inch was observed on the transverse ribs forming the joint (see Figure 2.26). Given that this crack is significantly smaller than 0.0118 in. (0.3 mm) (see Figure 2.20) corresponding to initiation of fiber pullout and strength degradation of UHPC in tension, it was concluded that the overall behavior of the transverse joint subjected to service load was outstanding. The test results also indicated that the system performance satisfied the deflection and crack width requirements recommended for the serviceability condition by AASHTO (AASHTO 2007).

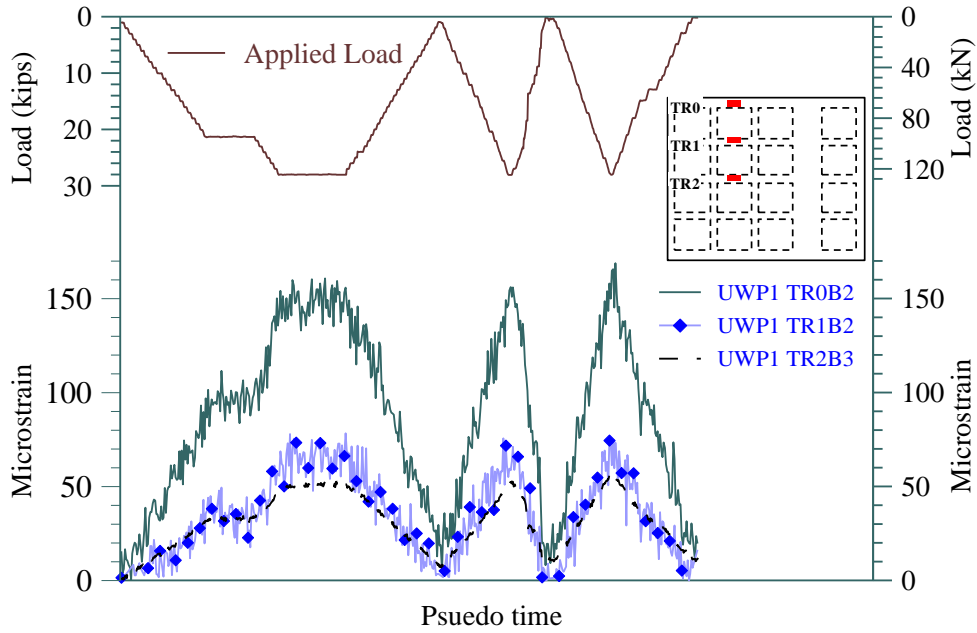
**Figure 2.25. Measured strains at the center of the panel across the transverse ribs of UWP1 at service load**

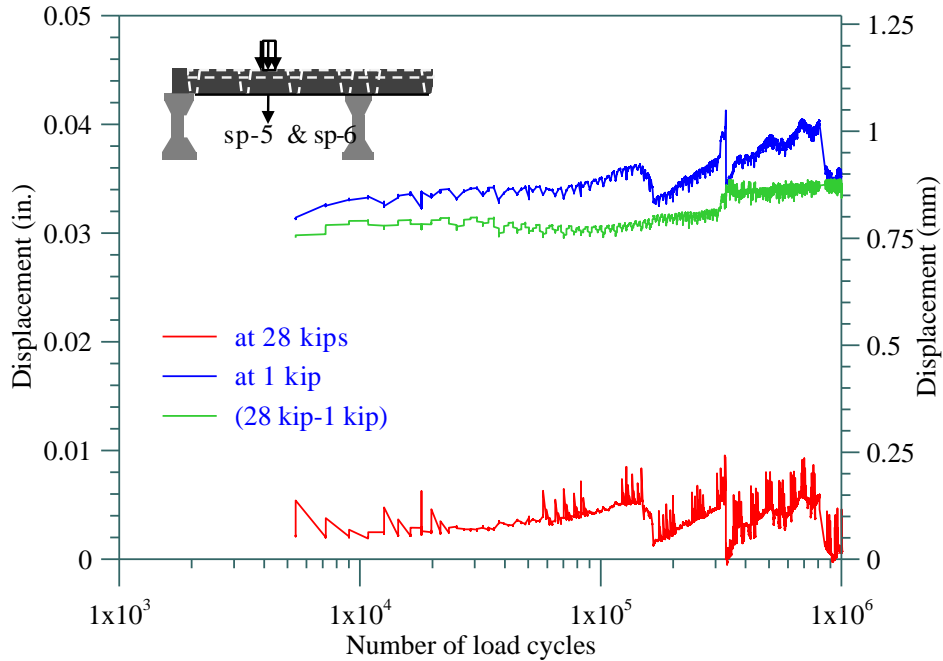
Based on the recorded data, the displacements recorded at the center of the joint at 28 kips and 1 kip are plotted as a function of the load cycle during the fatigue loading in Figure 2.27. It is apparent that the gauge data experienced drift due to ambient condition and other reasons during the test. When the displacement corresponding to the load increment of 27 kips (i.e., 28 kips–1 kip) was examined, however, it was clear that this displacement remained almost constant throughout the test and the change in the displacement reading is largely due to noise observed at 1 kip. With the variation of the displacement being very small and limitations with the sensitivity of the string potentiometers occurring, it is concluded that the UHPC did not experience any fatigue damage.

**Figure 2.27. The variation of the peak displacement at the center of the joint during the joint fatigue test**

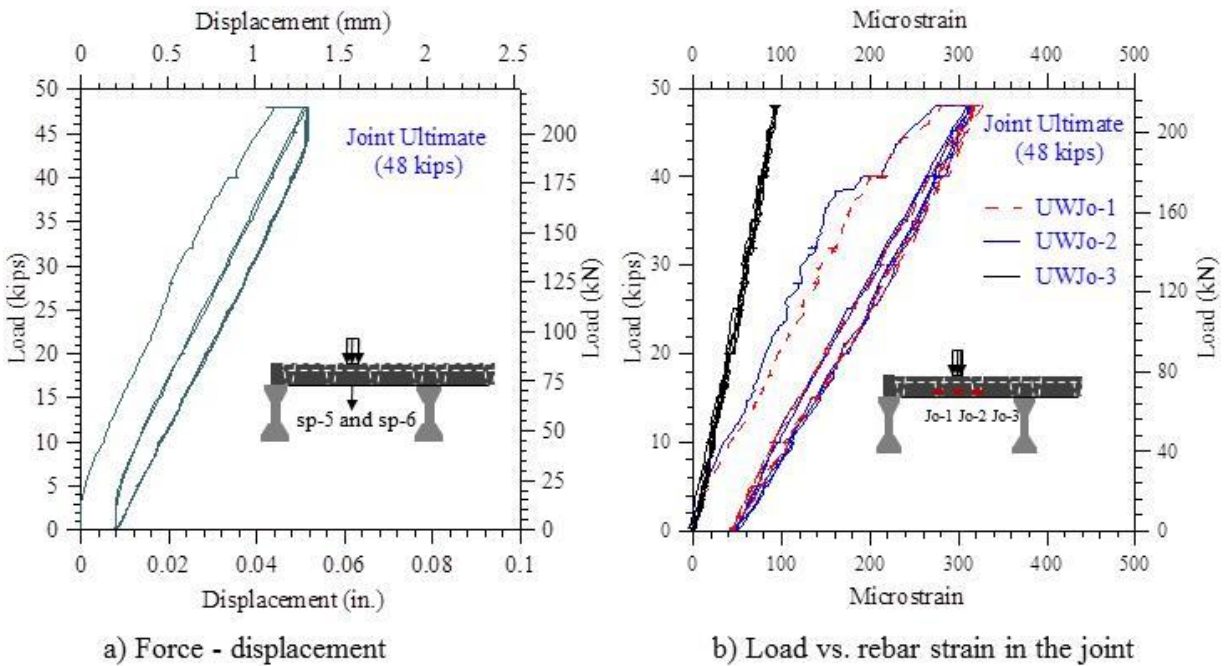
test was defined as 48 kips. Similar to the service load test, the joint was subjected to three load cycles at this load level to ensure the stability of the force-displacement response of the system. The load-deflection curve established at the center of the joint for this test is shown in Figure 2.31a. The transverse joint exhibited a linear force-displacement response even for this test, with insignificant damage and a maximum deflection of 0.05 inch. This deflection corresponds to  $L/1760$ , which is 46% of the AASHTO serviceability limit of  $L/800$  (see Section 9.5.2 in AASHTO [2007]) for continuous span bridges with pedestrian traffic.

**Figure 2.31. Measured force-displacement response and peak rebar strain at the center of the joint at the overload load of 48 kips**

The strain variations along the bottom reinforcement in the joint as a function of the applied load are shown in Figure 2.31b. The peak strain in the joint region bottom reinforcement was  $330 \mu\epsilon$ , which is only about 15% of the yield strain of the reinforcement. The strain variations in the bottom reinforcement in the transverse rib TR2 of the panels UWP2 and UWP1 are shown in Figure 2.32 and Figure 2.33, respectively. Figure 2.34 shows the variation of the strain at the center of the rib across the transverse ribs of panel UWP1, indicating their relative participation in resisting the load. A series of hairline cracks were observed in the central region of the joint and are shown in Figure 2.35. The maximum crack width measured along the transverse ribs forming the joint was 0.003 inch, which can be seen in Figure 2.36.

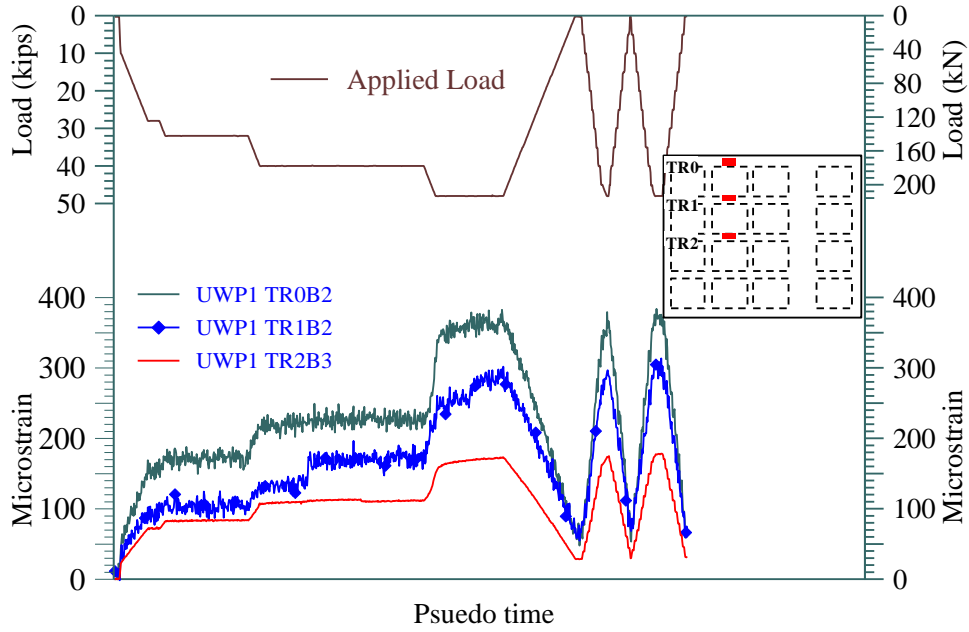
**Figure 2.34. Measured strains at the center of the panel across the transverse ribs of panel UWP1 at joint overload load**

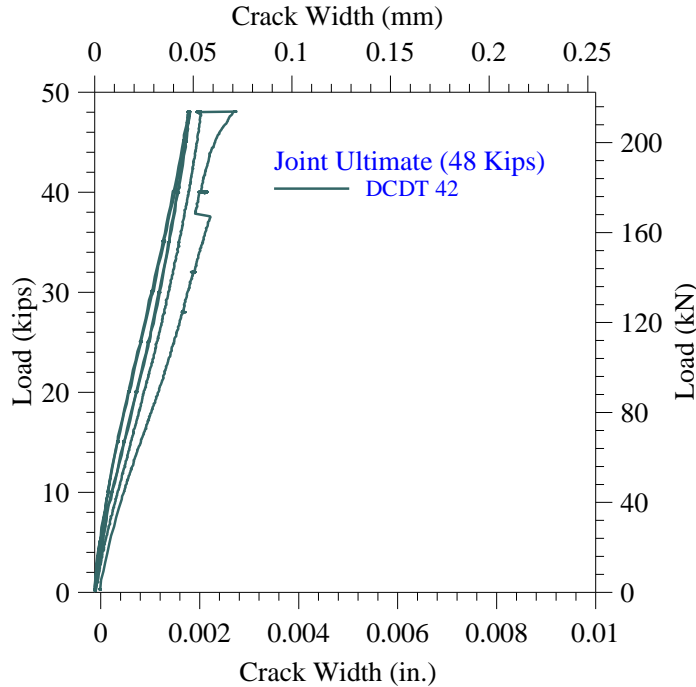
**Figure 2.36. The variation in the width of the most critical flexural crack in the transverse ribs forming the transverse joint**

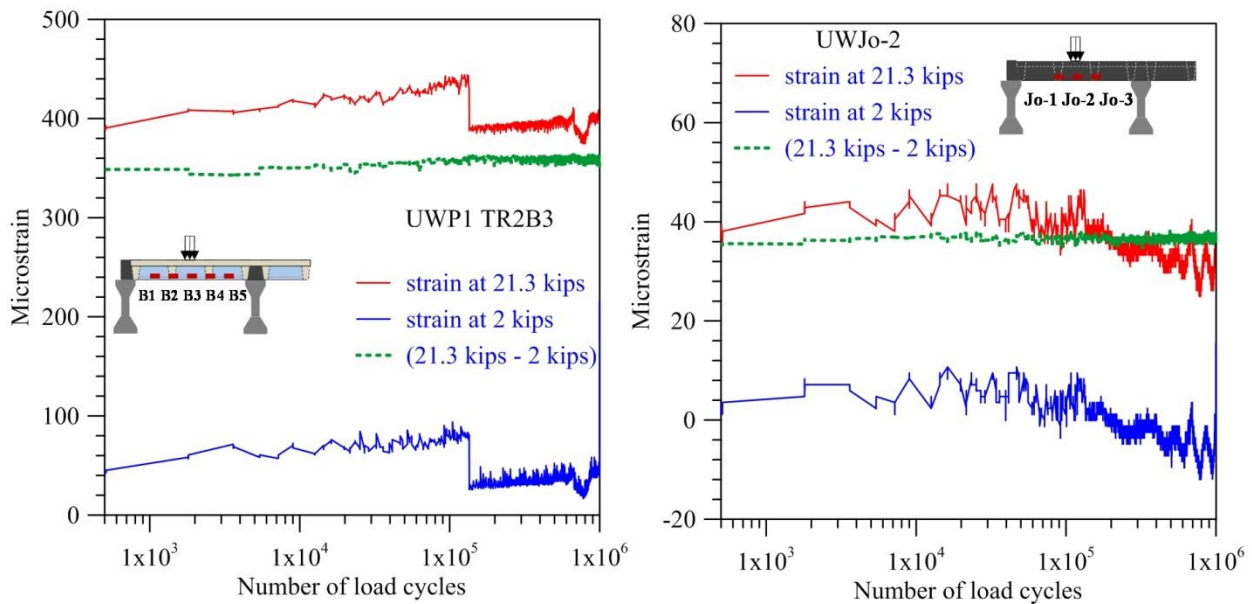
a) Peak rebar strain in the transverse rib      b) Peak rebar strain in the transverse joint

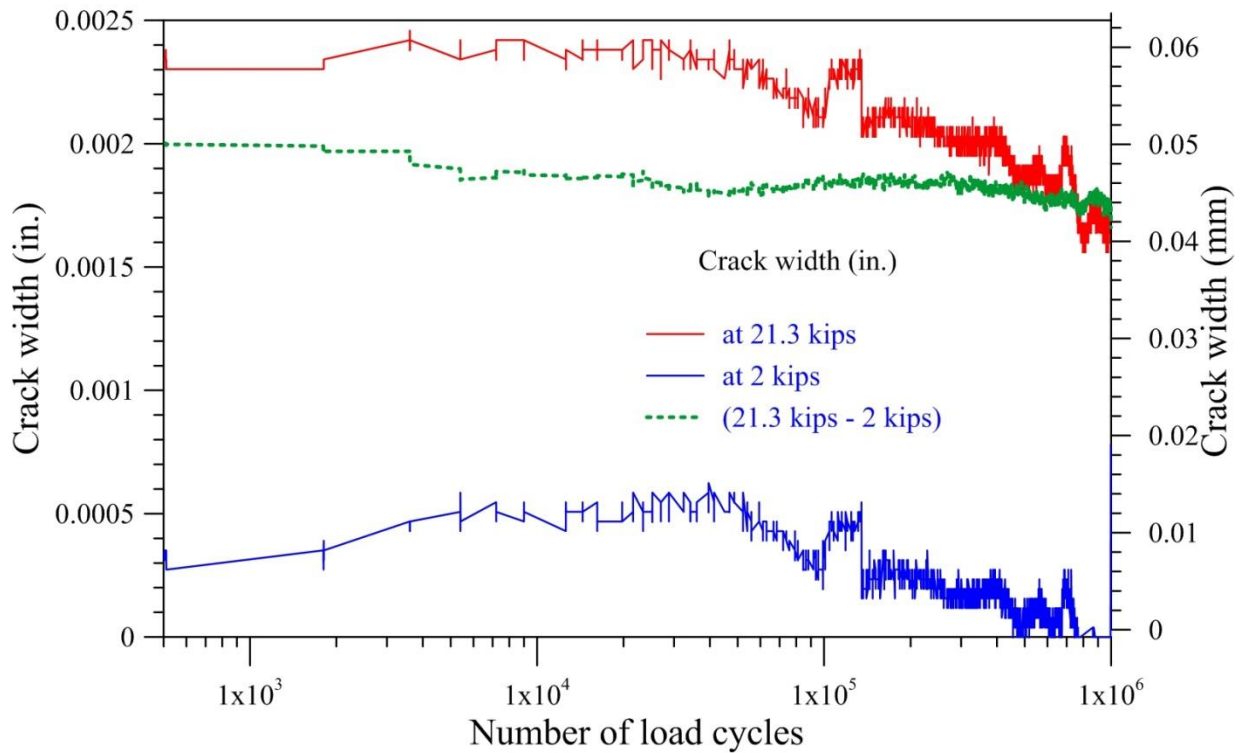
constant over the entire fatigue test and is shown in Figure 2.39. This data varied between 0.0018 inch and 0.0023 inch or within a range of 0.0005 inch, which is close to the sensitivity of the LVDTs used to measure the crack width. For the static load tests performed at the end of 135,000, 670,000 and 1,000,000 cycles, the load displacement, peak strain in the bottom reinforcement in the transverse joint, and crack width in transverse rib TR2 of panel UWP1 during the intermediate static load tests are presented in Figure 2.40. The initial secant stiffness of the panel at the peak load after 200, 135,000, 670,000, and 1,000,000 cycles of loading was 708.05 kip/inch, 667.71 kip/inch, 637.72 kip/inch, and 653.34 kip/inch, respectively. These values compare closely to each other and show variations of within 8% of the average stiffness value. From these observations and Figure 2.40, it is clear that the joint or the UHPC waffle deck system did not experience any significant fatigue damage even after subjected to 1,000,000 cycles at an amplified level of the service load.

**Figure 2.39. The crack width variation in transverse rib TR2 of panel UWP1 during panel fatigue test**

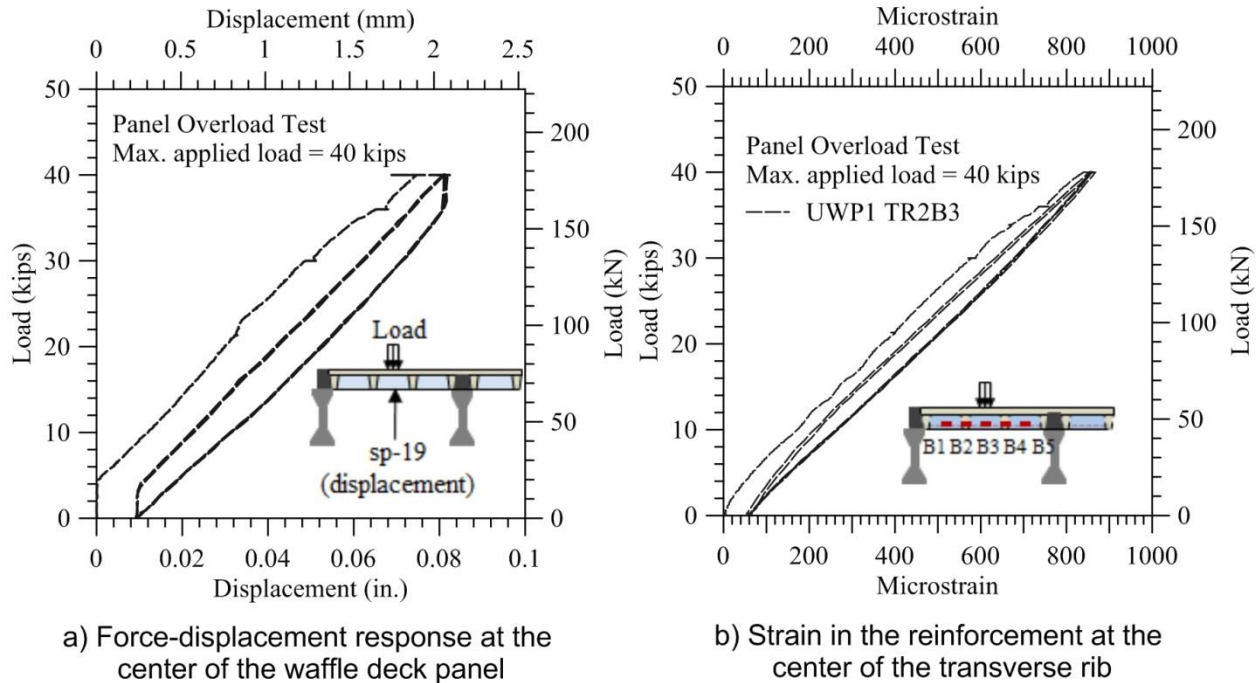
established at the center of panel UWP1 for this test is shown in Figure 2.41a. The panel exhibited a linear force-displacement behavior response with insignificant damage. A maximum deflection of 0.08 inch was measured at the center of panel UWP1. This deflection corresponds to  $L/1100$ , which is 73% of the AASHTO-specified serviceability limit of  $L/800$  for continuous spans with pedestrian traffic.

**Figure 2.41. Measured force-displacement response and peak rebar strain at the center of the transverse rib of UWP1 at the overload load of 40 kips**

The variation of the most critical strain in the bottom reinforcement of the transverse rib TR2 of panel UWP1 as a function of the applied load is shown in Figure 2.41b. The peak strain in the bottom reinforcement of transverse rib TR2 was only 880  $\mu\epsilon$ , which is only about 43% of the yield strain of the reinforcement. The strain variations in the bottom reinforcement placed in the transverse rib TR2 of panel UWP1 and the joint are shown in Figure 2.42 and Figure 2.43, respectively. Three to four hairline cracks were observed on both transverse ribs (TR1, TR2, and TR3) and longitudinal ribs (LR1 and LR2) of panel UWP1 (see Figure 2.44). A hairline crack was seen on the bottom surface of UWP1 (between ribs TR2 and TR3) at the peak load (see Figure 2.44a). The maximum crack width measured along the transverse rib TR2 in UWP1 was 0.008 inch, and its variation with the applied load is shown in Figure 2.45. Figure 2.46 shows the strain demand on the dowel bar in the panel-to-girder joint during the panel overload load test. It is clear that the dowel bars were engaged in load transfer when the 35-kips load was applied at the center of the panel.

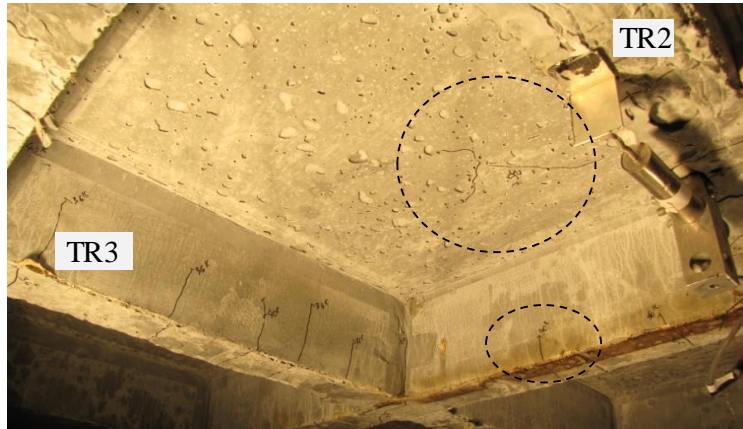
a) Cracking on the bottom surface of the slab and on a longitudinal rib

b) Cracking along transverse rib TR2 of UWP1

**Figure 2.44. Hairline cracks developed on panel UWP1 at an overload load of 40 kips**

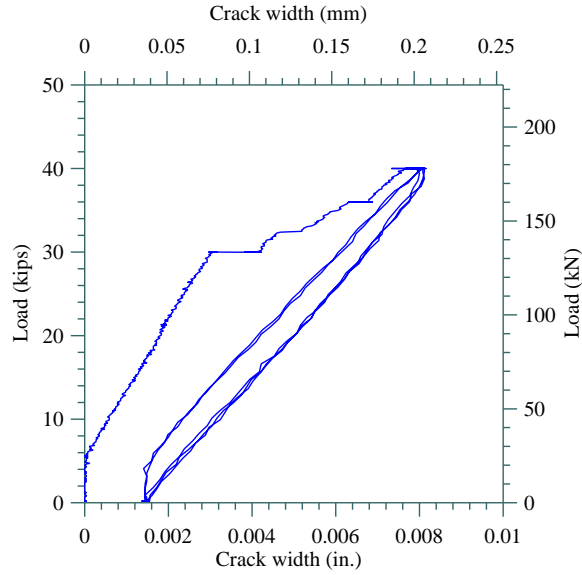
**Figure 2.45. Measured crack width in transverse rib TR2 of UWP1 during the overload load test**

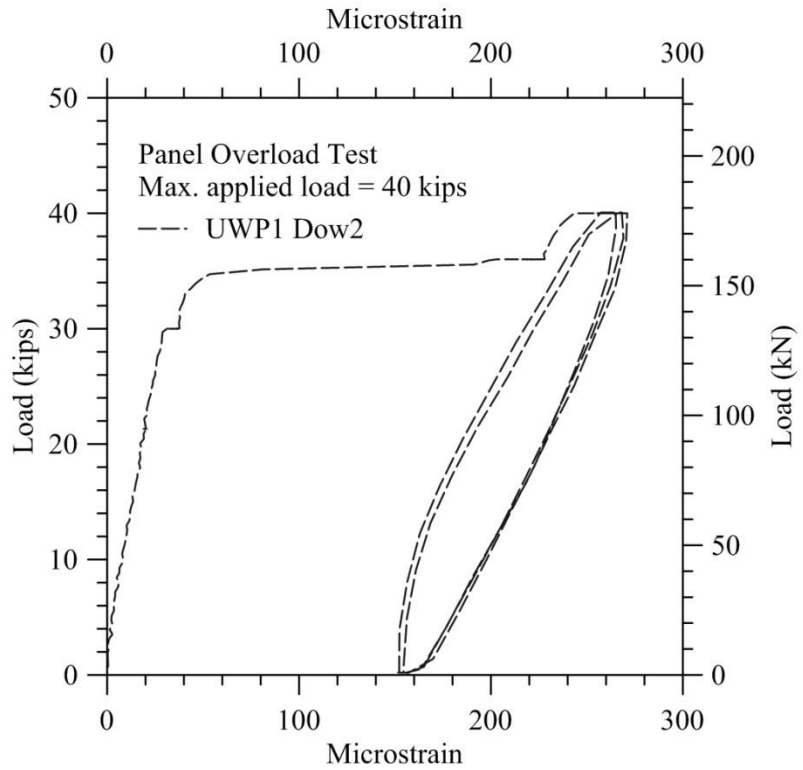
**a) Strain gauges on the dowel bars in Panel-to-girder joint**

**b) Strain in the dowel bar (shown in Figure a) in the panel-to-girder joint**

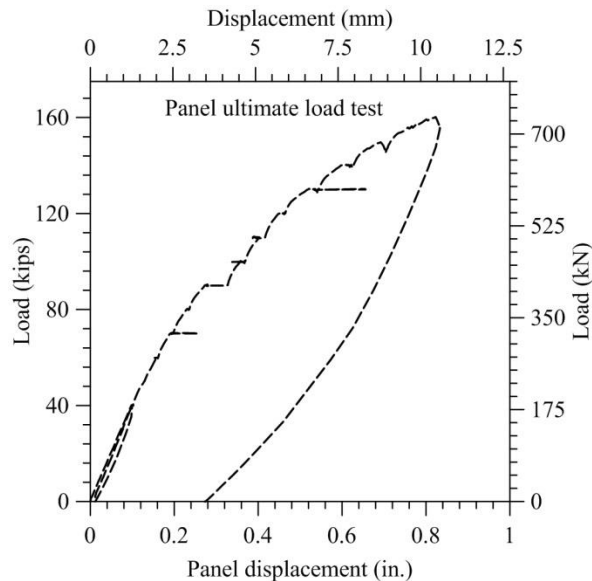
The ultimate load test was carried out to investigate the adequacy of the precast deck system and its connections under ultimate load conditions. The ultimate load referred to in this study was arrived at based on the recommendations from the Iowa DOT personnel. A total load of 160 kips, equivalent to 10 times the AASHTO truck service load, was applied at the center of panel UWP1. The load-deflection curve established at the center of this panel during testing is shown in Figure 2.47.

**Figure 2.47. Measured force-displacement response of waffle deck system**

The panel exhibited a linear force-displacement behavior response up to about 80 kips. A maximum deflection of 0.82 inch was measured at the center of panel UWP1 (center of transverse rib TR2) as the load was increased to 160 kips. The peak strain measured in the bottom reinforcement of transverse rib TR2 at the maximum load was around  $1,600 \mu\epsilon$ , which is about 76% of the yield strain of the reinforcement. A significant amount of cracking was observed on both the transverse ribs (TR1, TR2, and TR3) and longitudinal ribs (LR1 and LR2) of panel UWP1. The maximum crack width measured along the transverse rib TR2 in UWP1 was 0.08 inch. When the load was removed, the deck panel had a residual displacement of 0.28 inch.

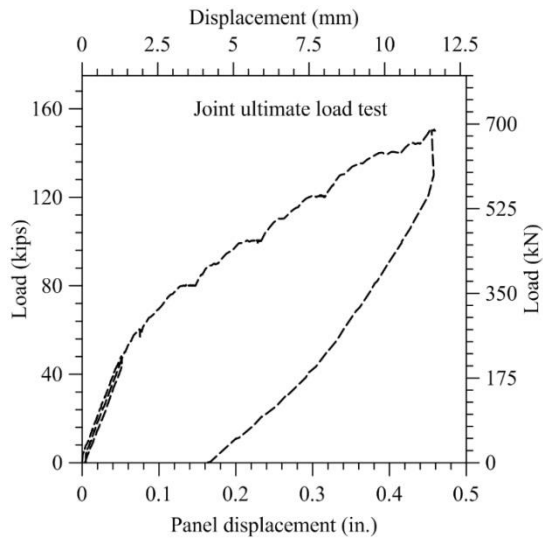
a) Force-displacement response

b) Cracks in the transverse joint at 150 kip load

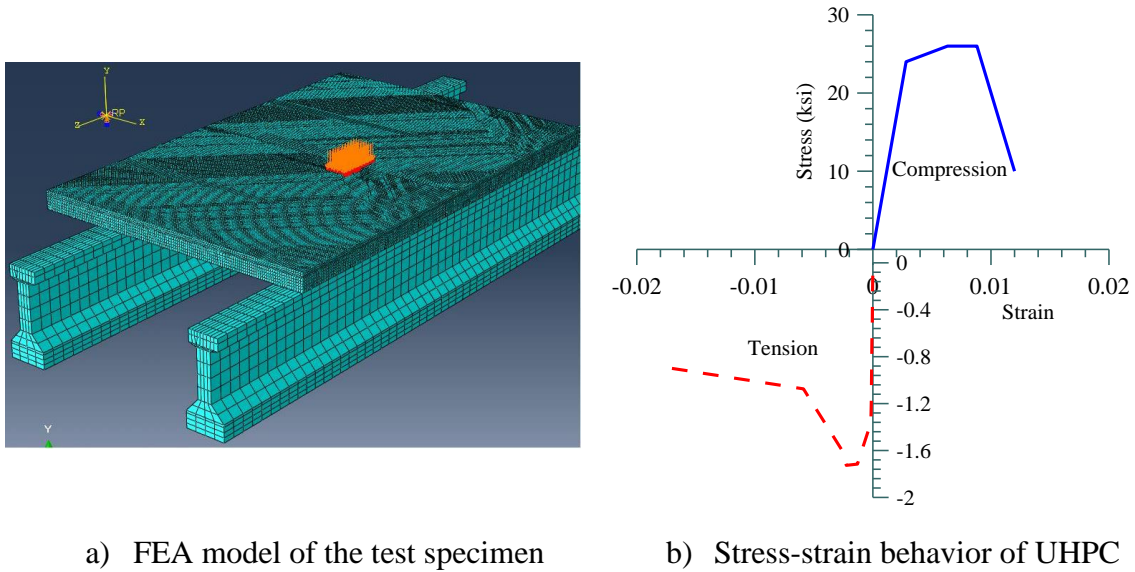
**Figure 2.50. Test specimen discretization and material behavior of UHPC used in FEA software (ABAQUS)**

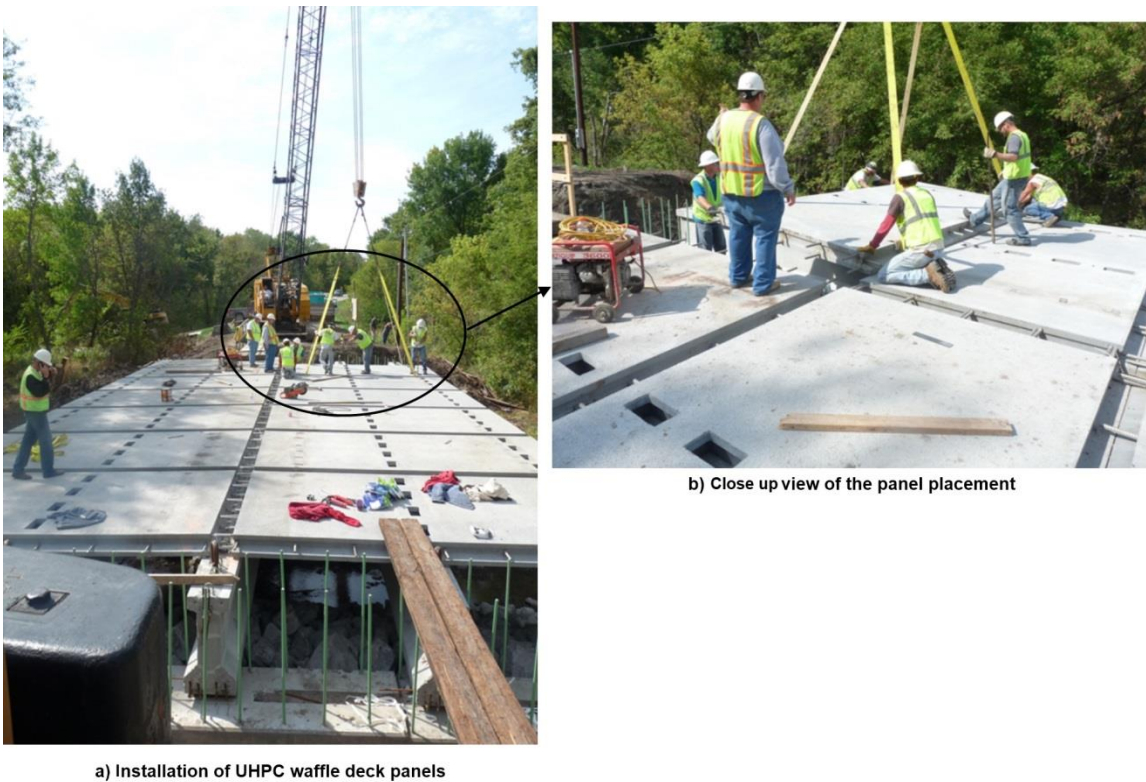
**Figure 3.5. Placement of UHPC waffle deck panels on the prestressed girders**

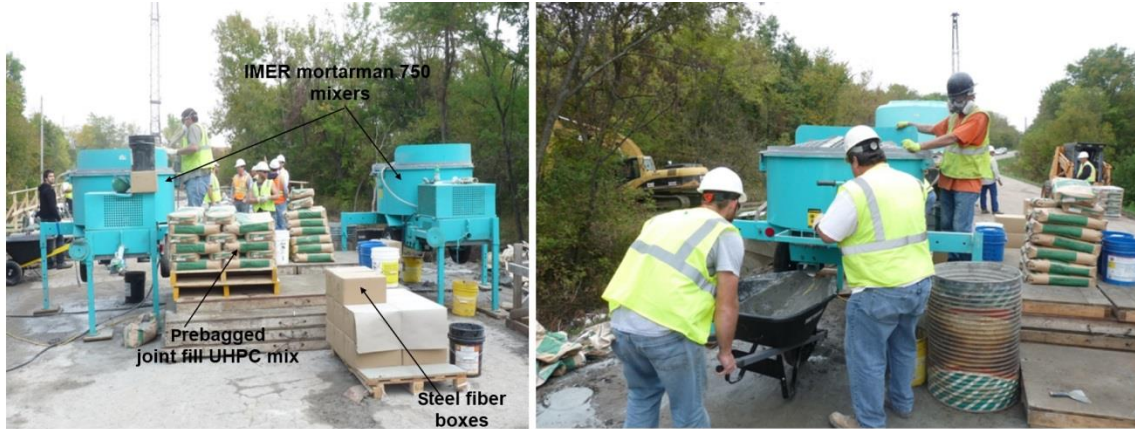
**Figure 3.8. Batching of UHPC joint fill using IMER Mortarman 750 mixers at the bridge site**

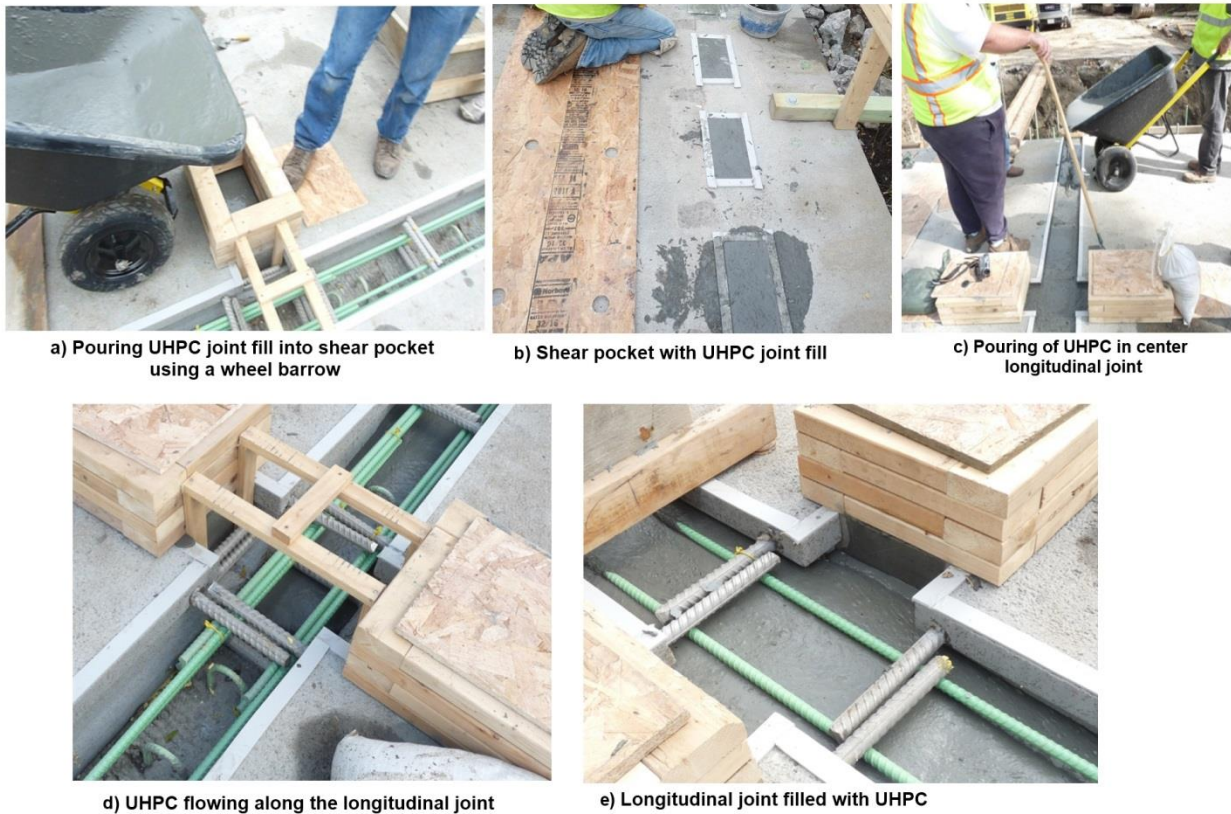
**Figure 3.9. Filling of joints with in situ UHPC and completed joints**

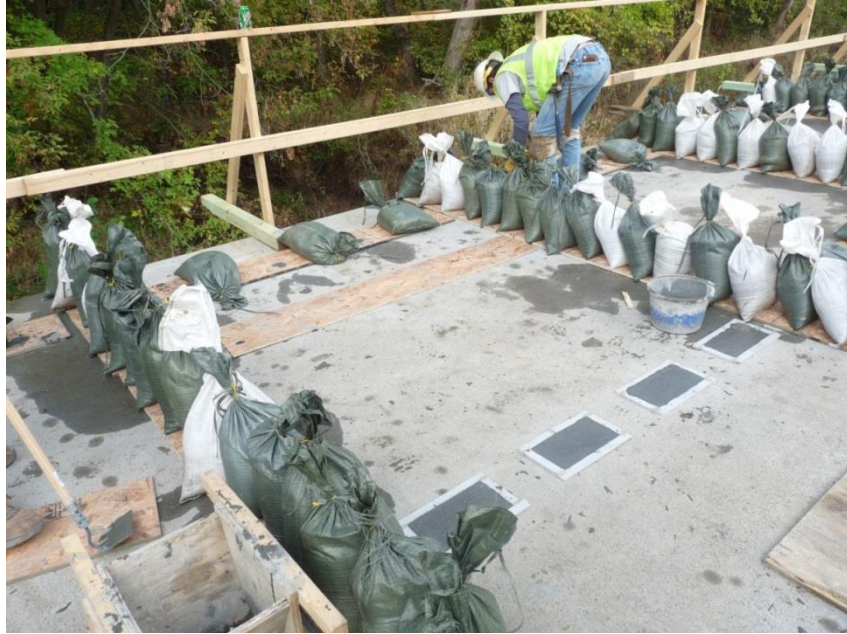
**Figure 3.10. Finished transverse joints (panel-to-panel joint) covered with plywood**

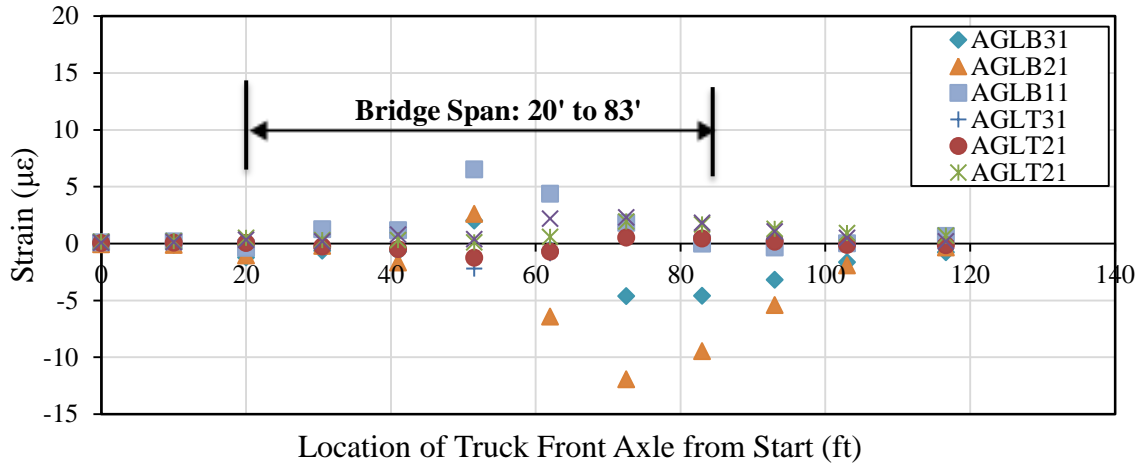
Figure 4.9. Girder top and bottom longitudinal strain near abutment for load path 2

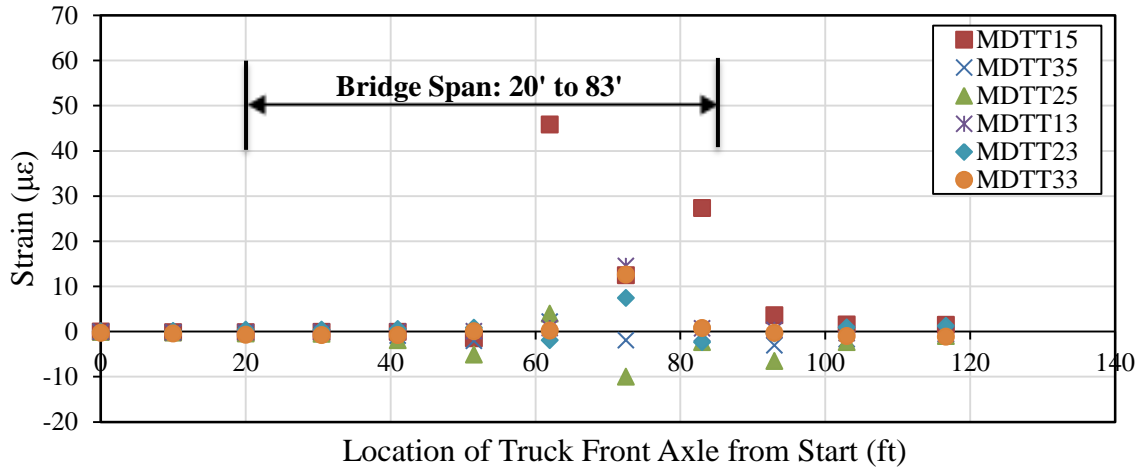
Figure 4.12. Transverse top strains at mid-span panel for load path 2
