Precast Concrete Elements for Accelerated Bridge Construction

Volume 1-1. Laboratory Testing of Precast Substructure Components: Boone County Bridge

**Final Report
January 2009**

the Iowa Highway Research Board (IHRB Project TR-561),
the Iowa Department of Transportation (CTRE Project 06-262),
and

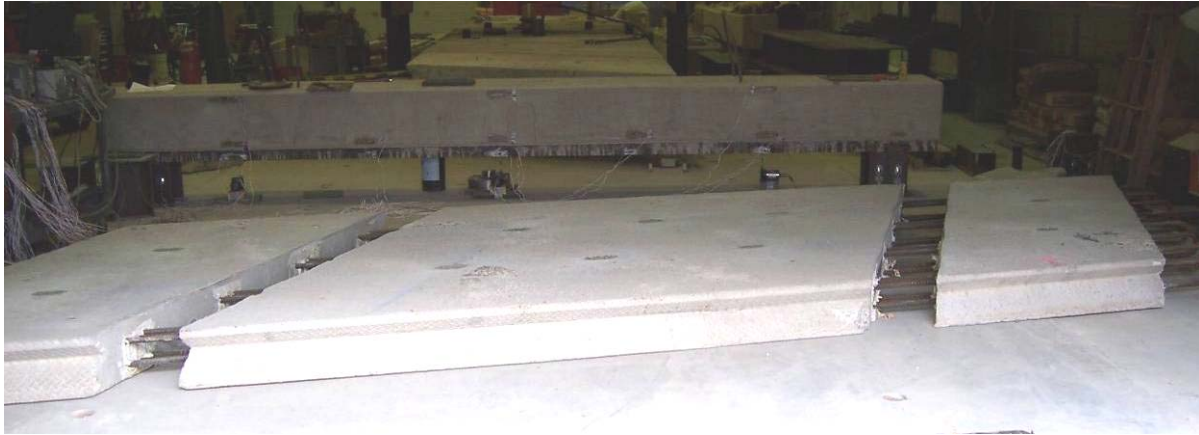
Post-tensioning channels used in the Boone County project avoided the corrosion protection issues related to the type of post-tensioning ducts and the presence of air voids in the ducts by eliminating the ducts all together. Open channels allowed the strands to be inspected as grout was placed and prevented the formation of air voids around the tendons. The channels in one of the deck panels can be seen in Figure 6.

Figure 6. Boone County replacement bridge deck panel

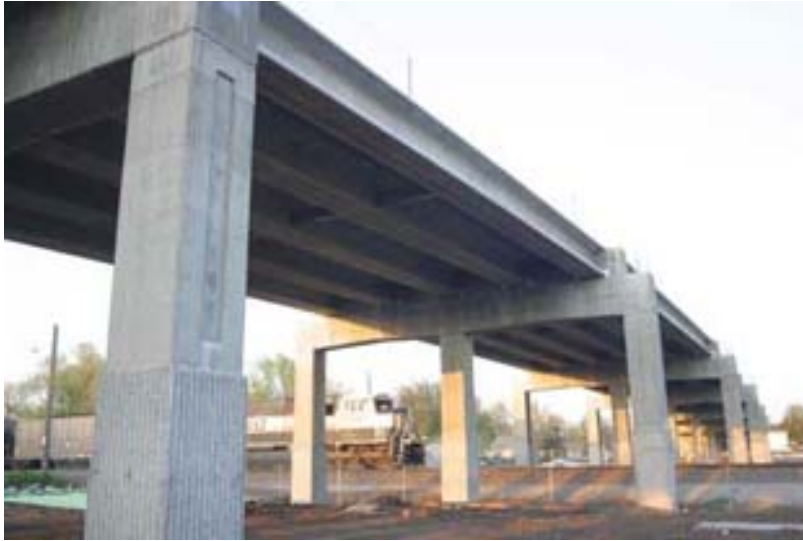
tensioned caps can significantly reduce the cap size, which reduces the weight of the substructure. For extremely large bridges, pier caps may be fabricated and transported in two pieces and post-tensioned together on site (Billington *et al.*, 1999).

Figure 8. Bridge pier cap located Lincoln, Nebraska

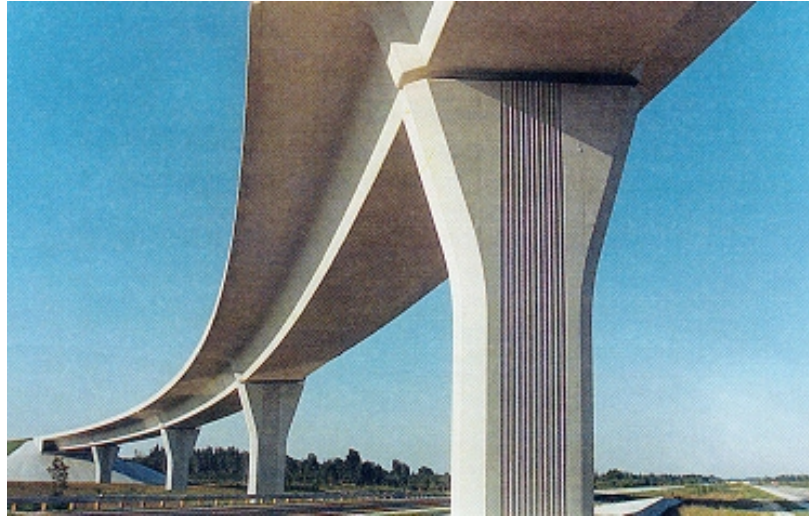
Figure 9. Slender pier design of the Florida Turnpike in Miami, Florida

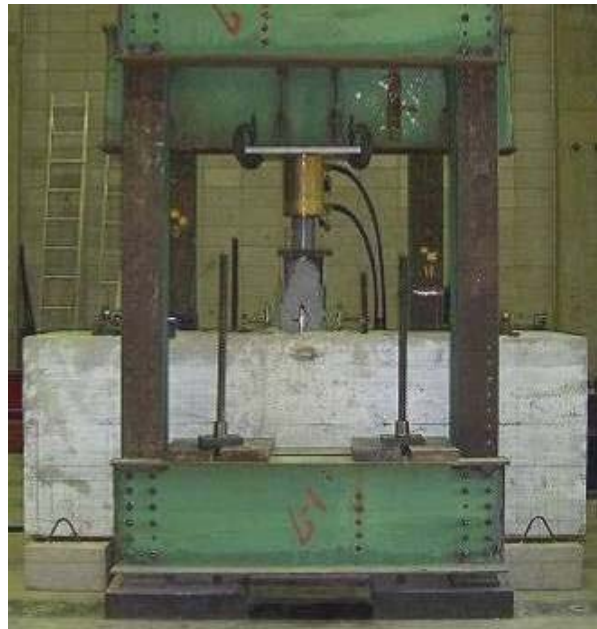
Abutment and pier cap specimens were tested seven days after the grouted concrete was placed, or as soon as the grouted concrete reached the appropriate strength, if strength was not met in seven days. Specimens were initially loaded to a proof load of 160 kip, twice the unfactored design load. This proof load was held for 15 minutes before loading continued. The load cell used for testing had a maximum capacity of 300 kips (± 10 pounds) while the hydraulic pump and Load Frame 1 each had capacities of 400 kips. Therefore, each specimen was loaded to 300 kips after which the load cell was removed, and loading continued to the maximum capacity of the test specimen. While the load cell was in use, strain and deflection measurements were taken at approximately 10 kip increments.

Figure 38. Laboratory test arrangement for ASC1

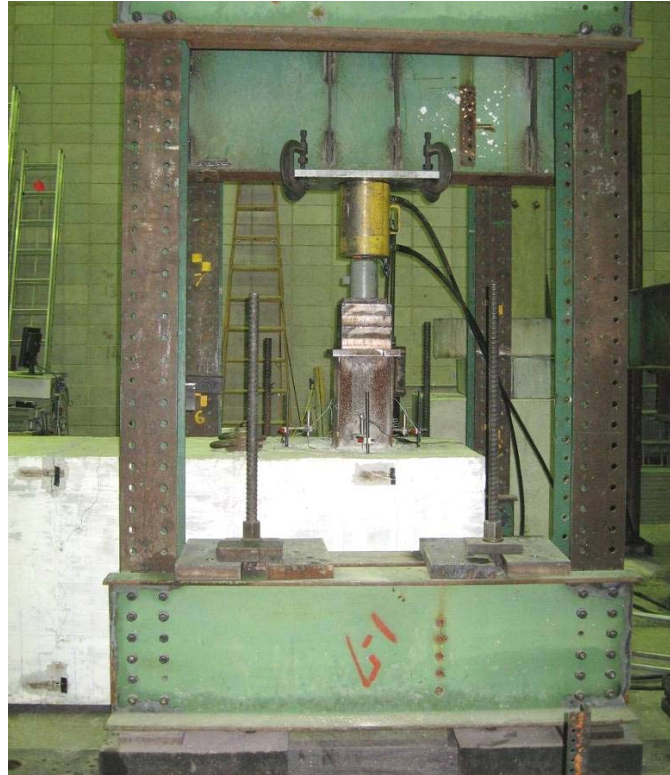
Each pile was loaded to 400 kips, measurements being recorded approximately every 10 kips with the load cell in place (up to 300 kips), and every eight kips after the load cell was removed. The differential deflections were monitored and the specimen was checked for cracks throughout the loading. Since there were no cracks on the specimens visible to the naked eye, none were marked.

Figure 43. Double pile abutment shear Test 1

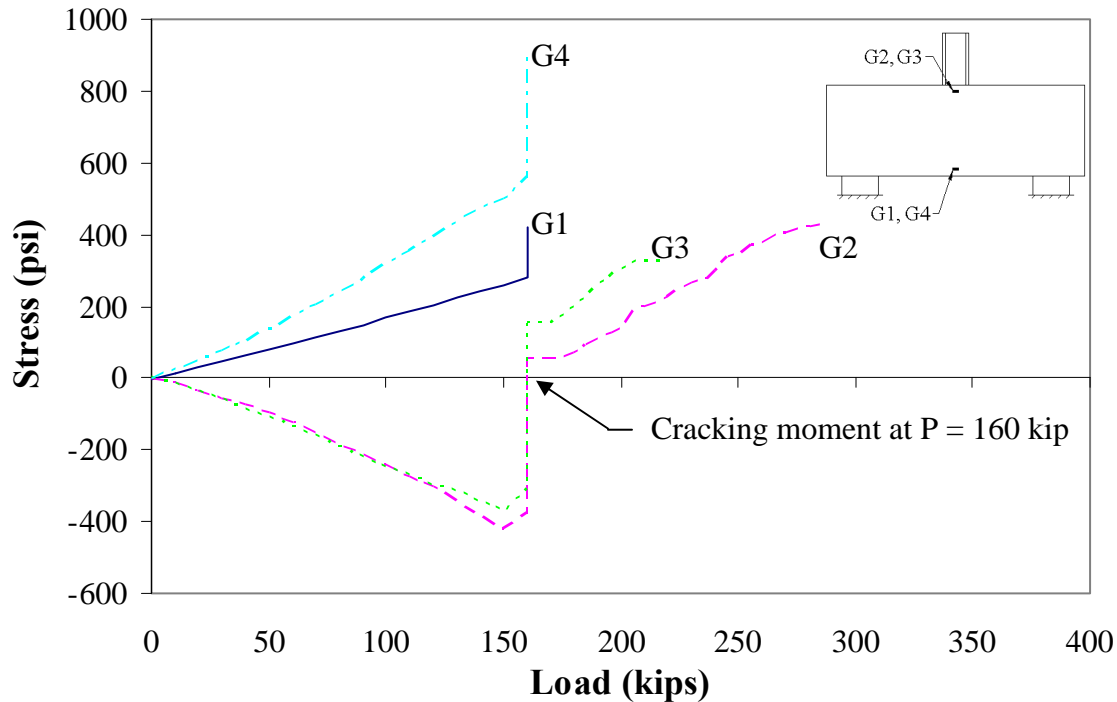
Figure 47. Concrete stresses in ASC3

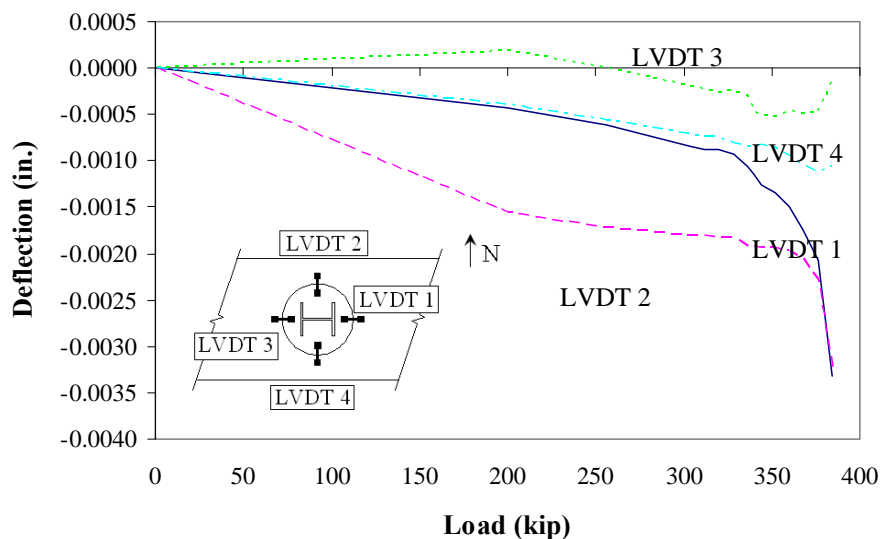
Figure 48. Differential deflection for ASC3

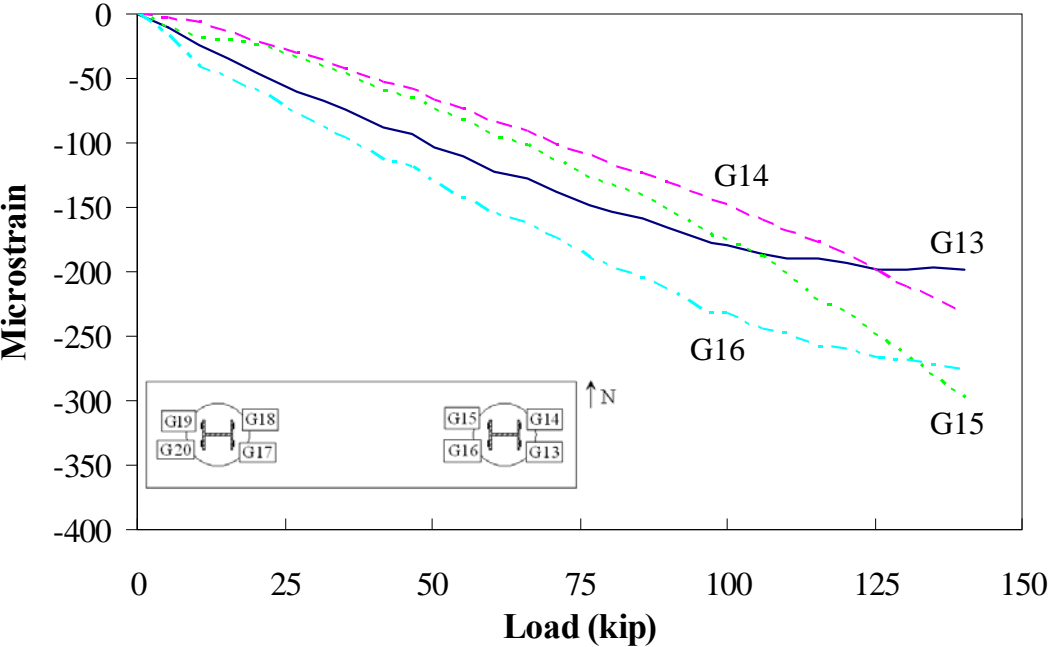
One of the difficulties encountered with the double pile test was using two different hydraulic jacks to load the piles at the same rate. The measured strains in the H-piles were analyzed first to ensure even loading between the piles and even load distribution through each pile. Results from the steel pile strain gages for ADC1 are presented in Figure 64 and Figure 65, respectively.

Figure 64. East pile steel strains in ADC1

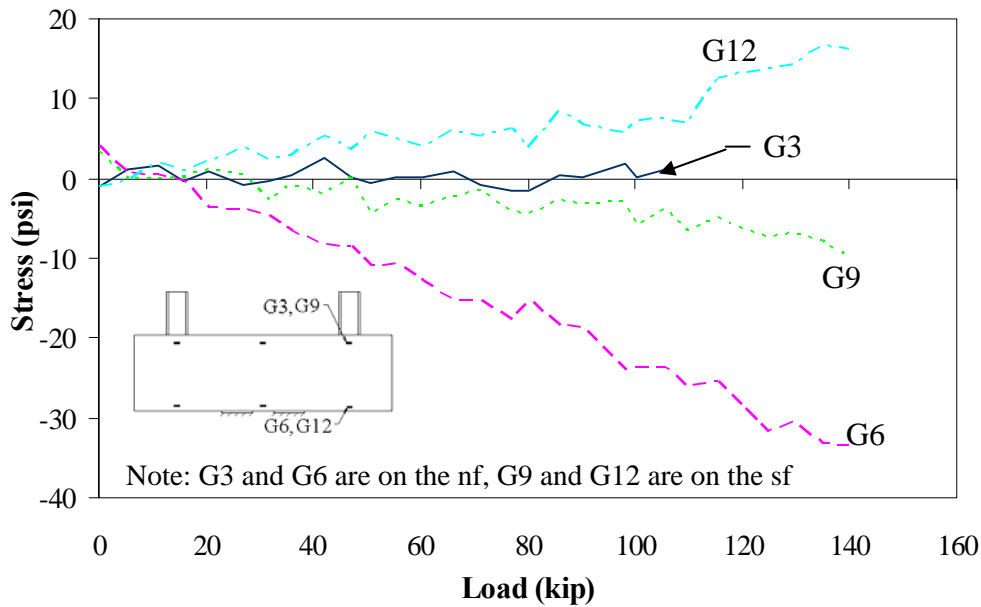
Figure 68. Concrete stresses at the west connection in ADC1

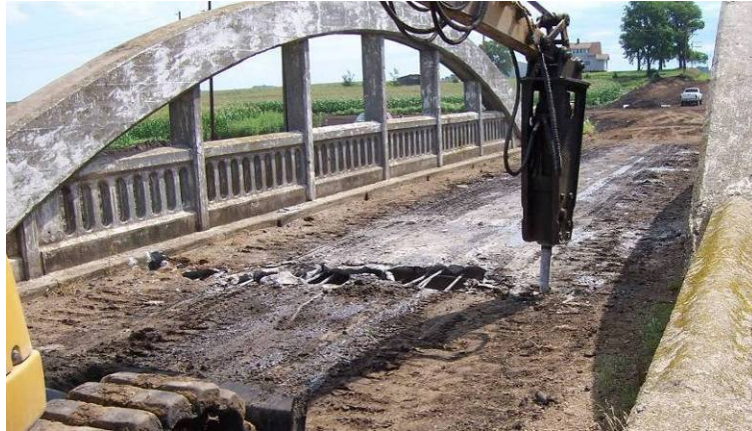
this causeway allowed access between the east and west banks after the original bridge was removed. Demolition of the bridge began the morning of July 24. The contractor used a back hoe with a hammer attachment, shown in Figure 102, to break apart the bridge deck and then used the back hoe to pull apart the bridge reinforcement.

Figure 102. Breaking apart the Marsh Arch bridge deck with a back hoe, July 24

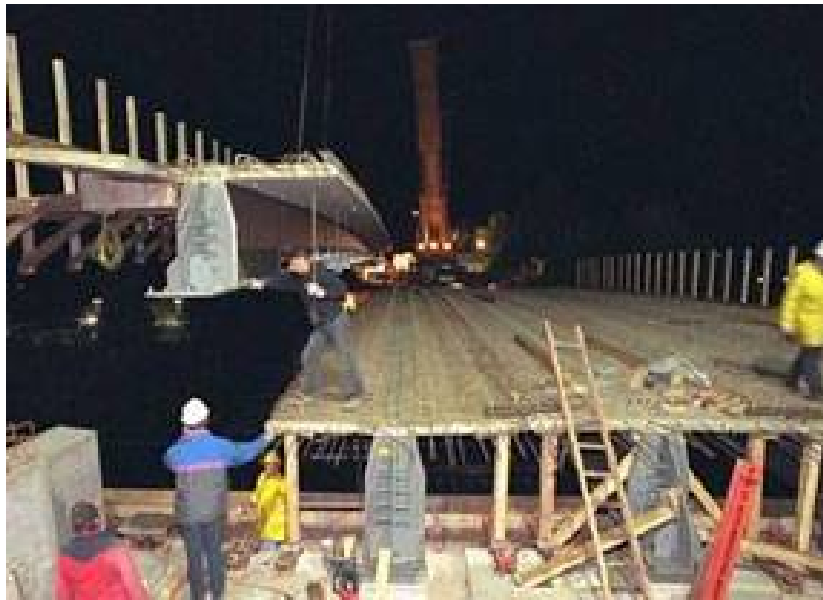
Figure 1.3. Placement of partial depth panels cast on beams (Russell *et al.*, 2005)

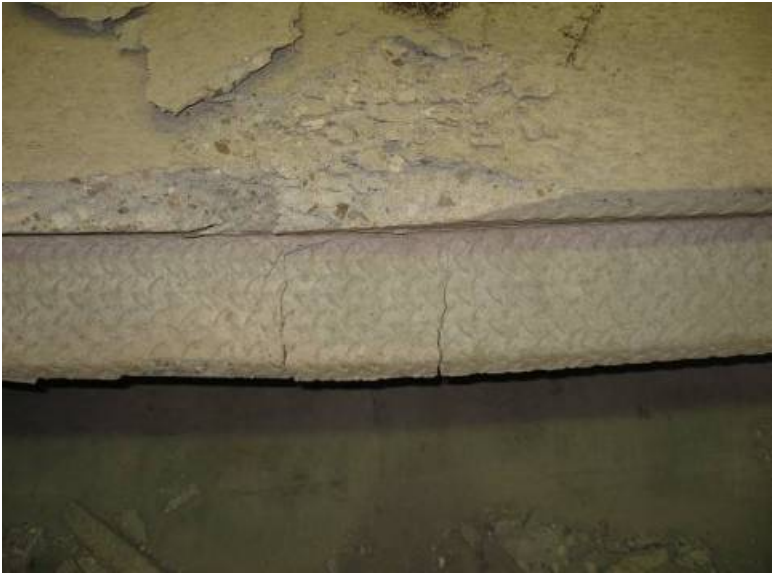
b) Flexure cracks

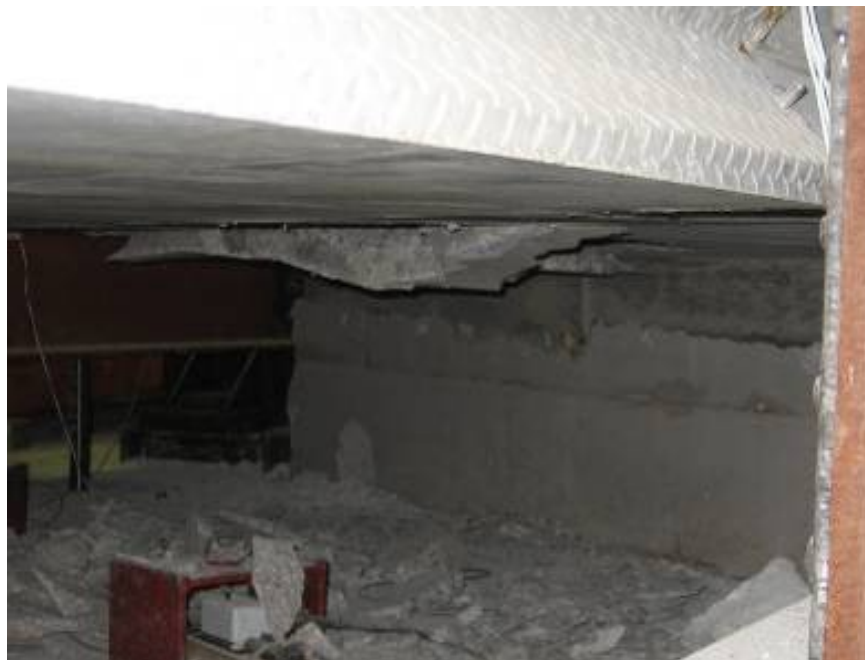
a) Top view of punching shear failure footprint

b) Top view after concrete removal

c) Underside of the deck panel

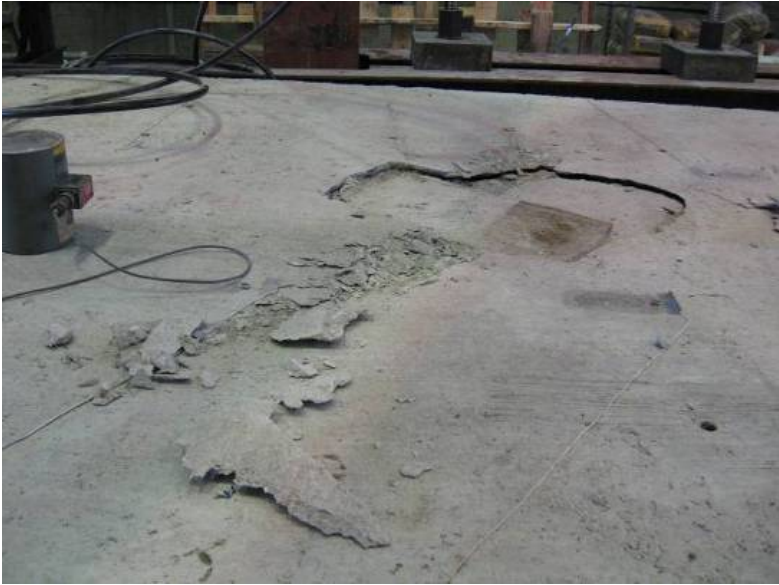
Figure 3.27. Punching shear and flexure failure due to tandem wheel footprint

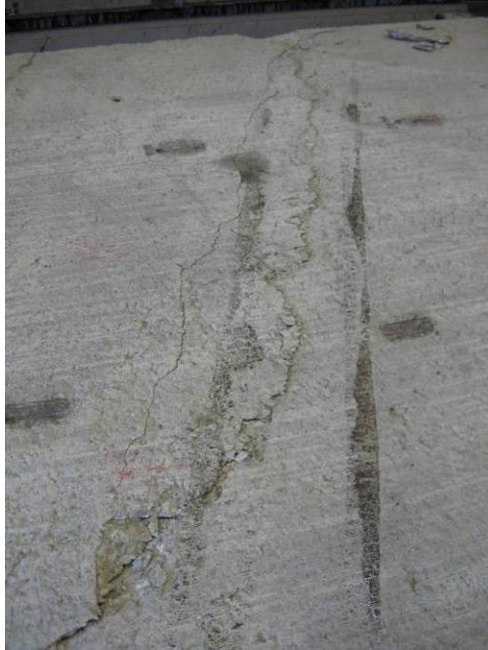
Figure 3.32. Flexural cracking in deck panel due to applied line load

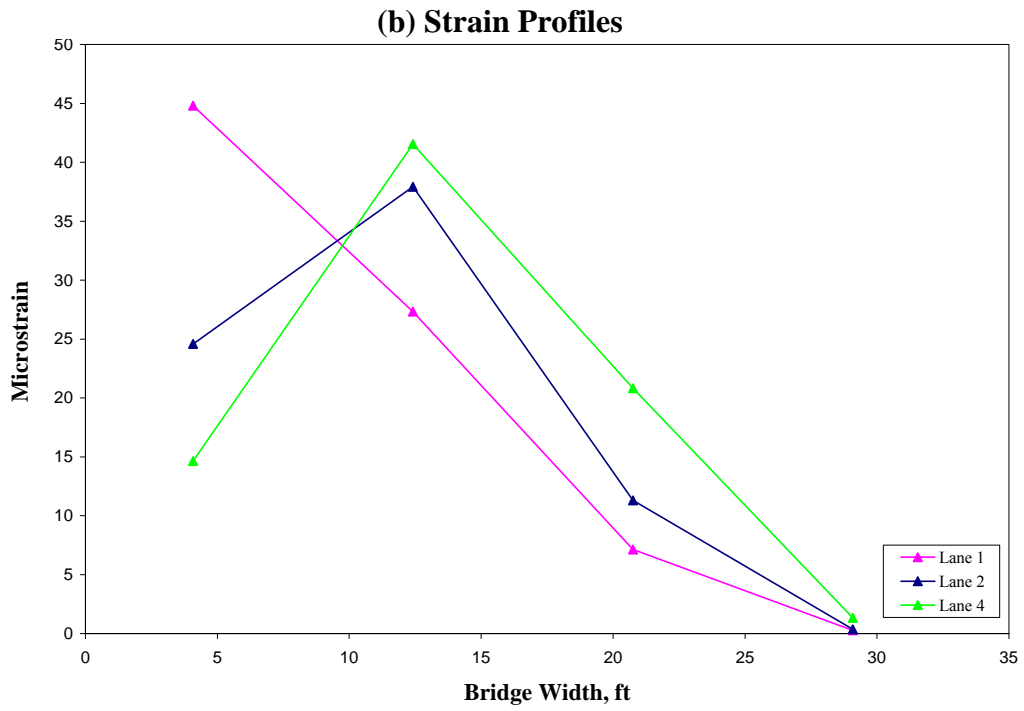
Figure 3.2 MS 2 Strain and Deflection Profiles (Load Case 1)
