Laboratory Investigation of Grouted Coupler Connection Details for ABC Bridge Projects

**Final Report
August 2015**

Sponsored by
Federal Highway Administration
Iowa Department of Transportation
(InTrans Project 12-441)

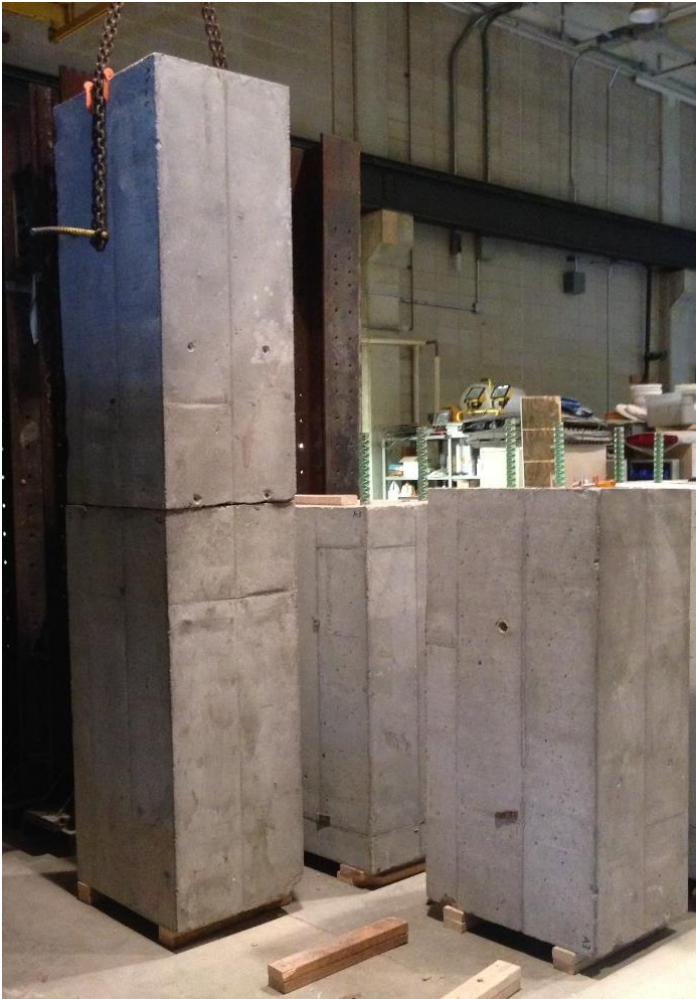
Figure 5. Dry fit of Side B on top of Side A in laboratory

Figure 5 shows both portions of the specimen reoriented vertically, in a dry fit configuration, with the coupler grout ports visible.

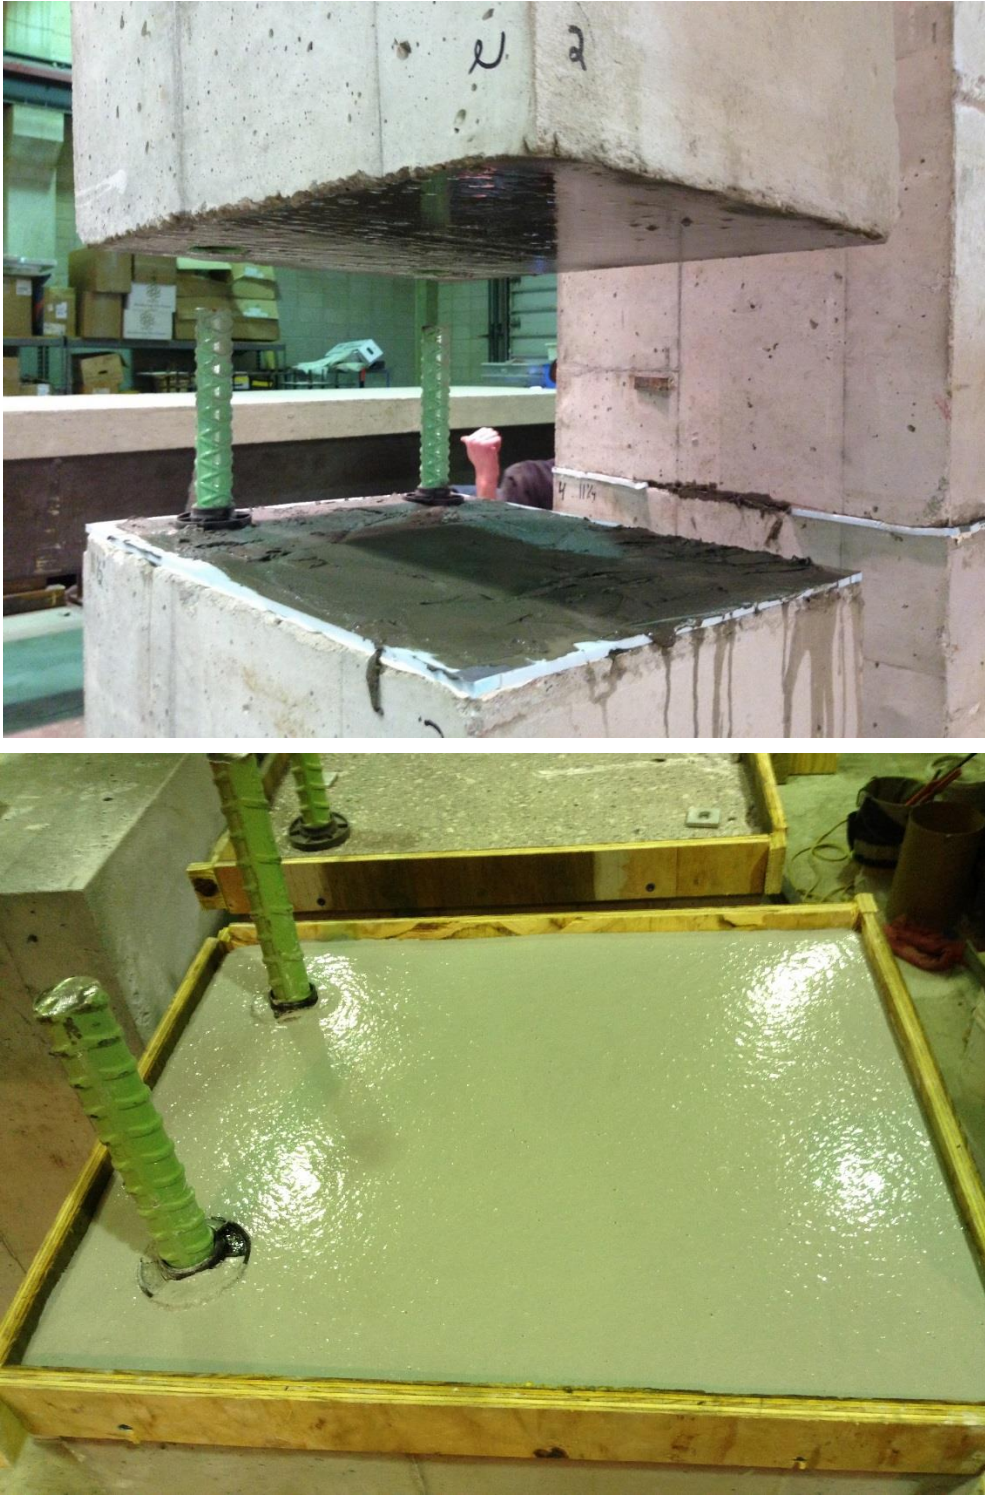
Figure 8. W. R. Meadows grout bed (top) and UHPC grout bed (bottom)

Sleeve-lock seal plugs were used on the protruding reinforcing steel to prohibit bedding grout from entering the couplers. Once all three were properly in place, the grout was placed on the top of the bottom specimen and the top specimen was carefully lowered on top (see Figure 8).

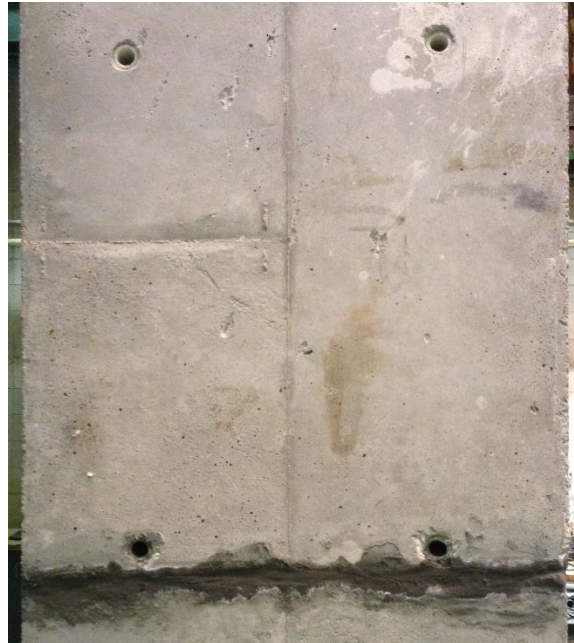
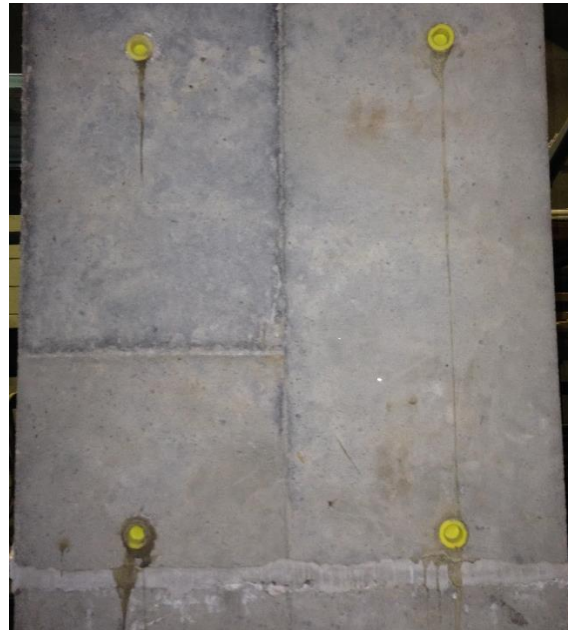
Each batch of grout was mixed per manufacturer recommendations and pumping of the grout was completed as follows: 1) mix grout, 2) fill pump hopper with grout, 3) insert nozzle of pump into lower port of the grouted coupler, 4) slowly pump the grout into the coupler until it begins to come out of the top port of the coupler, 5) with a steady stream of grout exiting the top port, plug the top port using a port plug, 6) quickly remove the pump nozzle and plug the bottom port with a port plug. Figure 13 illustrates the ports before grouting and Figure 14 illustrates the ports after grouting with port plugs installed.

Figure 13. Port plugs before grouting

Figure 14. Port plugs installed after grouting

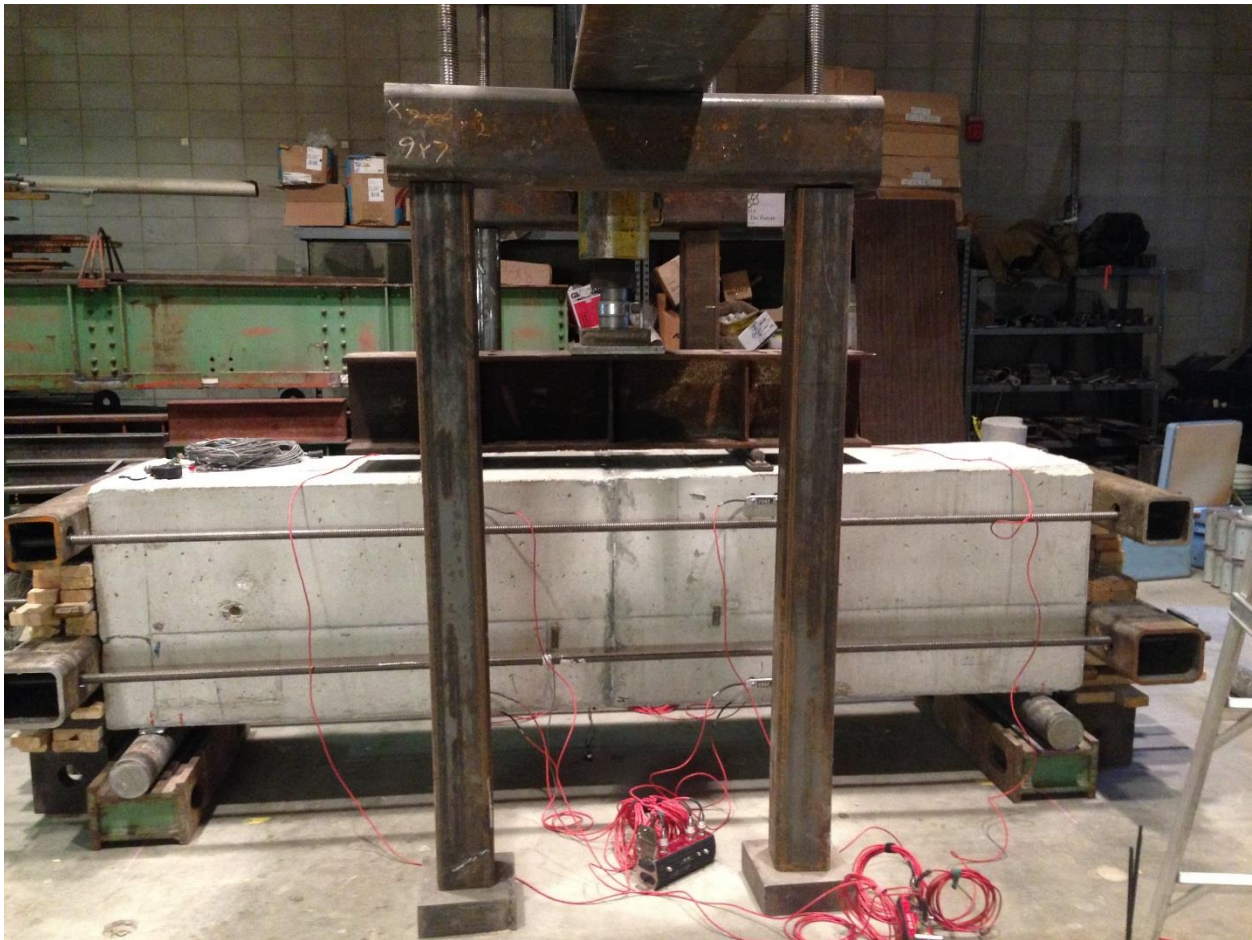
Figure 19. Specimen setup for static four-point bending test with applied axial load

Figure 19 shows a specimen in the test frame setup with an axial load applied with post-tension rods.

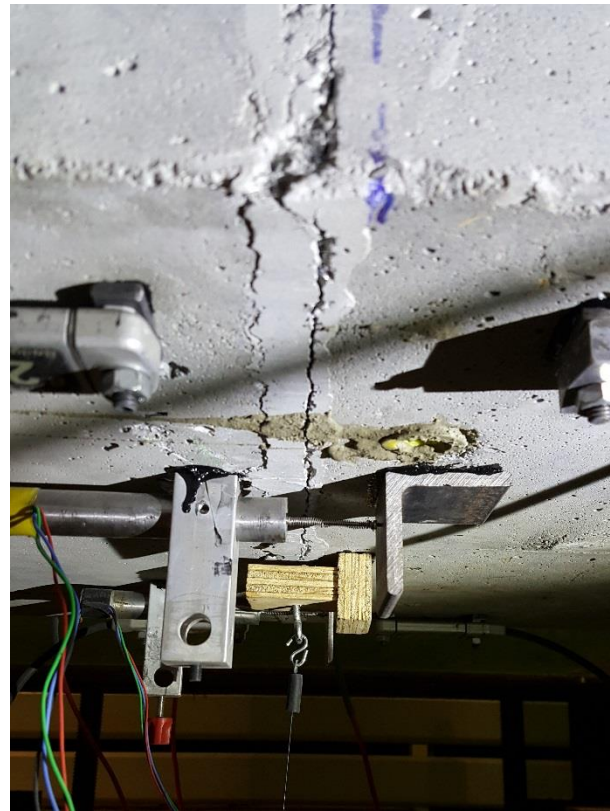
Figure 36. Crack width comparison during loading

Figure 36 shows a typical crack during loading of one specimen (Specimen 3) with standard grout (left) and Specimen 6 using UHPC (right).
