Evaluation of the Buena Vista IBRD Bridge: A Furthering of Accelerated Bridge Construction in Iowa

Final Report
February 2012

Sponsored by
Iowa Highway Research Board
(IHRB Project TR-605)
Iowa Department of Transportation
(InTrans Project 08-342)

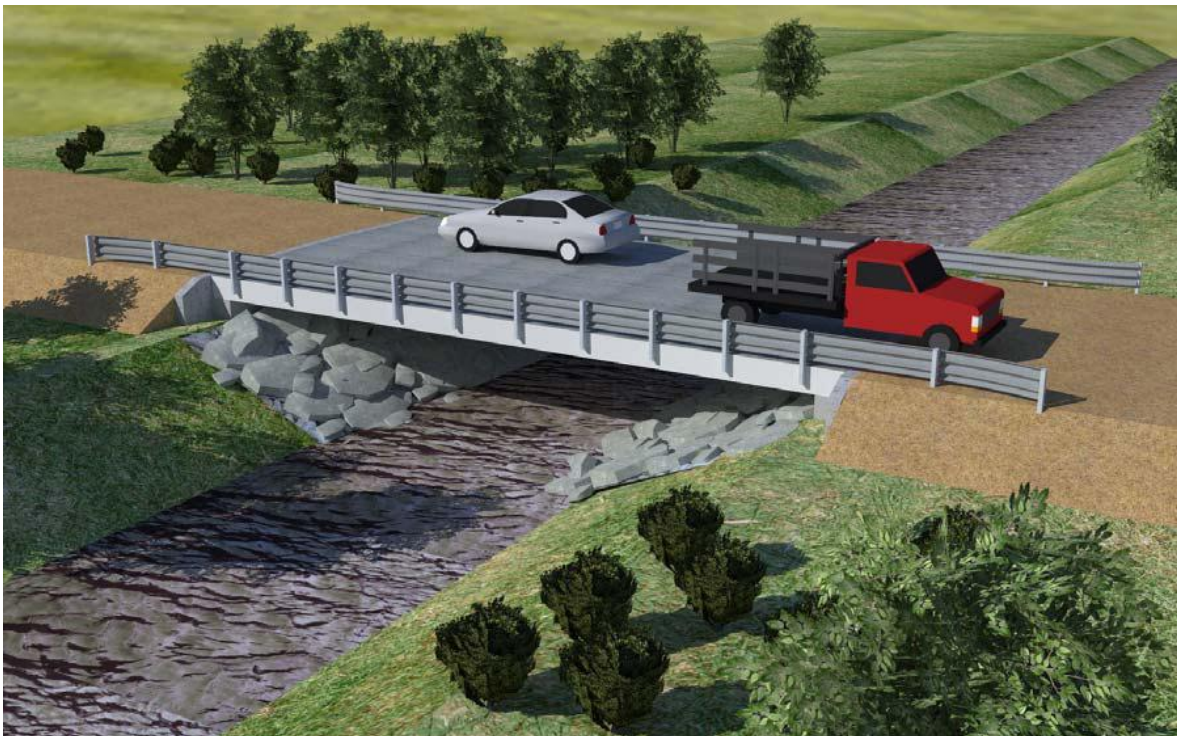
Figure 1.1. Concept model showing final bridge

The BVC Bridge is a nominal 50 ft long and 28 ft wide. (A complete set of plans for this bridge is included in Appendix A.) Several three-dimensional (3D) images were also created by Nielsen to assist the contractor in visualizing the accelerated bridge construction process. An overall view of the concept model of the bridge is shown in Figure 1.1.

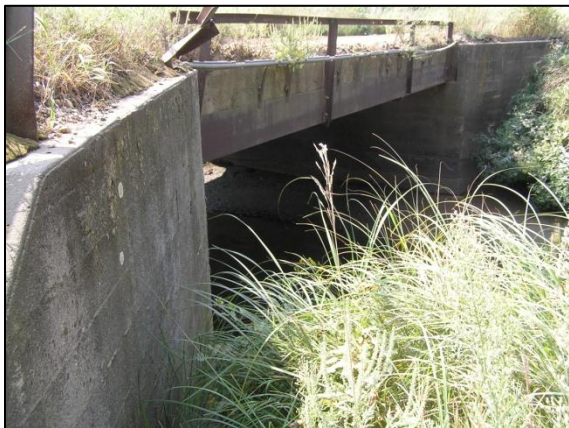
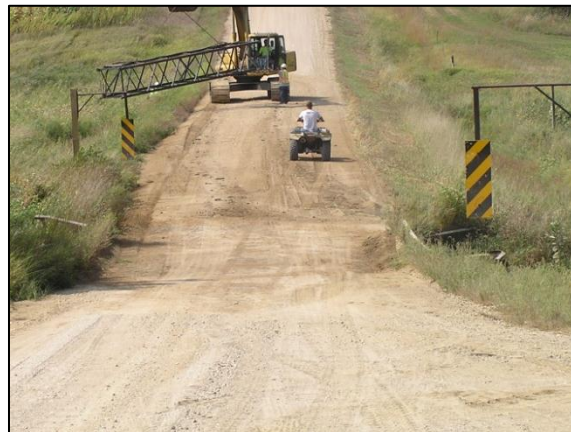
Figure 2.2. Original bridge at demonstration site

The new bridge replaced a posted timber bridge (26 ft 8 in. long by ~ 18 ft wide) that was constructed in 1936. The original bridge is shown in Figure 2.2.

a. Elevation

b. End view

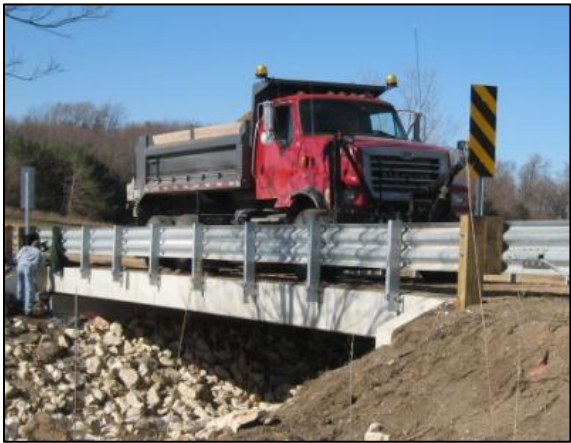
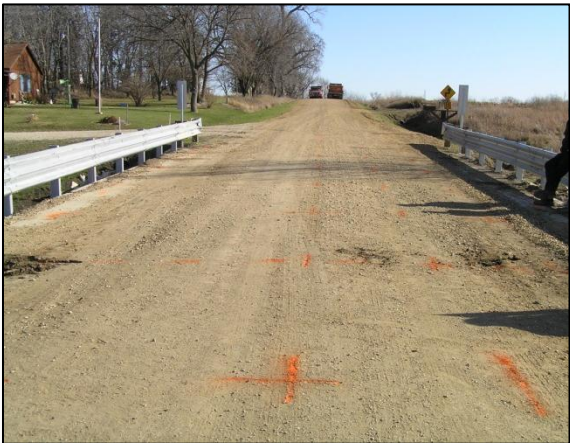
Figure 2.3. New Buena Vista County box beam bridge

The new bridge, shown in Figure 2.3, has precast abutment caps, backwalls, and box beams; and, this single-span bridge has a span length of 50 ft center to center of supports.

a. Elevation

b. End view

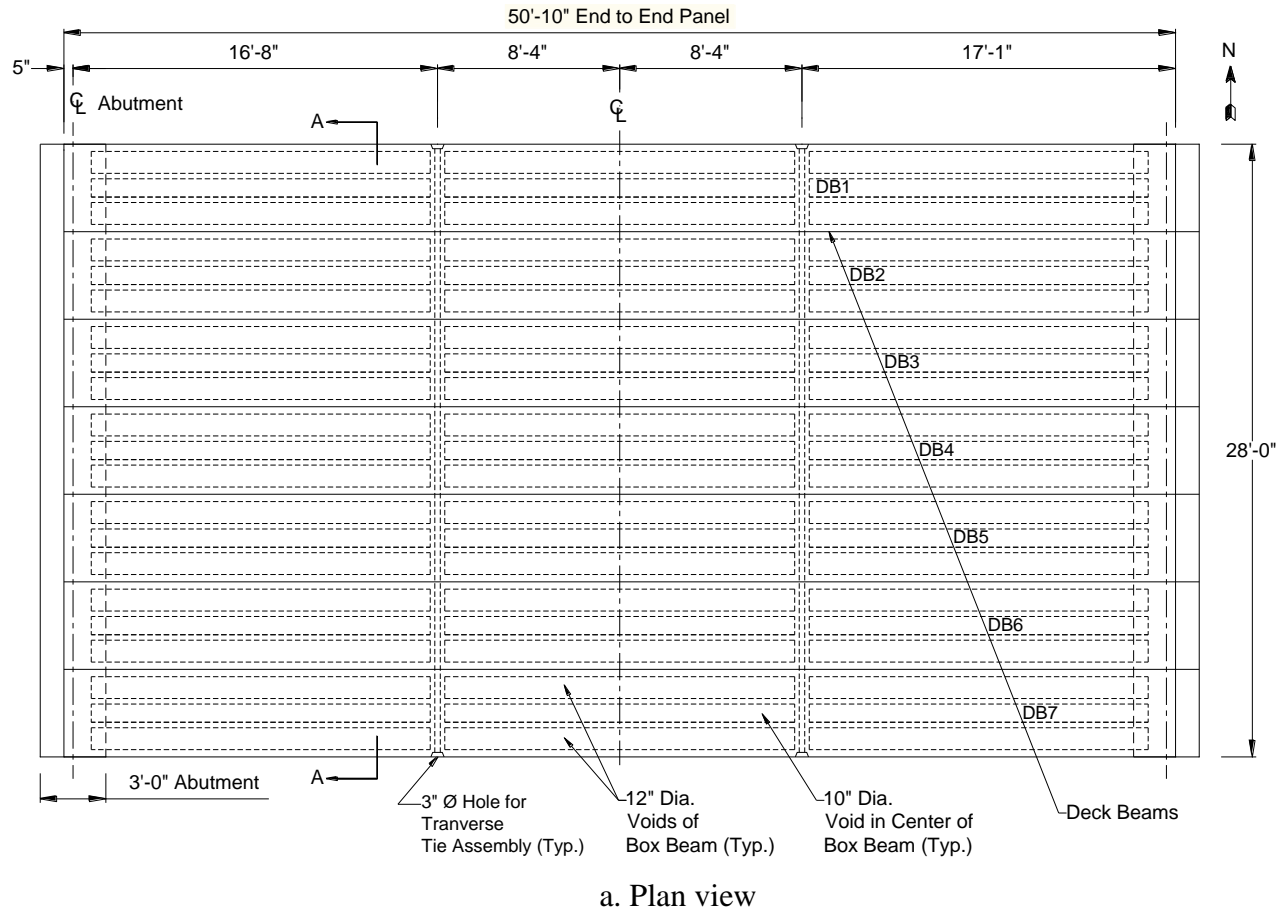
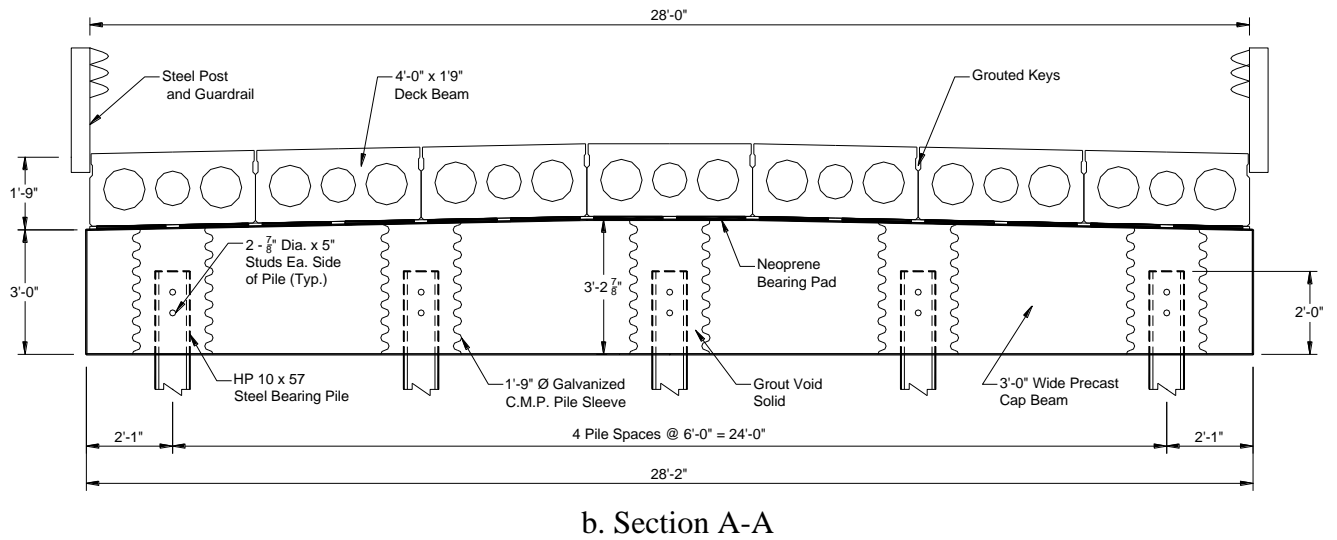
Figure 2.4. Plan and section of bridge

Overall dimensions of the bridge (shown in Figure 2.4) are out-to-out deck width of 28 ft and out-to-out length of 50 ft 10 in.

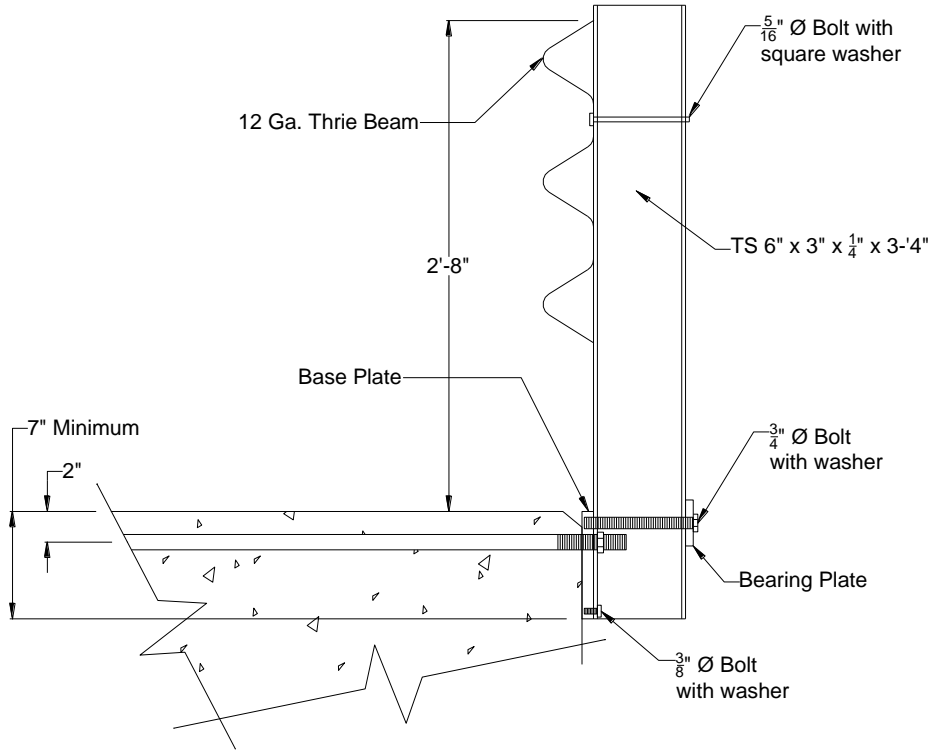
b. Profile view of guardrail and connection

The two exterior box beams were fabricated with 1 in. diameter anchor bolts on their exterior sides for connecting the eight guardrail posts. The posts were spaced uniformly on 6 ft 3 in. centers as shown in Figure 2.9.

Two anchor bolts (spaced 2 3/4 in. off the post centerline) were required for attaching each post. Guardrail posts (3 ft 4 in. long) were fabricated from TS 6 x 3 x 1/4 in. sections; a 12 gauge thrie beam was used for the guardrail. Each post is connected to a 3/4 in. thick steel base plate (8 in. x 7 in.) with a 3/4 in. diameter A325 bolt and a 3/8 in. diameter bolt. This assembly was connected to the bridge using the two 1 in. diameter anchor bolts described previously.

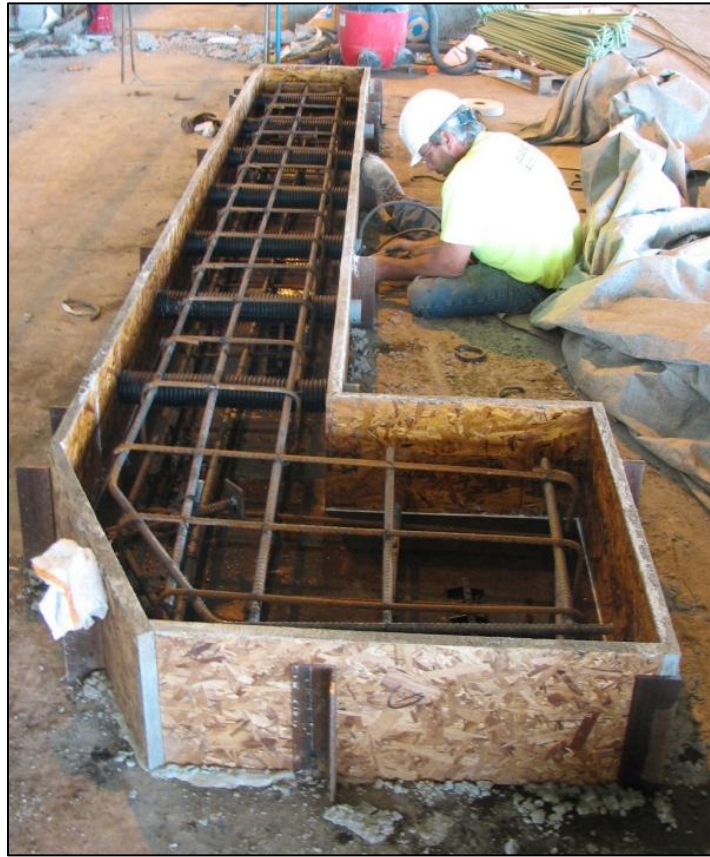
Figure 2.11. Backwall formwork

Backwall elements were cast one at a time; formwork, as well as the reinforcement for these elements, are shown in Figure 2.11. For installation, each of the backwall panels had three cable lifting loops and two screw inserts for additional lifting points.

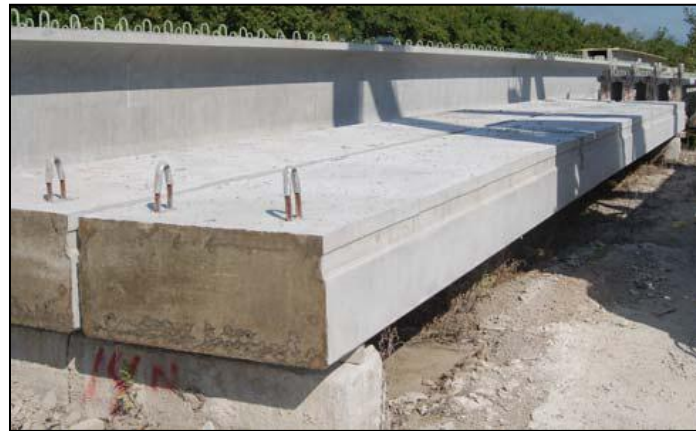
Figure 2.14. Voided precast beams

The fit between two adjacent box beams is shown in Figure 2.14. In this setup, the trueness of the elements, as well as the alignment of the transverse tie assembly, could be checked.

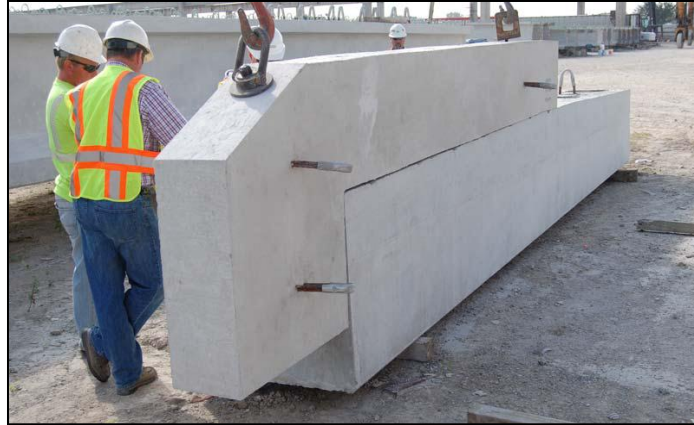
Figure 2.15. Precast backwall and abutment

Figure 2.15 shows one of the backwall segments positioned on the precast abutment cap. The four backwall segments were cast “flat” and lifted out of the forms using the three lift cables shown in this figure.

To lift the backwall segments into place, lifting hooks were attached with bolts screwed into inserts in the top of the backwall elements (Figure 2.15). After the 13 elements were inspected and partial assembly was completed, these were stored at the precast yard until needed at the bridge site.

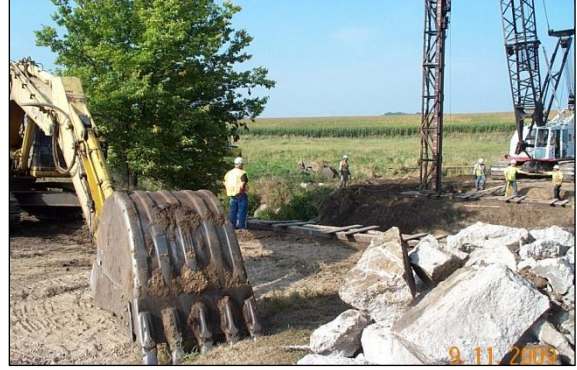
Templates used to position the five piles correctly in each abutment are shown in Figure 2.16b. When driving the piles, close attention had to be paid to their location and tolerances. Pile heads could not deviate from the specified locations by more than 3 in. in any direction, so that the precast pile cap could be installed easily.

b. Piling templates

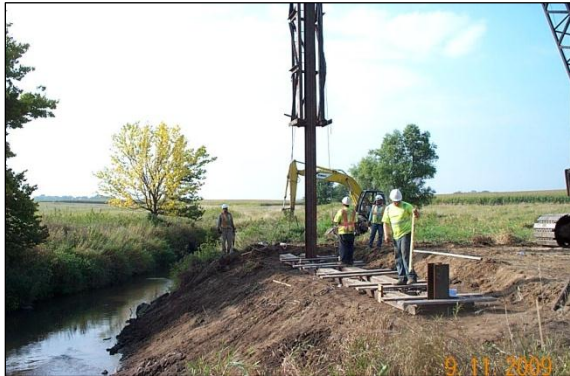
Figure 2.16c shows the driving of the second pile in the west abutment, while Figure 2.16d shows all west abutment piling is in place and cut to the desired length. Driving of the final pile in the east abutment is shown in Figure 2.16e; also shown in this figure is the installed filter fabric.

c. Pile driving in west abutment

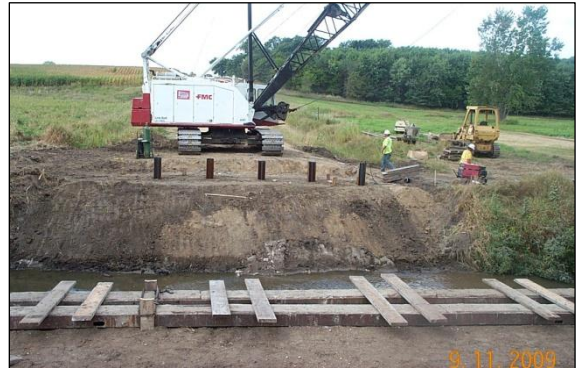
d. Piling completed in west abutment

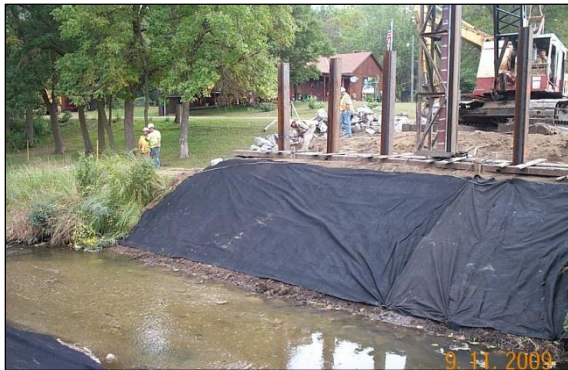
e. Driving piling in east abutment

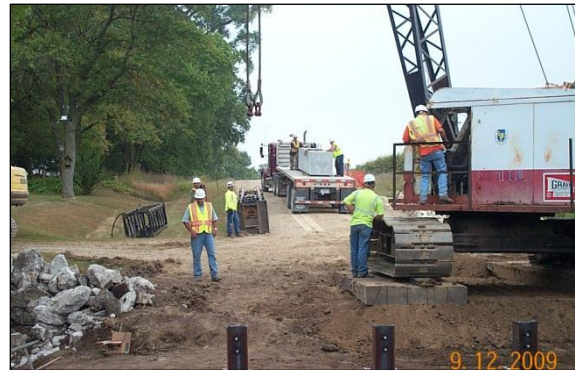
It took only one day (September 11, 2009) to drive all 10 piles required for the bridge substructure. Arrival of the east pile cap is shown in Figure 2.16f; the installed abutment cap is shown in Figure 2.16g.

f. East abutment cap arriving at site

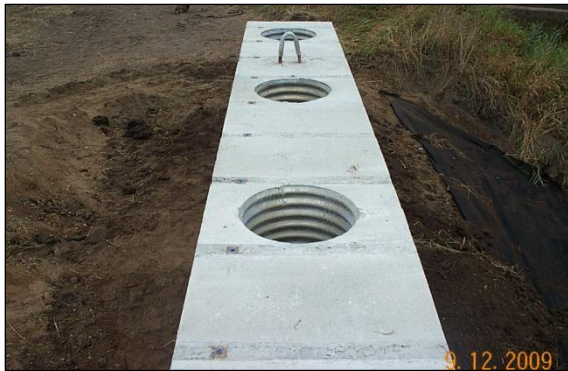
g. East abutment cap in place

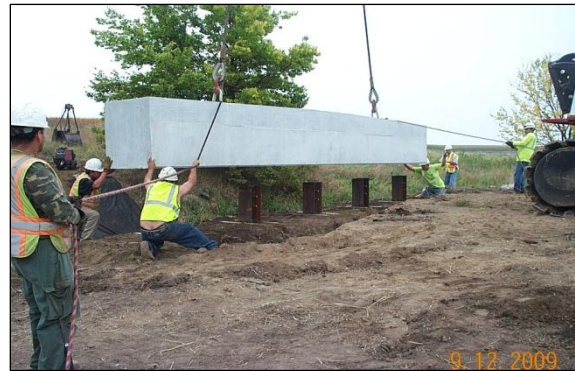
h. Installing west abutment cap

The same process was repeated for installation of the west abutment cap, which is shown being positioned in Figure 2.16h. After installation of the two abutment caps, concrete was placed in the abutment voids on September 12, 2009 and allowed to cure over the weekend.

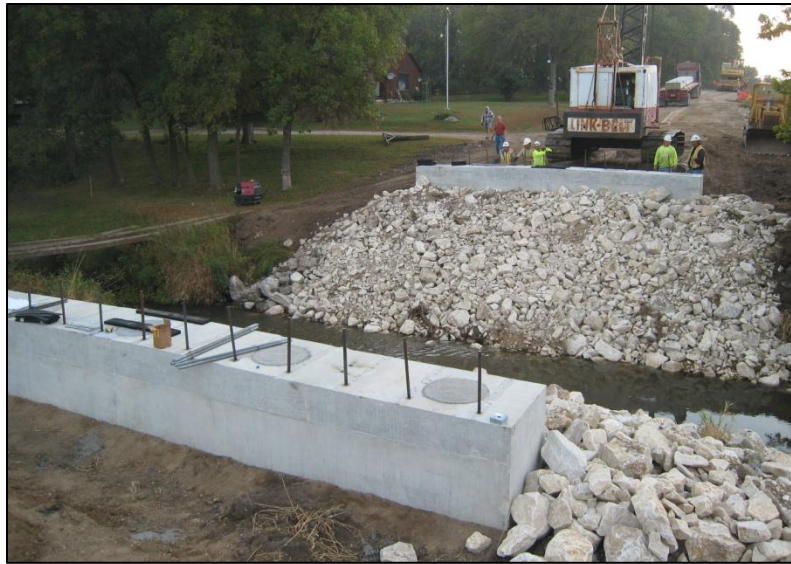
a. Both abutments in place

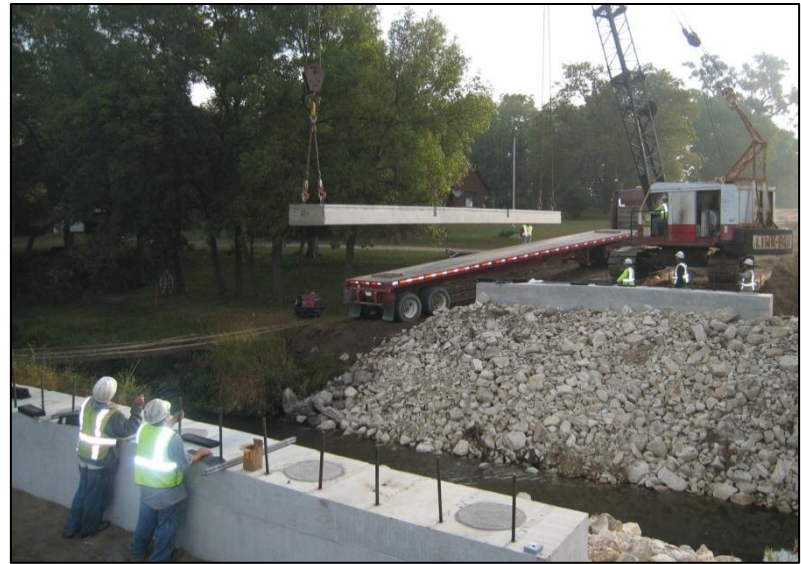
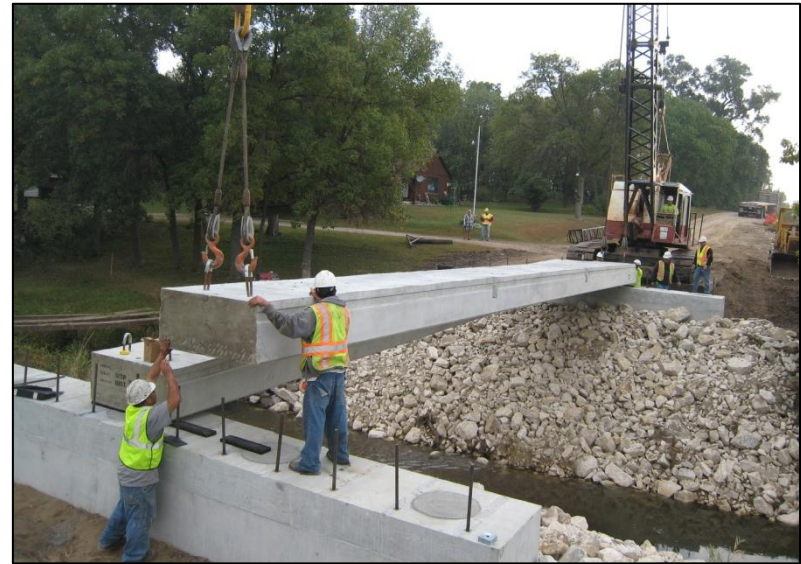
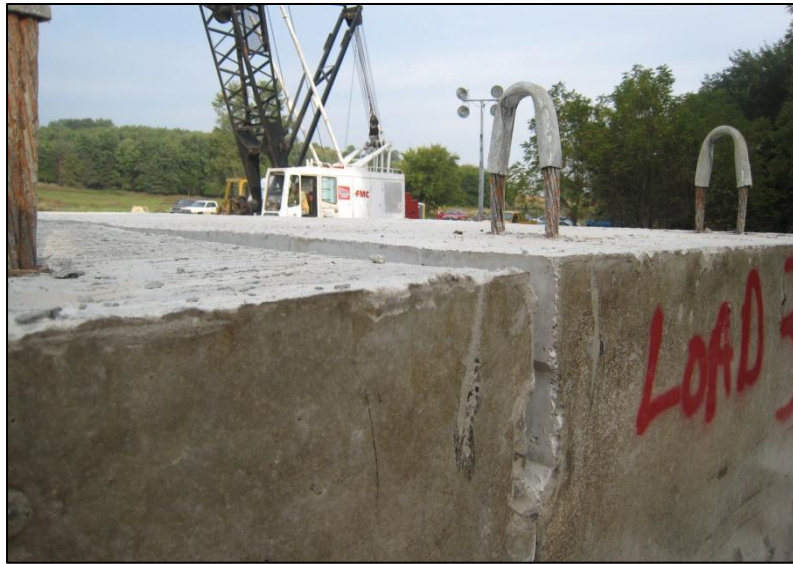
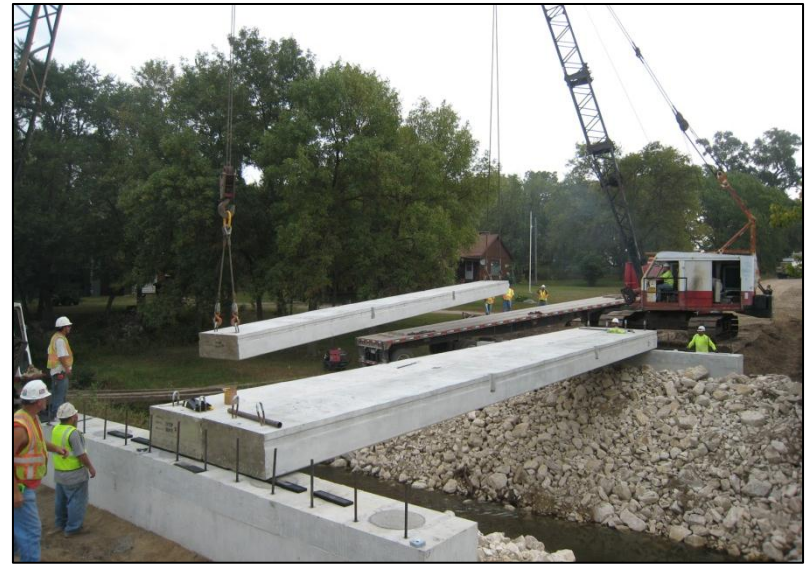
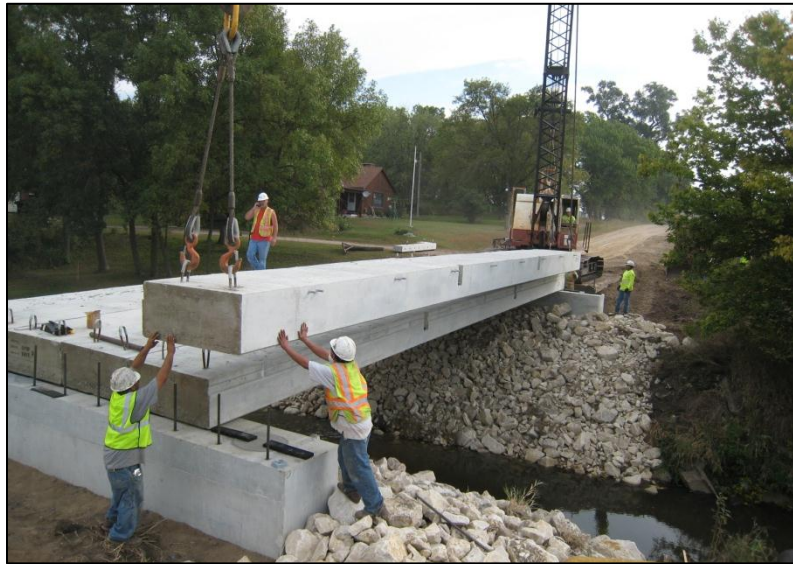
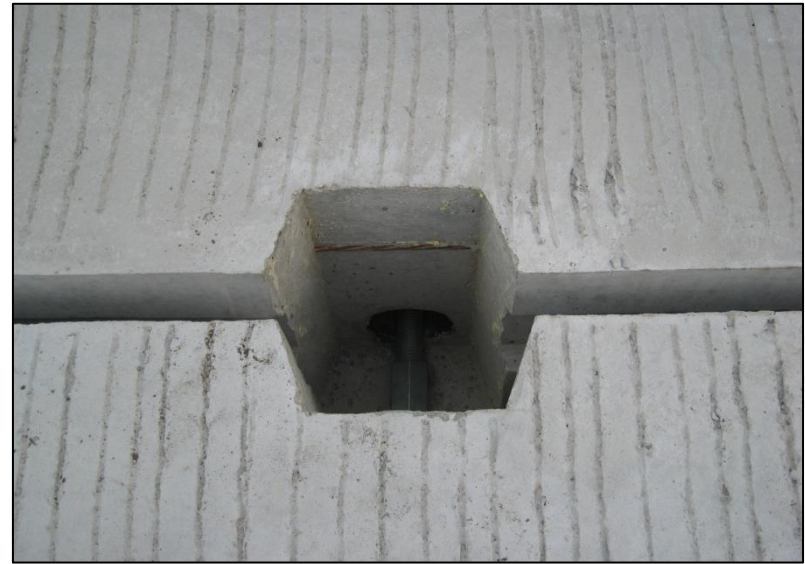
Figure 2.18. Construction of the superstructure

b. Unloading of Beam #4

d. Setting of Beam #5

e. Difference in beam thickness

f. Positioning of Beam #3

g. Positioning of exterior Beam #7

h. Tie rod block out

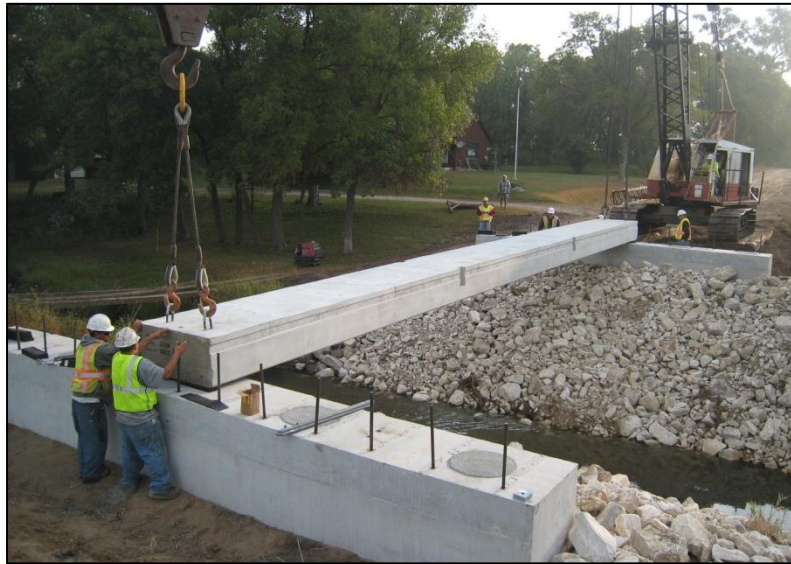
c. Positioning of Beam #4

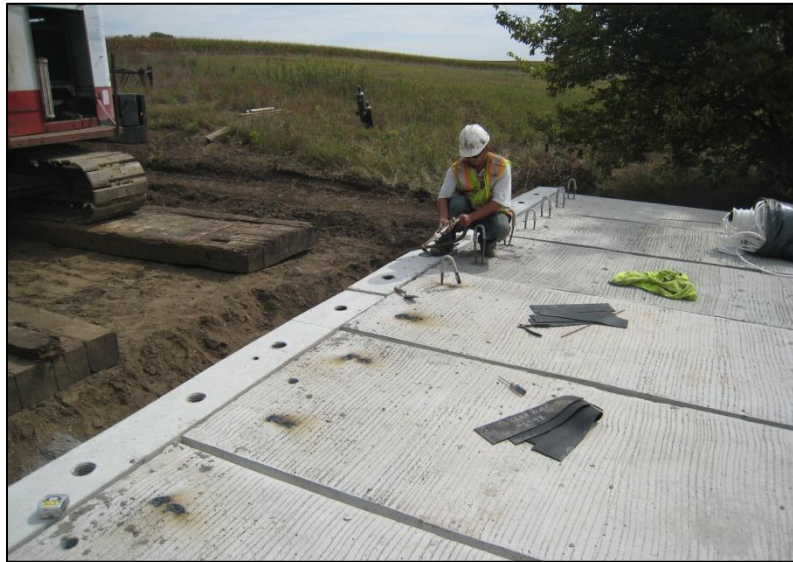
k. Cutting off beam lift cables

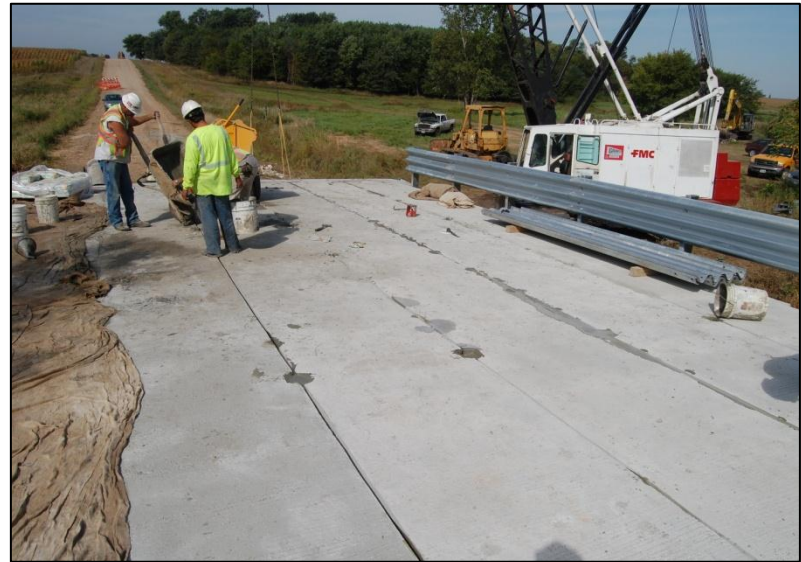
Figure 2.18. Continued

i. Tightening interior tie rods

j. Drill hole in abutment cap for new anchor rods

l. Placement of non-shrink grout

l	Workers shown placing non-shrink, non-metallic grout (NS Grout manufactured by The Euclid Chemical Company) in the joints between the adjacent beams and the pockets required for tightening the transverse tie assembly. Prior to placement of the grout, polystyrene backer rod was placed in the joint where required. Note the joint between Beams 6 and 7 has been completed and has been covered with wet burlap for curing.

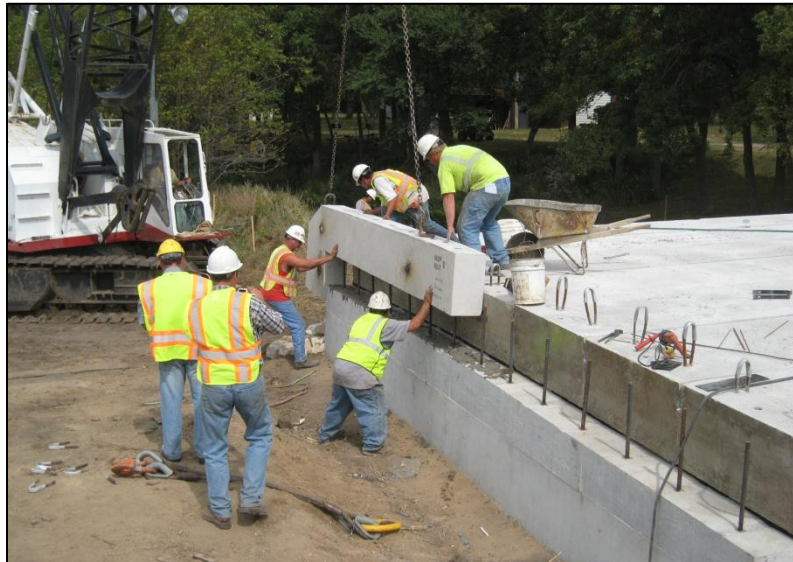
c. Placement of a backwall segment

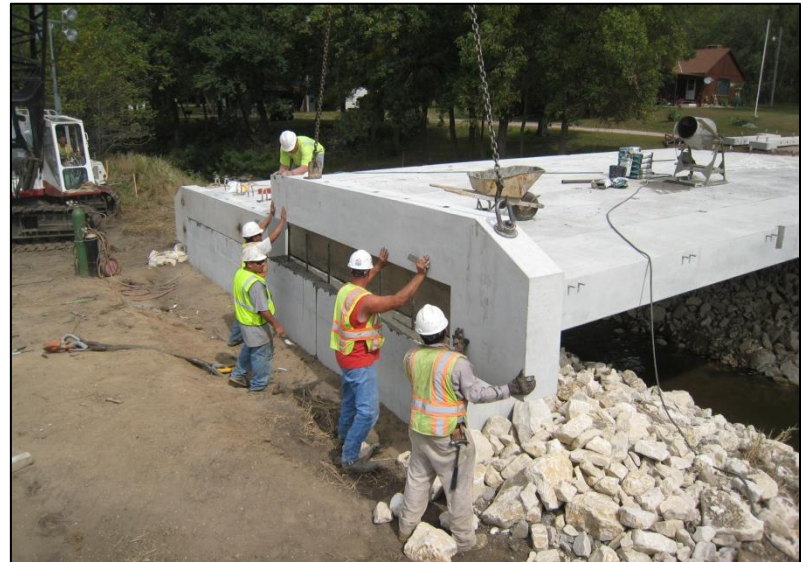
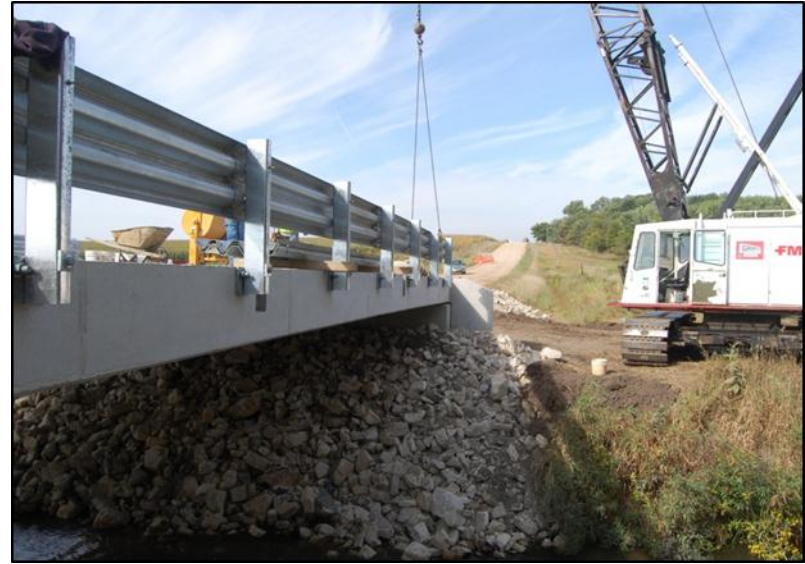
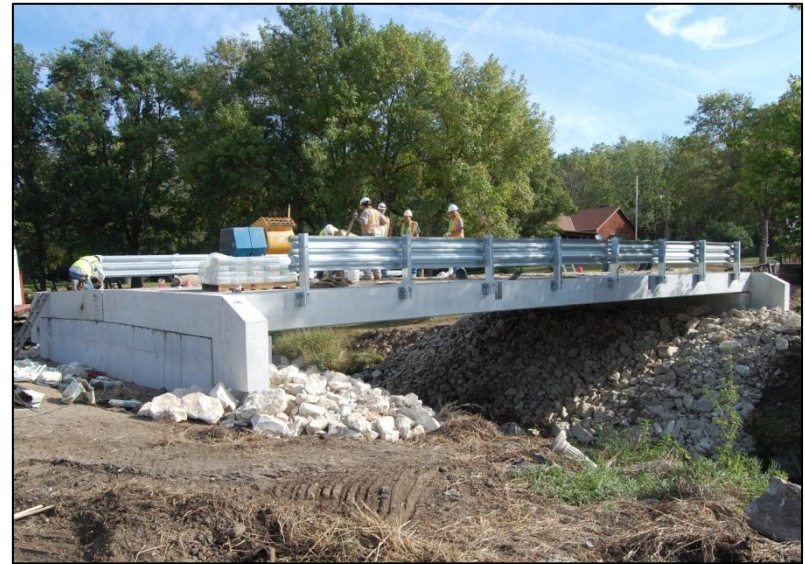
Figure 2.19. Installation of precast backwalls and guardrail system

a. Removing lifting loops on backwall segments

b. Placing grout bed for backwall segment

d. Placement of second backwall segment at west end

f. Completing north guardrail

h. "Completed" bridge

Details on the installation of the backwalls and guardrails are presented in Figure 2.19 and Table 2.5.

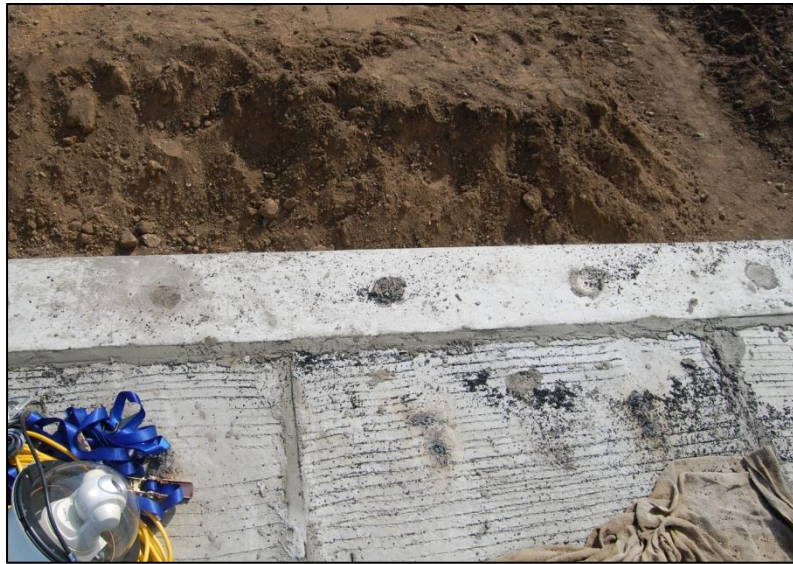
e. Grouting of various voids and joints

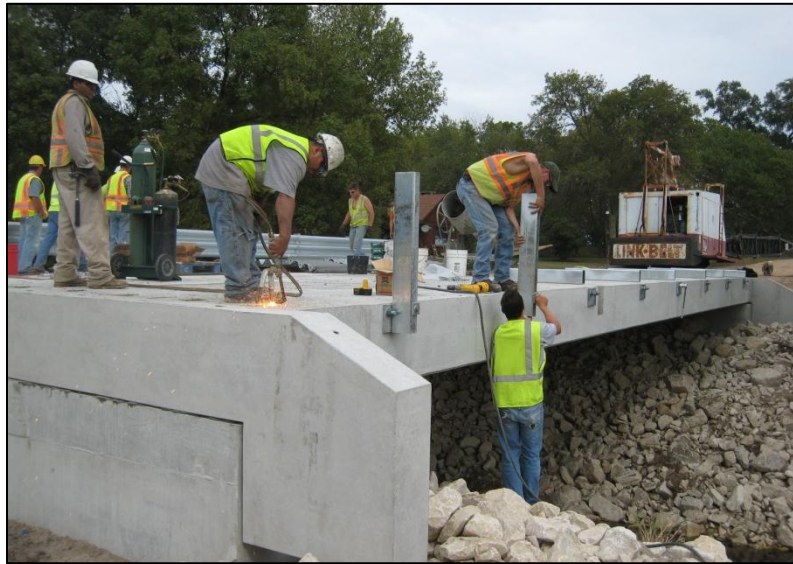
g. Installation of guardrail post on south side of bridge

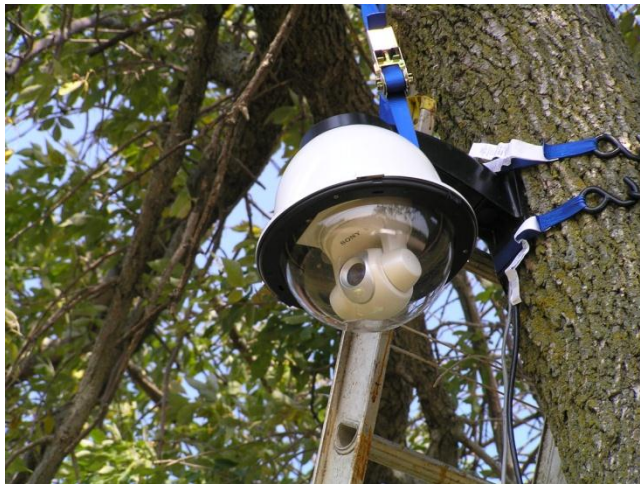
A Sony internet-based web-camera was installed relatively close to the northeast corner of the bridge site as shown in Figure 2.20a. A close-up of the camera is shown in Figure 2.20b.

This camera was installed on September 8, 2009 and recorded an image of the construction site every 5 minutes until September 15, 2009 when the camera was removed.

b. Time-lapse camera

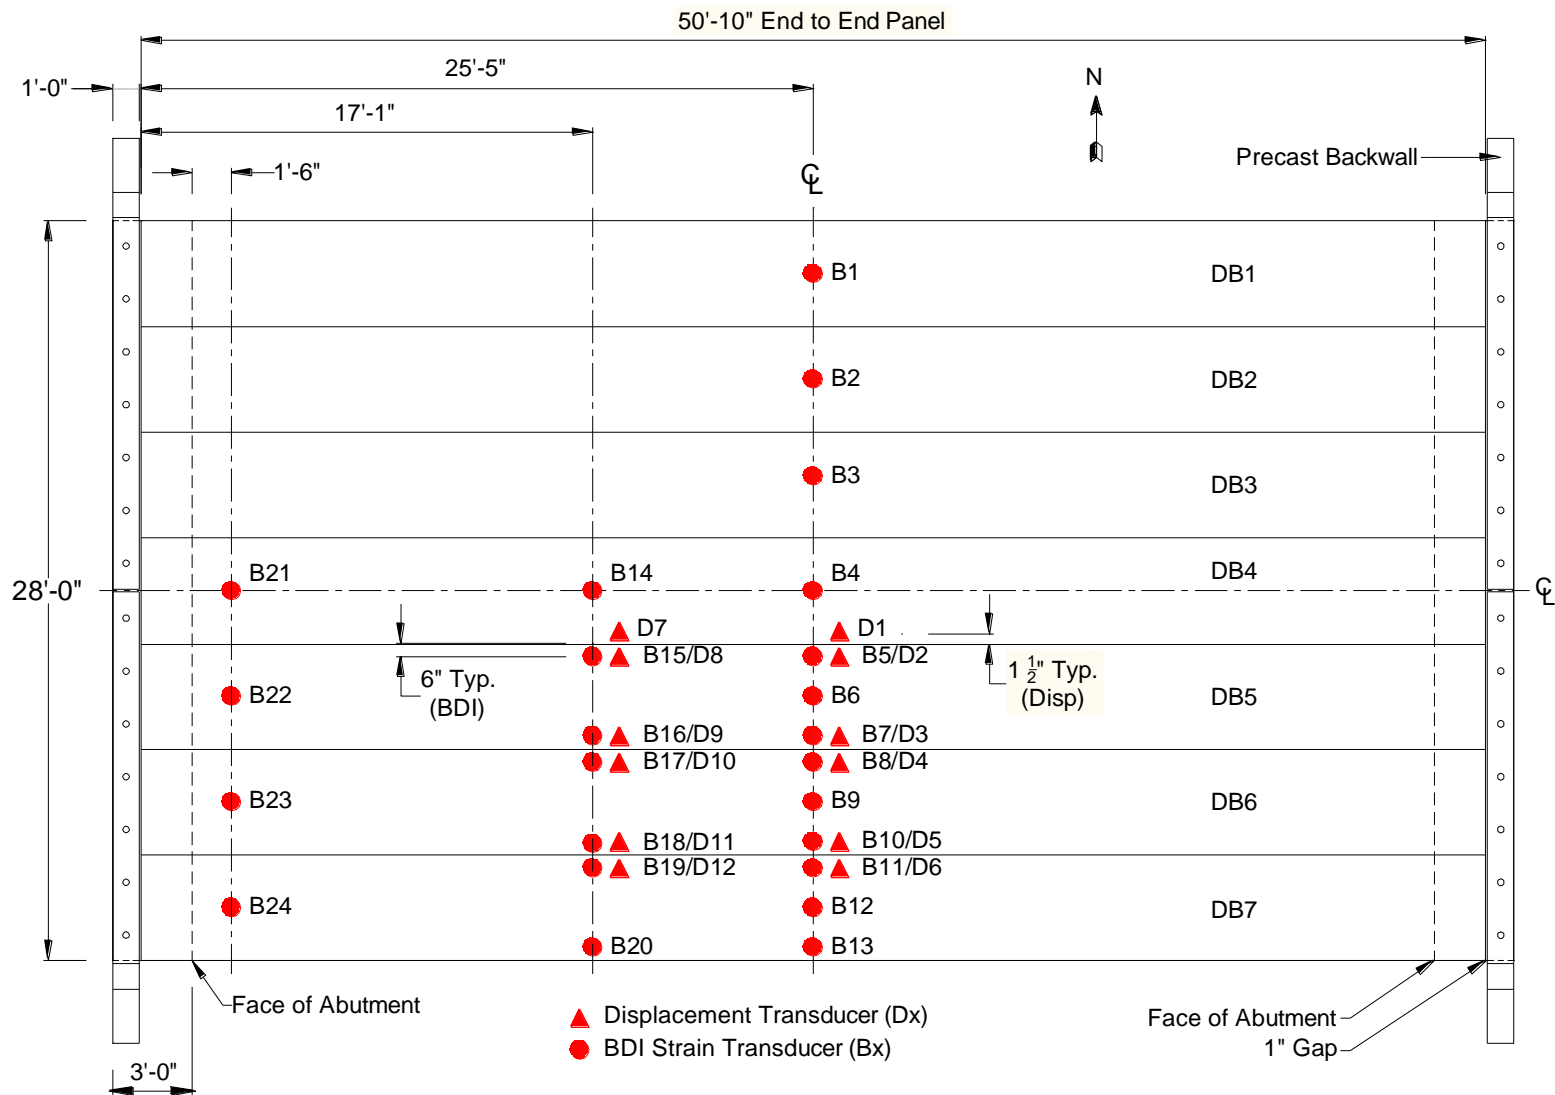
Figure 3.1. Instrumentation layout

a. 2009 Instrumentation

b. 2010 Instrumentation

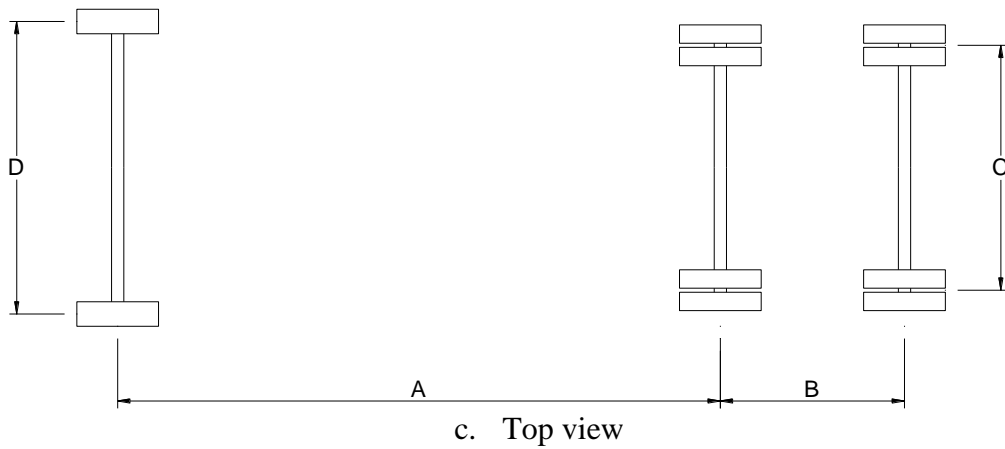
Figure 3.4. Dimensions and weights of test trucks used in 2009 and 2010 bridge field tests

The dimensions and weights of the test trucks used each year are presented in Figure 3.4. Truck 28 was used both years and was the truck used in the single truck load cases (LC1-LC5). Based on total weight, the weight of the truck was approximately the same each year; however, there was some difference in the axle weight distribution.

In 2009, Truck 13 was the second truck on the bridge in LC6 and LC7, while, in 2010, Truck 12 was used with Truck 28 in the two truck load tests (LC7). As Figure 3.4 shows, Truck 12's weight (used in the 2010 test) was about 3,000 lbs greater than Truck 13 (used in the 2009 test); however, the axle spacing in the two trucks is the same. An image of the two trucks on the bridge during LC7 in 2010 is shown in Figure 3.5.

Considering the slight difference in the truck weights between 2009 and 2010 (Figure 3.4) and the variation in the transverse distribution of the gravel in the trucks used in the 16 different tests (eight in 2009 and eight in 2010), there is very good agreement in the magnitudes of strains measured each year, as well as their distribution in the seven box beams.

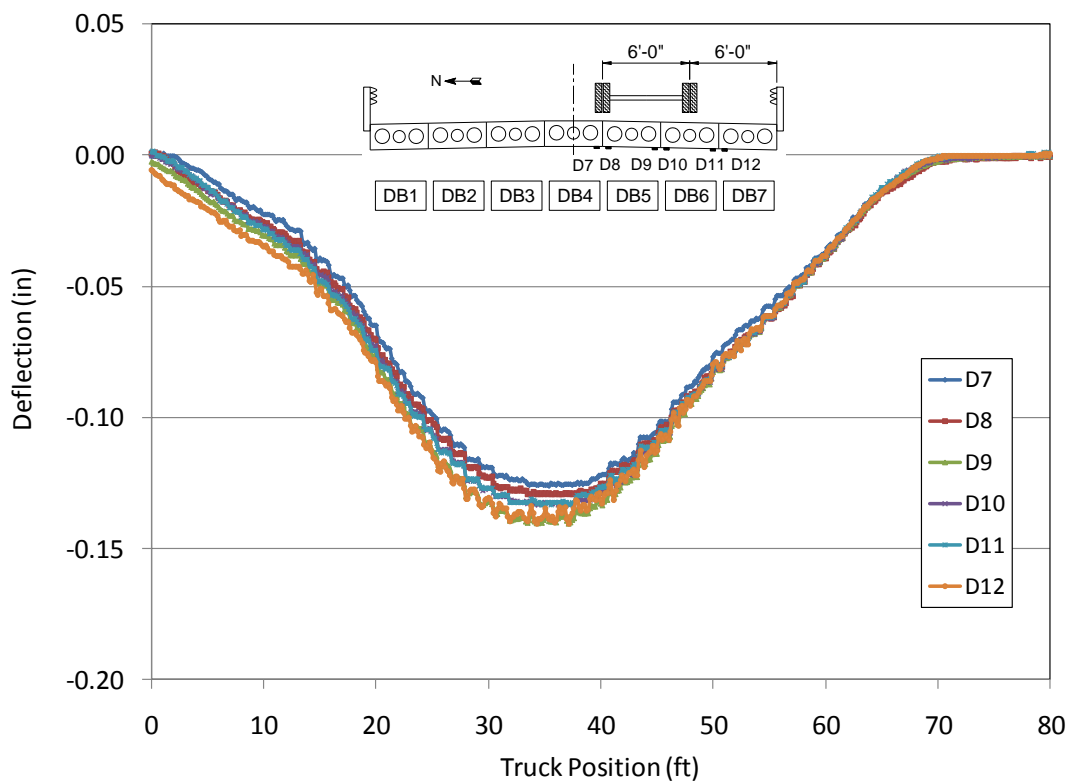
Figure 4.1. Representative time history – 2009 deflections

Representative time-history deflections for 2009 LC1, LC2, and LC7 are presented in Figure 4.1.

The various time history plots show deflections at midspan and quarter span at the edges of deck beams DB4, DB5, DB6, and DB7. With these data, the differential deflection between the four deck beams can be determined. A review of this deflection data indicates the differential movement between the adjacent deck beams for LC2 and LC7 is very small. In general, the deck beams that had the largest deflections were located closest to the applied load.

As noted previously, the maximum deflection (0.259 in.) occurred during LC7; when this value is normalized by weight to the standard HS20 truck and a dynamic amplification factor of 30 percent is used, the maximum deflection becomes 0.479 in., which corresponds to a span to deflection ratio of $L/1253$. The BVC deck beam bridge, therefore, is well within the AASHTO serviceability limit state for deflection.

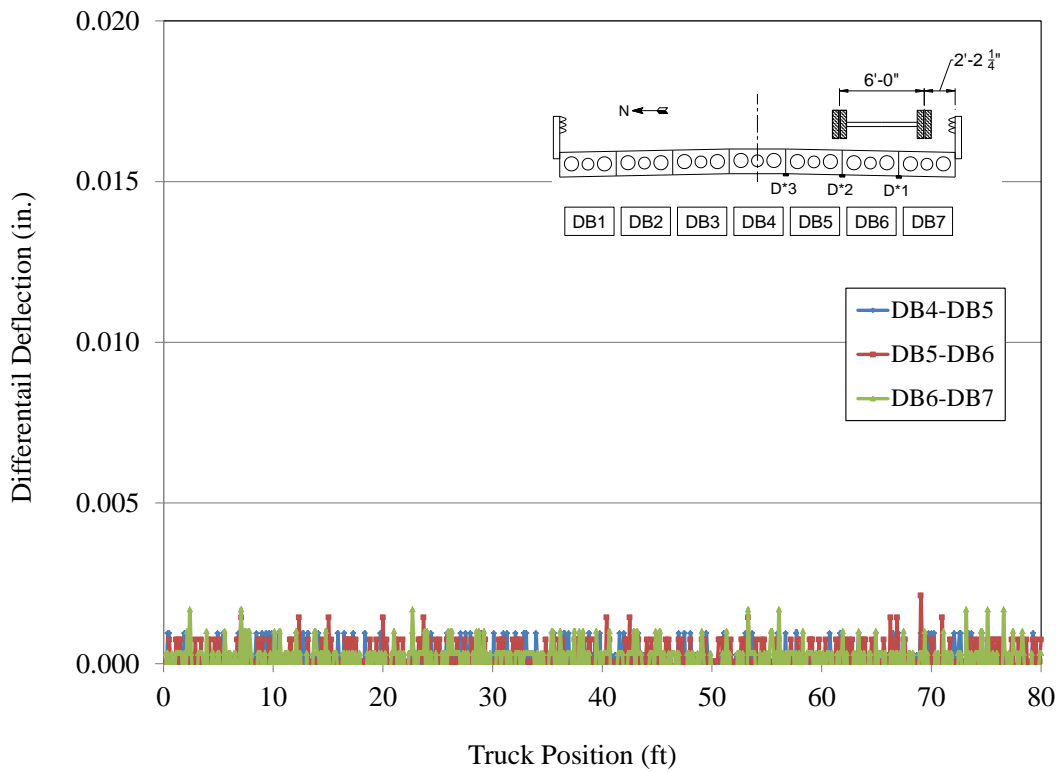
Figure 4.4. Representative time history – 2010 differentials

As was noted previously, the differential movements measured during the bridge test in 2010 were very small (approximately 1/10 the values measured during the 2009 tests. For this reason, only the 2010 differential movements measured during one load case, LC1, are presented in this report (see Figure 4.4).

In 2010, as noted previously, the differential movements were significantly less (approximately 1/10 as much) for all load cases and all joints. At the quarterspan, the maximum differential
