MPC 17-321 | C. Pantelides, D. Brown, J. Parks, and M.J. Ameli

Seismic Retrofit of Spliced Sleeve Connections for Precast Bridge Piers

March 2017

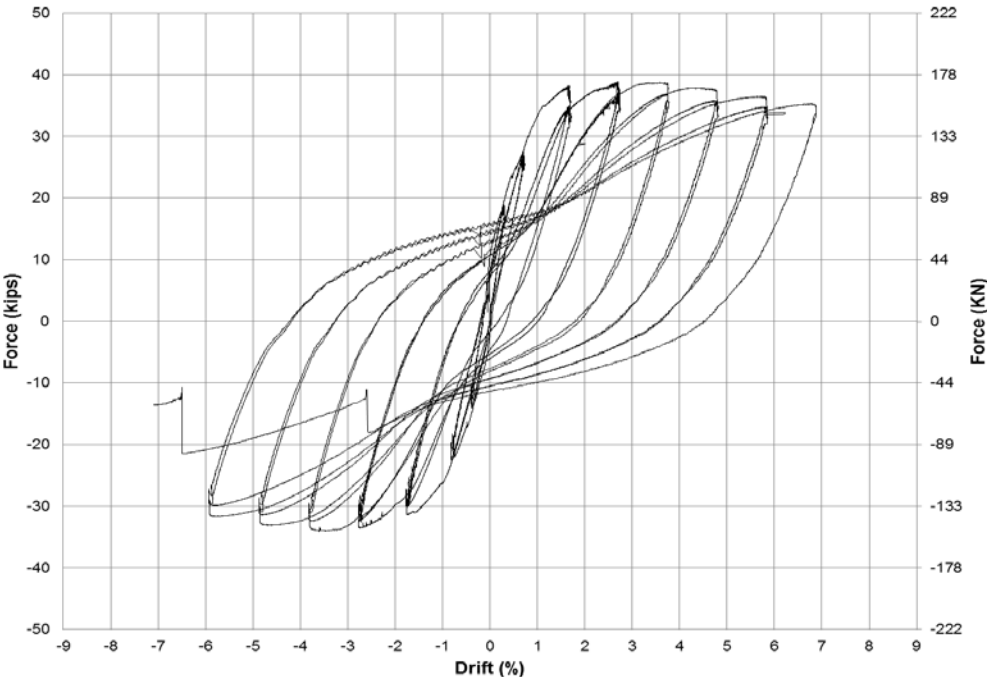
Figure 3.1 NM-O hysteresis curve

Specimen NM-O was a precast concrete column-to-footing assembly that had six GGSS connectors located in the footing. The hysteretic response of this specimen is shown in Figure 3.1, and the damage condition during the final displacement step of 7 inches and after testing is shown in Figure 3.2. It can be seen from the hysteresis curves that the ultimate load achieved during the test was 38.8 kip; the ultimate drift achieved was 6.42%, and the displacement ductility was equal to 6.1. The failure mode of the specimen was crushing of the column concrete followed by longitudinal rebar failure. The east extreme longitudinal bar fractured during the first cycle of the 7-in. displacement step, approximately 3 inches above the top of the footing. The lateral load capacity in the west direction was severely diminished once the east longitudinal rebar fractured. The lateral load capacity in the west direction, after the longitudinal rebar fractured, dropped to 65% of the ultimate lateral load capacity. A plastic hinge is evident at the column-footing interface of specimen NM-O; spalling extends up the column for a distance of 8 to 12 inches on the west and east extreme column faces. Structural cracking of the column occurred at three levels located approximately 6 inches, 10 inches, and 14 inches above the footing. The maximum crack width at the 6 in., 10 in., and 14 in. levels was 0.050 inches, 0.025 inches, and 0.030 inches, respectively. Cracking extended up the column higher than 14 inches but remained hairline in width throughout testing in this region.

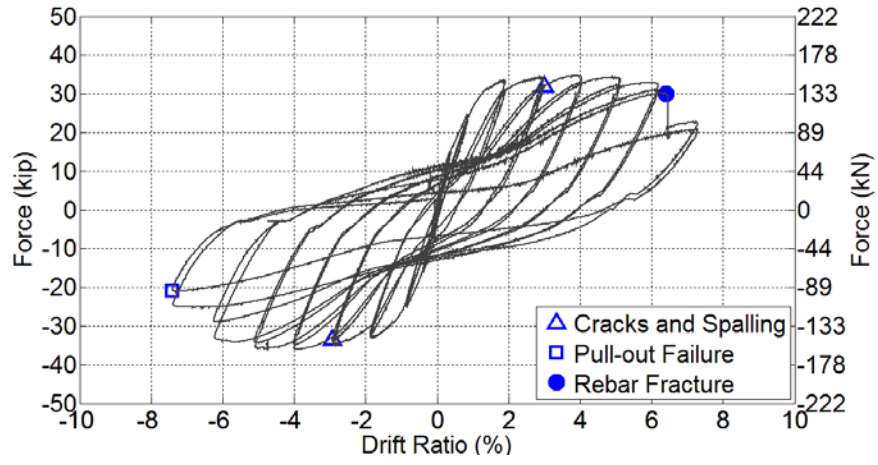
**Figure 3.3** Hysteresis response of specimen LE-O

The failure mode of specimen LE-O was fracture of an extreme longitudinal bar. The extreme west longitudinal bar fractured in LE-O. Once the extreme longitudinal bar fractured, the lateral load capacity of the specimens dropped below 20% of the ultimate load capacity. From the hysteresis curves, shown in Figure 3.3, the ultimate load achieved during the test was 37.7 kip; the ultimate drift achieved was 6.50%, and the displacement ductility was equal to 5.8. A very well developed plastic hinge was formed at the column-to-pier cap interfaces where extensive spalling and cracking occurred, as shown in Figure 3.4. Major structural cracking was isolated to three distinct heights from the footing or pier cap interface, where the highest crack was located 12 inches up the column for LE-O; these crack widths ranged from 0.016 to 0.060 inches.

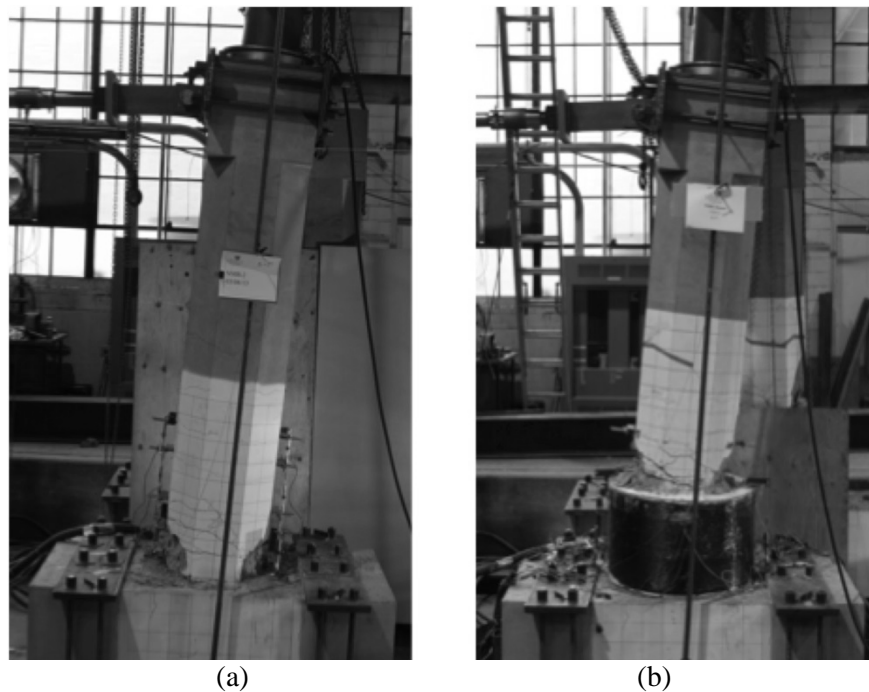
**Figure 4.7** Specimens displaced to the east at the maximum displacement: (a) NM-O, (b) NM-R

The objective of repairing specimen NM-O was to restore the diminished load and displacement capacity through plastic hinge relocation. Plastic hinge relocation was achieved after the repair and is shown in Figure 4.7. The hysteretic response and force-displacement envelope of NM-R is shown in Figure 4.8 and Figure 4.9, respectively. From these figures it is seen that both the load and displacement capacity of NM-R were restored. The ultimate drift achieved was 6.96%, and the ultimate load was approximately 45.56 kips. The displacement ductility that NM-R achieved was 7.52 when displaced to the east and 4.15 when displaced to the west.

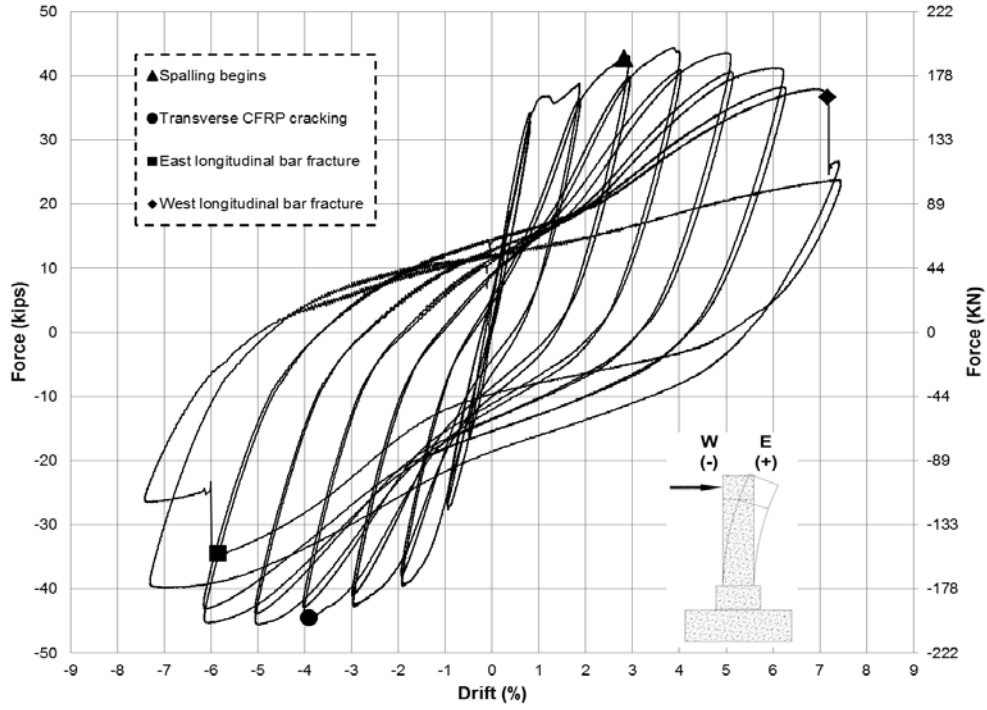
Figure 4.8 NM-R repaired specimen hysteresis curve

The displacement ductility when displaced to the west is approximately 55% of the displacement ductility when displaced to the east. The loading protocol displaces the specimen to the east before the west for each cycle, degrading the stiffness of the specimen, which causes this difference in displacement ductility. The average ductility, calculated from an averaged envelope curve of repaired specimen NM-R, is 5.95.

The 2-in. displacement step started with an audible event occurring during the first displacement to the east. The event can be seen in the hysteresis in Figure 4.8 as a plateau beginning at approximately 1% drift and continuing through completion of the cycle. The noise that was heard was due to relaxation of the tie-down rods that anchor the specimen to the strong floor. The unbalanced tension in the rods due to residual displacements from the original test was relieved as one of the rods shifted. This event resulted in the tie-down rods balancing the reaction forces on both sides of the specimen, subsequently making the hysteretic behavior of the test symmetrical from that point forth. New cracking occurred during this round with a 0.06-in. crack opening up 2 inches above the top of the repair on the east column face, as shown in Figure 4.12(b). A 0.025-in. crack originating 3 inches above the repair on the west face was created during the 2-in. displacement step. These cracks continued to grow throughout the test and are the beginning of the plastic hinge formation.

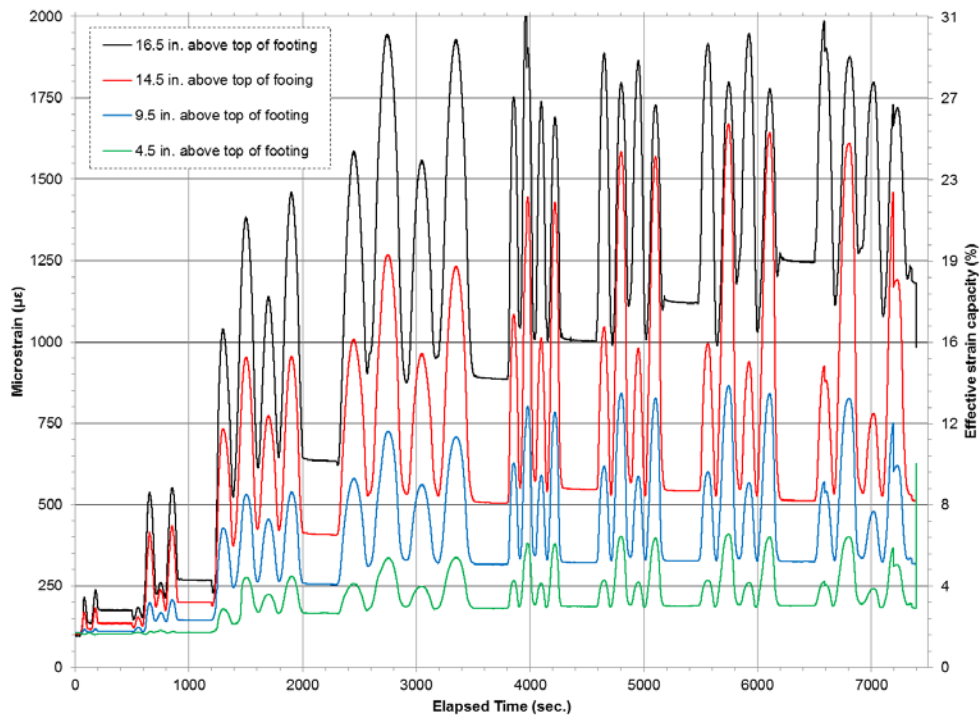
**Figure 4.14** NM-R CFRP wrap strain gauge data averaged by height

The performance of the CFRP jacket during the NM-R test is studied in this section. The four layers of unidirectional CFRP composite provided sufficient shear strength and confinement to the repaired cross-section, facilitating relocation of the plastic hinge region to the top of the repair. The CFRP jacket results are highly affected by the repair concrete properties. The specimen had non-shrink concrete, which caused pre-tensioning of the CFRP jacket to a strain of 0.01% prior to testing. The strain result from testing will be compared to the effective strain capacity of the CFRP jacket. The effective strain capacity for the repair was taken as 57% of the ultimate strain capacity recorded from tensile coupon tests [17]. The CFRP strain efficiency factor accounts for strain concentrations, and the multiaxial state of stress acting on the jacket when the CFRP wrapped member is subjected to compression and bending. The concrete that filled the NM-R specimen's CFRP jacket was non-shrink concrete that pre-tensioned the jacket to 105 microstrain. This is a very small amount of pre-tensioning, accounting for less than 2% of the jacket's effective strain capacity. Transverse CFRP cracking started during the test at the 4-in. displacement step and grew throughout the subsequent displacement steps, as illustrated in Figure 4.10. Although this characteristic is of concern, the transverse cracking did not adversely affect the results of the repair.

Figure 4.14 shows the uneven vertical distribution of strain throughout the CFRP jacket during the NM-R joint test. Four different levels of strain gauges, placed at different heights above the top of the footing, are averaged together on all four sides of the CFRP jacket, giving an average top band, top, middle, and bottom strain value. The top band, top, middle, and bottom levels of strain gauges are located 16.5 inches, 14.5 inches, 9.5 inches, and 4.5 inches above the top of the footing, respectively. The maximum strain reached in the bottom, middle, and top levels is 15%, 38%, and 78% of the maximum strain reached in the top band level. Figure 4.14 shows a plateau in the strain that the wrap develops, which begins with the 4-in. lateral displacement step. The maximum lateral load was reached during the 4-in. displacement step. The peak strains for each displacement step follow the shape of the response envelope from the test, implying that the jacket strain level is controlled by load rather than displacement. The maximum strain recorded in the jacket was on the east side of the wrap at the level of the top band as 3200 microstrain, or a maximum of 50% of its effective strain capacity.

Uneven straining of the jacket, when displaced east and west, is shown in Figure 4.14. The second displacement in each cycle, corresponding to a displacement in the east direction, experiences more strain than in the first displacement. This uneven directional straining is present up to the first cycle of the 4-in. displacement step, up to an elapsed time of 4000 s, when the jacket developed the transverse crack. The cracking relieved the uneven distribution of directional strain. The onset of transverse cracking can be seen from individual strain gauge data from the top band, shown in Figure 4.15. The top band east strain gauge is engaged in both displacement directions through the first cycle of the 4-in. displacement step, at the 4% drift ratio, when transverse cracking began. Onset of the crack relieved the strain in both directions, and the CFRP wrap began to act similarly to the top band west strain gauge, as shown in Figure 4.15(a). Between displacement steps, the wrap is experiencing residual strain from dilation of the repaired concrete. Figure 4.14 and Figure 4.15 show an increase in residual strain after each displacement step. The largest increase in residual jacket strain is between the 1-in. and 2-in. displacement steps due to radial cracks, as shown in Figure 4.12(a), which caused the concrete inside the repaired section to dilate, increase the pressure on the CFRP wrap, and thereby increasing the wrap strain.

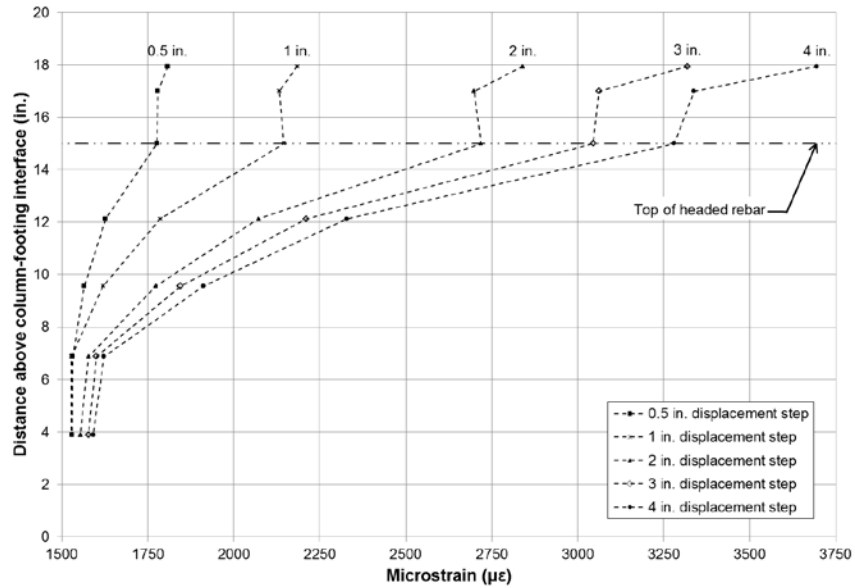
**Figure 4.16** NM-R west face wrap strain profile up to 4-in. displacement step

Figure 4.16 shows the uneven distribution of strain vertically throughout the jacket; the strain profile is a plot of the strain gauge height above the footing versus the maximum strain that the gauge read during a displacement step. All points from a given displacement step are connected with a dashed line due to the uncertainty in strain between points. The strain, as a function of distance above the top of the footing, exponentially increases up to a height of 15 inches above the top of the footing. At 15 inches above the top of the footing there is a discontinuity in the strain profiles. The post-installed headed bars extended to 15 inches above the top of the footing and are the reason for the discontinuity in the CFRP wrap strain profiles. The mechanisms that transfer tension to the CFRP wrap are the headed rebar and the column bearing on the non-shrink concrete. The discontinuity in the strain profile signifies the contribution that the headed rebar plays in transferring tension to the CFRP wrap.

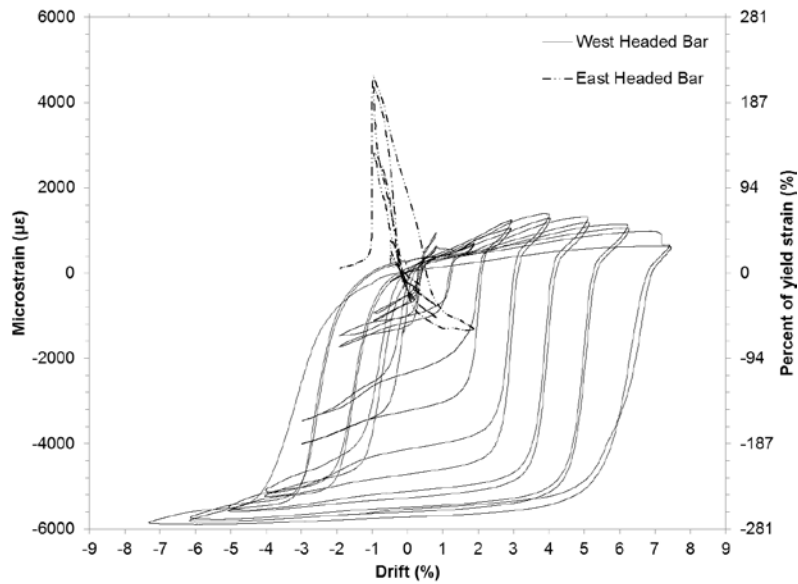
**Figure 4.17** NM-R headed bar strain gauge data from 7.5 inches above the footing level

The behavior of the headed rebar observed during testing seems to be influenced by the final damage state. The east longitudinal rebar in the column of NM-R fractured during testing, diminishing the flexural capacity of the specimen in that direction. The headed rebar replaced this lack of flexural capacity in both tension and compression, creating a bending moment couple. The east headed rebar yielded in tension during the 1-in. displacement step, reaching strains of over 1.9 times the yield strain during this displacement step. After the 1-in. displacement step the east strain gauge was lost. It is assumed that the east headed bar went well beyond 1.9 times the yield strain in subsequent displacement steps. The west headed rebar yielded in compression during the 3-in. displacement step, reaching compressive strains of nearly 2.8 times the yield strain during the 7-in. displacement step.

Plastic hinge relocation of NM-O was successfully achieved by NM-R, as shown in Figure 4.17. The hysteretic response of the repaired specimen NM-R is compared in Figure 4.18 with the hysteretic response of the as-built specimen NM-O superimposed. It can be seen that the repaired specimen had an approximately 30% larger lateral load capacity than the as-built specimen. This increase in load capacity is thought to be due to two reasons. First, the moment arm for the repair test is decreased by nearly 20% due to the height of the repair; therefore, a larger load is required to achieve a plastic hinge. Second, the repair test occurred after the as-built test; therefore, the concrete compressive strength of the as-built concrete was larger.

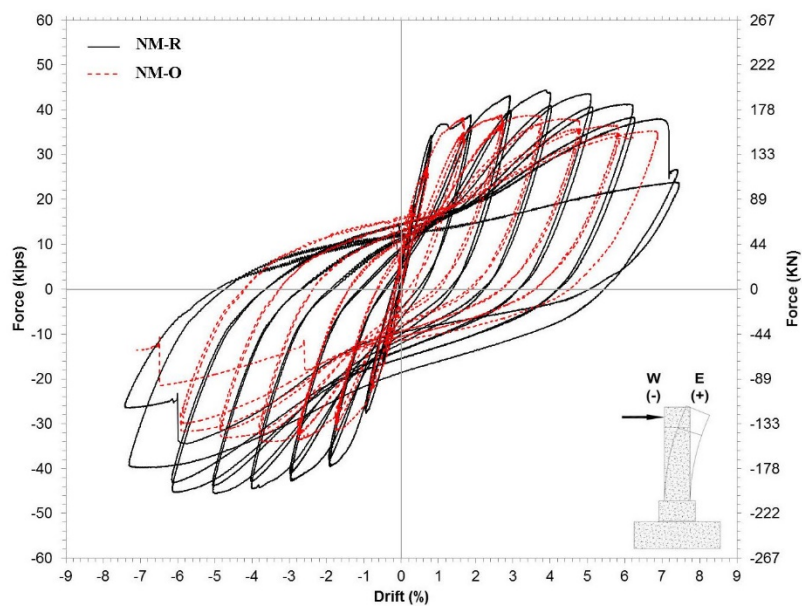
**Figure 4.18** Comparison of hysteresis curves for NM-O and NM-R

The displacement capacity of NM-R is slightly greater than the displacement capacity of NM-O. This is an interesting outcome because the repair should have a decreased displacement capacity due to the shortened column length. The shortened column means that for a given displacement, the repair would have a larger rotational demand than the as-built one. However, the as-built joint is a connection of precast concrete elements using GGSS connectors, and the displacement capacity may be adversely affected due to slip and rocking. The repair transforms the precast joint into a system that performs more like a monolithic assembly. The averaged displacement ductility of NM-R of 5.95 is nearly identical to the displacement ductility of NM-O of 6.10. The repair was capable of restoring the diminished load,

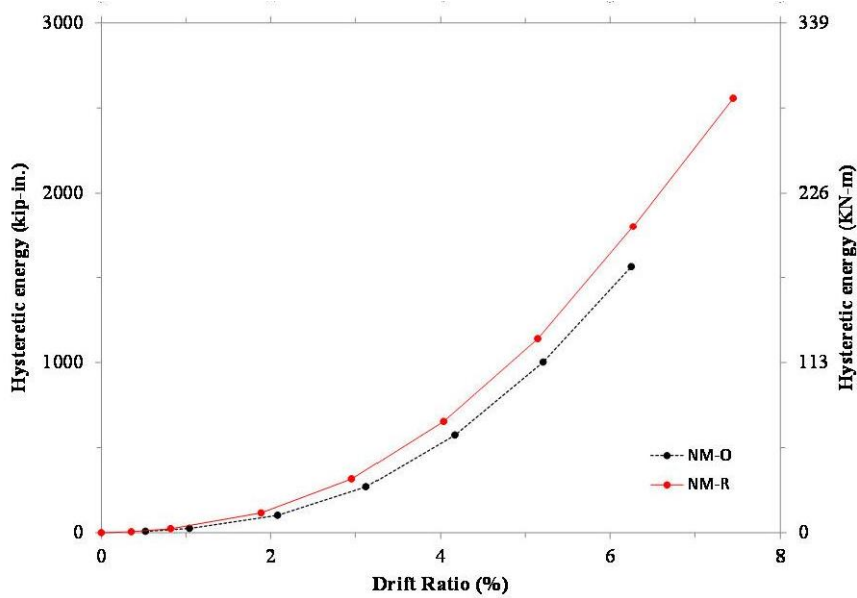
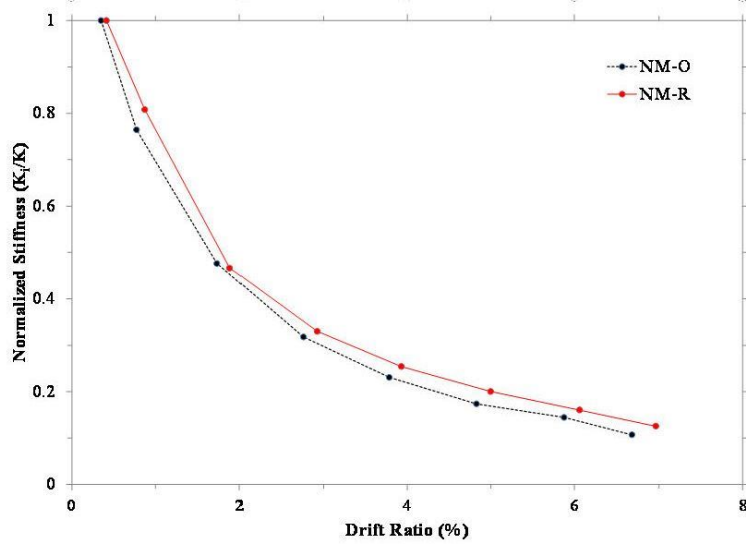
**Figure 4.19** NM-R performance comparison: (a) hysteretic energy dissipation, (b) normalized stiffness degradation

The hysteretic energy dissipation and stiffness degradation characteristics were investigated and compared to NM-O, as seen in Figure 4.19(a) and Figure 4.19(b), respectively. The cumulative energy dissipation of NM-R is slightly greater than NM-O for all drift ratios; at the completion of the 6% drift ratio, NM-R has dissipated 15% more energy than NM-O. The stiffness degradation characteristics of NM-R and NM-O are very similar when normalized to the 0.5% drift ratio stiffness. The normalized stiffness of NM-R is slightly larger than NM-O at all drift ratios. These performance parameters confirm that the repair restored the assembly to a performance level similar to the original condition. Further details of the repair method for column-to-footing joints are presented elsewhere [18].

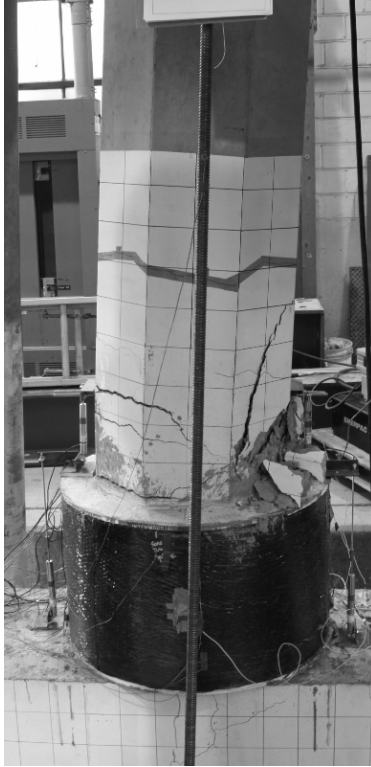
**Figure 4.20** Specimen LE-R monotonic pushover at maximum drift

A static pushover test was applied to specimen LE-R before the cyclic quasi-static test was carried out. The static pushover consisted of a displacement to the east equal to 6.65 in. The column at this maximum displacement is shown in Figure 4.20. It can be seen that the plastic hinge has been successfully moved above the repair with extensive spalling on the east side of the column that extends up to 20 inches from the top of the repaired section. There are, in addition, major flexural cracks that opened on the west side of the column at 2 inches, 9 inches, and 12 inches above the repaired section.

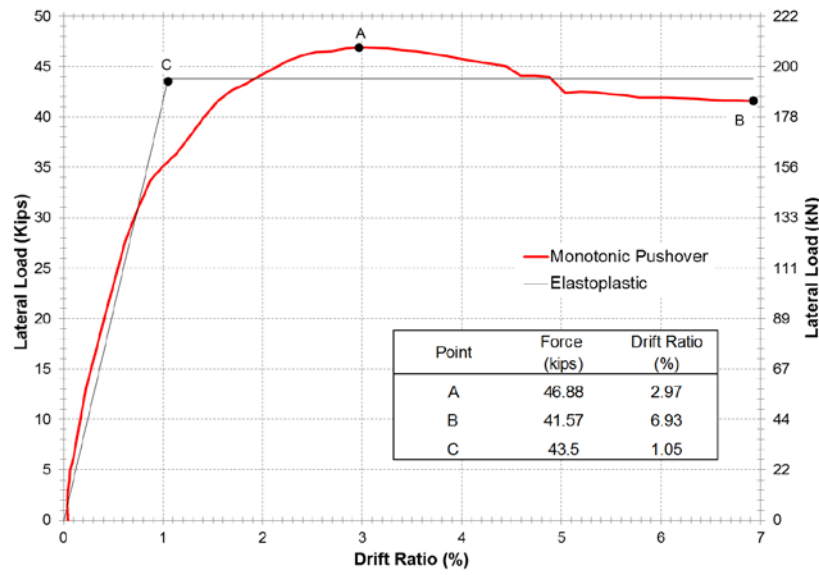
**Figure 4.22** LE-R monotonic pushover curve

The monotonic pushover curve shown in Figure 4.22 was obtained during the static push test. Point A in the figure corresponds to the maximum lateral load from the monotonic pushover, which occurred at a drift level of 2.97%. After the maximum lateral load was reached, the concrete on the east side of the column began to crush and the lateral load began to decrease until the actuator was stopped at point B. To determine the displacement ductility of LE-R from the monotonic pushover curve, an idealized elastoplastic curve is superimposed on the monotonic pushover curve. Point C represents the theoretical yield point of the system. To obtain the elastoplastic curve, the equal area method was used. The displacement ductility was computed by dividing the drift at point B by the drift at point C; a ductility of 6.6 was obtained for LE-R from the monotonic pushover. The results for LE-R are from a monotonic pushover instead of a cyclic test and cannot be reasonably compared to the results of LE-O, but the value of 6.6 is believed to be slightly above the ductility of the specimen under cyclic loads.

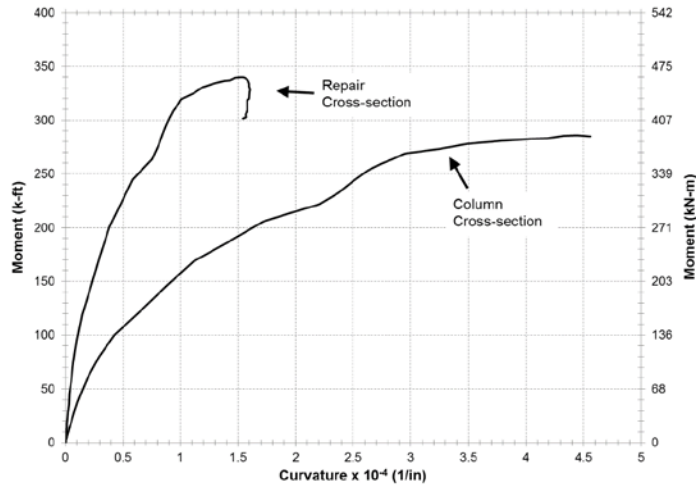
**Figure 4.23** LE-R monotonic pushover moment-curvature

To better understand the behavior of LE-R during the monotonic pushover, an analysis of the moment versus curvature of the repaired region and the region of the column just above the repair was performed using experimental data. Figure 4.23 shows the moment curvature of these two sections; it is clear that the stiffness of the repaired region was much greater than that of the original column. Also, once the maximum moment was reached, the repaired section experienced no additional curvature since larger deformations took place in the column just above the repair. In addition, pier cap deflection and slippage of the test specimen were negligible.

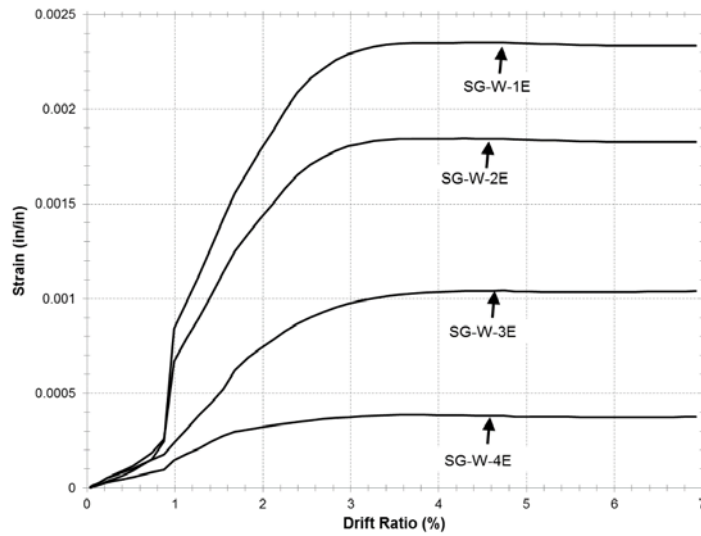
**Figure 4.24** LE-R east CFRP jacket hoop strains

The strains that were observed in the CFRP jacket during the monotonic pushover were examined. Figure 4.24 shows the hoop strain on the east side of CFRP jacket which is the direction that the column was pushed. Strain gauges 1E, 2E, 3E, and 4E were located 2 in., 4 in., 9 in., and 14 in. below the top of the CFRP jacket, respectively. This side of the jacket experienced the highest strain; the amount of strain decreases towards the pier cap. Figure 4.24 shows a noticeable plateau in the CFRP jacket hoop strain; this occurs at about the 3% drift level which is where the maximum horizontal load occurred. The fact that the strains in the jacket remain constant after the maximum lateral load is reached suggests that the strains in the CFRP jacket are more dependent on the applied horizontal load rather than the displacement of the column.

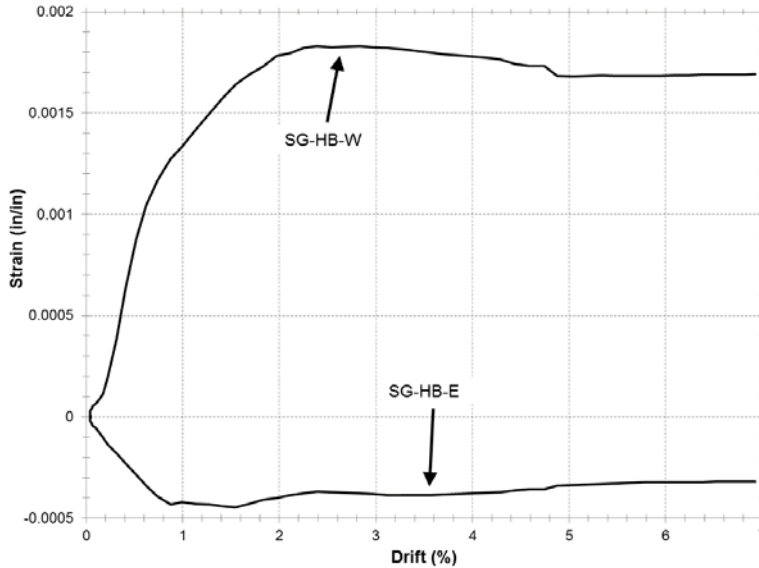
**Figure 4.25** LE-R headed bar strains

Strains in the extreme headed bars during the monotonic pushover test are presented in Figure 4.25. Since the column was pushed to the east, Figure 4.25 shows that the post-installed headed bars on the west side of the column pick up the tension and transfer it to the pier cap while the east headed bars go into compression. From these strain gage data, it is clear that none of the instrumented post-installed bars have exceeded the yield strain of 0.00207 in./in.

The headed bars also have a plateau or drop in strain near the drift level at which the maximum lateral load occurred. Similar to the strain in the CFRP jacket, the strain in the headed bars depends more on the horizontal load rather than the column displacement.

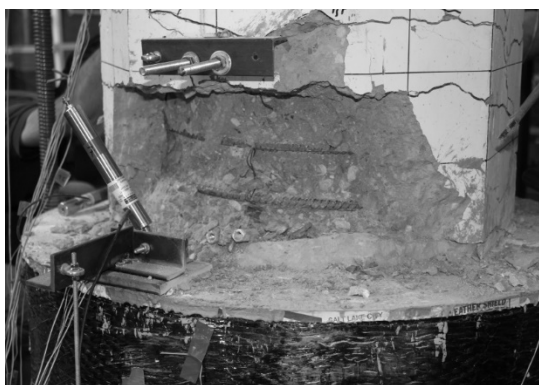
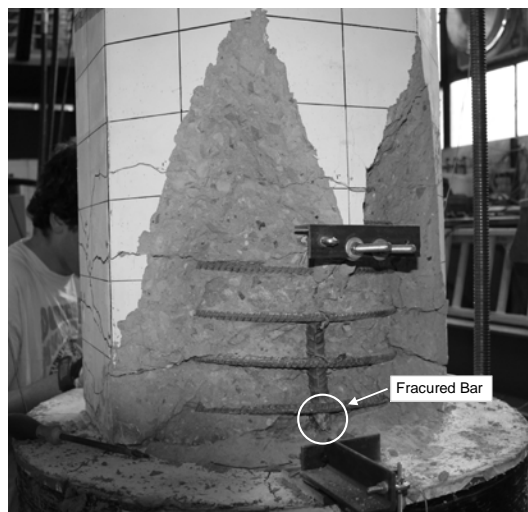
Repaired specimen LE-R, which was already damaged from the monotonic pushover test, was retested using the loading protocol shown in Figure 2.7. Even with the initial damage from the monotonic pushover, the column was able to reach a maximum drift of 7.2% and a maximum lateral load of 40.5 kip before fracturing the extreme east longitudinal column bar just above the repaired section. To clearly see the relocation of the plastic hinge in LE-R, Figure 4.26 compares specimens LE-O and LE-R at maximum drift. In Figure 4.26(a), the plastic hinge formed just above the pier cap while in Figure 4.26(b), the plastic hinge was relocated to a position just above the repair. Figure 4.27 shows the final damage of the west side and east side of the column. The west face of the column had spalling that went 10 inches up the face of the column, exposing transverse reinforcement. On the east column face, additional spalling of the concrete occurred, exposing more of the column reinforcement; ultimately the extreme longitudinal bar on this side fractured. No additional flexural cracks developed during the test. The cracks that developed from the monotonic pushover test just continued to widen from 0.05 to 0.125 inches by the end of the cyclic test.

**Figure 4.27** Final damage of repaired specimen LE-R: (a) west face, (b) east face

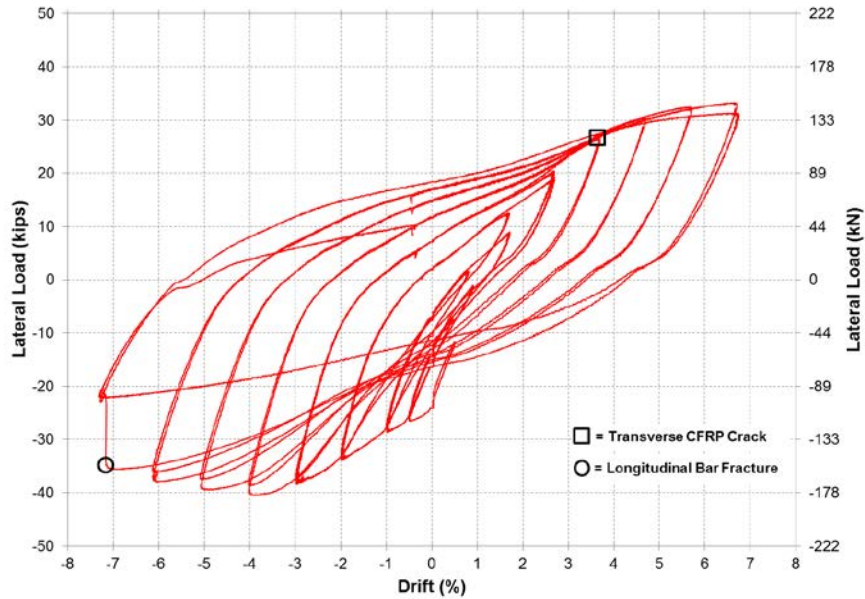
**Figure 4.28** Repaired specimen LE-R hysteresis curve

Figure 4.28 shows the hysteretic response for the cyclic test of repaired specimen LE-R. When the column was pulled back to zero displacement after the monotonic pushover test, it required a lateral force of -22 kip to maintain this position due to the permanent deformation of the steel reinforcement. Therefore, instead of the hysteresis curve beginning at zero force and zero displacement, it begins at a force of -22 kip and zero displacement. Since there was extensive damage to the column from the monotonic pushover test, the right side of the hysteresis curve has an unusual shape. The left side of the hysteresis, however, was only slightly affected from the monotonic pushover test and has a more normal shape since the column had not yet been displaced in that direction.

Two notable observations during the cyclic test are marked on the hysteresis in Figure 4.28. The square symbol marks the cycle in which transverse cracking of the CFRP jacket began to occur and the circle symbol denotes fracture of the column longitudinal reinforcement. Note that there is no apparent change in the hysteresis curve due to the transverse CFRP crack. The cracking of the CFRP jacket occurred just above the top of the headed bars and is shown marked by a white line in Figure 4.29. The crack in the CFRP had a final width of 0.125 inches, a length of 38.75 inches, and only existed on the west side of the jacket. The crack was caused by an increased curvature demand on the repaired section when the column was pushed to the west.

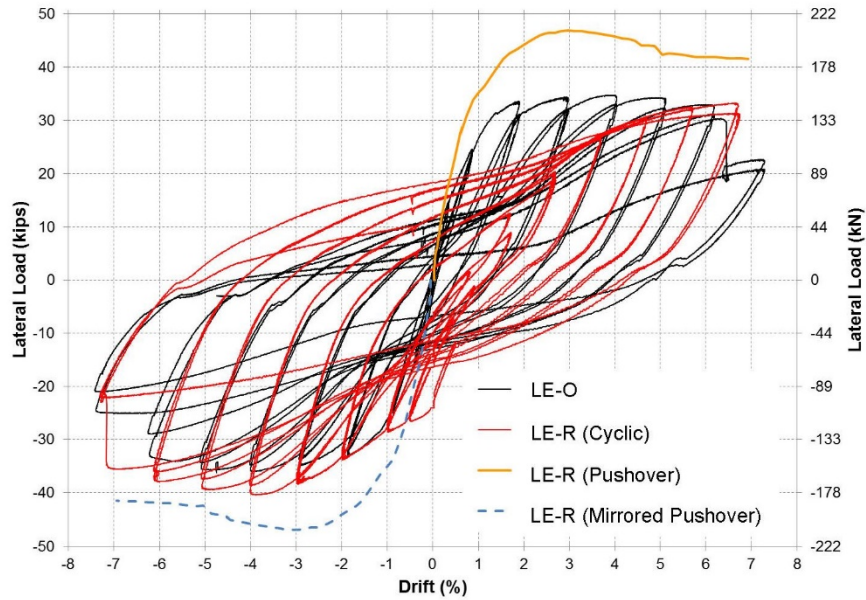
**Figure 4.30** Comparison of test results for as-built specimen LE-O and repaired specimen LE-R

Figure 4.30 compares both the monotonic pushover and cyclic hysteresis results of repaired specimen LE-R to the as-built specimen LE-O. Since the right side of the hysteresis of LE-R represents a column that was severely damaged from the monotonic pushover test, it was ignored for the comparison. From Figure 4.30 it can be seen that the lateral load for both the monotonic pushover and cyclic tests of LE-R is larger than the lateral load for LE-O. This increase in the lateral load was expected since moving the plastic hinge up the column shortens the moment arm to that section. The displacement capacity of LE-R is the same as that of LE-O for both the monotonic pushover and cyclic tests. Since there was no test of LE-R that can be directly related to LE-O, it is difficult to make an absolute comparison in terms of displacement capacity, ductility, and energy dissipation. However, from the results observed, it would be appropriate to conclude that LE-R would have performed at least as well as LE-O if it were tested under identical conditions.

Also in Figure 4.30, a mirrored plot of the monotonic pushover is superimposed in the 3<sup>rd</sup> quadrant of the graph in order to compare the monotonic pushover performance to the cyclic performance of LE-R. From this comparison, it can be seen that up to a drift level of -3% the hysteretic response of LE-R was slightly affected by the initial damage from the monotonic pushover. After a drift level of -3%, however, the hysteretic response of LE-R does not appear to be affected by the initial damage from the monotonic pushover and follows a similar shape to the monotonic pushover curve. Further details of the repair method for column-to-pier cap joints are presented elsewhere [19].
