Evaluation of the 24th Street Bridge

Final Report
November 2010

IOWA STATE UNIVERSITY
Institute for Transportation

Sponsored by
Federal Highway Administration
Iowa Department of Transportation

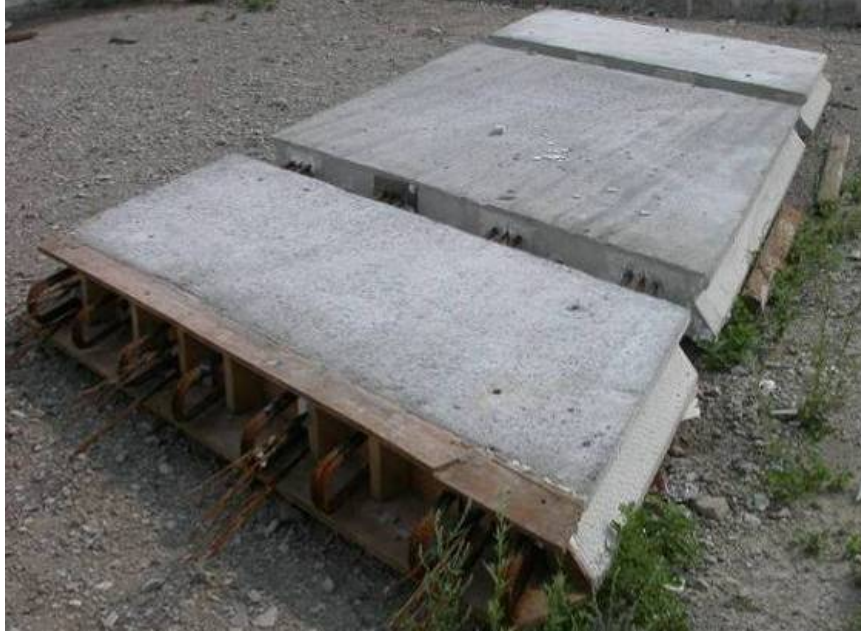
Figure 1.1. Boone County precast concrete deck panel (Wipf, et al. 2009)

In 2006 (Wipf, et al. 2009) the Iowa DOT and Iowa Highway Research Board (IHRB) constructed one of the first accelerated precast deck bridges in the state in Boone County, Iowa. The precast deck for the bridge was 16 ft-1 in. transversely and 8 ft- 1 in. longitudinally. The deck has eight transverse prestressing strands and transverse #7 bars located at the opening were the deck is grouted to the girders. The grout openings run the full longitudinal length of the deck. Figure 1.1 shows the Boone County deck panel. The development of the 24th street bridge deck panels evolved from the knowledge learned during the design, fabrication, and construction of the Boone County Bridge.

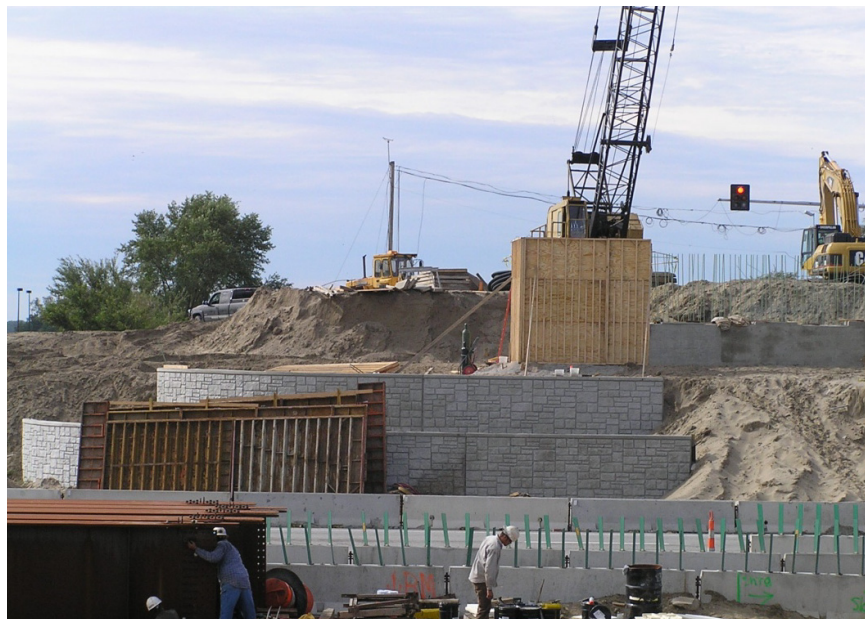
Figure 2.1. Construction of south abutment and terrace walls

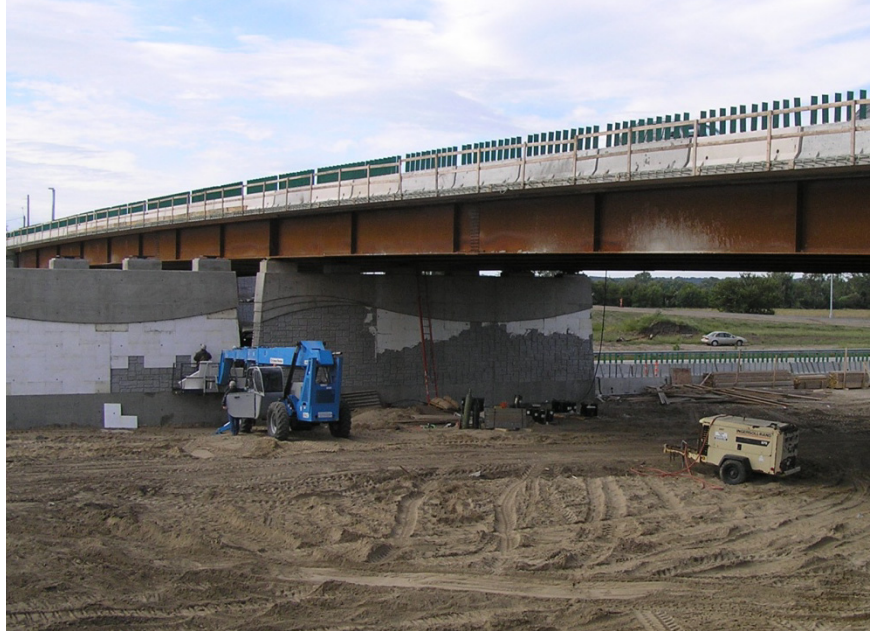
Figure 2.2. Girders on west center pier during Phase I construction

The 24th Street Bridge was constructed in two phases at an existing bridge site. The west lanes were constructed during Phase I of the project and the east lanes were constructed during Phase II. The new bridge carries six lanes of 24th street traffic (four through lanes and 2 turning lanes) over Interstate 80 in Council Bluffs, IA. The bridge is two spans with a total length of 353 ft-6 in. from center-line of abutment bearings. The south and north spans are 178 ft-6 in. and 175 ft-0 in. respectively. The girders are continuous over the center support and simply supported at the abutments. The abutments consist of one row of vertical piling and one row of battered piling with a concrete cap and backwall. The spill through slope is terraced down to the road level as shown in Figure 2.1. The center pier has two rows of vertical piling support with a continuous concrete pier cap shown in Figure 2.2.

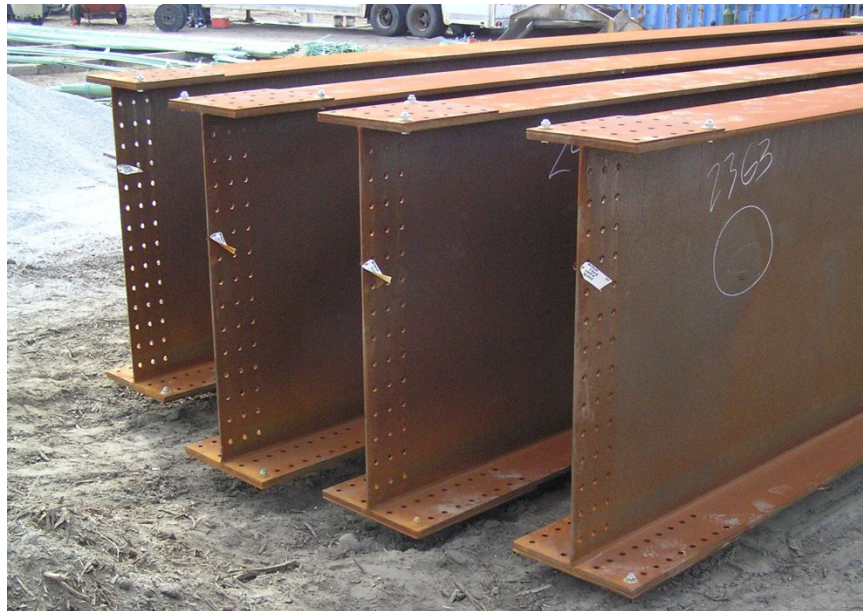
Figure 2.3. Girder ends at field splice location

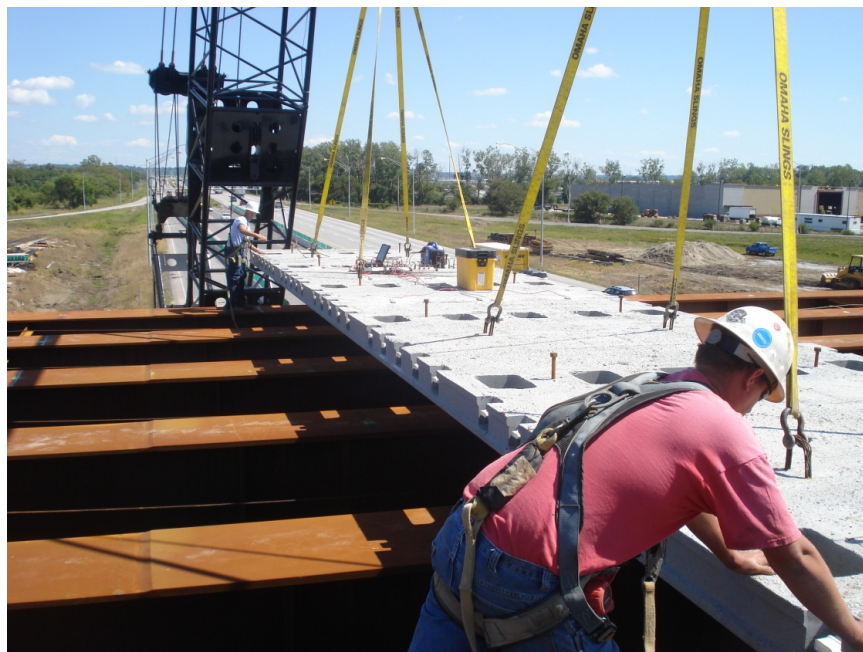
Figure 2.5. Placing precast deck panel on girders

The precast deck panels, being placed in Figure 2.5, were designed to act compositely with the girders, requiring the deck be connected to the girders through the use of shear connectors. The deck panels are 10 ft long x 52 ft-4 in. wide x 8 in. thick. The deck panel layout is shown in Figure 2.6. Each panel has 28 1 in. by 3 in. embedded ducts to house four longitudinal post-tensioning strands which run the full length of the bridge. Each panel is transversely prestressed with 10 1/2 in. dia. strands. Figure 2.7 shows the schematic of the typical precast deck panel. The deck to girder composite action was obtained with the use of 1 ft 4 in. by 11 in. shear stud pockets in the precast panels as shown in Figure 2.8. Shear studs were welded on the girder within the “pockets” of the panels; the “pockets” were then filled with grout.

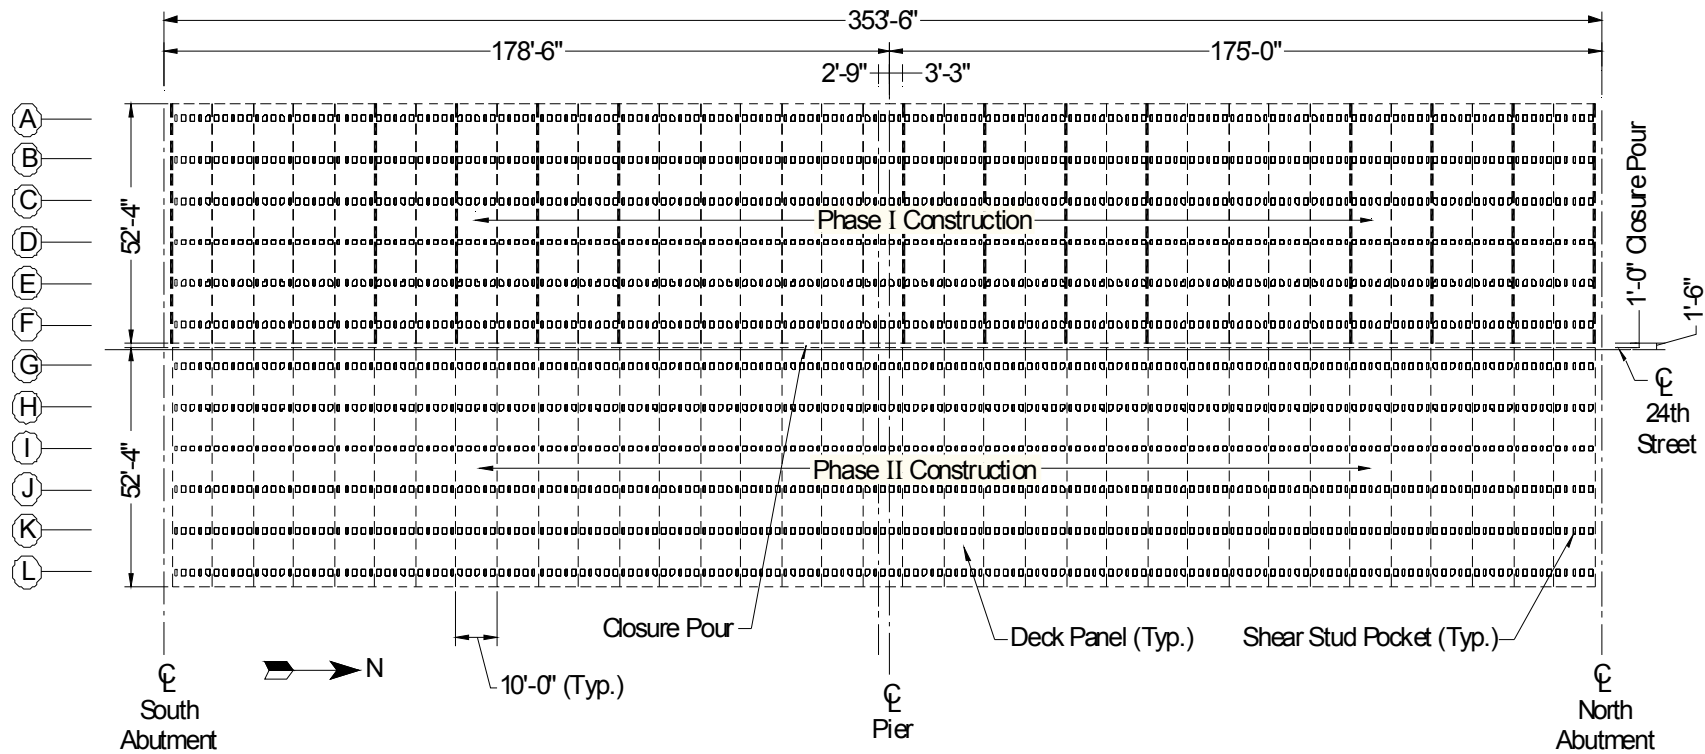
Figure 2.6. Precast panel layout

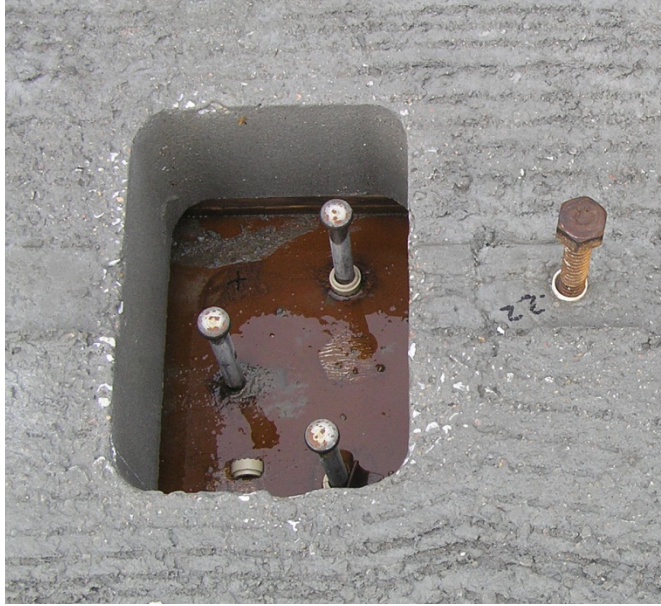
Figure 2.8. Shear stud pocket and studs

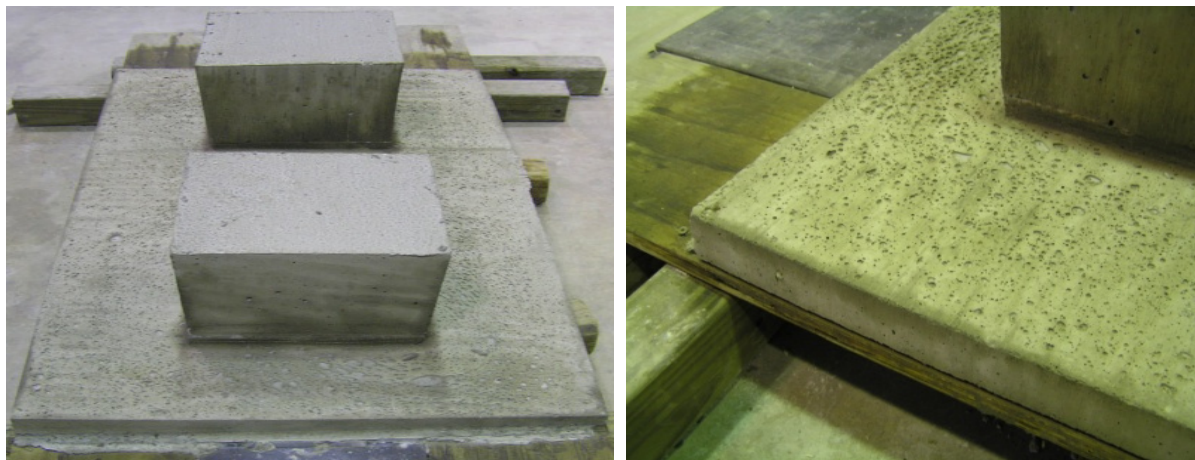
a. Grout filled pockets and haunch

b. Close up of grout at haunch

Figure 3.1. Stud pocket and haunch mockup after form removal

No difficulty was found in bending the four studs in the corners of the stud pocket. Bending of the center two studs was more arduous but still possible. The grout was then placed into the two stud pockets in the mockup and agitated with an electric vibrator. Figure 3.1 shows the mockup after removal of the forms, clearly indicating that grout can sufficiently flow through the stud pockets and into the haunch area in the specified dimensions. The grout, however, did have small air pockets/voids that formed on the surface as seen in Figure 3.1b. It is uncertain how the air pocket would affect the long term performance of the haunch grout.

During construction of the panels the precaster had difficulty finding an economical blackout form during casting of the panel. The tapered edges of the pocket as seen in Figure 3.1 were eliminated and the sides of the blackout were redesigned to be vertical in order to provide cost savings to the project.

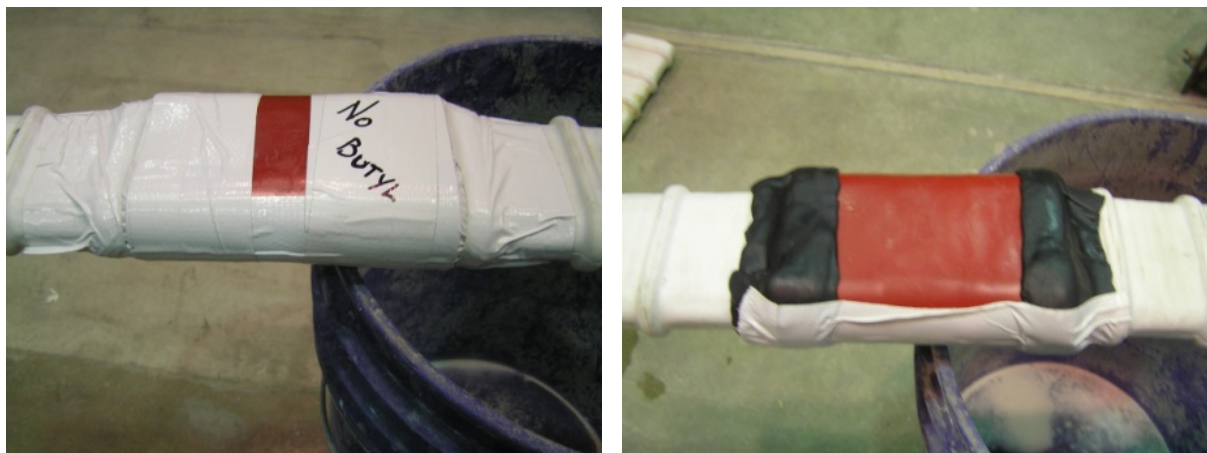
a. Waterproof duct tape

b. Butyl rubber and duct tape

Figure 3.2. Mockup splice connections for 1 in. x 3 in. P-T duct

The 1 in. x 3 in. duct splice connection detail was evaluated to determine if grout or moisture would seep into the duct at the connection. Two mockup duct splices were constructed and placed in grout. One duct splice was constructed of Polyken waterproof duct tape, as shown in Figure 3.2a. The second splice mockup was constructed with butyl rubber strips wrapped around the joint interfaces of the duct and coupler, the longitudinal joint of the coupler was sealed with a strip of Polyken duct tape, as shown in Figure 3.2b. Both methods of grout proofing the splices were found acceptable.

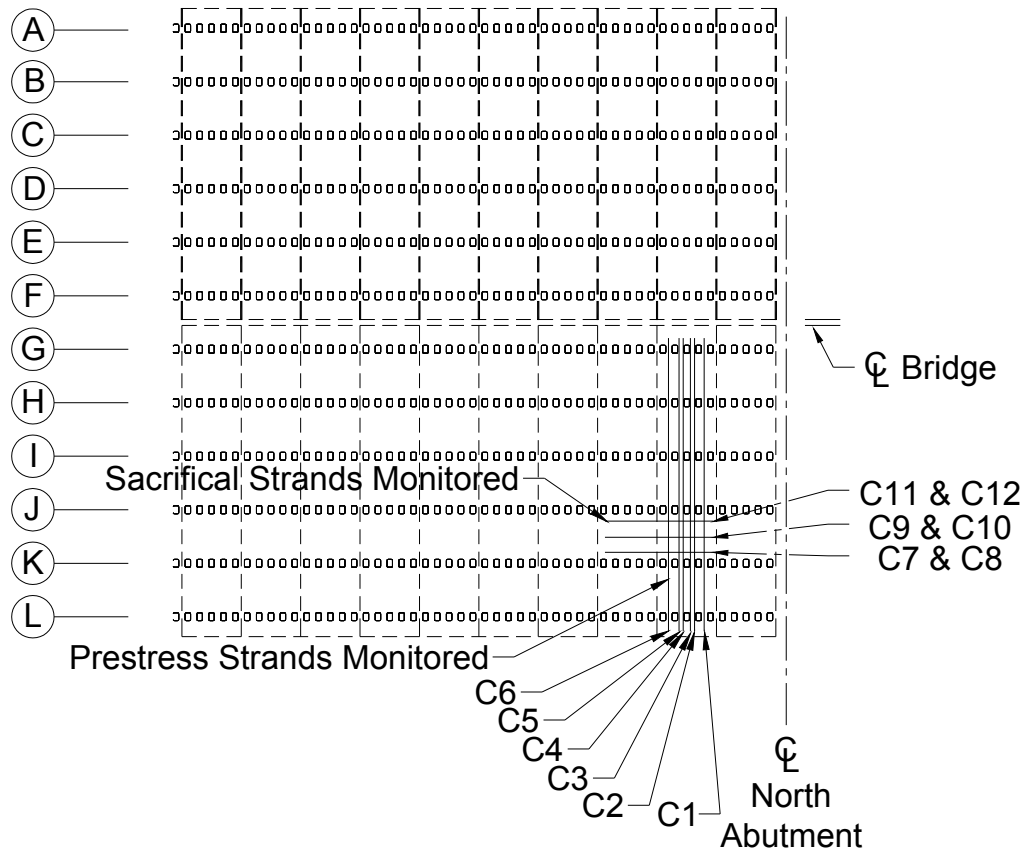
Figure 4.2. Location of strands monitored for corrosion at north abutment

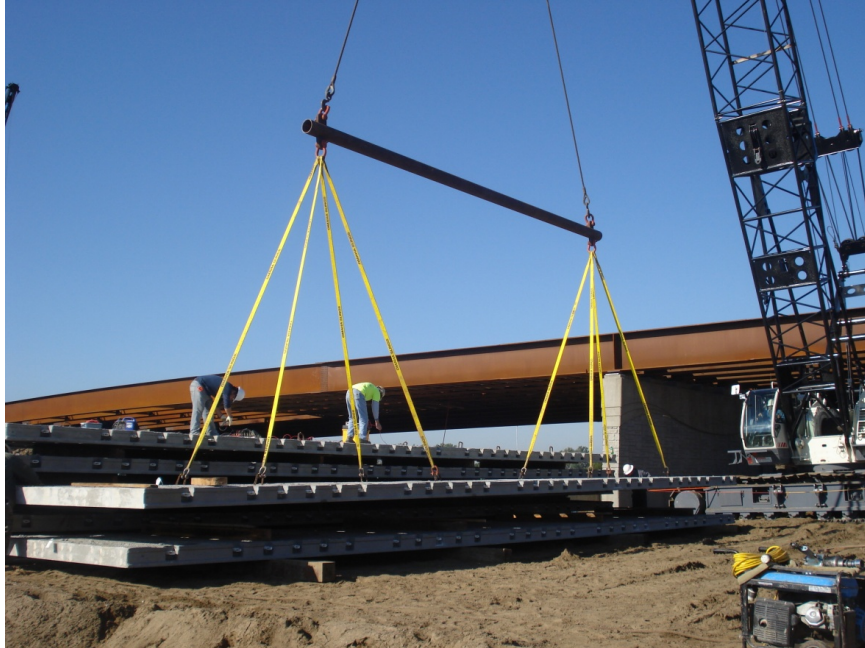
Figure 4.4. Precast deck panel in construction staging yard ready for placement

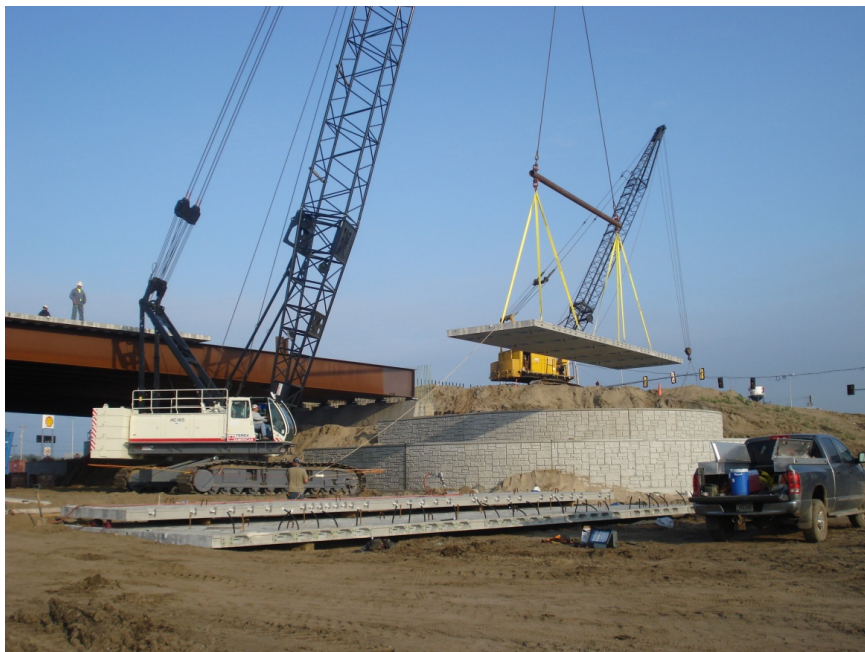
Figure 4.5. Deck panel being lifted into place

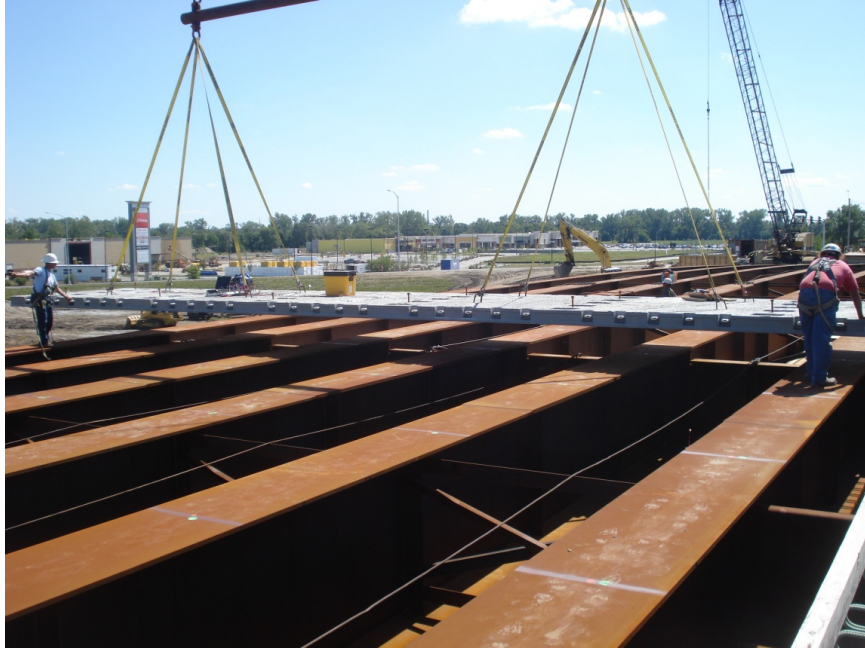
Figure 4.6. Final maneuvering of precast deck panel placement

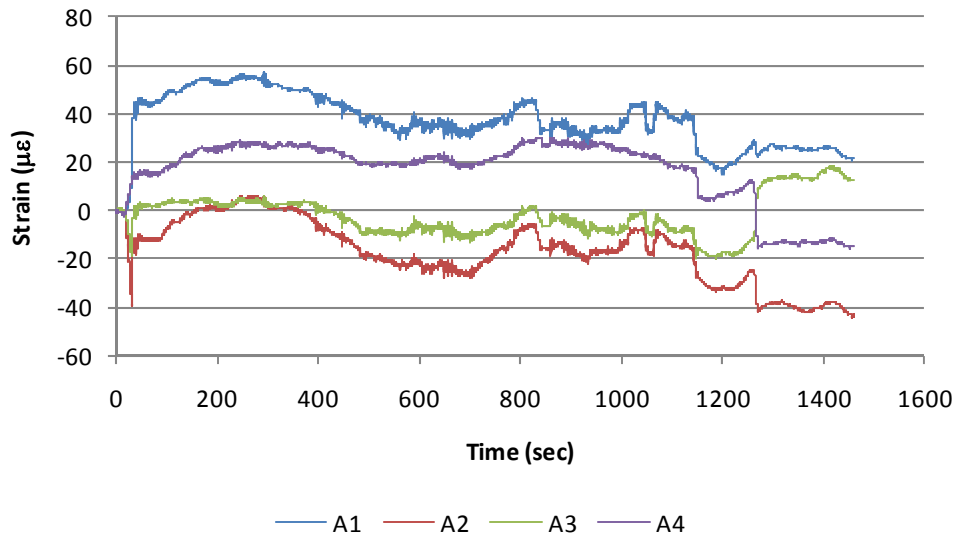
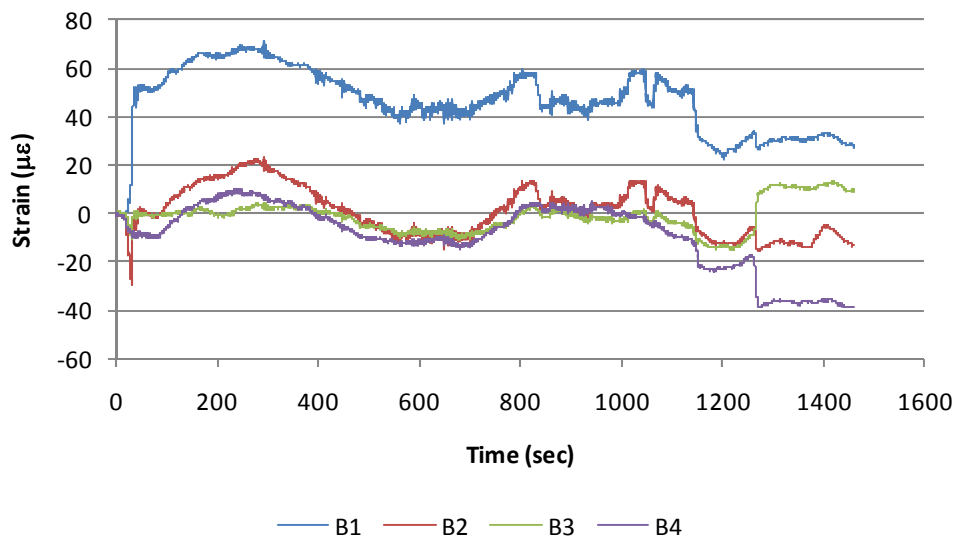
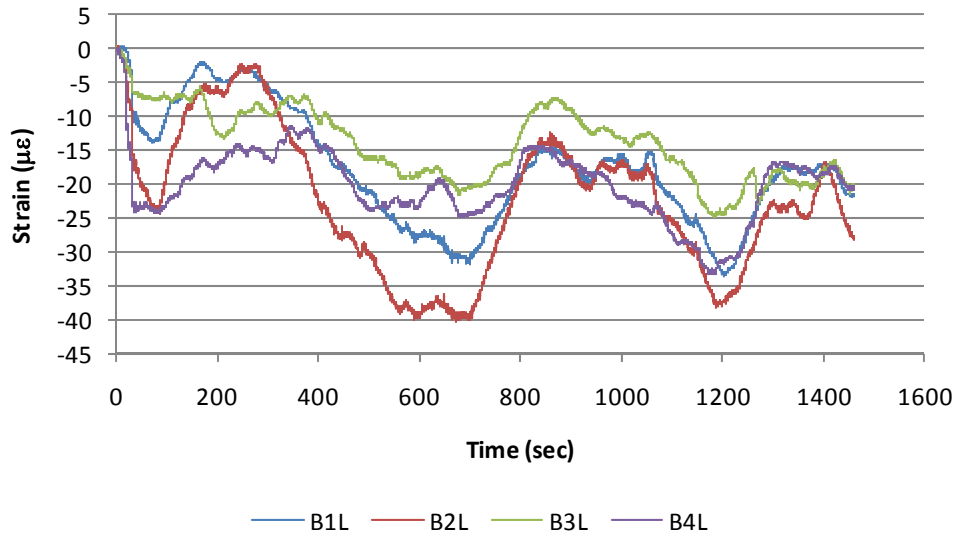
a. A-line strain readings

b. B-line strain readings

c. B-line longitudinal strain readings

d. C-line strain readings

Figure 4.8. Panel No. 1 strain readings during panel placement

The strain results for Panel No 1 are shown in Figure 4.8. As shown by the strain, the panel was fully lifted after 40 secs., representing the spike in the strain reading. Then, as the crane lifted and swung the panel over to the bridge, the strain peaked ($68 \mu\epsilon$) at about 240 secs. At approximately 550 secs. to 1250 secs., the construction workers were aligning the panel to the proper location on the girders. At some points during this time the panel had points of contact with the girders.

After 1250 secs., the panel was in place and had its leveling bolts resting completely on the girders. The transverse strain along grid line 1, which is the center line of the panel, showed the highest strain readings. The strain on grid line 1 varied from $55 \mu\epsilon$ to $68 \mu\epsilon$ all in tension. The longitudinal gauges located along gridline B varied between $3 \mu\epsilon$ to $40 \mu\epsilon$ all in compression during the placement of the panel.

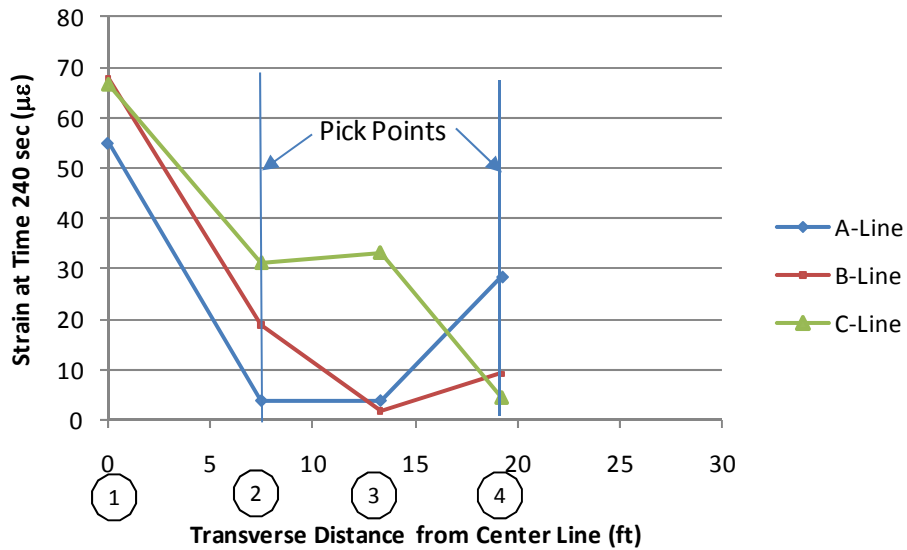
a. Strain at 33 seconds

b. Strain at 240 seconds

Figure 4.9. Strain profile along gridlines A, B, and C, Panel No. 1

Figure 4.9. shows the strain profile along grid lines A, B, and C at time 33 secs. and 240 secs. At 33 secs., the panel is fully picked up and at 240 secs., the panel reaches its maximum strain at nearly all the strain locations. At location zero, which is grid line 1 and center line of the panel,

the strain is at its maximum. In general, the strain decreases as it moves away from the center of the panels. The strain at and between the pick points have very little consistency between gridlines.

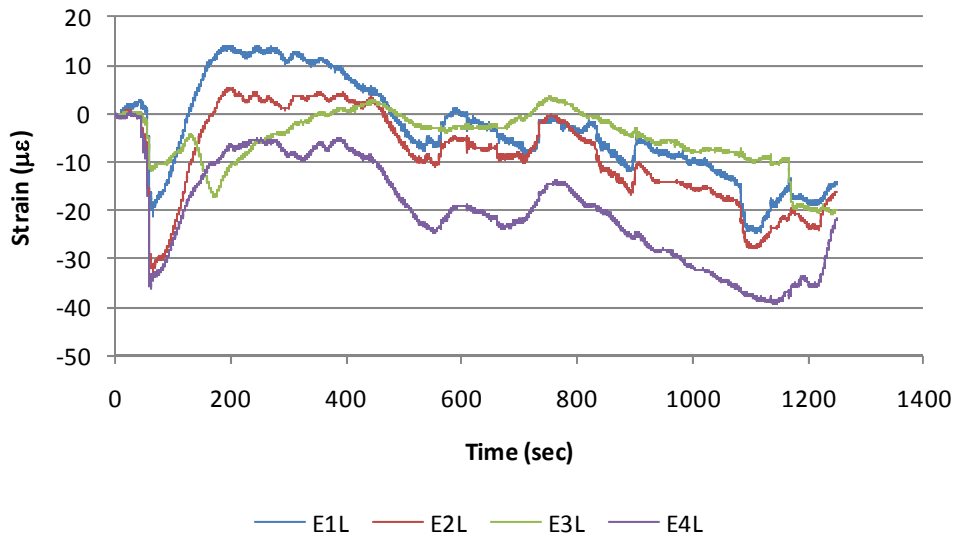
a. D-line strain readings

b. E-line strain readings

c. E-line longitudinal strain readings

d. F-line strain readings

Figure 4.10. Panel No. 2 strain readings during placement

The strain readings for Panel No. 2 are shown in Figure 4.10. As seen at approximately 63 secs. the panel is fully picked up. The panel was then lifted and swung over the girders. At approximately 560 secs., the panel was being maneuvered by the construction workers into placement. Then, at approximately 1150 secs., the panel's leveling bolts were fully resting on the girders. Panel No. 2 reached a maximum strain of approximately 230 $\mu\epsilon$. The maximum strain occurred at location F2. At the time of maximum strain the strain in all the gauges varied from 48 $\mu\epsilon$ to 230 $\mu\epsilon$. The lowest strain consistently occurred along gridline 4.

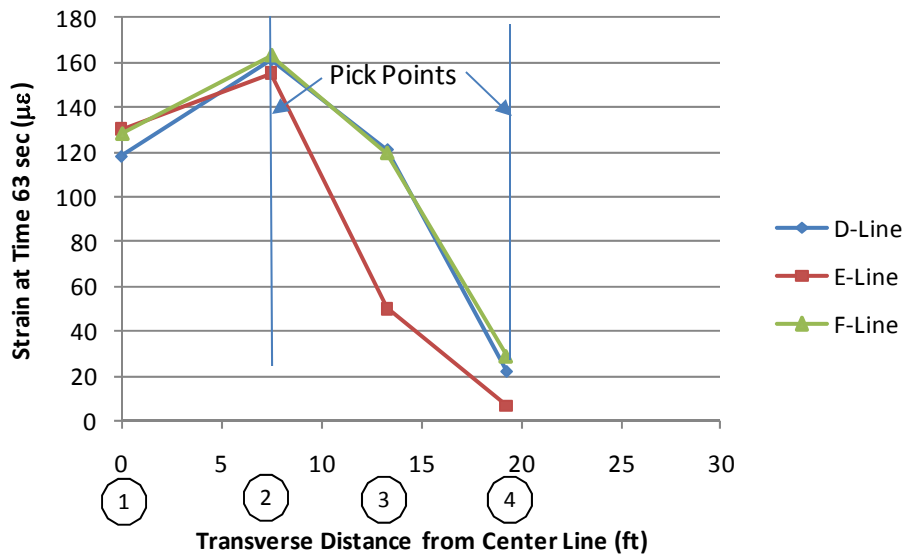
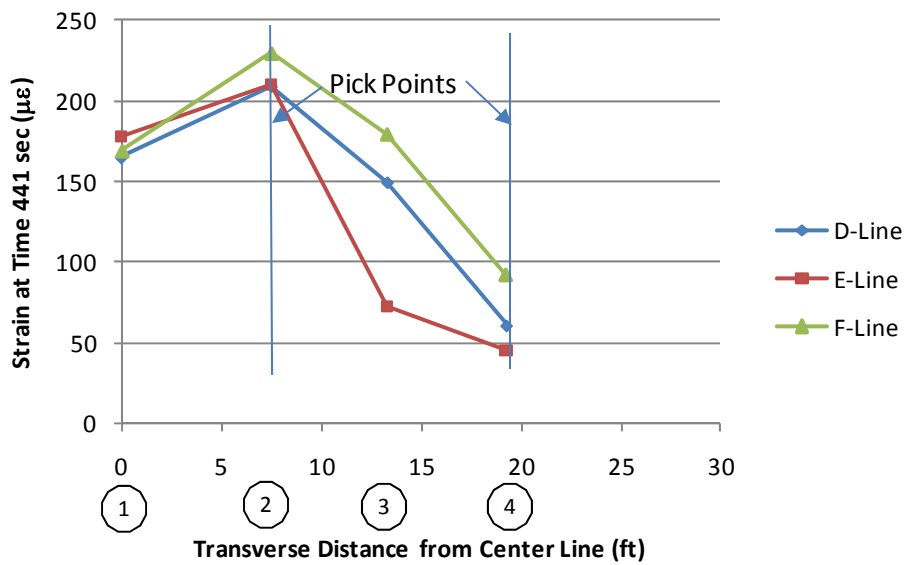
a. Strain at 63 seconds

b. Strain at 441 seconds

Figure 4.11. Strain profile along gridlines D, E, and F, Panel No. 2

The strain profile along grid lines D, E, and F are shown in Figure 4.11 at time 63 secs. and 441 secs. At time 63 secs., (time at which panel is full picked up) the strain at gridline 1 (centerline of the panel) is at approximately 130 $\mu\epsilon$. The strain then increases to the pick point at gridline 2 to 160 $\mu\epsilon$. The strain then steadily decreases to gridlines 3 and 4. The strain at gridline 4 is approximately 30 $\mu\epsilon$. A similar pattern occurred at time 441 secs. (time at which panel reach max strain); however, the strain values were higher. At gridline 1 the strain was approximately 170 $\mu\epsilon$, then it increased to approximately 210 $\mu\epsilon$ and then went down to an average value of approximately 70 $\mu\epsilon$ at gridline 4.

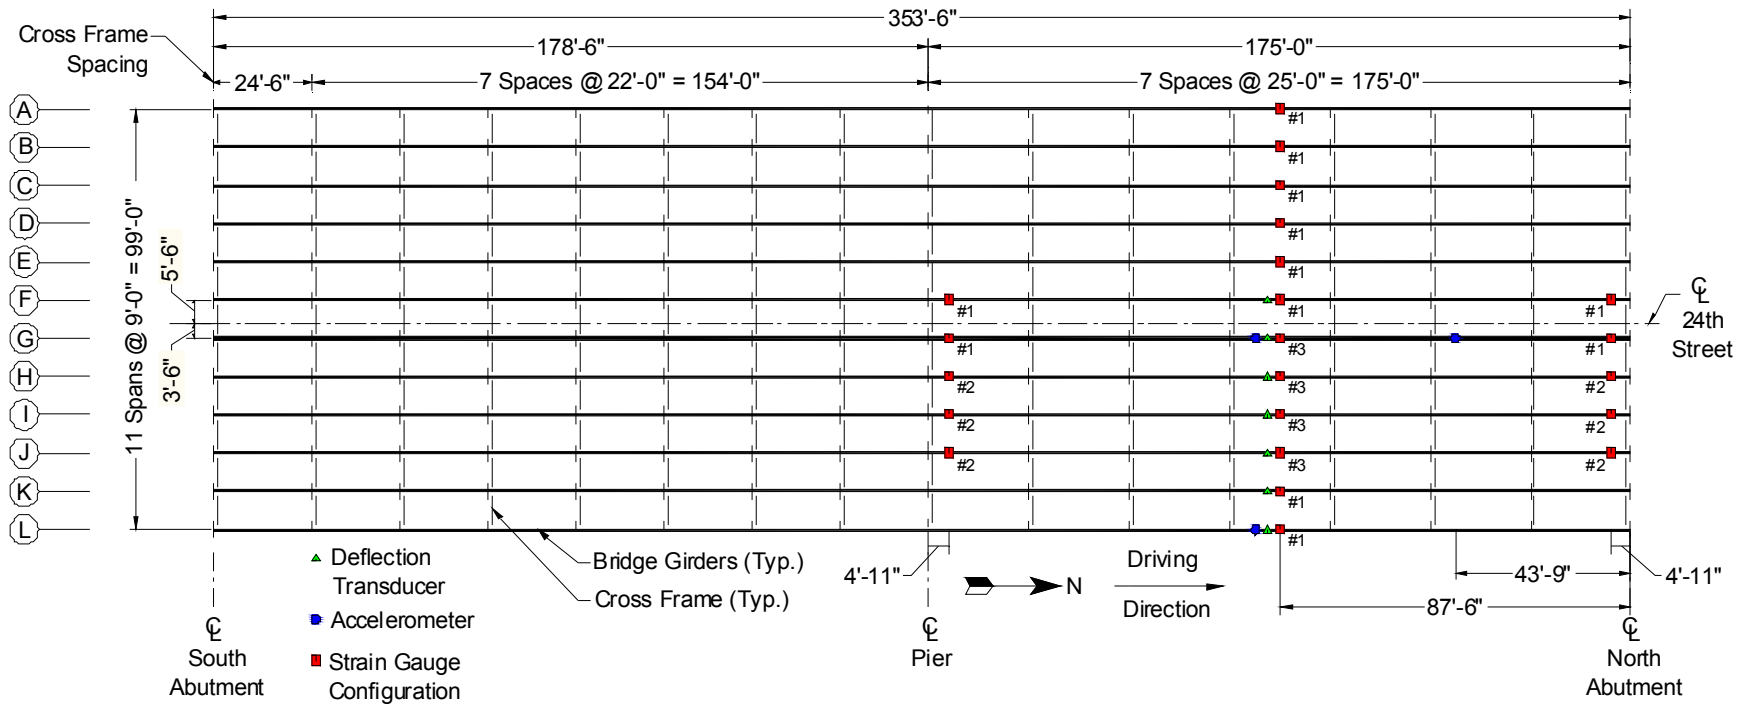
Figure 4.15. Gauge location on bridge

A diagnostic live load test was conducted on the completed bridge to compare structural performance with expected design performance. Strain gauges and deflection transducers were installed on critical superstructure members. BDI strain gauges were placed at the pier, mid-span, and abutment of the north span as shown in Figure 4.14. The gauges had three different configurations as depicted by the number next to the gauge location in Figure 4.14. The three different configurations are shown in Figure 4.15. Deflection transducers were placed on girders F through L at the mid-span of the north span only. The deflections transducers were placed on the bottom of the girder similar to configuration 1 in Figure 4.15. Accelerometers were also placed at mid-span and quarter-span of the bridge north span.

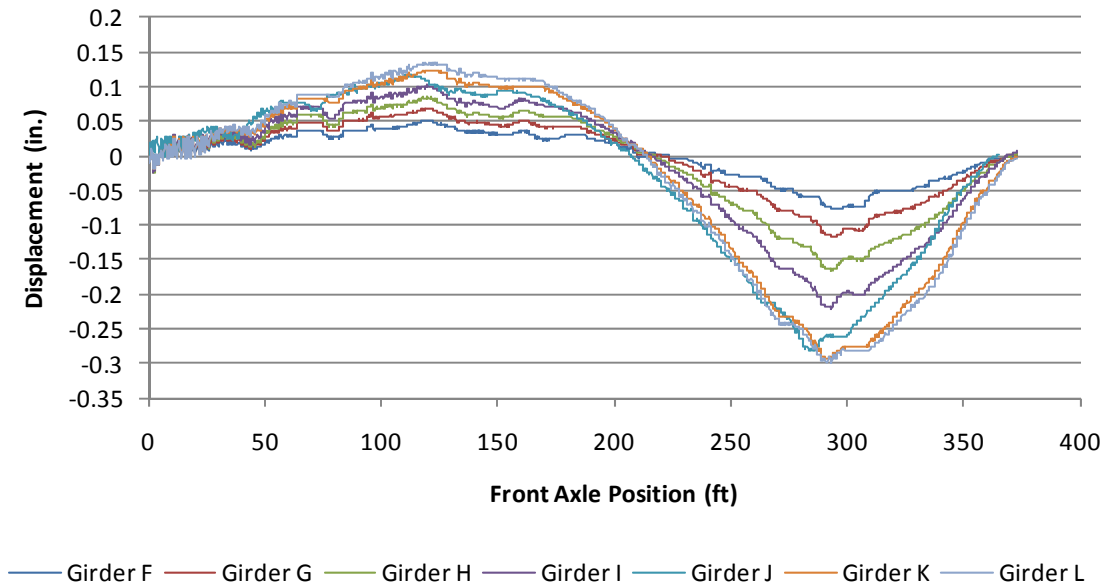
Figure 4.19. Representative time history deflections for Load Case 2

Deflection transducers were installed on the bottom flange of the seven east girders. Representative time-history deflections for load case 2 at the north span mid-span with respect to front axle position are shown in Figure 4.19. The load truck was located in the center of the east driving lane for load case 2. In general all load cases produced the same deflection shape for the bridge with positive deflection when the truck was on the south span and negative deflection when the truck was on the north span. For all the load cases a deflection range of -0.32 in. to +0.21 in. was seen when the truck was on the south span and a range of -0.41 in. to +0.23 in. when the truck was on the north span for the seven girders. The maximum north span deflection of -0.41 in. corresponds to a span to deflection ratio of $L/5120$.

4. The maximum north span deflection was observed to be -0.41 in., which corresponds to a span to deflection ration of L/5120.
5. The maximum strain of +66 $\mu\epsilon$ occurred at the midspan of girder L during LC1. The maximum strain range of 88 $\mu\epsilon$ occurred at the same location and load case.

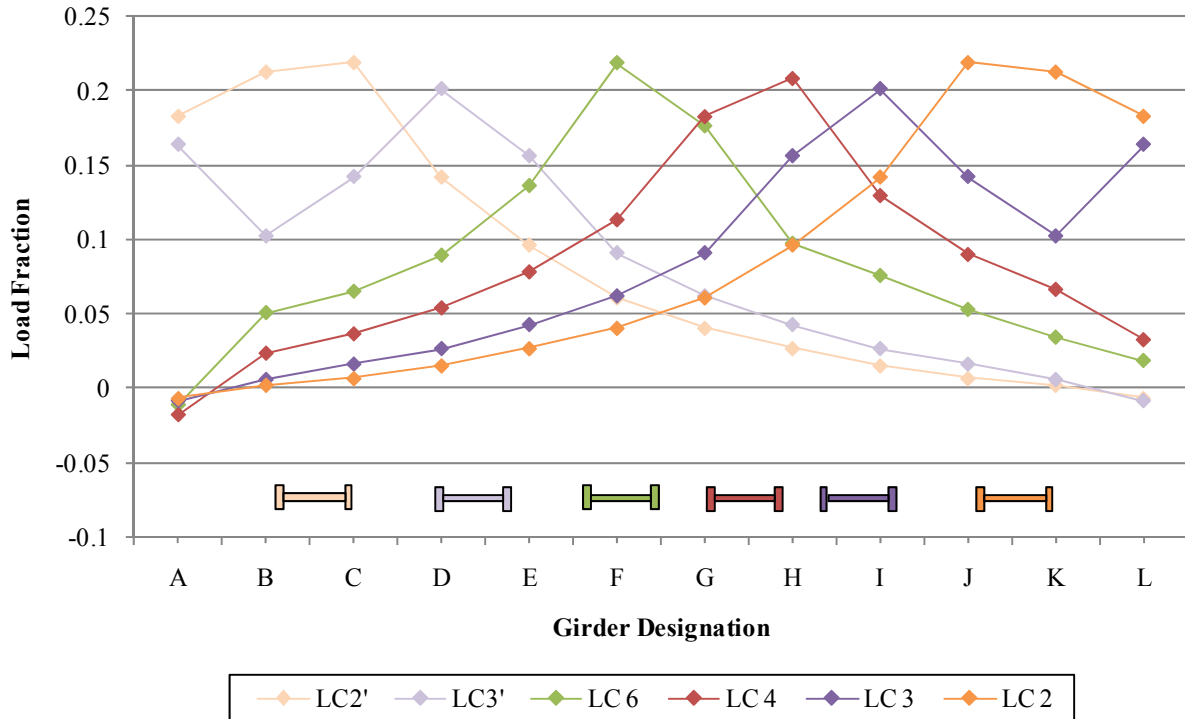
Figure 4.27. Load fractions combined to form load distribution

Load distribution was determined experimentally by adding the load fractions of complementing load cases. Combining LC2, LC3, LC4, and LC6 with the transpose of LC2 and LC3 (designated at LC2' and LC3') provided proper lane loads for determining load distribution. Figure 4.26 shows the load fractions of the six load cases combined for load distribution. Figure 4.27 shows the experimental load distributions along with the code distribution factors from the American Association of State Highway and Transportation Officials (AASHTO) Load and Resistance Factor Design (LRFD) 2004. The largest obtained load distribution factor was obtained at Girder H with a value of 0.63. The lowest girder distribution factor was 0.30, which was located at Girder A. Girder A and L, however, are located below the side walk areas; therefore, Girder B and K may be more representative of the load distribution at the edge girders. The lowest distribution at Girder B and K was 0.42. When comparing the experimental test results with AASHTO LRFD load distributions, the experimental results were less than code distributions.

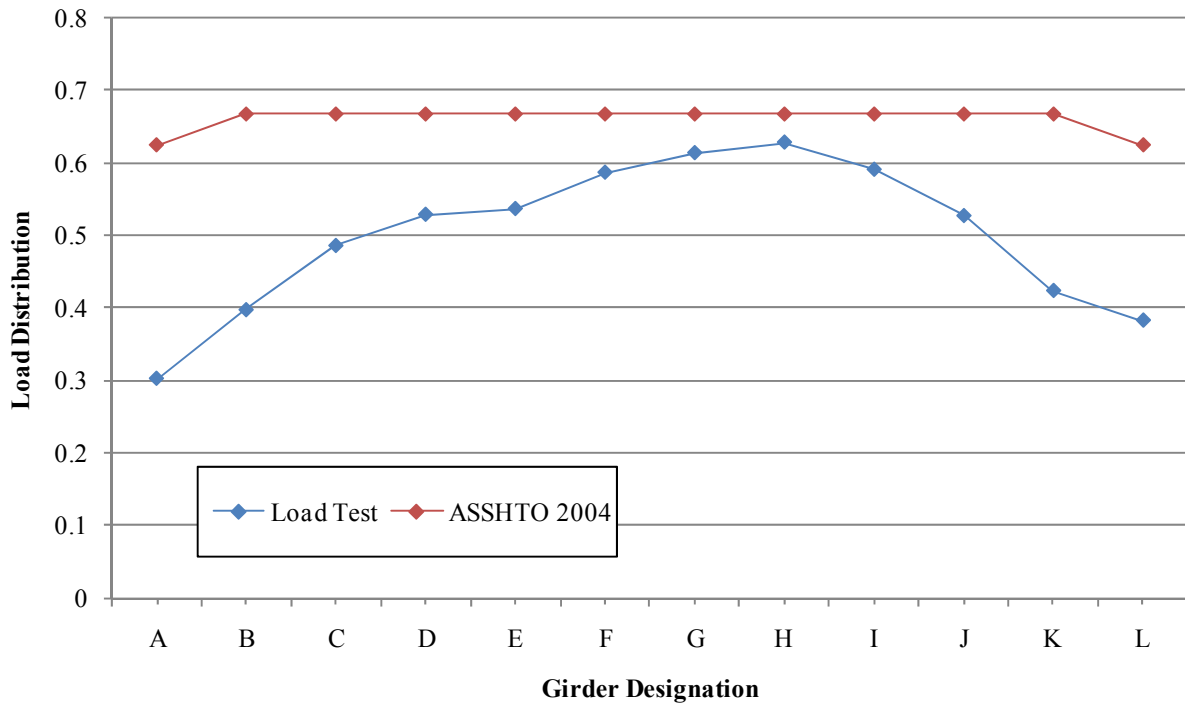
Figure 4.28. Experimental and codified load distributions

9. The largest load distribution factor was found at girder H with a value of 0.63. The lowest load distribution factor of 0.30 occurred at girder A.
10. The load distribution factors obtained from field testing were within AASHTO LRFD load distribution requirements.
11. The neutral axis location obtained from field test was located between 58 in. and 61 in. from the bottom of the flange. The girder depth is 61 in.; therefore, the neutral axis lies near the top of the steel girder but not in the haunch or deck slab.

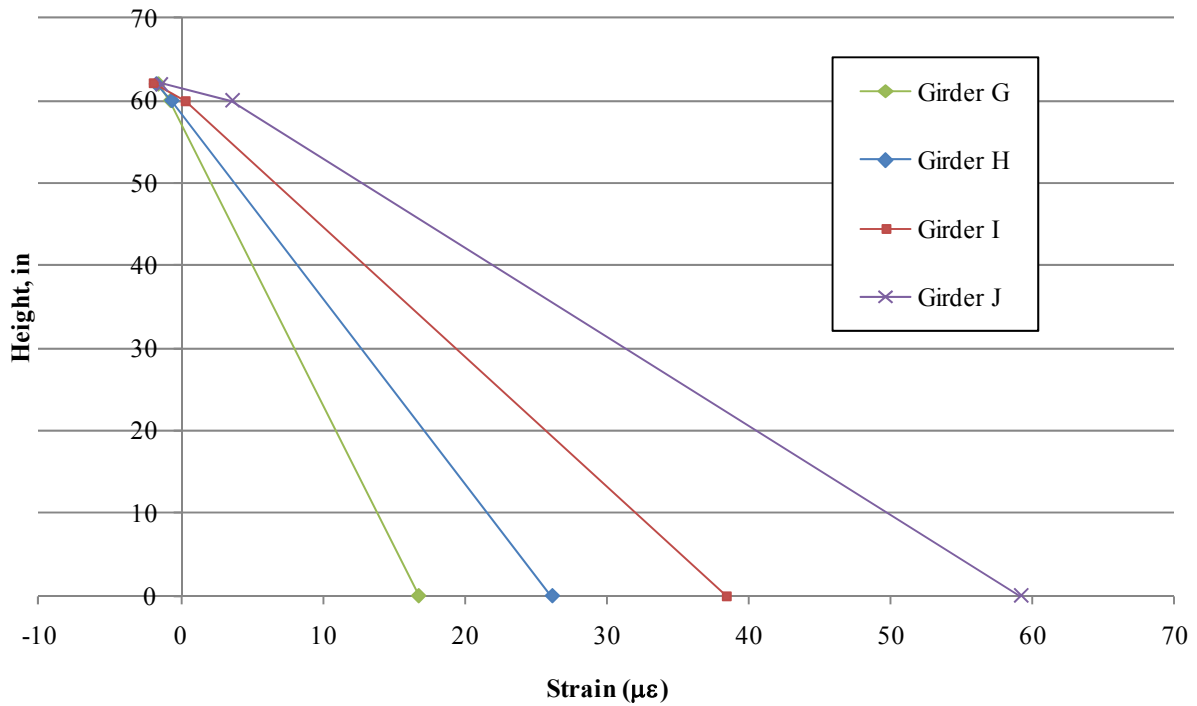
Figure 4.29. Strain depth profile for girders G through J, Load Case 2

The girders with strain configuration #3 were used to estimate the location of the neutral axis during testing. Figure 4.28 and Figure 4.29 shows the strain profile for girder G through J for LC2 and LC3. The steel girder total depth was 61 in. with 1 in. flanges top and bottom. A girder haunch existed between the precast panel and girder of between ½ in. to 1 in. The location of the neutral axis during testing was approximately 58 in. to 61 in. from the bottom of the girder. The neutral axis location appears to be located near the top of the steel girder but not within the grouted haunch region or in the precast slab.

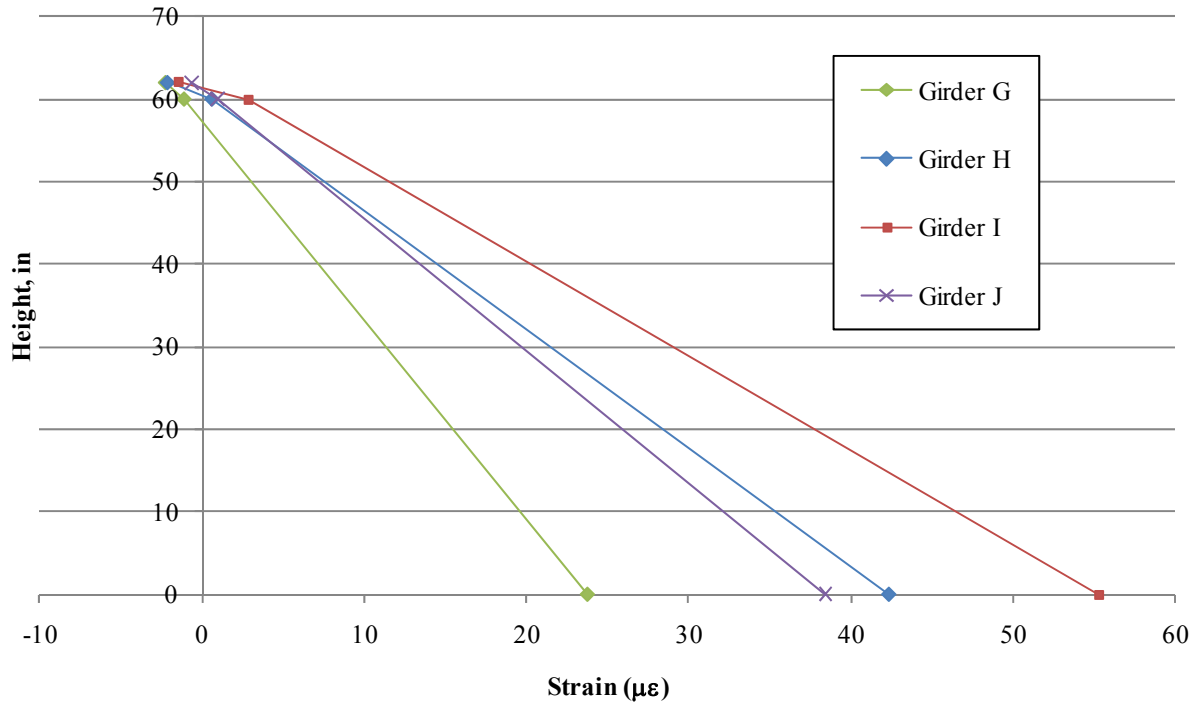
Figure 4.30. Strain depth profile for girders G through J, Load Case 3
