# **Western Michigan University**

### **Development and Validation of a Sensor-Based Health Monitoring Model for the Parkview Bridge Deck**

Final Report

January 31, 2012

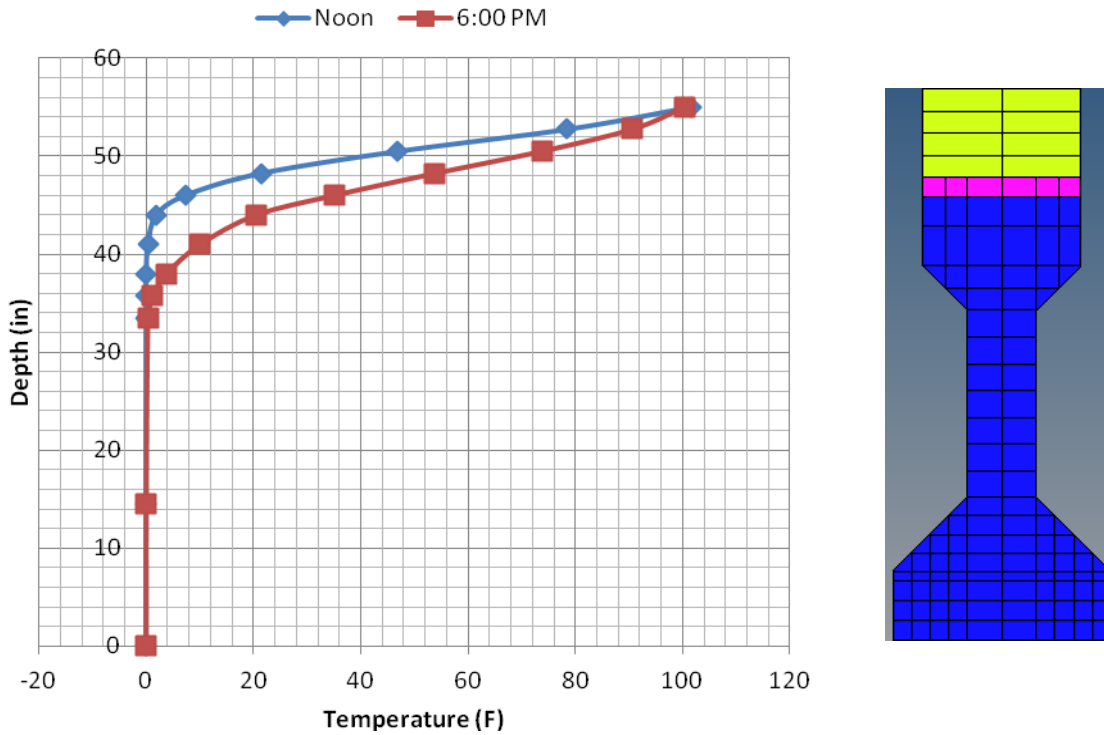
Vibrating wire gages embedded in the deck panels contain thermistors and records strains as well as temperature. Within a limited area, vibrating wire gages are attached to top and bottom reinforcements of the deck panels. However, bottom layer sensors are not available above the girders. Literature recommended the fifth and second-order thermal profiles for concrete girders to represent thermal gradient profile at noon and 6 p.m. during a summer day. Hence, the fifth and second-order thermal profiles that were calibrated with the measured temperature at the depth of vibrating wire gages were used for thermal gradient load at noon and 6:00 p.m. for the girders and the deck above the girders (Figure 6-12). On the other hand, the temperature records from top and bottom thermistors were used for the rest of the deck (Figure 6-13). Even though different temperature profiles were used to represent temperature distribution within concrete elements, a constant temperature was assigned to the top surface of the entire deck. There are no

reliable models to represent temperature profile during winter. Hence, temperature and stress data recorded during summer were used for model calibration.

Figure 6-12. Temperature distribution along the depth of a girder and the deck above the girder

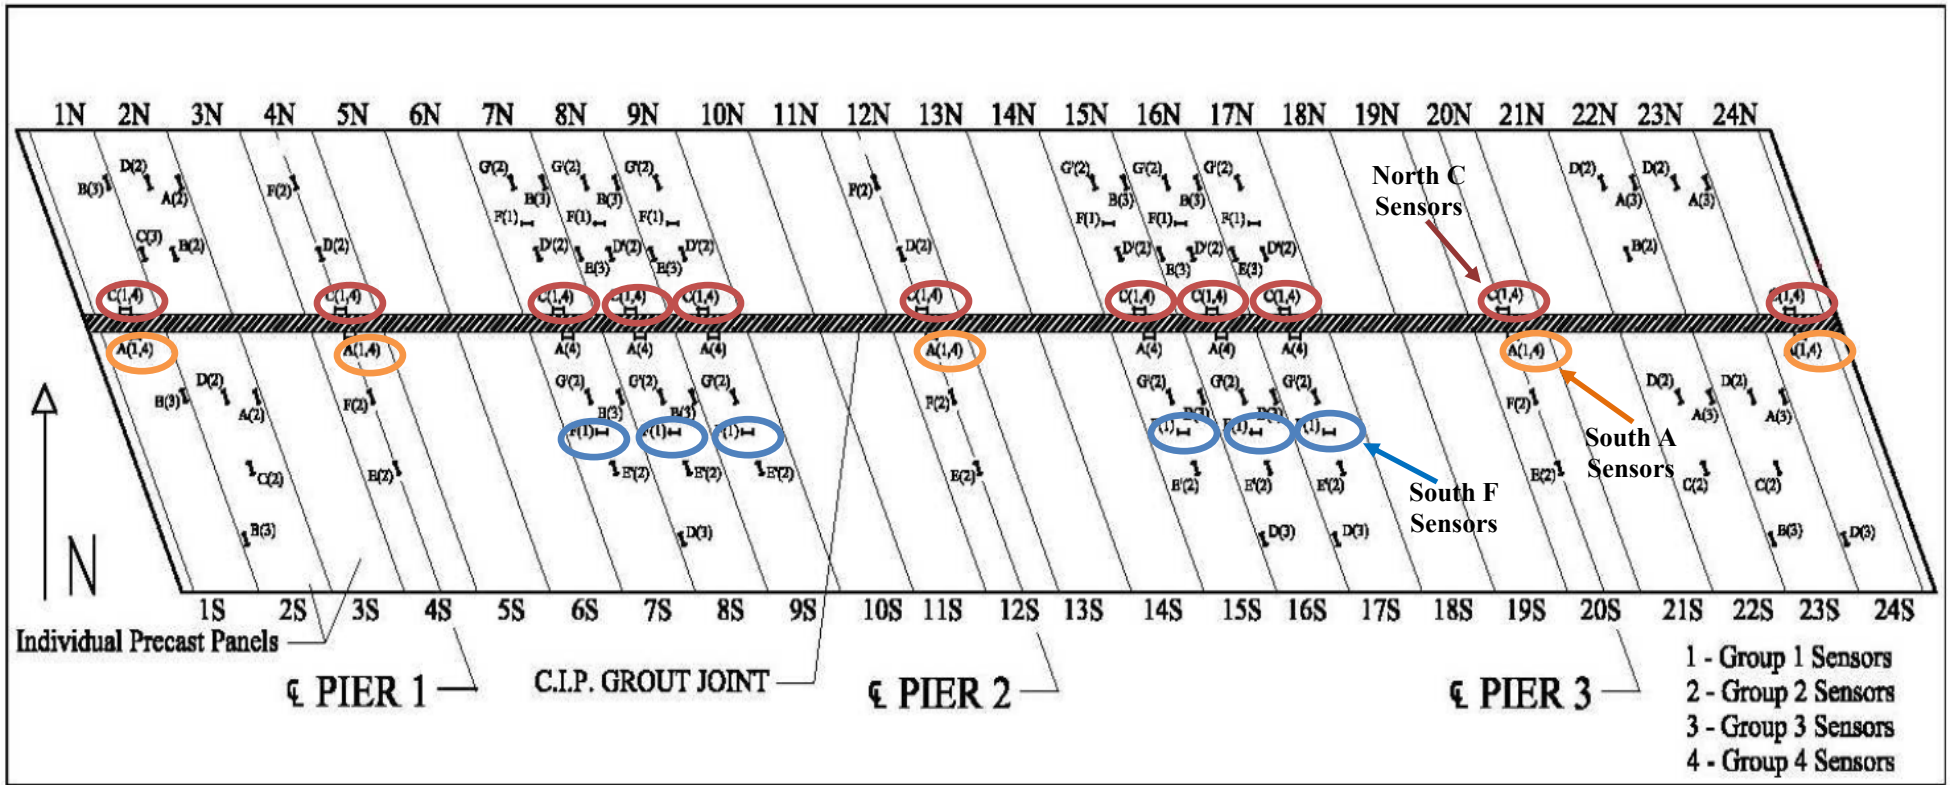
Figure 6-23. Sensor locations and deck layout

Deterioration of joint between panel 7 and 8 on the north span (i.e., 7N and 8N in Figure 6-23) was considered. Considering the worst case scenario, joint separation was simulated. Abaqus version 6.10 allows changing material properties between analysis steps. This option was used and grout modulus of elasticity was changed to a very small value so that there was no load transfer across the joint. Post-tension strands were continued through the joint, irrespective of the joint condition. Stress variation in panel 7N and 8N without and with deterioration is shown in Figure 6-29 and Figure 6-30, respectively. Stresses shown in the figures are due to change in temperature from noon to 6 p.m., as discussed in Section 6.4.3. When there is no deterioration at the joint, panel 7N and 8N behave monolithically while the deck panels remain compressed (note that the negative values presented in the figures represent compression). On the other hand, panels start to show tensile stresses as monolithic behavior between panels is lost due to deterioration at the joint (Figure 6-30).

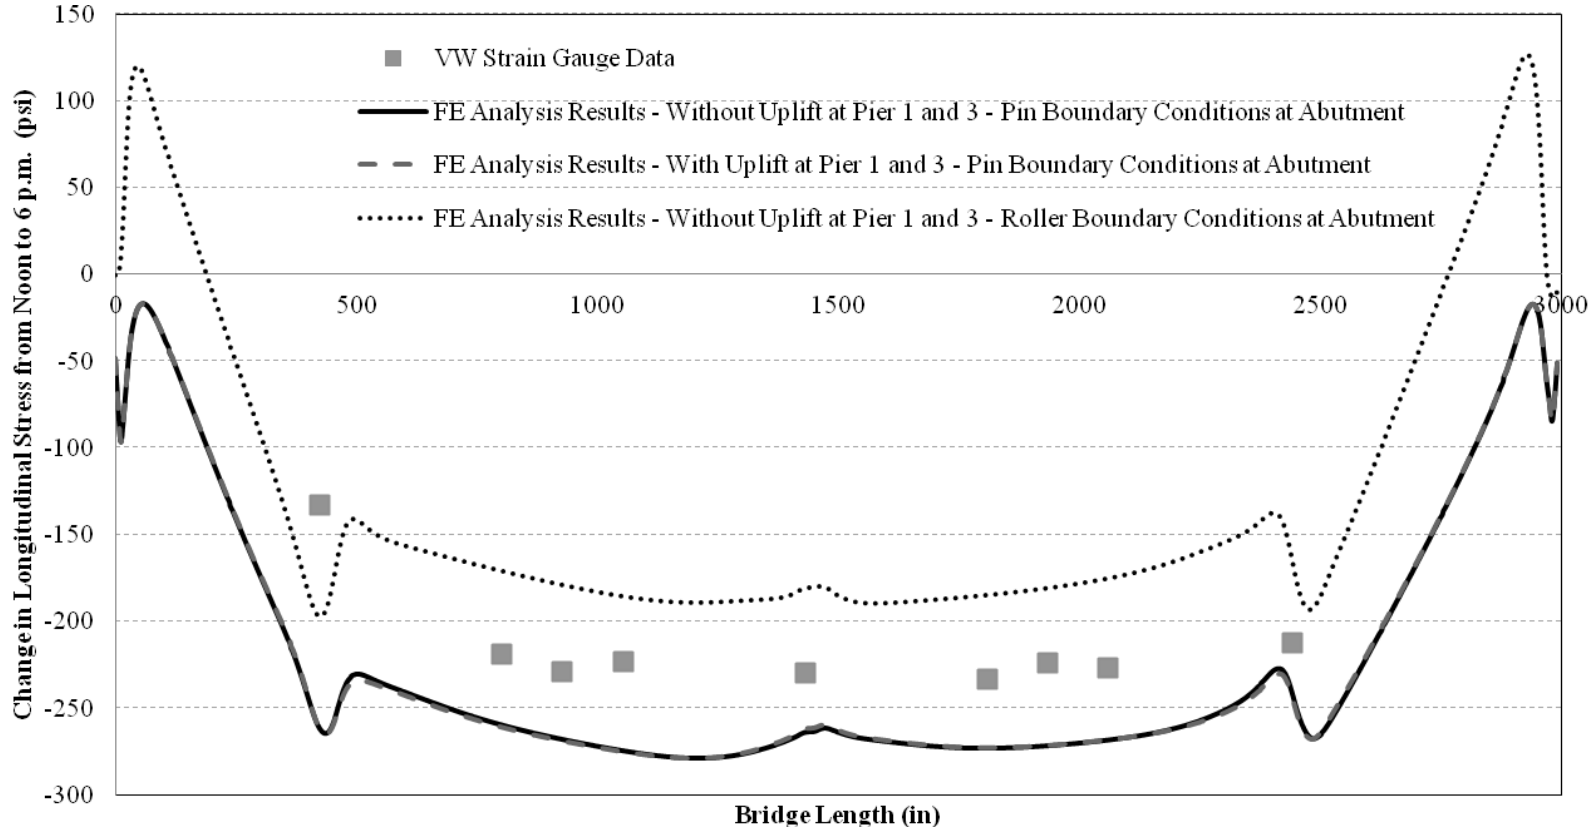
The differences observed in analysis results and sensor data can be attributed to the difference in actual temperature variation within the deck and the temperature profiles used in the analysis and potential movements at the abutments.

Figure 6-25. Change in longitudinal stress from noon to 6 p.m. under thermal load

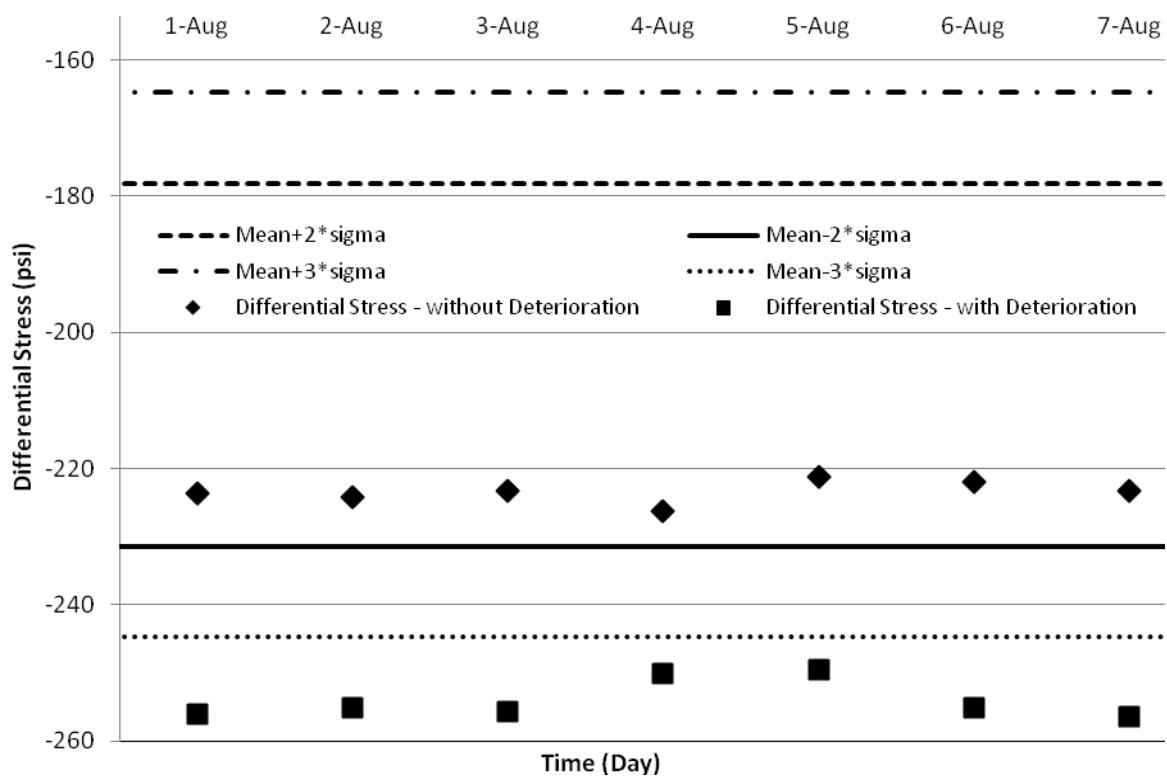
Figure 7-19. Deterioration prediction model for the joint between north panel 7 and 8 (Span2)

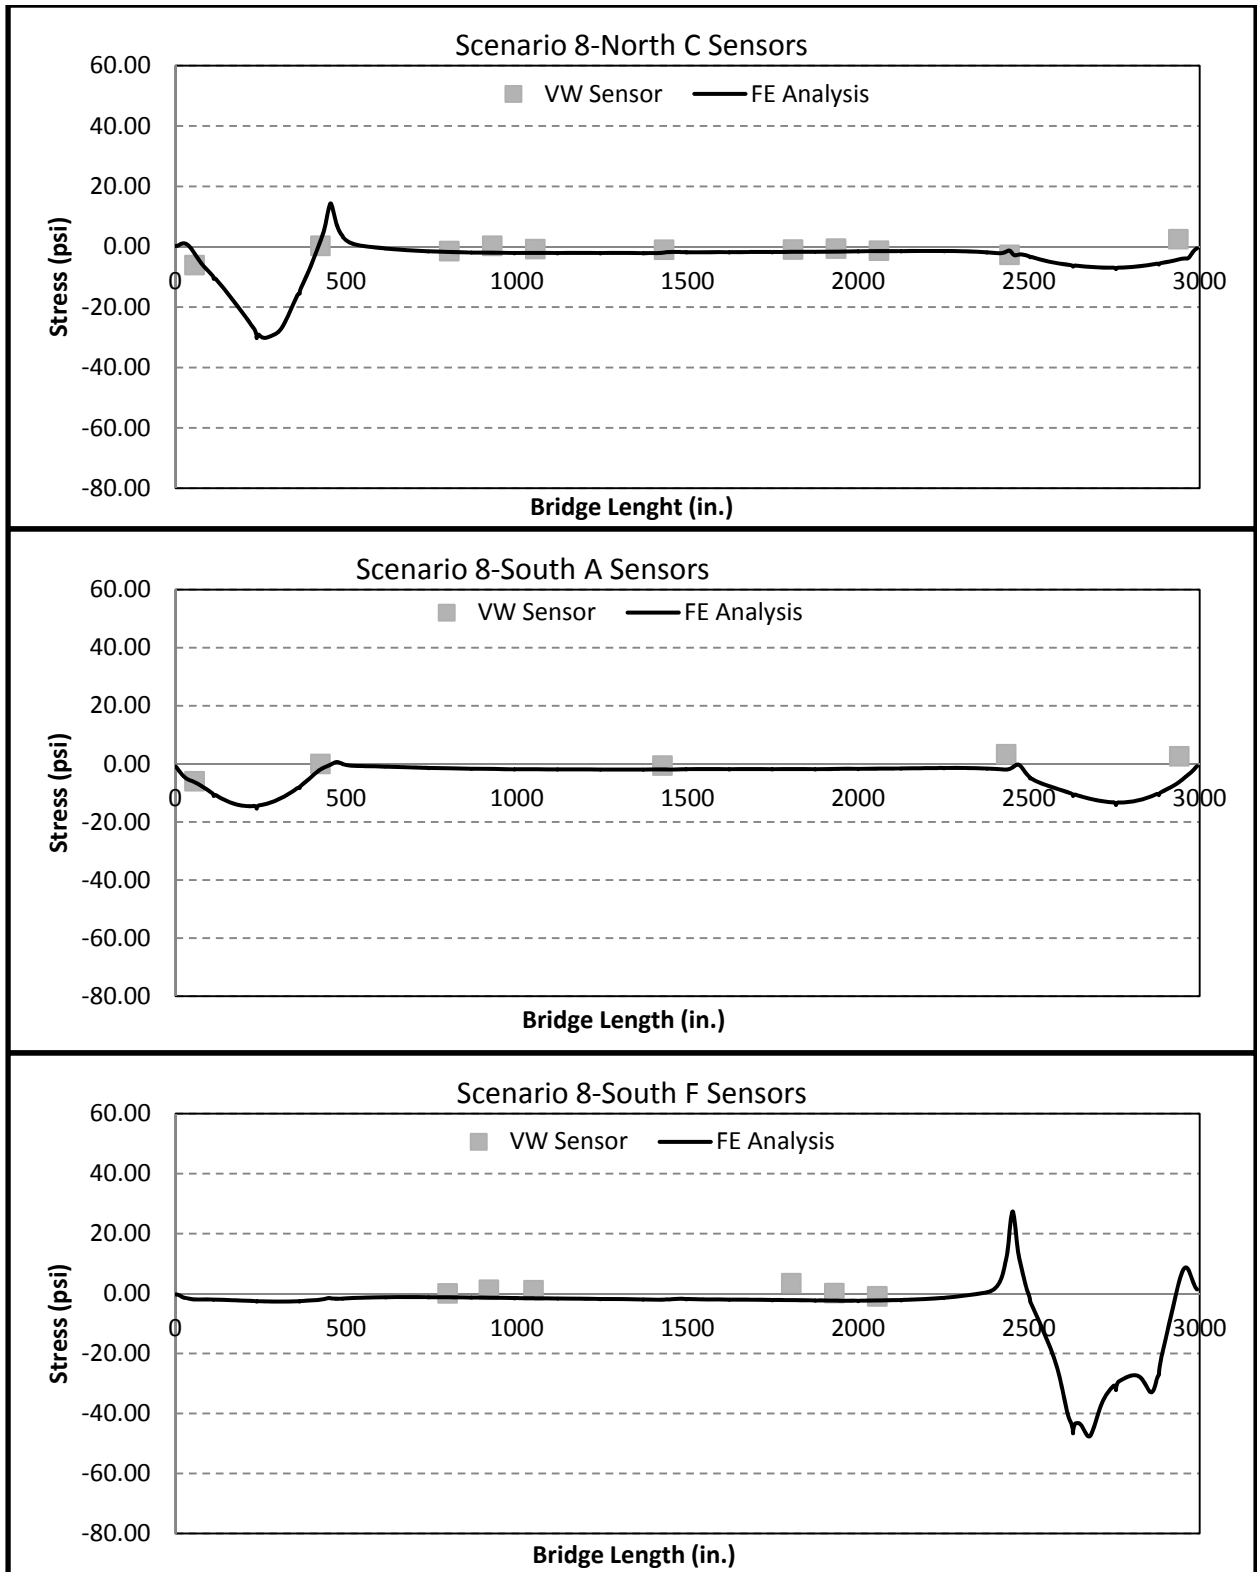
Figure B-7. Comparison of load test data and FE analysis results – Scenario 8
