Polyurethane Foam Infill for Fiber-Reinforced Polymer (FRP) Bridge Deck Panels

FINAL Report

Prepared for
Missouri Department of Transportation
Construction and Materials

May 2014

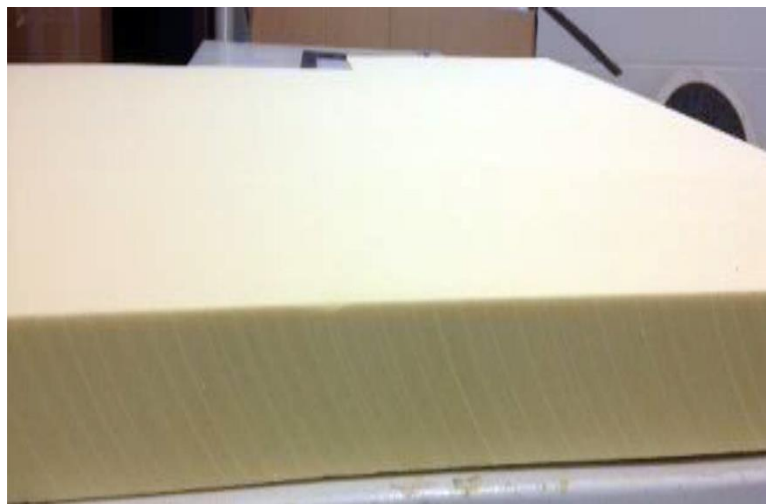
The Type 1 (PU RIGID), shown in Fig. 2.1, consists of a relatively high density polyurethane foam (6 pcf) without any special provisions or configuration. The advantage of the Type 1 material is that the manufacturing process is relatively simple as it only entails bonding of a top and bottom facesheet to the foam to form the sandwich panel. The disadvantage is that horizontal shear transfer between the facesheets relies solely on the shear strength and stiffness of the PU foam. The other disadvantage is that as the density of the PU foam increases, which increases horizontal shear transfer strength and stiffness, the cost increases.

Figure 2.1: Type 1 Polyurethane Foam (PU RIGID)

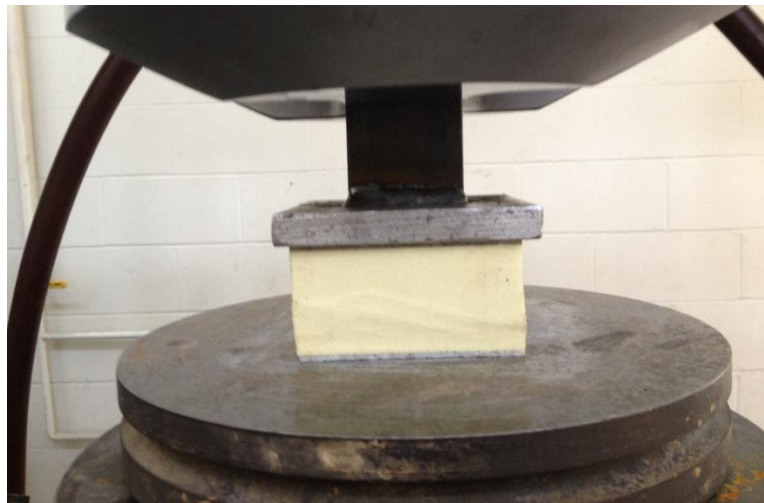
Figure 2.10: Damage at Failure for Flatwise Compression Testing of Type 1

fail. Also, this yield point is present on the stress versus strain curves for all three specimens, and it is easy to determine the stress and strain at this point. As a result, the flatwise compressive strength will be considered as the stress at this point. A visual representation of what the failure of the specimens actually looked like just after failure and at the end of the test is shown in Figs. 2.10 and 2.11, respectively.

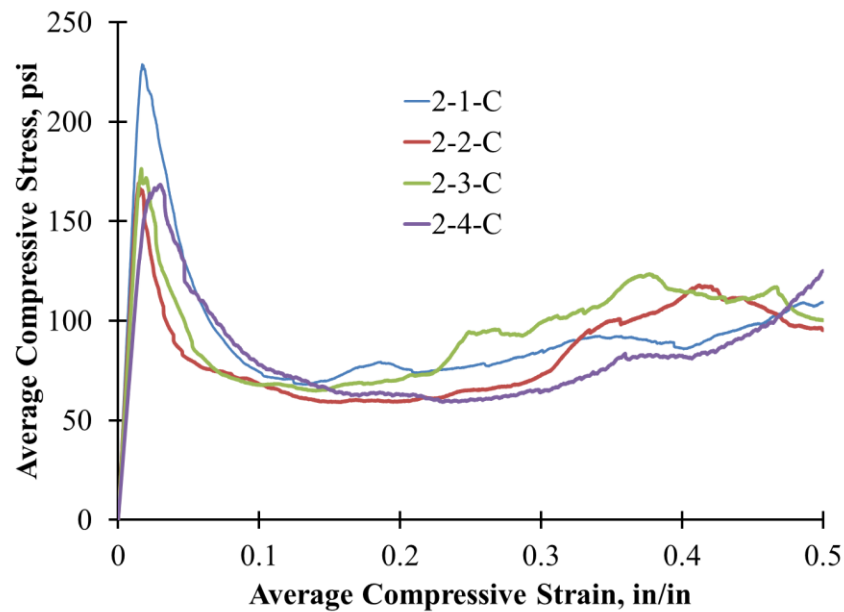
Moving forward with the analysis, the initial false nonlinearities and discrepancies in the load versus displacement response were corrected, and the stress and strain were calculated for each specimen. The plot of stress versus strain is presented in Fig. 2.12. The stress versus strain response has two distinct regions that are apparent in the figure, and each region can be explained based on the Type 2 core construction. The Type 2 core consists of thin, interconnecting, glass mat/resin webs that form a bi-directional FRP gridwork that is infilled with a low density polyurethane foam. This FRP gridwork plays an important role in the stress versus strain response.

Figure 2.12: Stress-Strain Results for Type 2 Flatwise Compression Test

In the first region, the web reinforcement has an apparent linear elastic behavior because the material consists of resin and fibers that display Hookean behavior to a point. The flexible foam contributes almost nothing to the response directly, but it does provide stability for the webs as they are very thin relative to their length. As a result, the global stress versus strain response in this region is linear, but as the load increases, minor defects in the webs or adjacent foam resulted in portions of the FRP gridwork beginning to buckle, and the behavior transitioned into the second region.

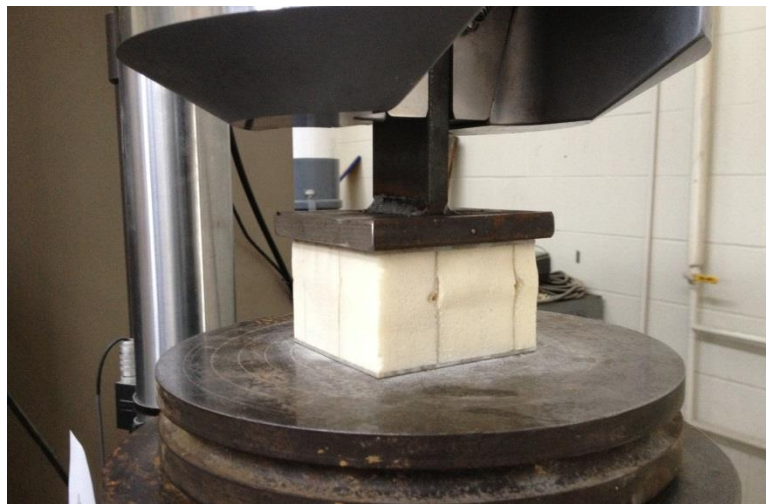
Figure 2.13: Damage at Failure for Flatwise Compression Testing of Type 2

The compressive strength and stiffness were calculated using the stress versus strain plots. The flatwise compressive strength is more evident for the Type 2 core because failure occurred suddenly and was accompanied by a significant drop in load immediately after the peak value. Therefore, the stress at the maximum load was considered to be the flatwise compressive strength. A visual representation of what the failure of the specimens actually looked like just after failure and at the end of the test is shown in Figs. 2.13 and 2.14, respectively.

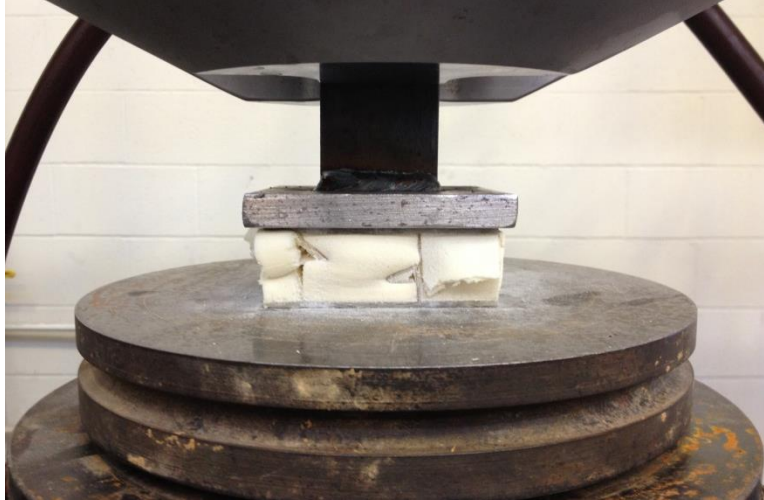
Figure 2.14: Damage at End of Test for Flatwise Compression Testing of Type 2

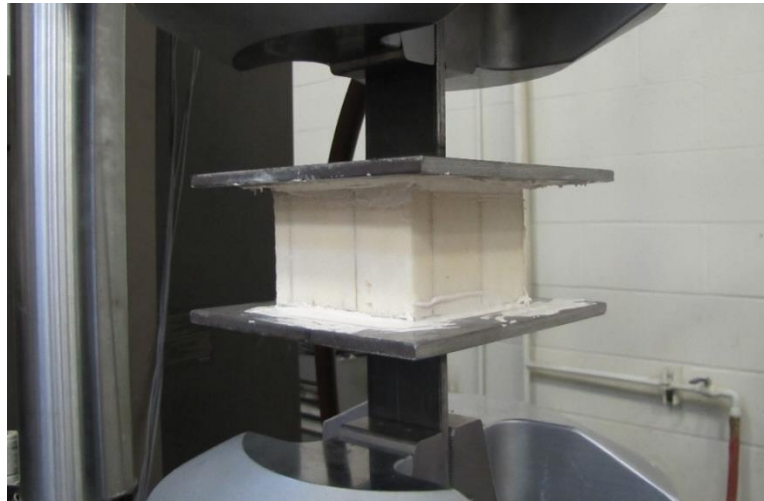
After the initial curing period, the assembly was marked to ensure it would be tested using the same orientation. It was removed and stored at standard room temperature and humidity conditions until testing was completed a few days later. The epoxy required a minimum 8 hour curing period to achieve full strength. Figure 2.15 shows a photograph of Specimen 2-1-T after it was adhered to the plates.

Figure 2.15: Prepared Specimen for Flatwise Tension Test

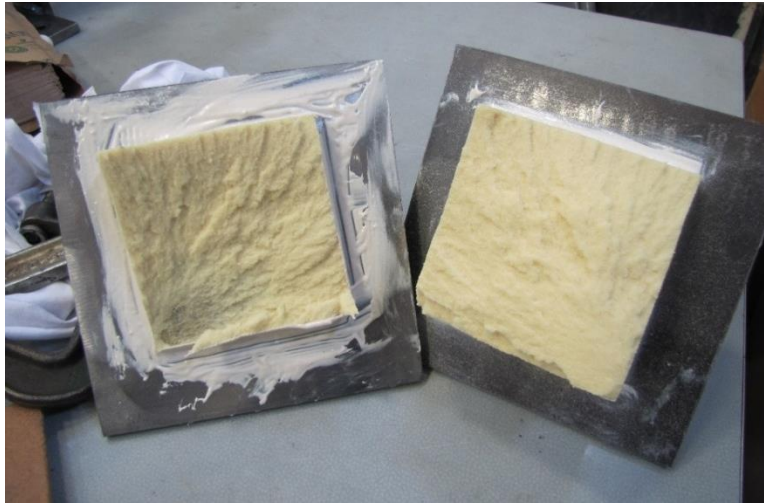
Figure 2.19: Fracture Surface for Flatwise Tension Testing of Type 1

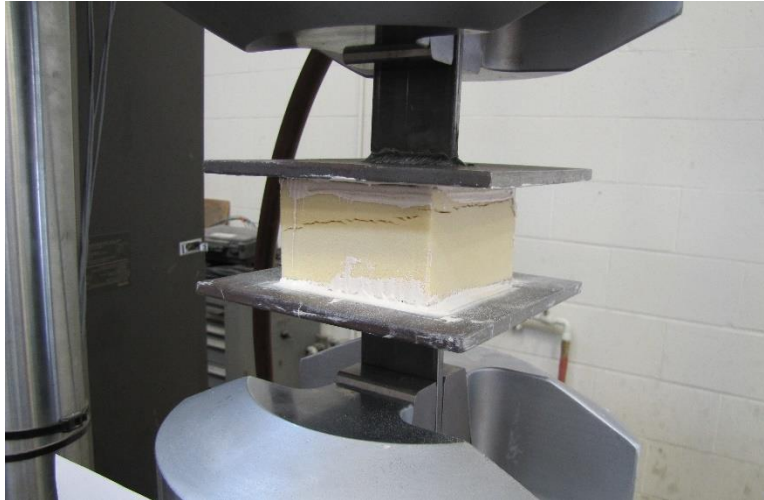
2.3.2.3. Results for Type 3. As with the flatwise compression testing, the flatwise tension testing for the Type 3 core consisted of testing the foam alone without any mat reinforcement. Representative square blocks of the Type 3 material were sectioned for testing, with three random samples chosen from the five available specimens. The stress-strain response of the Type 3 foam was essentially linear prior to failure, where an abrupt drop in stress occurred when the foam fractured, similar to the response shown in Fig. 2.17 for the Type 1 foam. Figure 2.23 is a photograph of the fracture that occurred at the peak load.

Figure 2.23: Damage at Failure for Flatwise Tension Testing of Type 3

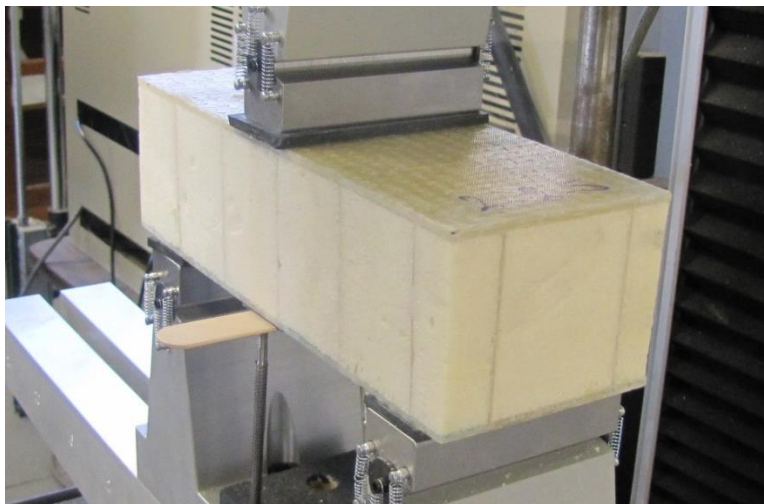
Figure 3.3: Type 2 (WEB-CORE) Sandwich Panel Specimen

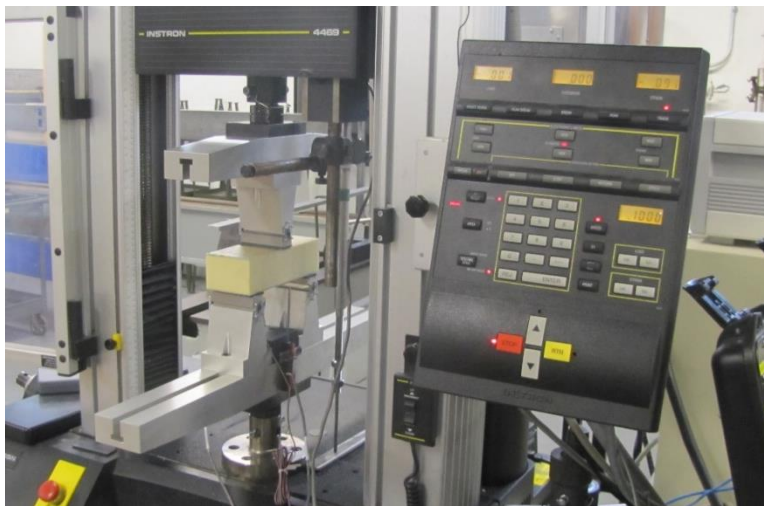
Figure 3.5: Three Point Flexural Test Setup

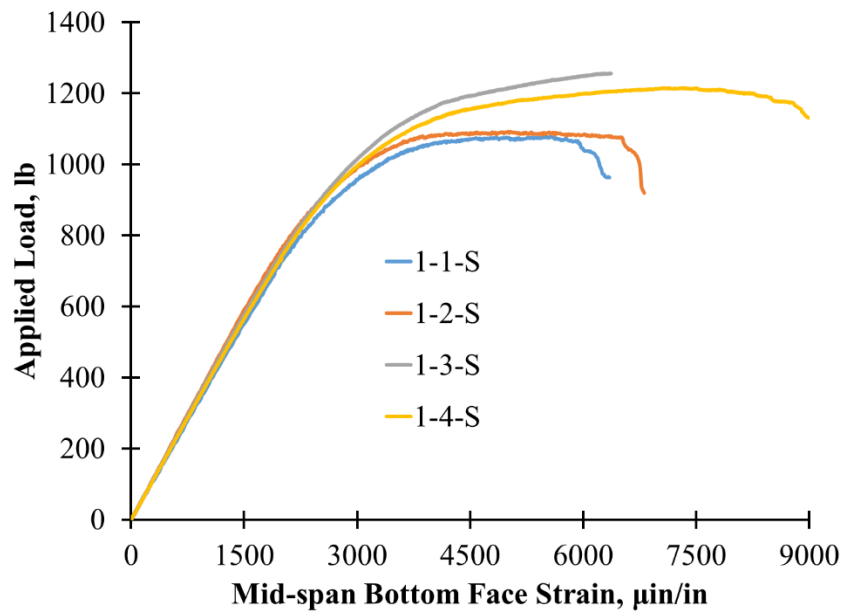
Figure 3.7: Applied Load vs. Mid-Span Bottom Face Strain for Type 1

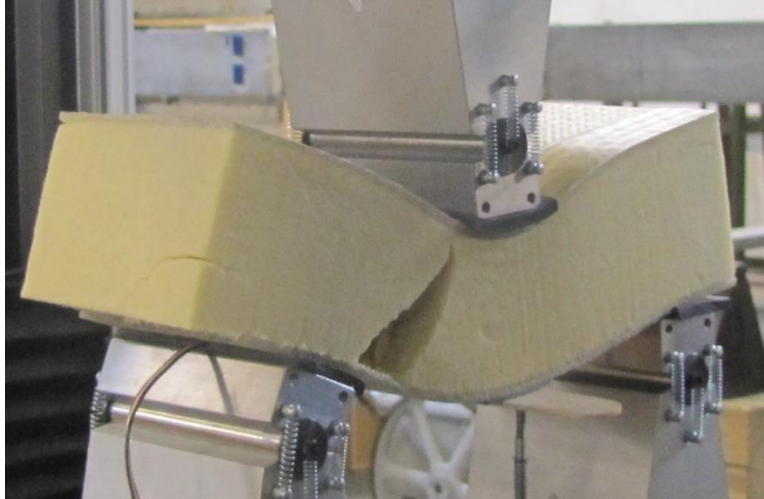
Figure 3.10: Ultimate Failure Due to Shear Failure of the Core Material for Type 1

specimen ultimately failed due to shear stresses in the core. A photograph of the initial crushing of the foam where the response became nonlinear is shown in Fig. 3.8. Also, photographs of the ultimate failure due to excessive wrinkling of the facing, as well as shear failure in the foam, are shown in Figs. 3.9 and 3.10, respectively.

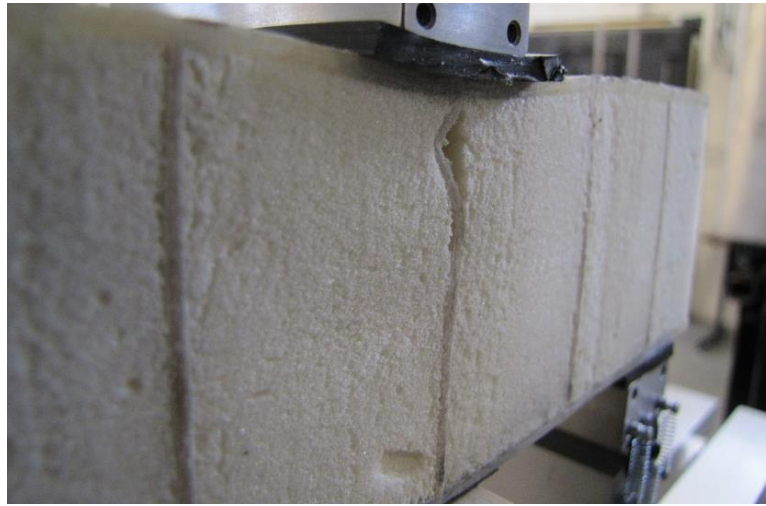
In conclusion, the initial failure mode for all three specimens was local indentation directly beneath the load initiated by buckling of the reinforcing webs. Then, the ultimate failure mode for each of the specimens was excessive local indentation caused by fracturing of the reinforcing webs. A photograph of the damage to the specimen when the response became nonlinear is presented in Fig. 3.13. A photograph of the damage at ultimate failure when the load reached its peak value is presented in Fig. 3.14.

Figure 3.13: Initial Failure Due to Buckling of the Reinforcing Webs and Local Indentation for Type 2

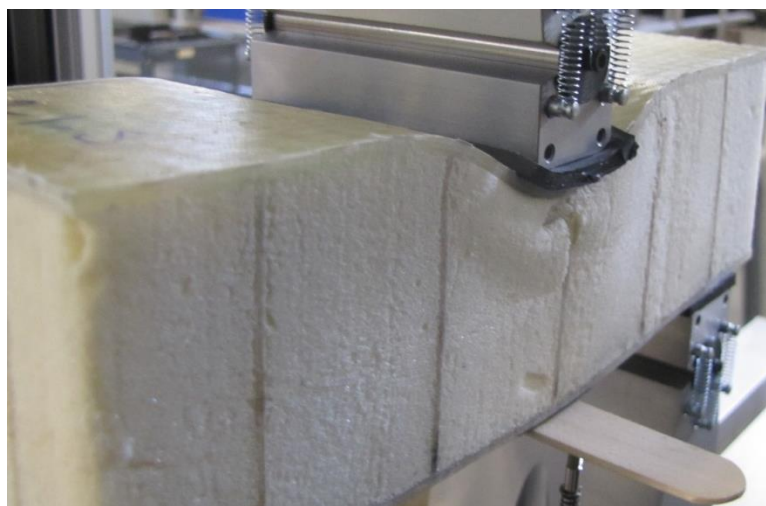
Figure 3.14: Ultimate Failure Due to Fracturing of Reinforcing Webs and Excessive Local Indentation for Type 2

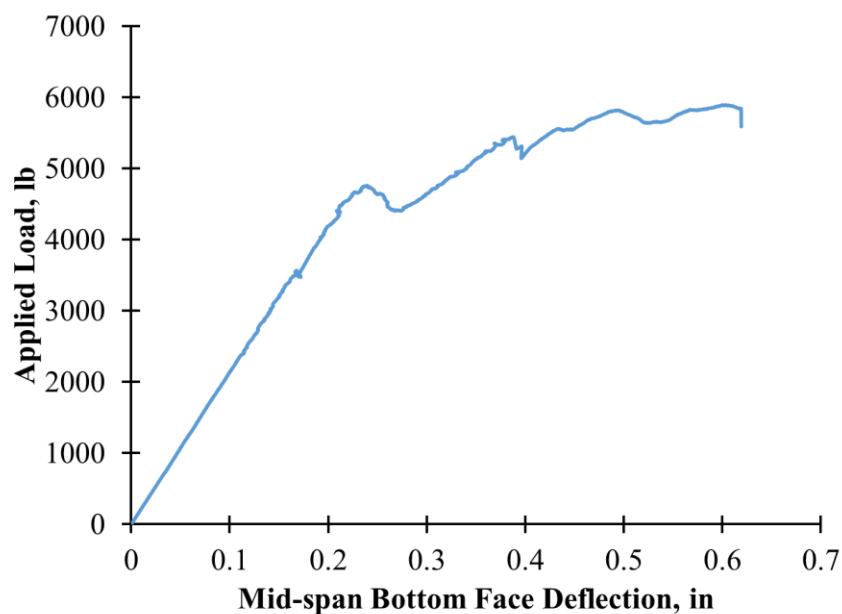
3.2.2.3. Results for Type 3. For the three point flexural tests, one specimen was prepared and successfully tested for the Type 3 sandwich construction. Unfortunately, the foam blocks needed to manufacture the Type 3 panel for the small scale flexural tests were difficult to obtain in the size that was needed, and only one representative small scale beam could be manufactured in the time allowed for this stage of the project. Therefore, very few specimens could be produced from the single beam. After the test, the initial false nonlinearities and offset were corrected for each of the data curves, and the corrected data was plotted. The bottom face deflection and the strain in the bottom facing at mid-span were plotted as the dependent variable versus the load in Figs. 3.15 and 3.16, respectively. From these curves, several observations were made about the material behavior, and based on the observations made during the tests, a failure mode for the Type 3 specimens was determined.

Figure 3.15: Applied Load vs. Mid-Span Bottom Face Deflection for Type 3

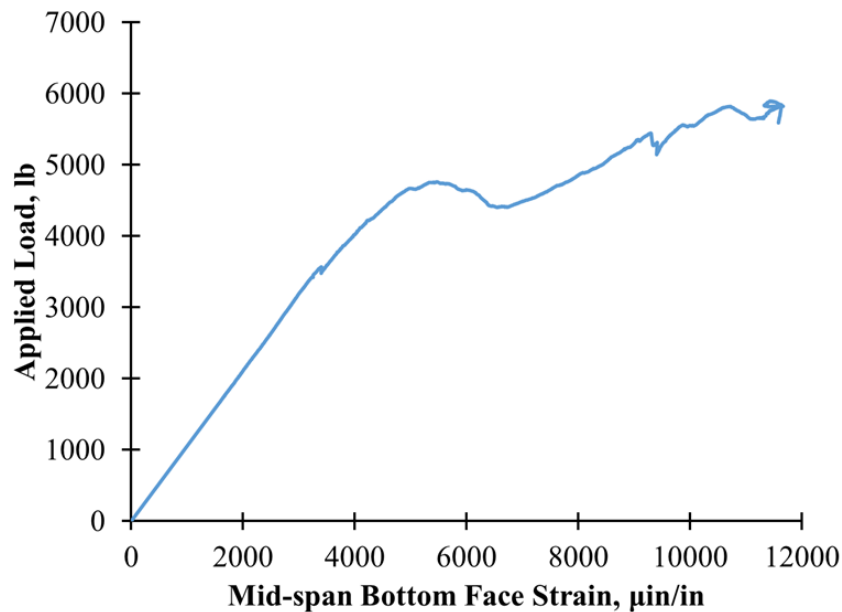
Figure 3.16: Applied Load vs. Mid-Span Bottom Face Strain for Type 3

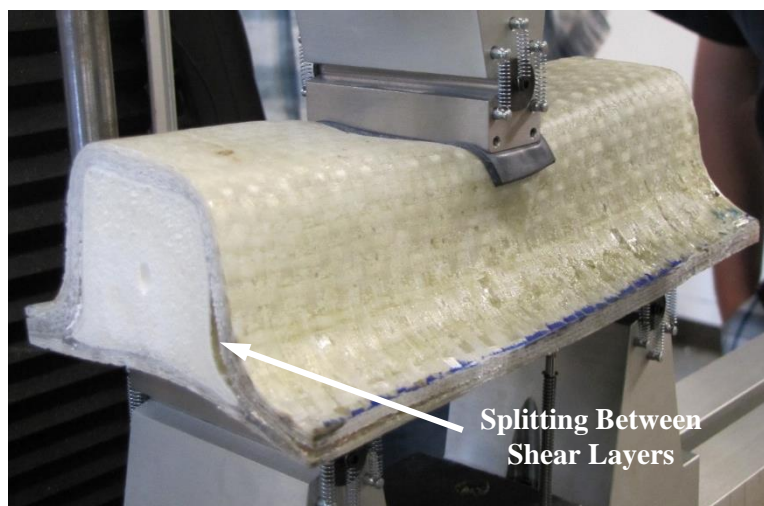
Summarizing the test, the initial failure mode involved splitting between the shear layers just above one of the supports, and the shear layer separation that formed became progressively larger throughout the remainder of the test, which likely had a significant effect on the response of the specimen. The ultimate failure mode was excessive local indentation, which led to crushing of the shear layers under the load point. A photograph of the splitting between shear layers at the beginning of the test that caused some nonlinearity in the response is shown in Fig. 3.17. The localized damage under the load point that caused erratic jumps in the applied load at the end of the test is shown in Fig. 3.18. Also, the severity of the unsymmetrical deformation caused by splitting of the shear layers by the end of the test is shown in Fig. 3.19.

Figure 3.17: Initial Failure Due to Splitting Between Shear Layers for Type 3

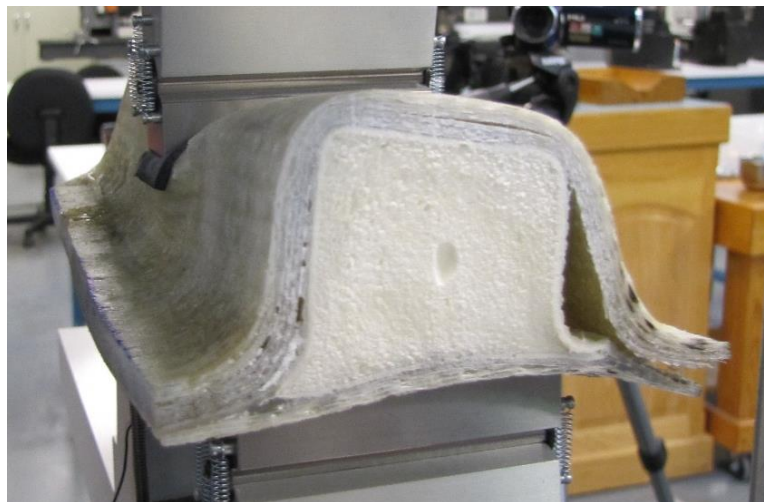
Figure 3.19: Unsymmetrical Deformation Caused by Splitting Between Shear Layers for Type 3

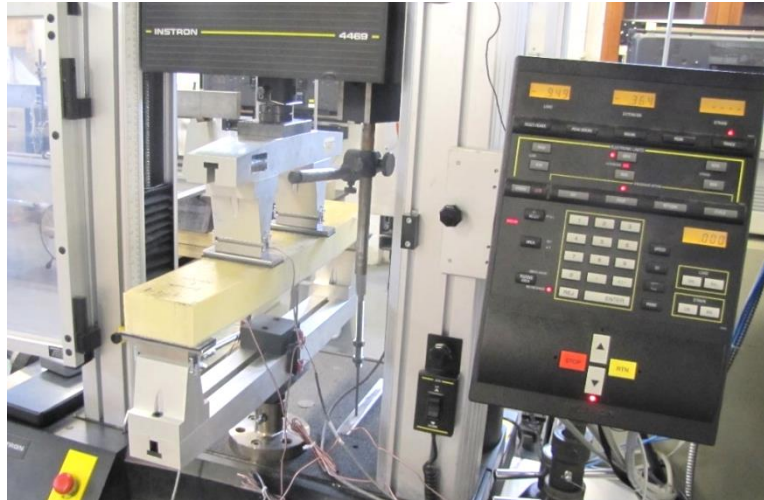
Figure 3.23: Four Point Flexural Test Setup

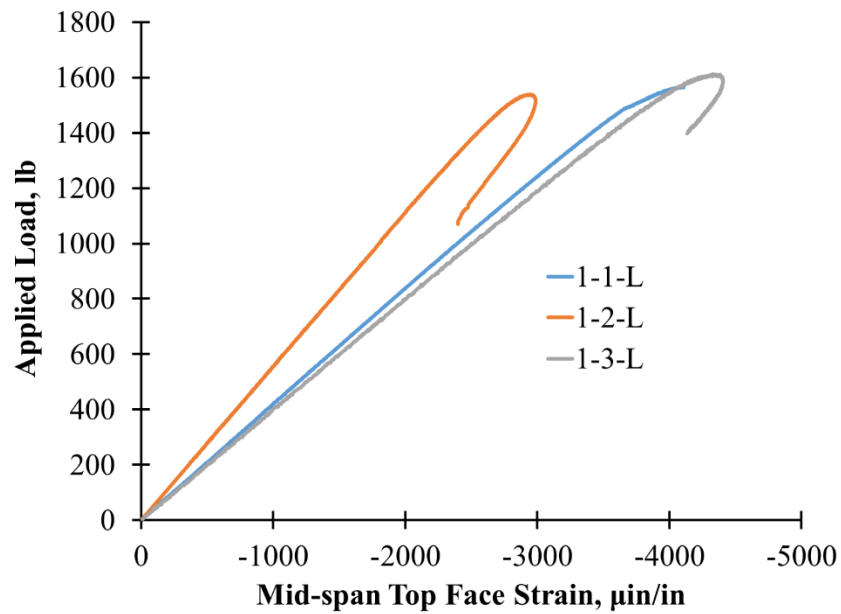
composite response that is linear elastic. Therefore, the linear behavior was again expected for the four point flexural specimens.

Figure 3.25: Applied Load vs. Mid-Span Top Face Strain for Type 1

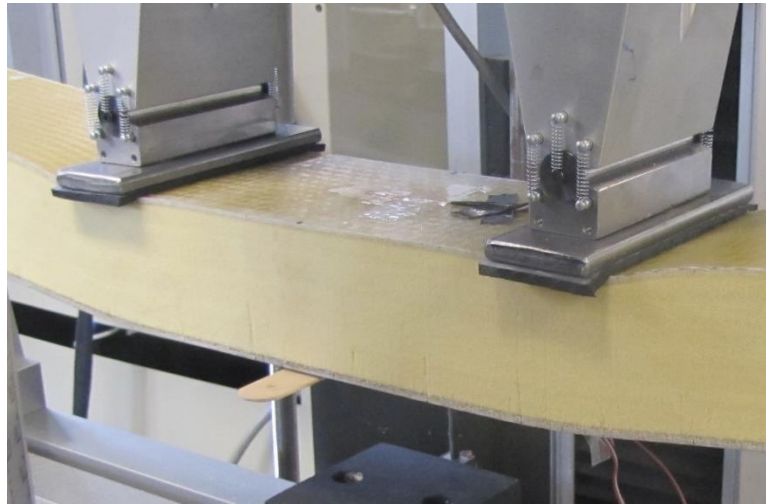
Figure 3.27: Initial Failure Due to Local Indentation for Type 1

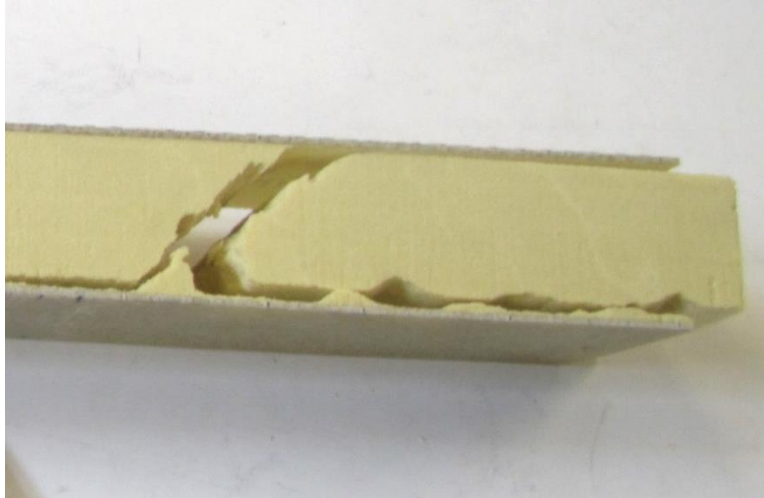
Figure 3.29: Ultimate Failure Due to Shear Failure of the Core Material for Type 1

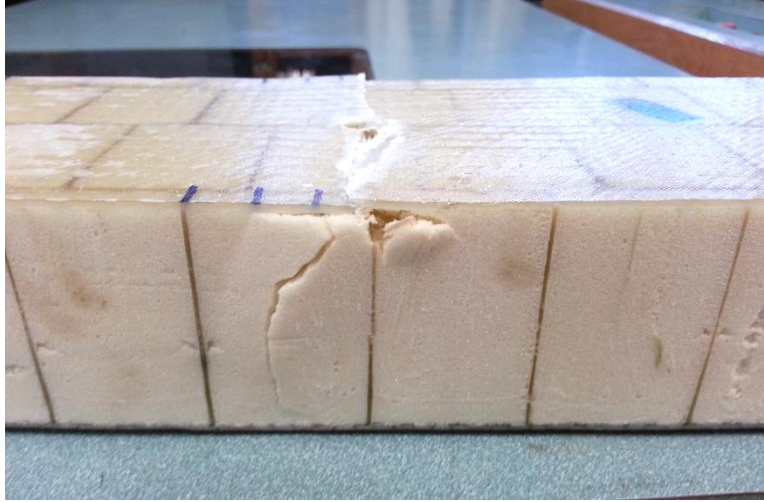
Figure 3.35: Ultimate Failure Due to Compressive Failure of the Top Facing for Type 2

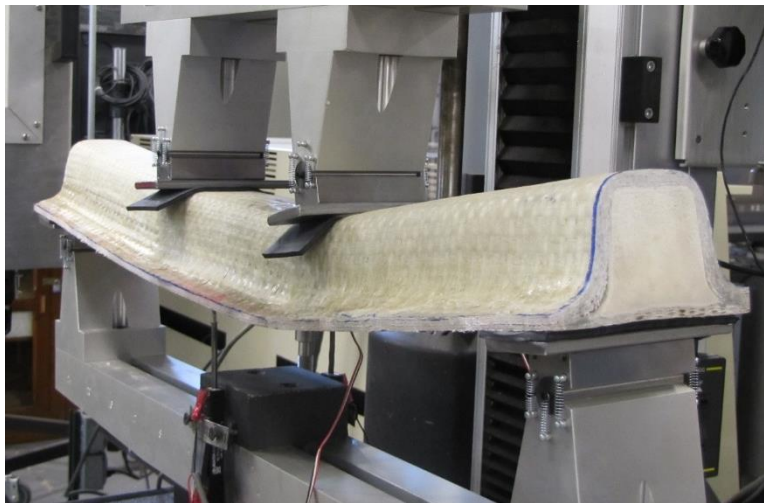
Figure 3.39: Ultimate Failure Due to Compressive Failure of the Top Facing for Type 3

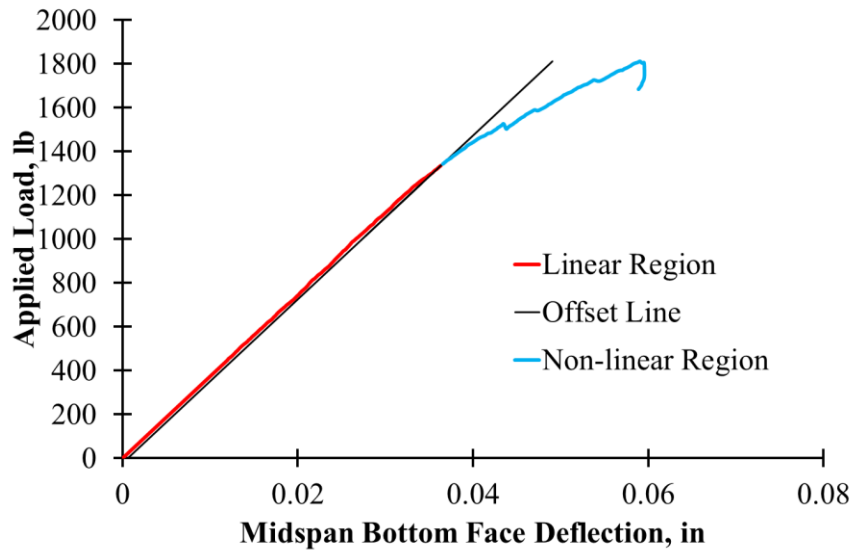
Figure 4.5: Estimate of Initial Failure Load Using Offset Method

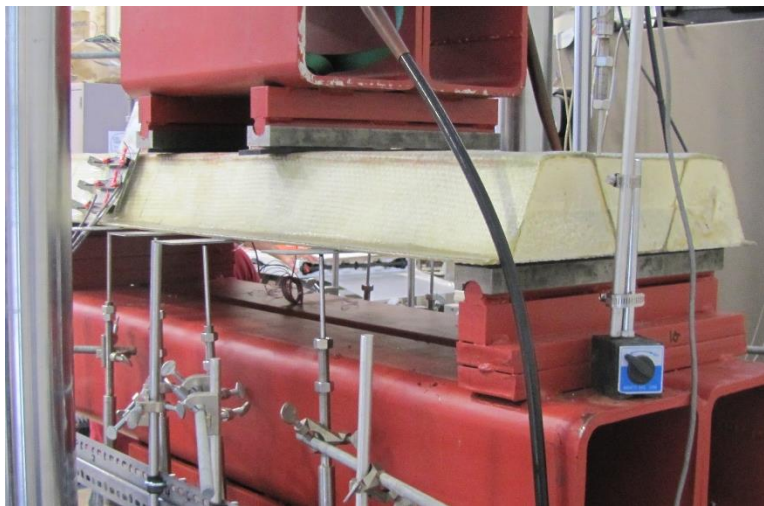
Figure 5.7: Mid-Scale Panel Test Setup

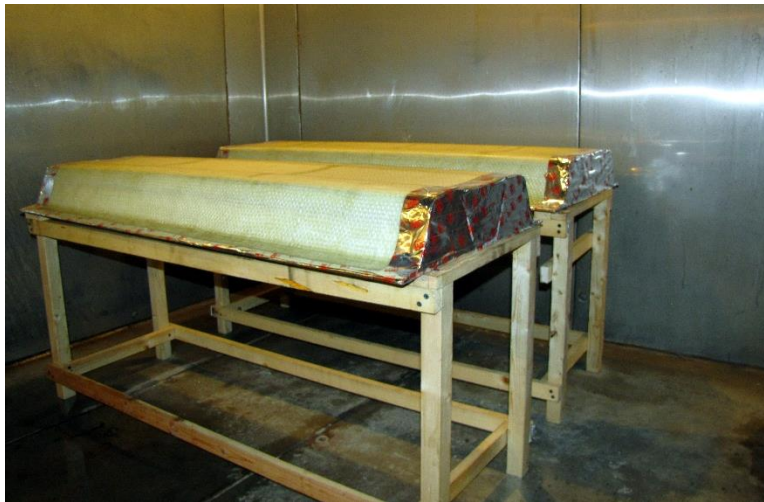
Figure 5.14: Durability Specimens within Environmental Chamber

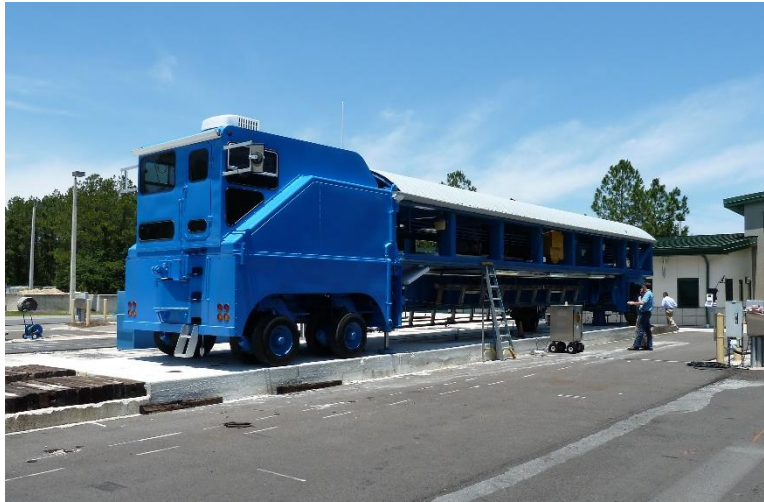
Figure 6.1: Load Test of Full-Scale Prototype Panel
