# Synthesis on the Use of Accelerated Bridge Construction Approaches for Bridge Rehabilitation

**Final Report**  
**December 2015**

Federal Highway Administration  
Accelerated Bridge Construction University Transportation Center  
U.S. Department of Transportation Office of the Assistant Secretary  
for Research and Technology  
Iowa Department of Transportation  
(Part of InTrans Project 05-52)

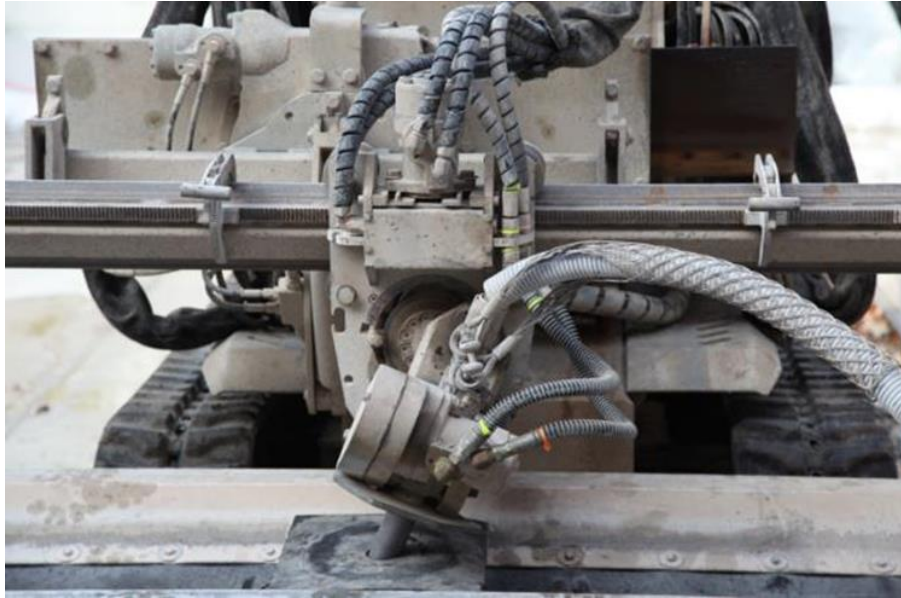
As mentioned previously, hydrodemolition is a process that makes use of a high-pressure water jet to remove damaged or deteriorated concrete. A hydrodemolition unit as well as a surface removed using hydrodemolition are shown in Figures 1 and 2, respectively.

**Figure 1. Hydrodemolition machine**

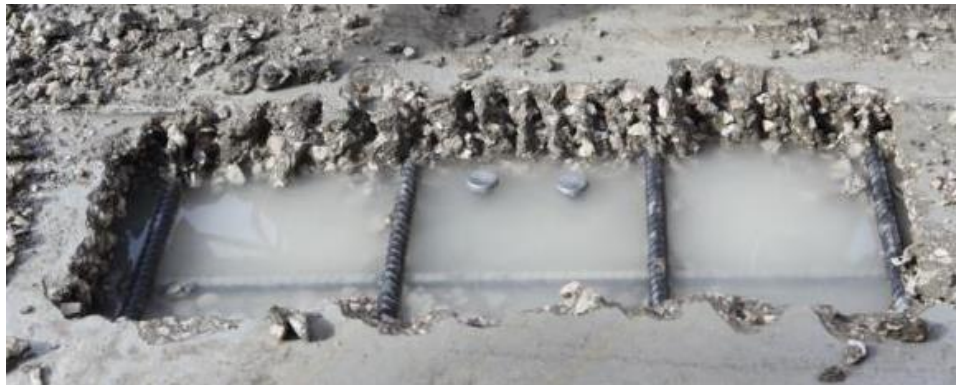
**Figure 2. Removal area using hydrodemolition**

Damaged concrete can be removed with relatively high precision, allowing the designer/contractor to be much more selective in their removal process. The interface created from the water jet provides for a very rough surface, which should result in a better bond between the remaining concrete and the repair materials compared to the surface generated by jackhammers and sandblasting. Furthermore, other methods may cause microcracking of the concrete or may damage the underlying steel reinforcement or superstructure; whereas, hydrodemolition leaves these areas unharmed, making it a good option for both partial- and full-depth removal (Phares et al. 2014).

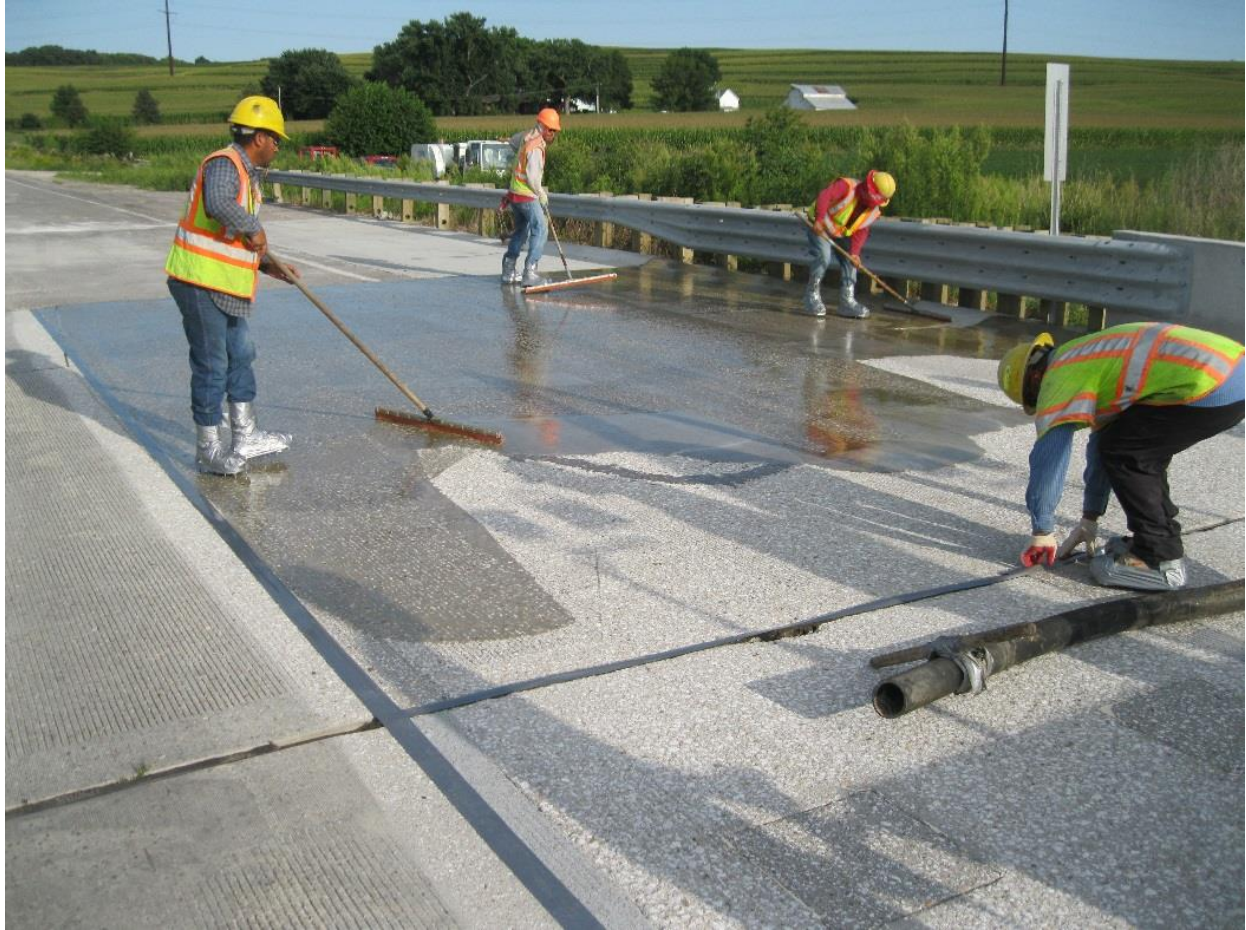
Polymer overlays can reduce infiltration and increase skid resistance; however, they cannot be used to improve ride quality or drainage because of the relatively thin nature of their application. Because the polymer is very lightweight, it may have the added benefit of creating additional live load capacity on the deck by minimizing the additional dead load added (Sprinkel and Sellars 1990). Application of a polymer overlay is shown in Figure 3.

**Figure 3. Polymer overlay application**

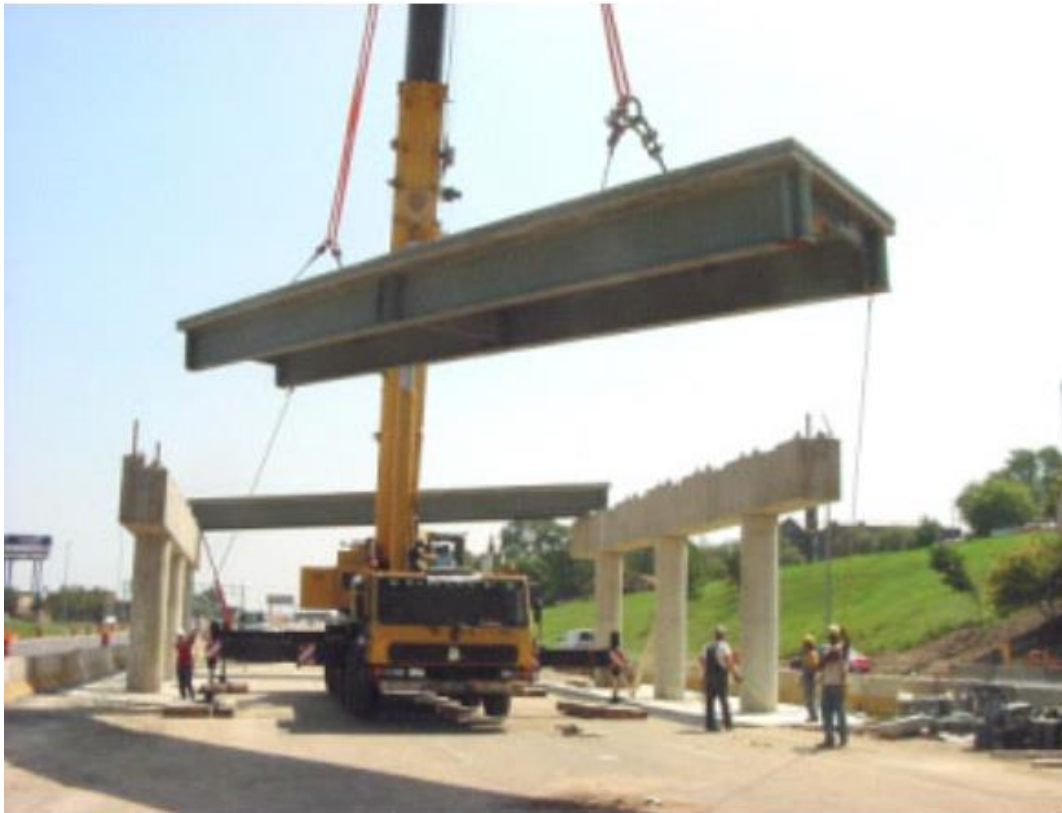
Inverset girders are beams that are cast inverted in forms so that, when they are turned upright, the tension areas are already precompressed, leading to a potential increase in durability. This system is shown in Figure 25.

**Figure 25. Inverset panel being lifted into place**
